To: Jerald Schnabel
Continental Materials Corp.
File: May 2021 Monitoring Summary

From: Paul Kos
Denver, CO 80222
Date: June 30, 2021

Reference: May 2021 Geotechnical Monitoring Summary Pikeview Quarry

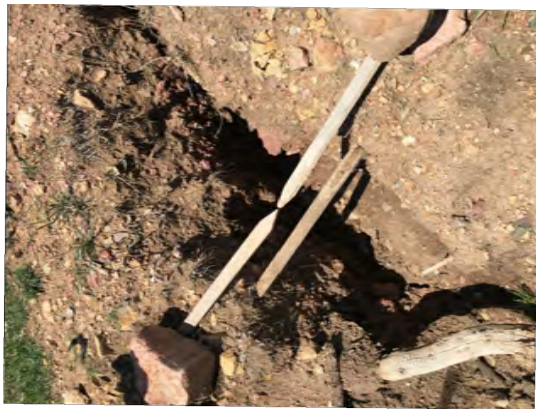
- Pickets were placed around one of the larger cracks to track any changes over the coming months. (Photo 6)
- The culvert remains cleared but partially blocked inside. Future storm events are expected to remove the remaining sediment, but CMC will use a water truck to clean out the inside of the culvert. (Photo 1)

6. PICKETS PLACED AROUND CRACK

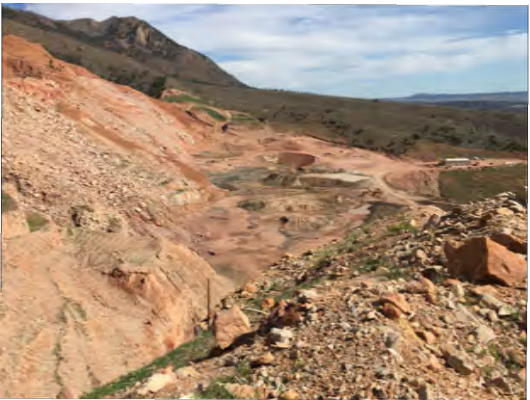
- Fill: Material is being imported and temporarily placed on the “production floor”. During the visit, different types of material including mulch and general fill were being deposited here for future placement. (Photo 3)
- Visual inspections of the Pikeview Quarry did not reveal any evidence of large-scale instability outside of the landslide areas previously identified. No bulging, rippling, over-steepening, depressions, slumps, or dry slip-offs were observed in areas that have been graded and/or reclaimed.

3. VIEW NORTH TO PRODUCTION FLOOR

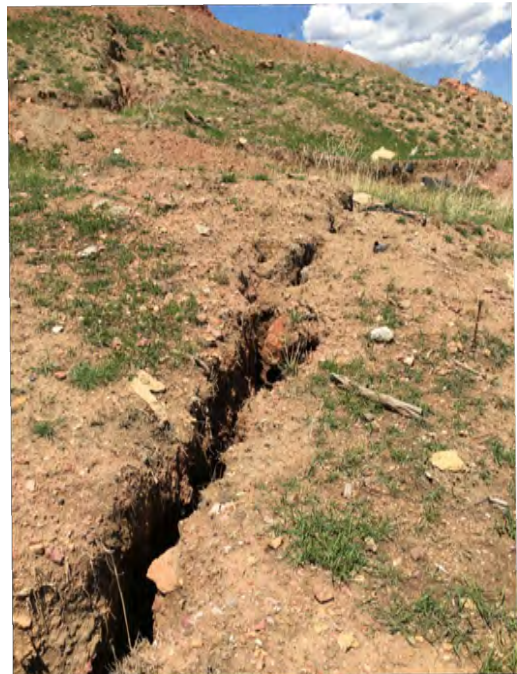
- Open Cracks: An open crack was observed during this visit. This feature is in an area where cracking is expected to occur as a result of ongoing slope settlement and relaxation. The edges of the crack have eroded suggesting it is not a new feature. (Photo 7)

- Healed Cracks: A crack was observed on the slope adjacent to the slide where cracking had previously been observed. This crack runs parallel to the slide and appears to be “healed” and did not indicate any recent movement.

7. HEALED CRACKING PARRALEL TO SLIDE

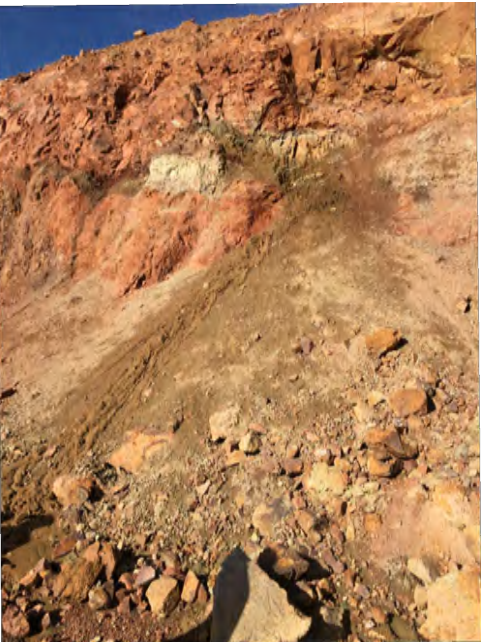
- Seepage was observed on the steep slopes of the middle peak, and in some of the haul roads along the slopes. (Photo 2)
- The water level of the pond at the top of the road near Mid-Peak is lower. (Photo 4)

2. SEEPAGE FROM ROCK AT MID-PEAK

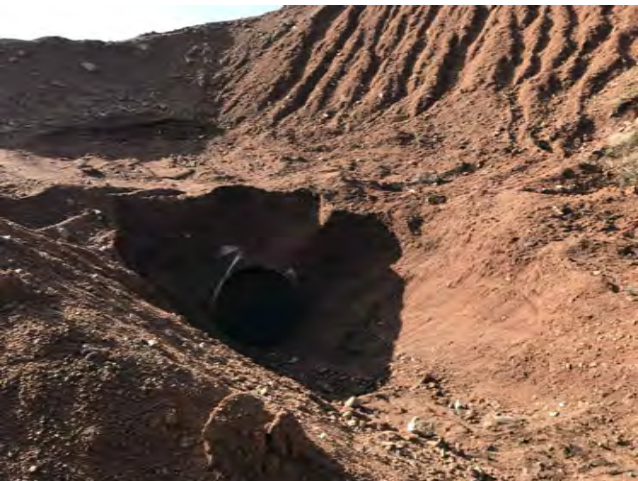
1. CULVERT PARTIALLY CLEARED, LIGHT COMING THROUGH

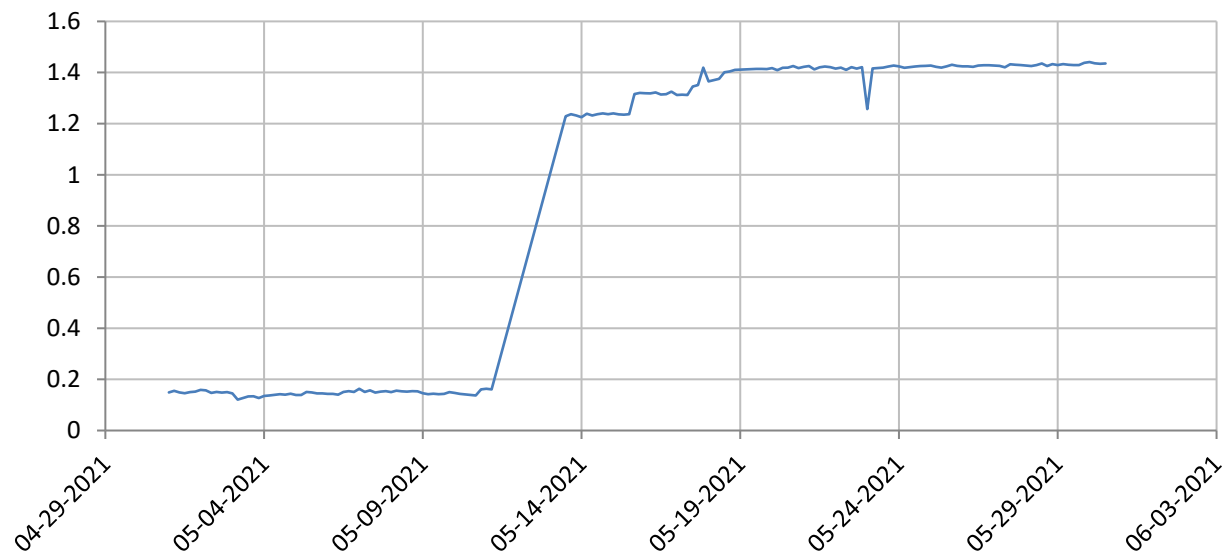
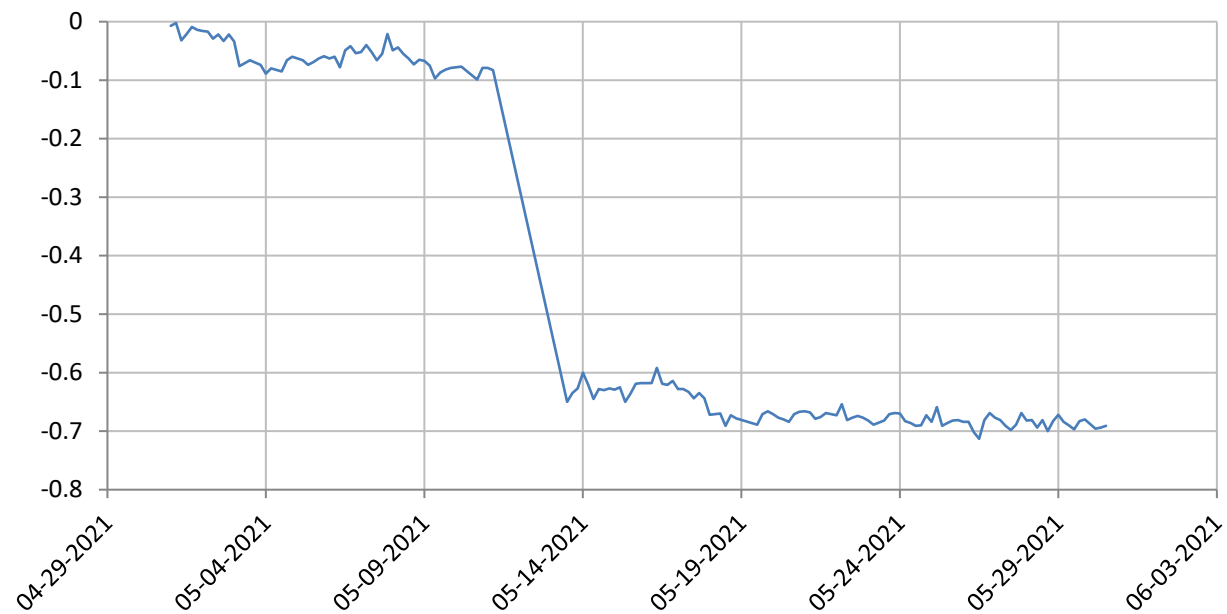
Prism TOE3

Prism ID	Cumulative Transverse Displacement (ft)	Cumulative Height Displacement (ft)	Monthly Delta (ft)	Cumulative Delta (ft)	Needs / Recommendations
CP1	-0.003	-0.031	-0.0118	0.0319	
CP2	-0.066	-0.018	-0.0025	0.4019	
CP3	0.265	-0.236	-0.0009	0.3582	
NP1	0.097	-0.091	0.0955	0.1508	Slope creep at slow velocity.
NP2	0.008	-0.081	0.0287	0.1155	
NP66	0.312	-0.395	0.1937	0.5684	Slope creep at slow velocity.
P1	0.348	-0.064	-0.0049	0.3543	
P2	0.156	-0.054	-0.0075	0.2165	
P25	-0.023	0.018	-0.0020	0.1381	
P32	-0.091	-0.111	0.0256	0.2745	
P33	-0.116	-0.068	0.0126	0.2207	
P35	0.043	-0.192	-0.0091	0.4341	
P4	0.369	-0.138	-0.0068	0.4810	
P5	0.401	-0.168	-0.0083	0.6143	
P63	15.317	-6.268	0.0191	16.5500	Slope creep at slow velocity.
P69	-0.04	-0.033	-0.0039	1.9787	
P70	0.367	-0.307	-0.0006	0.6006	
TOE1	0.262	-0.001	-0.0461	0.4372	
TOE2	0.287	-0.238	0.3672	0.4089	Prism moved by animals. Slope creep at slow velocity.
TOE3	1.435	-0.691	1.5684	1.7176	Prism repositioned. Slope creep at slow velocity.
