Bowie #1 inspection report

Permit Number: C-1981-038 Mine Name: Bowie No. 1 Mine Operator: Bowie Resources, LLC Operator Address: Mr. Basil R Bear P.O. Box 1488 Paonia, CO 81428	County: Delta Operation Type: Underground Permit Status: Active Ownership: Private
	Operator Representative Present: None
Operator Representative Signature: (Field Issuance Only)

Inspection Start Date: June 30, 2021 Inspection Start Time: 09:30 Inspection End Date: June 30, 2021 Inspection End Time: 12:00		Inspection Type: Coal Partial Inspection Inspection Reason: Normal I&E Program Weather: Clear	
Joint Inspection Agency: None		Joint Inspection Contacts: 	
Post Inspection Agency: None		Post Inspection Contacts: 	
Inspector(s): Robert Zuber, P.E.	Inspector's Signature: <i>Robert D. Zuber</i>		Signature Date: 7/1/2021

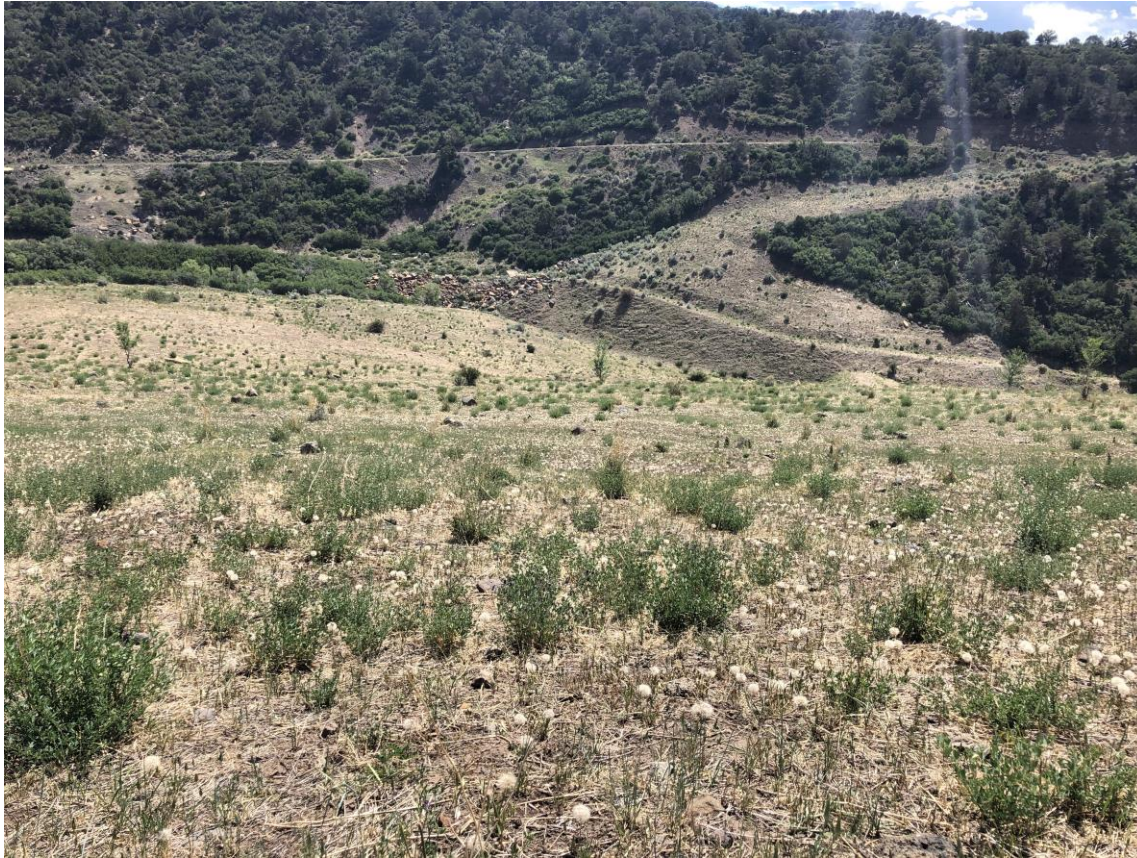
No erosion was seen at the reclaimed area of the East Mine, the ROM and Timber Storage areas, or the West Mine. The buttress at the West Mine appears stable.

The vegetation at the West Mine is sparse, and the grass that is present is mostly short. A predominant species there is alfalfa. Some bare areas were seen at this area.

West Mine, looking down at sparse vegetation, butte, and pond

Because the vegetation at the West Mine is not doing well (it could be stressed by a low amount of moisture, insects, or other factors), the Division recommends that cattle and other livestock be kept off of this area until it recovers.

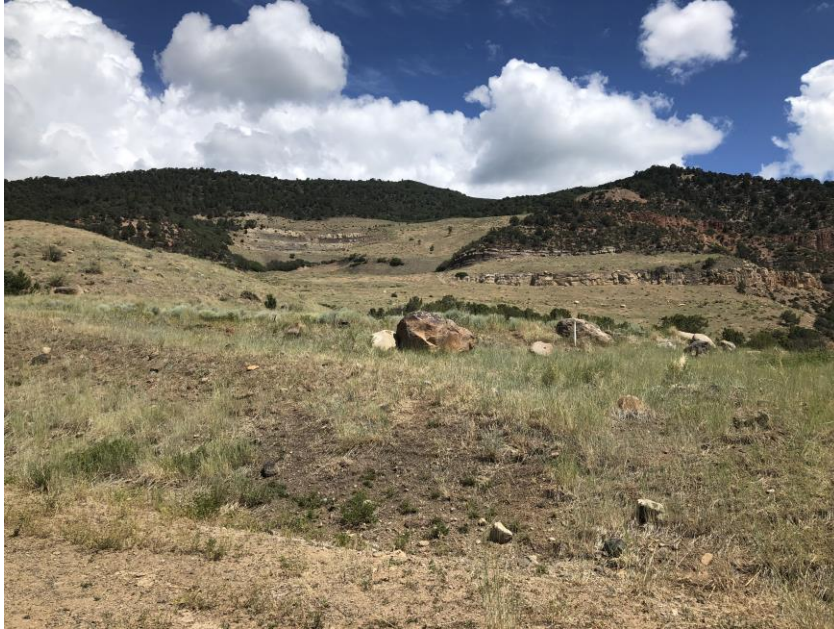
East Mine, looking up from road next to reclaimed pond below RDA

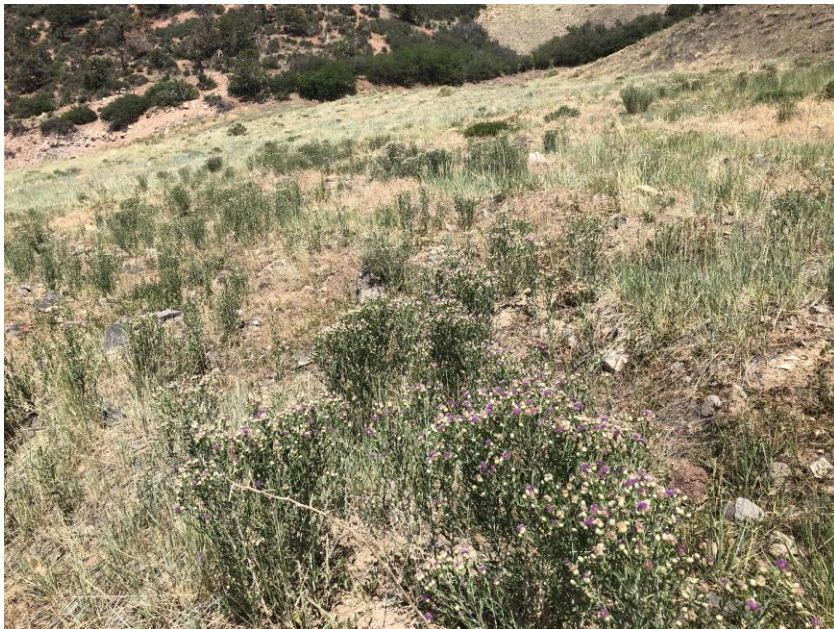
Weeds were seen around the site. Particularly, Russian knapweed was seen at the East Mine, about 700 feet north of the RDA, along the road.

Russian knapweed at East Mine
