Bowie #2 inspection report

PERMIT INFORMATION

Permit Number: C-1996-083 Mine Name: Bowie No. 2 Mine Operator: Bowie Resources, LLC Operator Address: Mr. Basil Bear P.O. Box 1488 Paonia, CO 81428	County: Delta Operation Type: Underground Permit Status: Active Ownership: Private
	Operator Representative Present: None
Operator Representative Signature: (Field Issuance Only)

Inspection Start Date: June 30, 2021 Inspection Start Time: 12:10 Inspection End Date: June 30, 2021 Inspection End Time: 13:20		Inspection Type: Coal Partial Inspection Inspection Reason: Normal I&E Program Weather: Cloudy	
Joint Inspection Agency: None		Joint Inspection Contacts: 	
Post Inspection Agency: None		Post Inspection Contacts: 	
Inspector(s): Robert Zuber, P.E.	Inspector's Signature: <i>Robert D. Zuber</i>		Signature Date: 7/2/2021

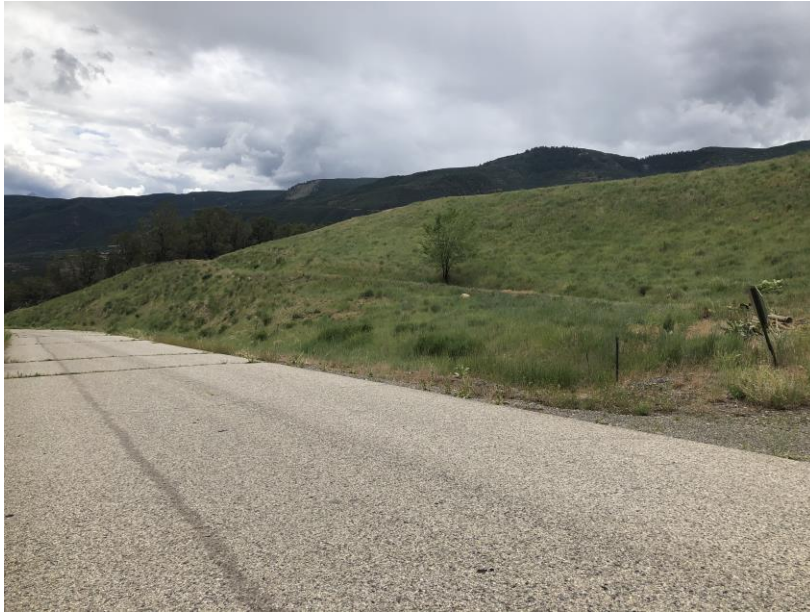
Topsoil Stockpile A

At topsoil stockpiles and coverfill piles, berms, vegetation, and silt fence are keeping these resources in place.

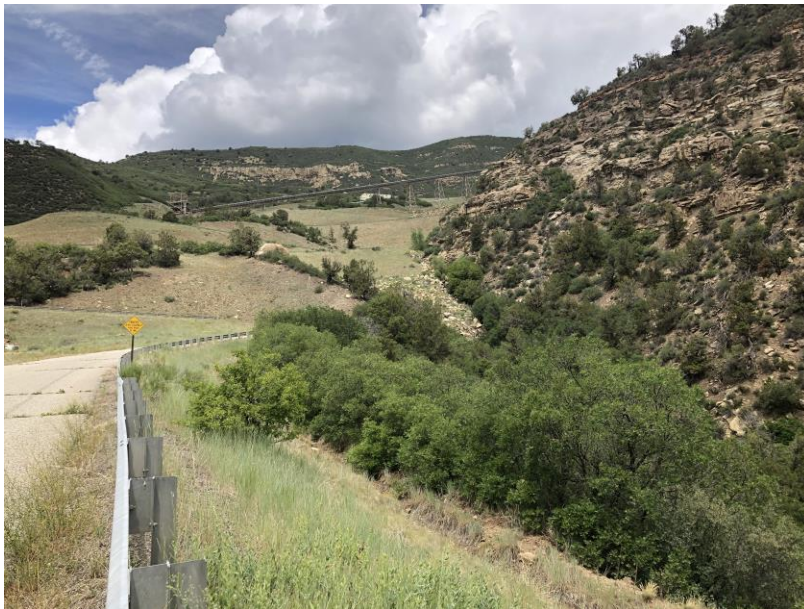
Slopes below portal areas

No problems were identified at the facility areas. All benches appeared stable with no signs of erosion beneath them. These include the pads for the B Portal and the D Portal. Other comments on facilities:

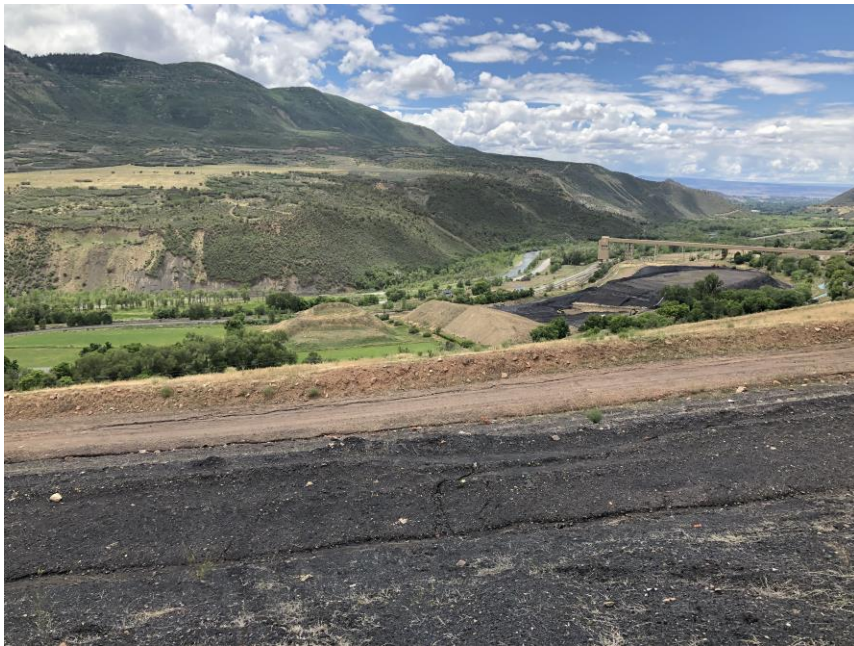
Gob Pile #3 and soil piles, from Gob Pile #2

No significant issues were seen at Gob Pile #3, where BRL staff have been focusing their reclamation activities. **Small puddles were seen on the top of this pile. BRL should avoid any larger puddles developing in the future with grading and/or other practices.**

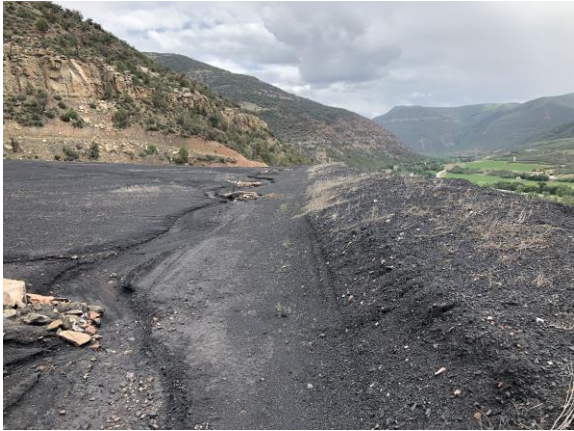
Gob Pile #2 drainage channel

Gob Piles #1, #2 and #4 looked stable. On the upper and lower lifts of Gob Pile #2 only small rills were observed. Most of the drainage control practices on the upper (flat) portion of this pile appear to be functioning well, but some check dams should be repaired. No puddles were observed.
