## inspection report

**PERMIT INFORMATION**

<b>Permit Number:</b> C-1981-028 <b>Mine Name:</b> Keenesburg Strip Mine <b>Operator:</b> Coors Energy Company <b>Operator Address:</b> Mr. Ben Moline PO Box 4030 Golden, CO 80402	<b>County:</b> Weld <b>Operation Type:</b> Surface <b>Permit Status:</b> Permanent Cessation <b>Ownership:</b> Private
	<b>Operator Representative Present:</b>  None
<b>Operator Representative Signature: (Field Issuance Only)</b>

**INSPECTION INFORMATION**

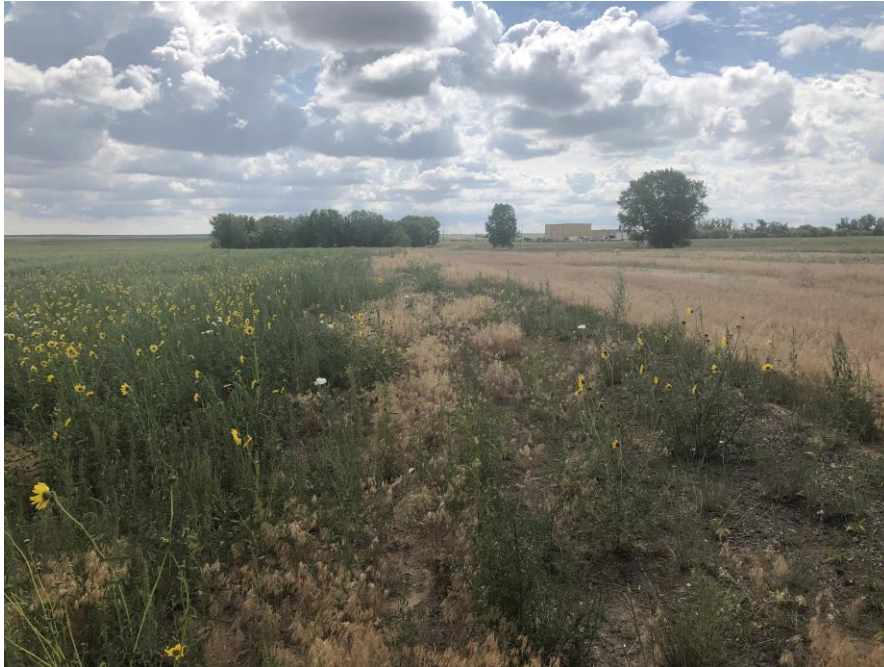
Cheat grass is the predominant species in some of the newly reclaimed areas, such as the reclaimed road adjacent to Sediment Pond 2. In other newly reclaimed areas (e.g., the Long Term Spoil Area), sunflowers are numerous, but not a lot of reclamation grasses were seen.

**Area 42 with reclaimed road on right (tree clump is at Sediment Pond 2)**

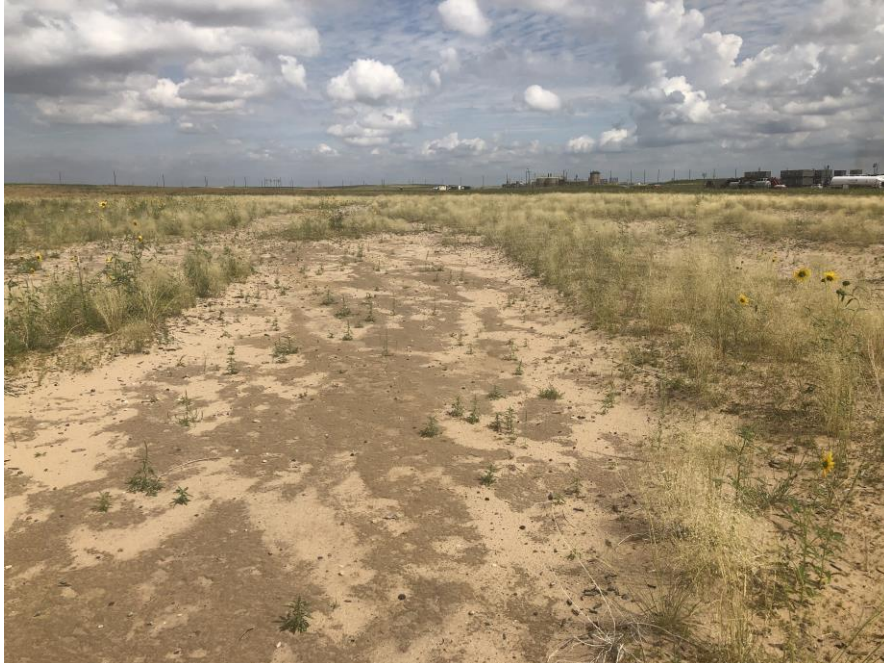
No rills were observed, but bare areas exist where soil movement has been observed in recent months. This was seen on the Long Term Spoil Area and at the reclaimed Topsand Pile A-3.

**Reclaimed Topsand Stockpile at north end of site (was stockpile A-3)**

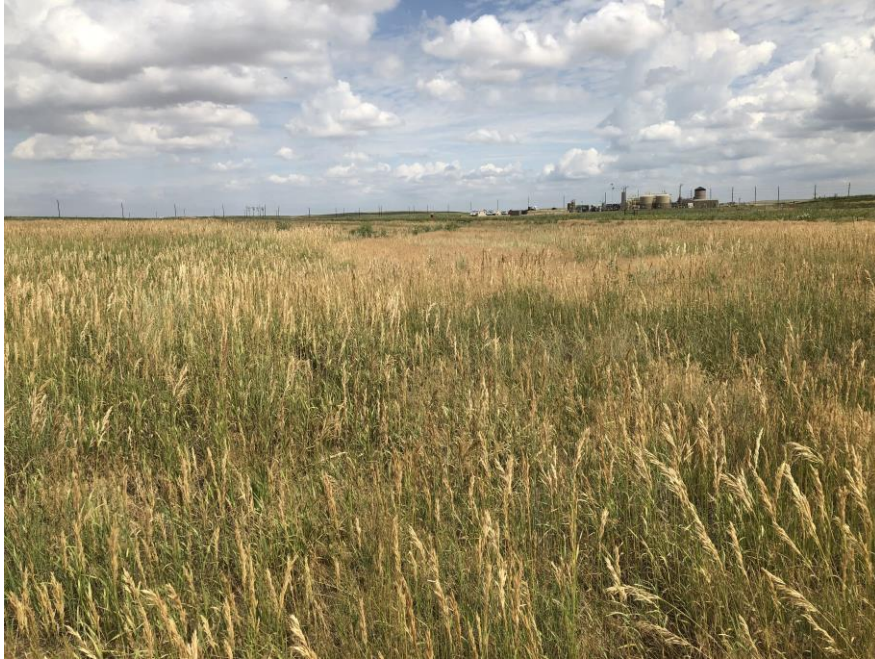
In Area 24 at the northwest corner of the site, the reclamation grasses are very healthy, although patches of cheat grass can be found. The north end of the B Pit was in good shape.

**Area 24 (northwest corner of permit area)**

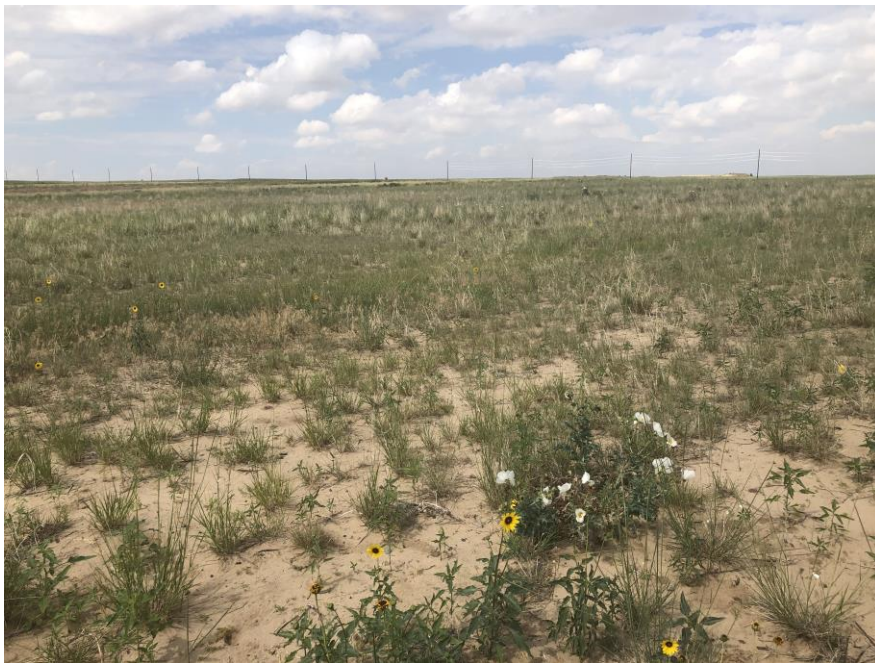
**North end of B Pit**
