MINERALS PROGRAM INSPECTION REPORT
PHONE: (303) 866-3567

MINE NAME: Tezak No 2 Pit	MINE/PROSPECTING ID#: M-1981-080	MINERAL: Sand and gravel	COUNTY: Fremont
INSPECTION TYPE: Monitoring	INSPECTOR(S): Timothy Cazier, P.E.	INSP. DATE: June 16, 2021	INSP. TIME: 10:15
OPERATOR: Tezak Stone & Aggregate Supply, Inc.	OPERATOR REPRESENTATIVE: Nathan Tezak	TYPE OF OPERATION: 112c - Construction Regular Operation	
REASON FOR INSPECTION: Normal I&E Program	BOND CALCULATION TYPE: Partial Bond	BOND AMOUNT: \$55,535.00	
DATE OF COMPLAINT: NA	POST INSP. CONTACTS: None	JOINT INSP. AGENCY: None	
WEATHER: Clear	INSPECTOR'S SIGNATURE:

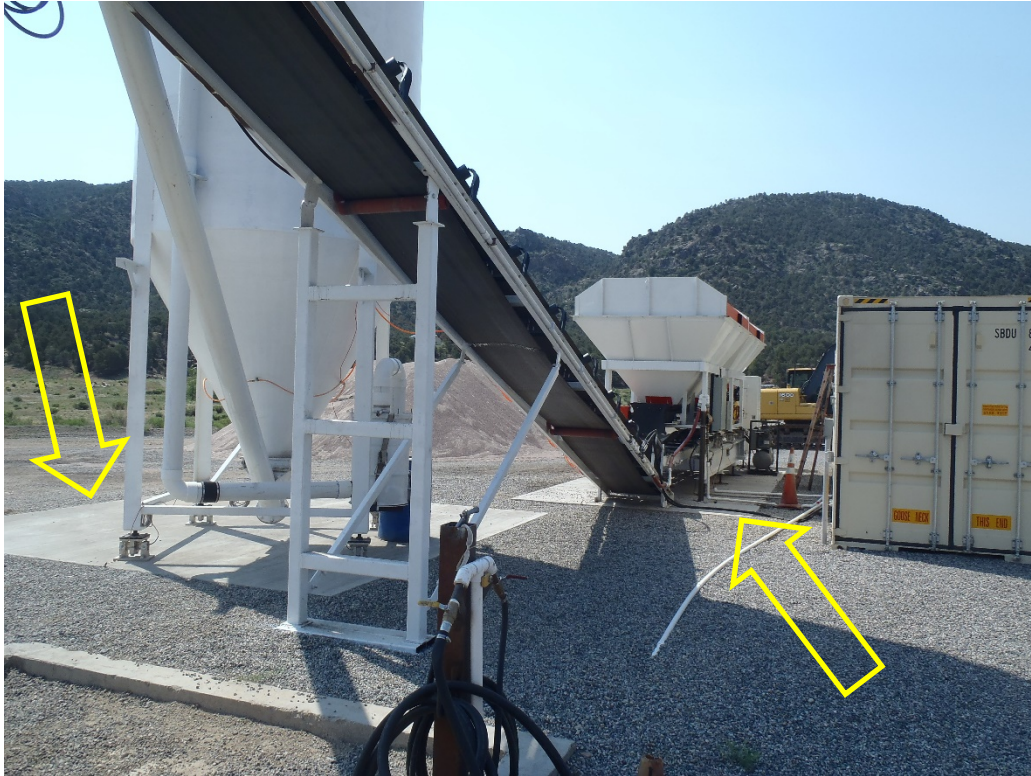
Financial Warranty: The \$55,535 bond held by the DRMS was last updated in 2018 and included 19.8 acres of reseeded. As noted below, a concrete batch plant (*approved in 1988 under TR-01*) has been added since the last inspection. Based on batch plant pad dimensions, the demolition cost for the hopper and silo pads (see **Photo 1**) is about \$250 (see **Attachment A**). The current bond amount is considered adequate for the observed mine disturbance, but the DRMS will include the pad demolition in the next full reclamation cost update.

Photo 1. Concrete batch plant silo & hopper pads (looking south).

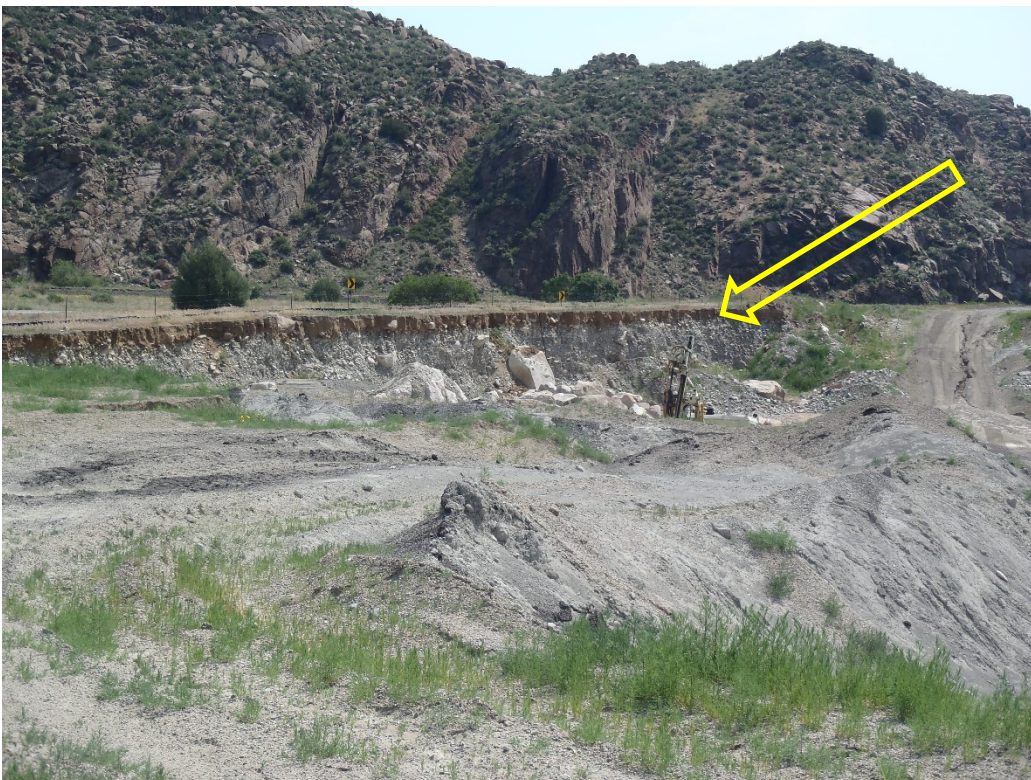
Topsoil: Topsoil is stockpiled in two locations, both on the south side of the pit: one near the center (see **Photo 10**); and the other in the southwest corner (see **Photo 11**). The topsoil horizon can be seen in **Photo 2**.

Photo 2. Active highwall, opposite Hwy 50 visual berm (looking NE; note topsoil layer).

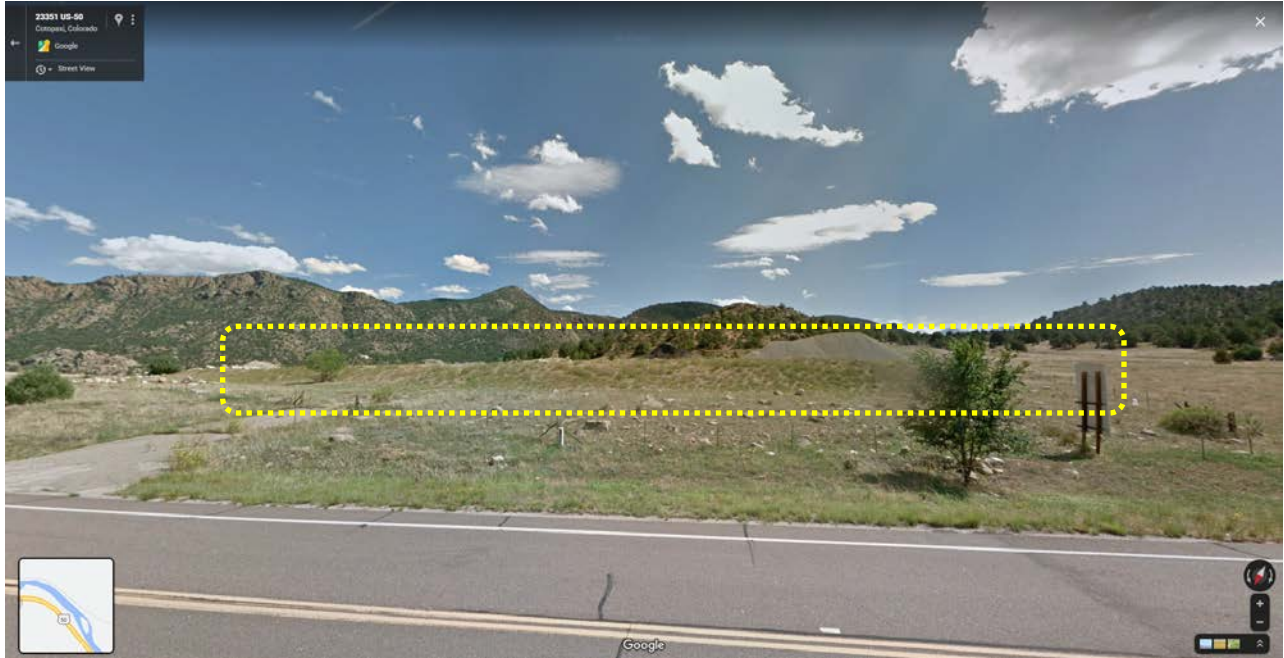
Photo 3. Visual berm opposite active highwall from Hwy 50 (Google Maps street view, 2018 image).

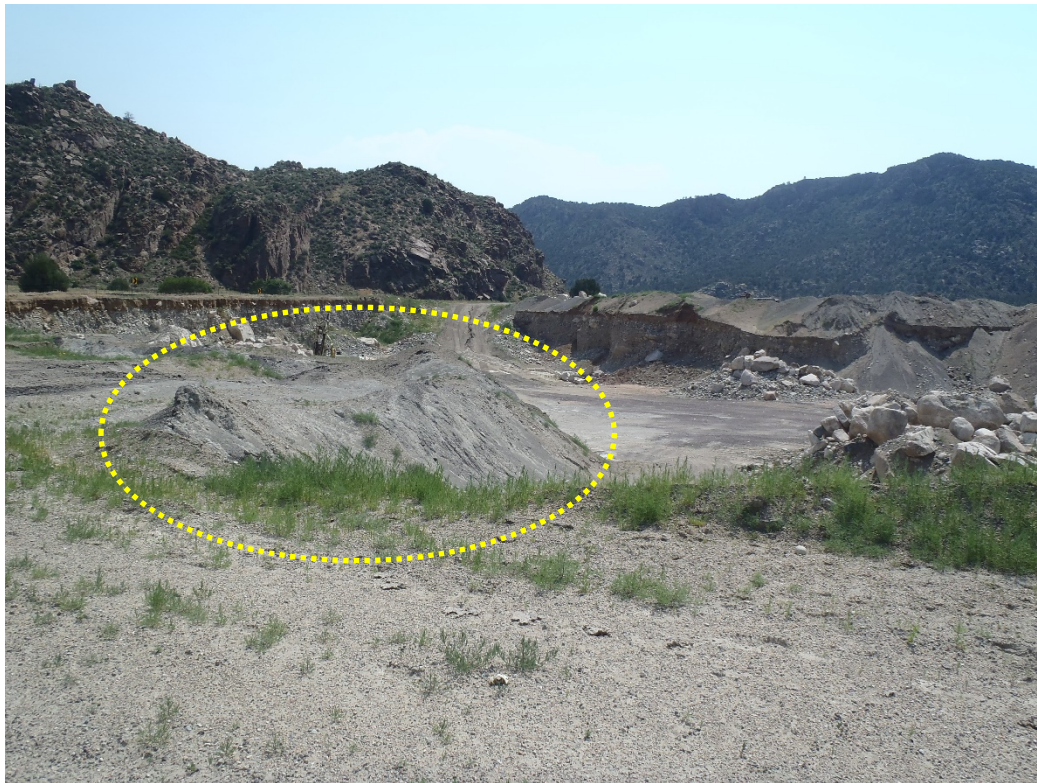
Processing Waste: A large stockpile of crusher fines was observed on the north side and a smaller fines stockpile was observed in the active pit (see **Photo 4**).

Photo 4. Active pit with smaller fines stockpile (looking east).

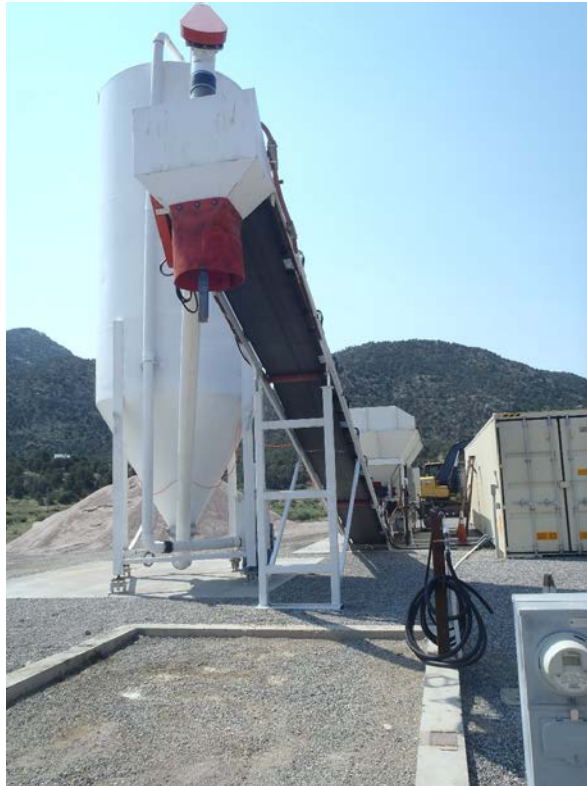
Support Facilities On-site: A drill, an excavator and the aforementioned concrete batch plant (see **Photo 5**) were observed on site.

Photo 5. Portable batch plant (near truck scales, looking south).

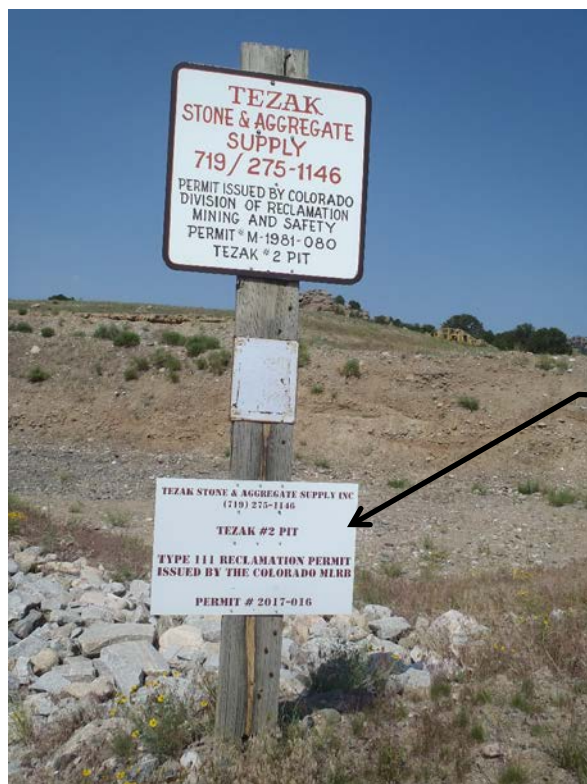
111 Permit sign (M-2017-016) should be removed

Photo 6. Permit sign at CR 37 entrance.

Signs and Markers: The permit sign was properly posted (see **Photo 6**). As the conversion to a 112 permit to include the 111 permit (M-2017-016) was approved, the 111 permit sign at the entrance should be removed. Boundary markers were observed to delineate the affected area boundary (see **Photo 7**).

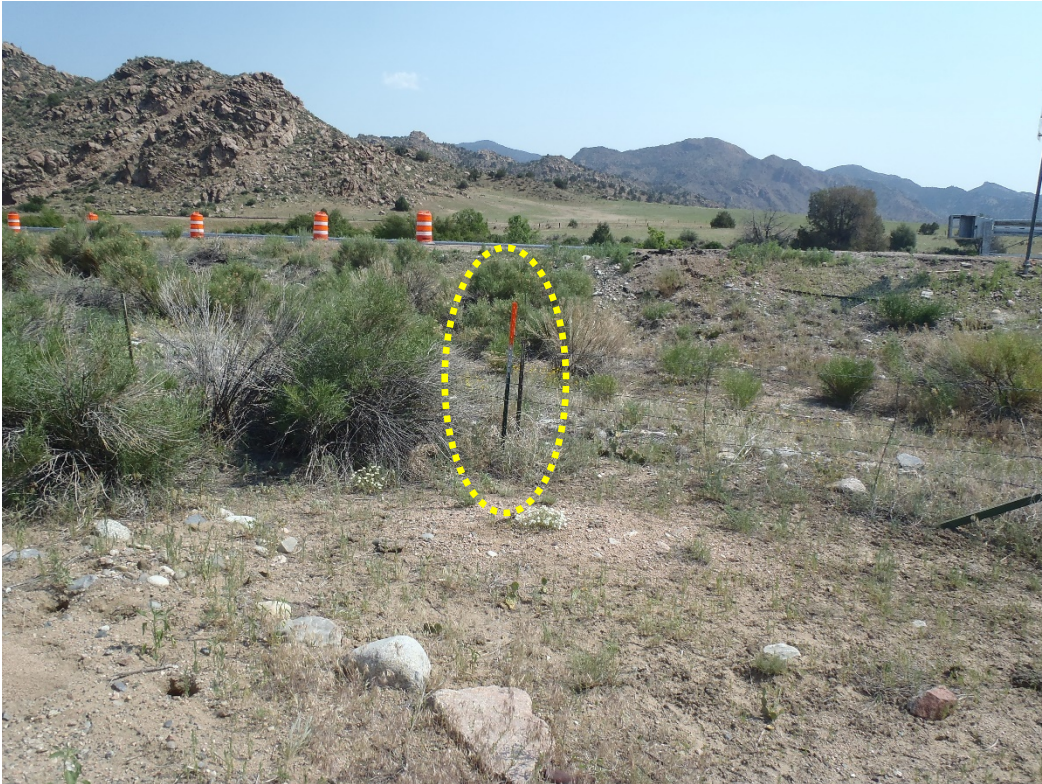
Photo 7. Typical affected area boundary marker (NE corner, looking north).

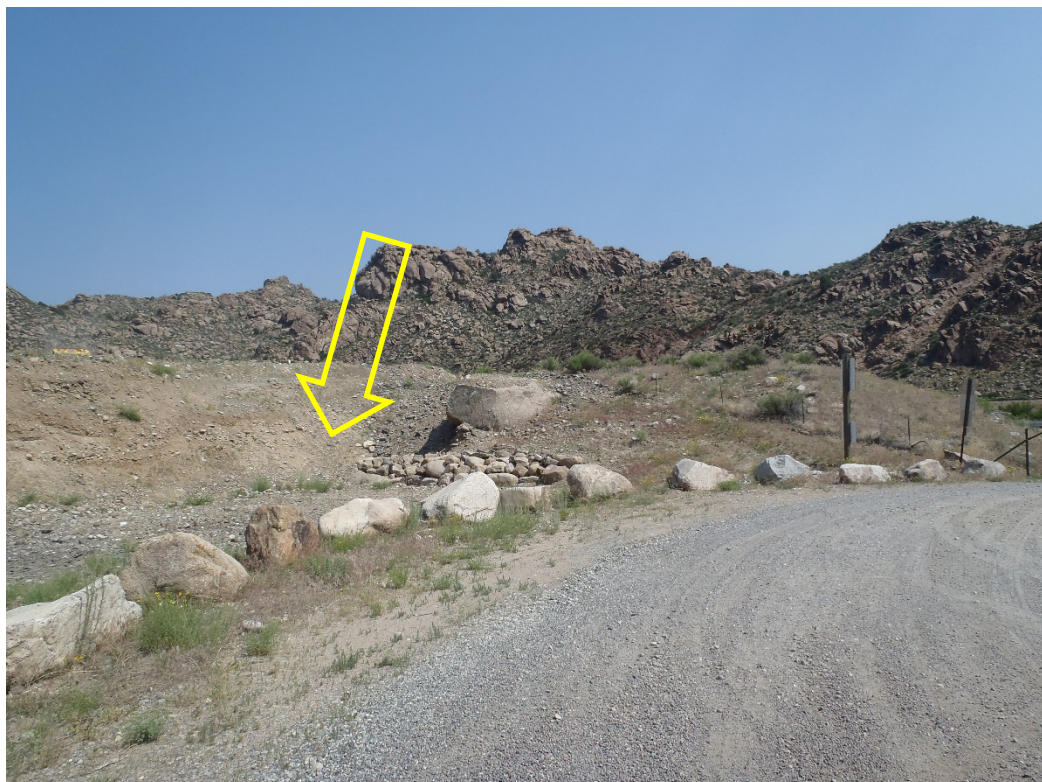
Storm Water MGT Plan: No oil or fuel spills observed. Mr. Tezak had a copy of the stormwater management plan with him. Stormwater drains to one of the two sediment ponds (see **Photos 8 and 9**) and typically infiltrates, unless the capacity is exceeded. No maintenance appeared necessary for either pond.

Photo 8. Main sediment pond (adjacent to CR 37, looking north) .

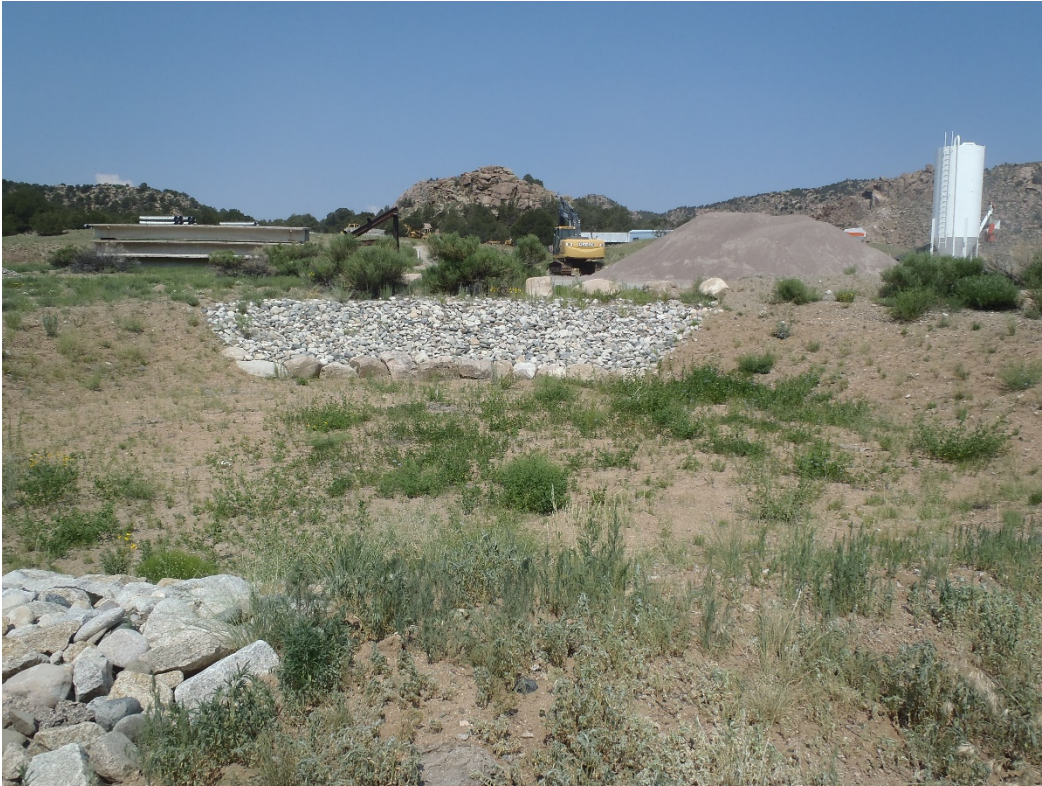
Photo 9. Southeast sediment pond (near batch plant, looking NW).

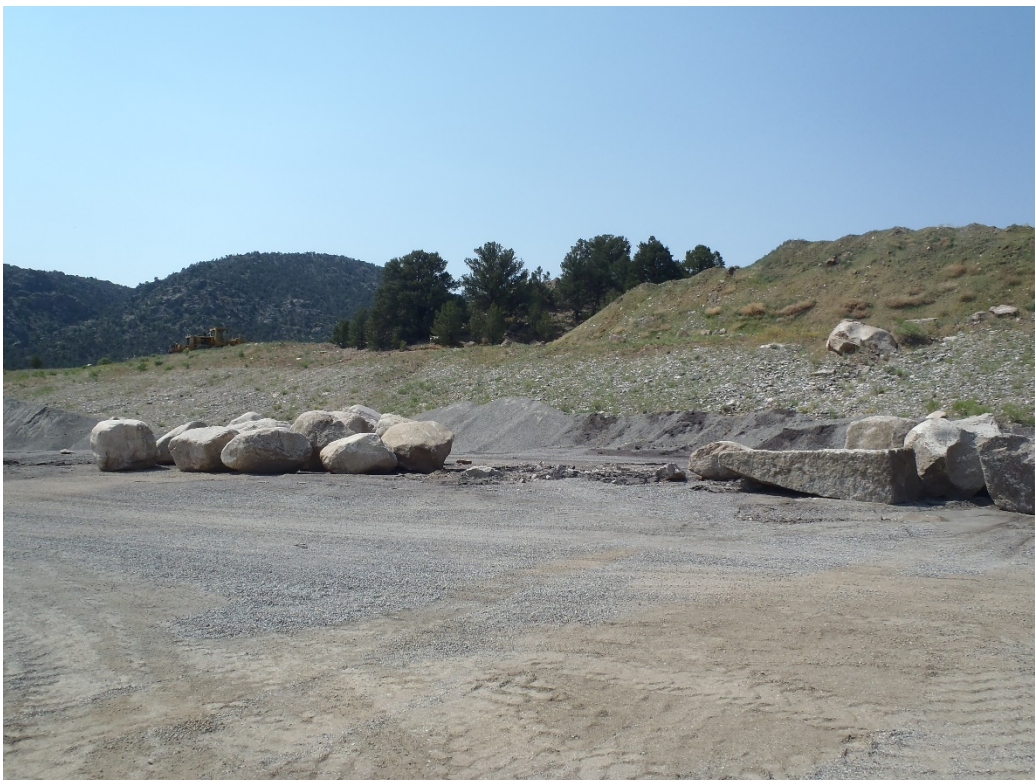
Photo 10. Topsoil stockpile (south side, looking SE).

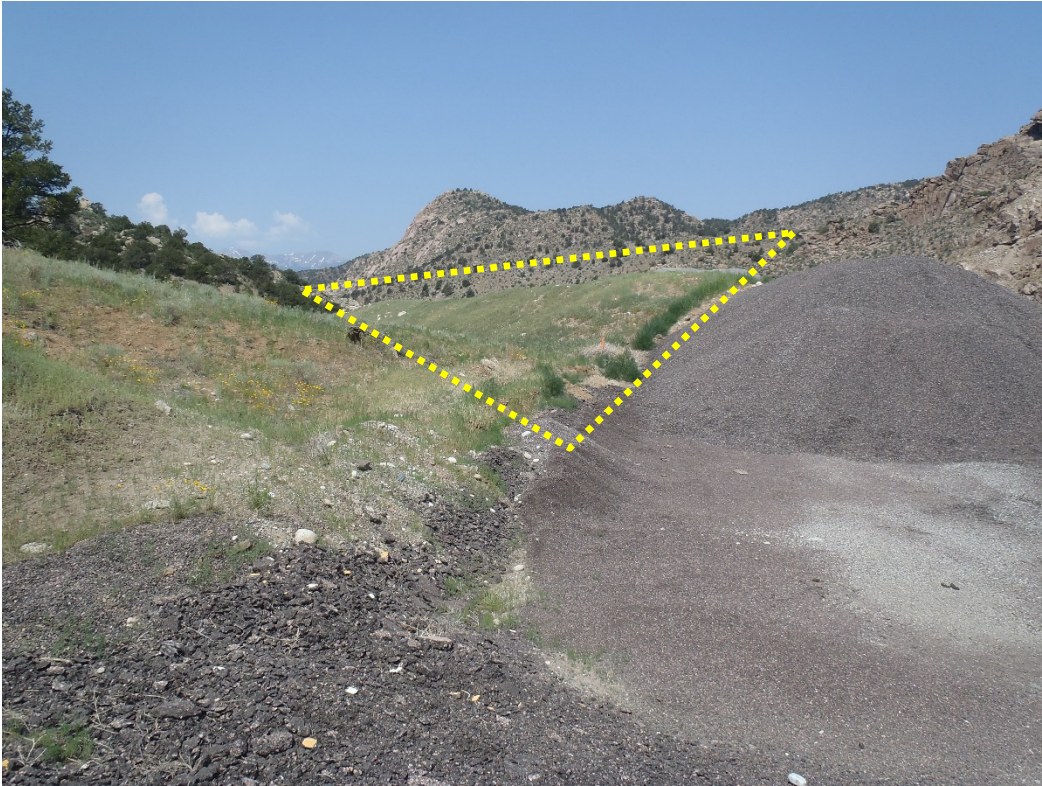
Photo 11. Topsoil stockpile (SW corner, looking west).
