PERMIT INFORMATION

Permit Number: C-1981-018 Mine Name: Deserado Mine Operator: Blue Mountain Energy, Inc. Operator Address: Mr. Kurtis Blunt 3607 County Road 65 Rangely, CO, 81648	County: Moffat, Rio Blanco Operation Type: Underground Permit Status: Active Ownership: Private
	Operator Representative Present: Kurt Blunt
Operator Representative Signature: (Field Issuance Only)

Inspection Start Date: June 30, 2021 Inspection Start Time: 10:30 Inspection End Date: June 30, 2021 Inspection End Time: 13:20		Inspection Type: Coal Partial Inspection Inspection Reason: Normal I&E Program Weather: Clear	
Joint Inspection Agency: None		Joint Inspection Contacts: None	
Post Inspection Agency: None		Post Inspection Contacts: None	
Inspector(s): Clayton Wein	Inspector's Signature:

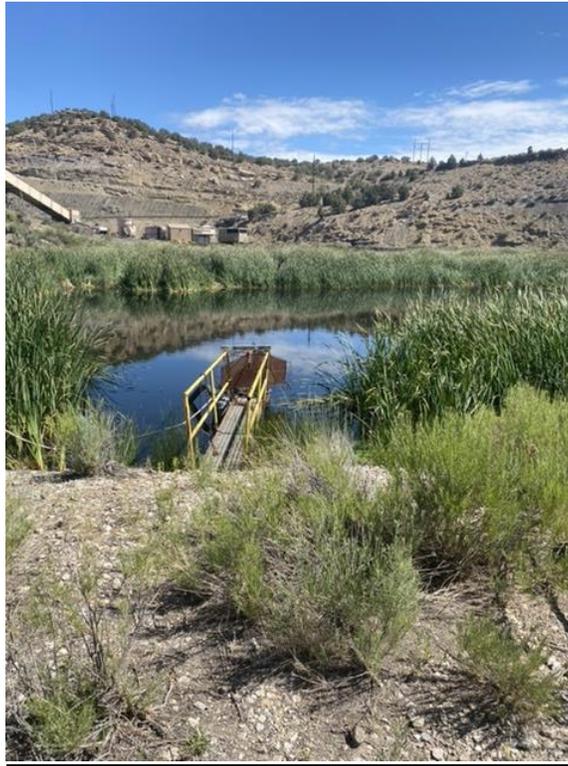
There are three ponds located at the main facilities are. The DP-1 pond is located on the lower bench. The pond was impounding water during the inspection. The inlet to the pond was unobstructed and stable. The trash rack over the outlet was clear of debris (Photo 1). The pond was discharging. The embankment for the pond was stable with vegetative cover. No indications of erosion were observed. The PP-1 pond is located on the middle bench. The pond was holding water and was observed to be stable. There were no erosional concerns. The PP-2 pond, located on the upper bench, was also holding water. The outlet was clear of debris. The embankment was vegetated and stable. No erosional features were identified.

Photo 1: The outlet of the DP-1 Pond.

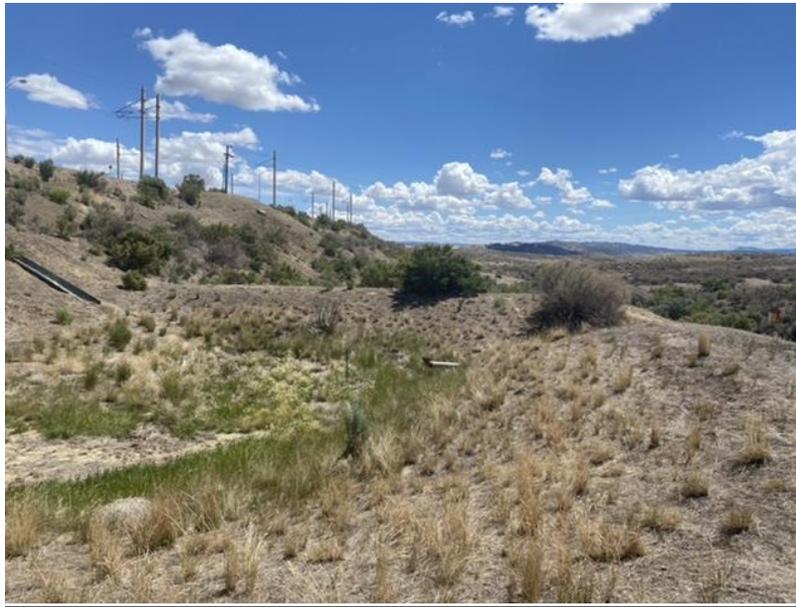
One sump, RS-1, and one pond RR-1, are located on the south side of the rail loadout. RS-1 was dry during the inspection. The sump's embankments were stable with vegetative cover. There were no erosional concerns. The outlet for the sump was stable. The RR-1 pond was dry. The inlets for the pond were stable. The embankment was observed to be vegetated and stable (Photo 2). There were no erosional issues.

Photo 2: The embankment of the RR-1 pond.

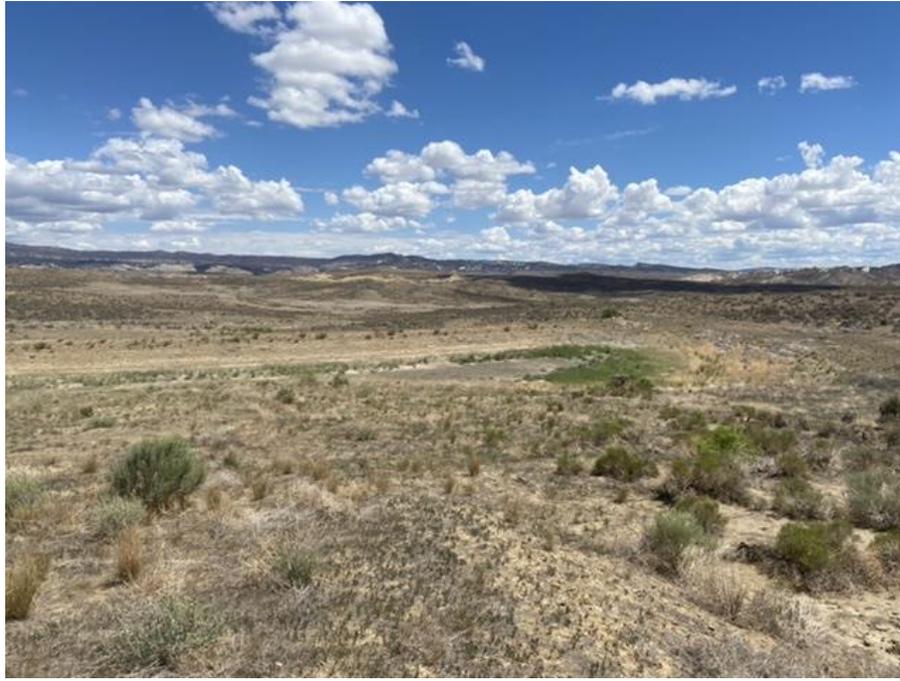
The B Seam Dewatering System No. 2 was inactive during the inspection. The upper cell was dry. The embankment was vegetated and stable. There were no concerns of erosion identified. The second cell was also dry (Photo 3). The embankment was observed to be vegetated and stable. No erosional features were noted.

Photo 3: The 2nd cell of the B Seam Dewatering System No. 2.

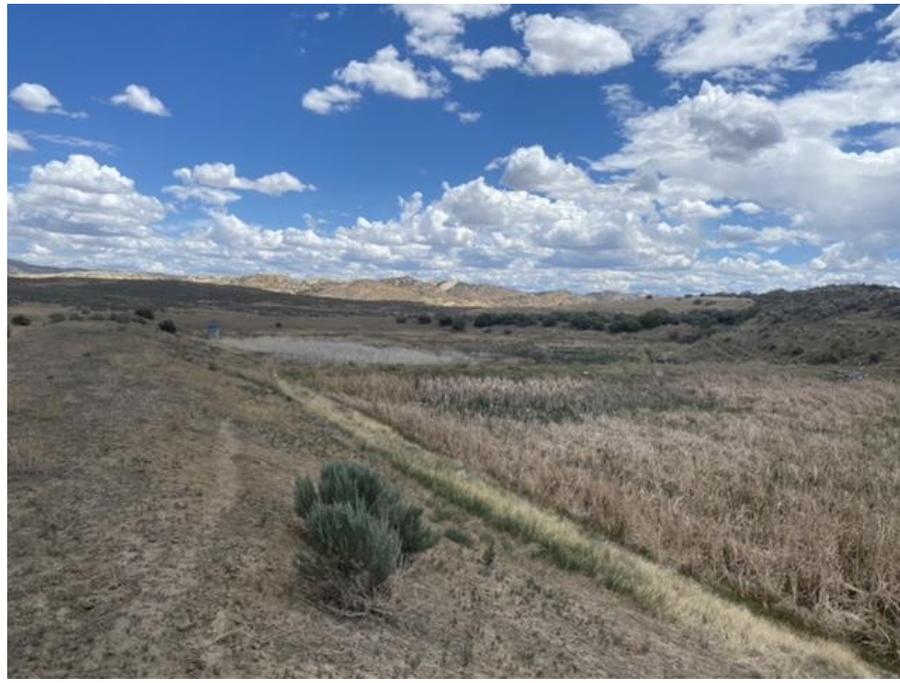
The RP-2/3 pond is located at the northeastern base of the RP-2/3/4 refuse pile. All 3 cells of the pond were dry during the inspection. The trash rack on the outlet was unobstructed. The pond's embankments were stable with vegetative cover (Photo 4). There were no noted erosional features. The RP-4 pond is located at the Northwestern base of the RP-2/3/4 refuse pile. This pond was also dry. The outlet was clear. The embankment had no indication of instability or erosion. The embankment is covered with vegetation.

Photo 4: The RP-2/3/ pond.

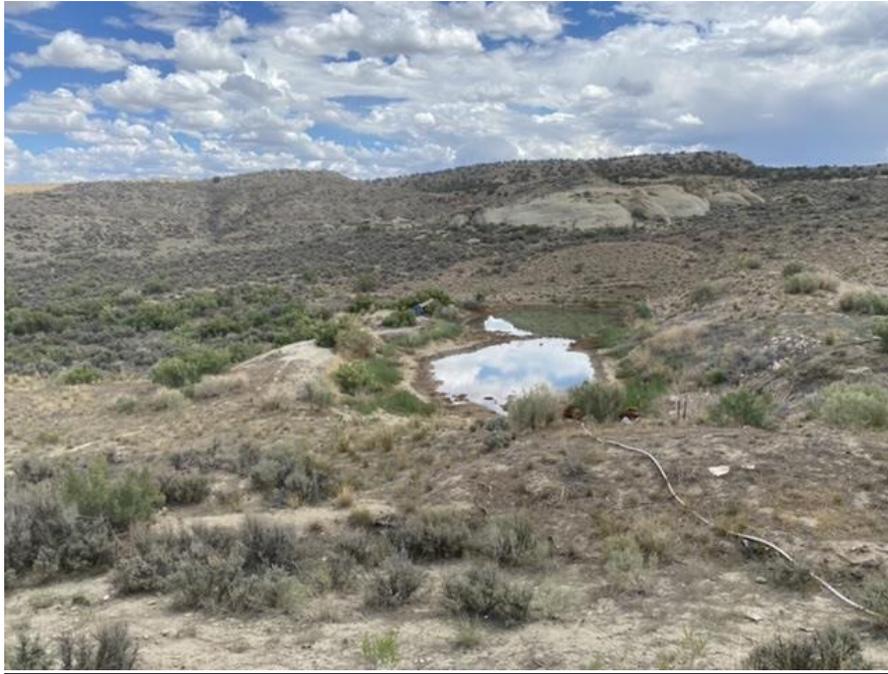
The SDH-3/5 D Seam Dewatering System had a small amount of water impounded in its cell (Photo 5). There was no discharge to Red Wash occurring. The outlet was unobstructed and stable. The pump for the system was being replaced during the Division's June 3, 2021 inspection. The pump had been completely installed and tested prior to this inspection. The embankment of the cell was vegetated and stable. There were no observed erosional concerns.

Photo 5: The SDH-3/5 D Seam Dewatering System cell.
