**STATE OF
COLORADO****Ebert - DNR, Jared <jared.ebert@state.co.us>**

pictures of mining claim M2001-022 june 2021

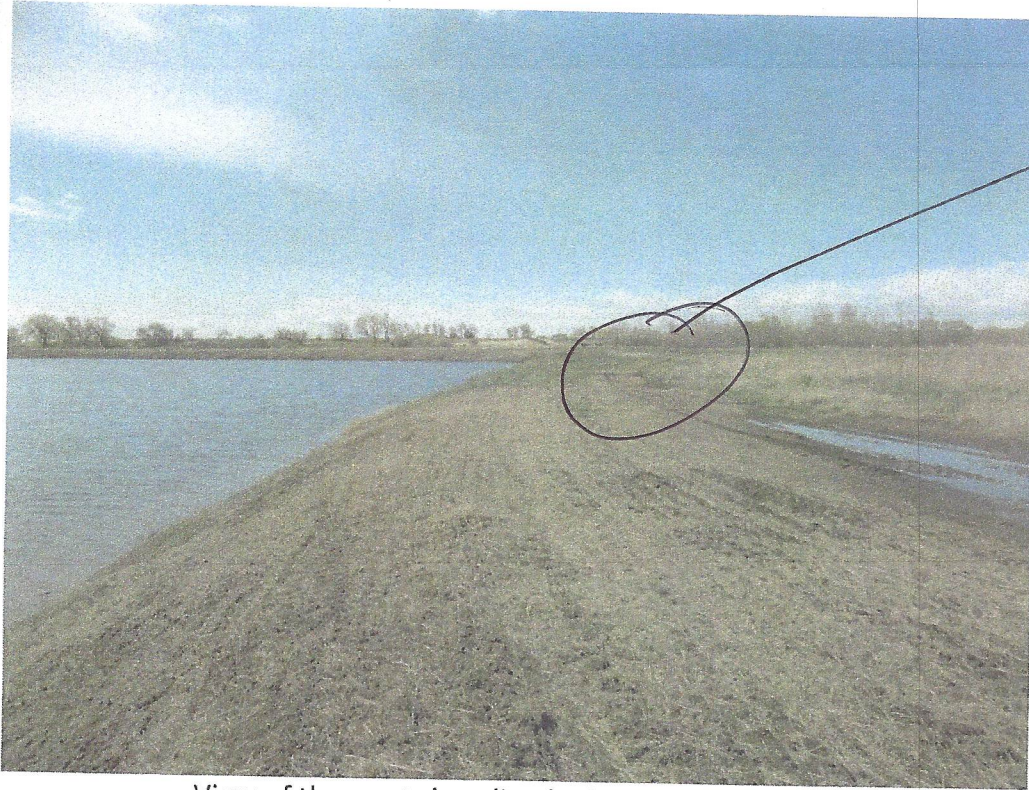
There is
a hole
From Mining
was wondering
why not
filled in.

View of the west shoreline looking south in Cell 4

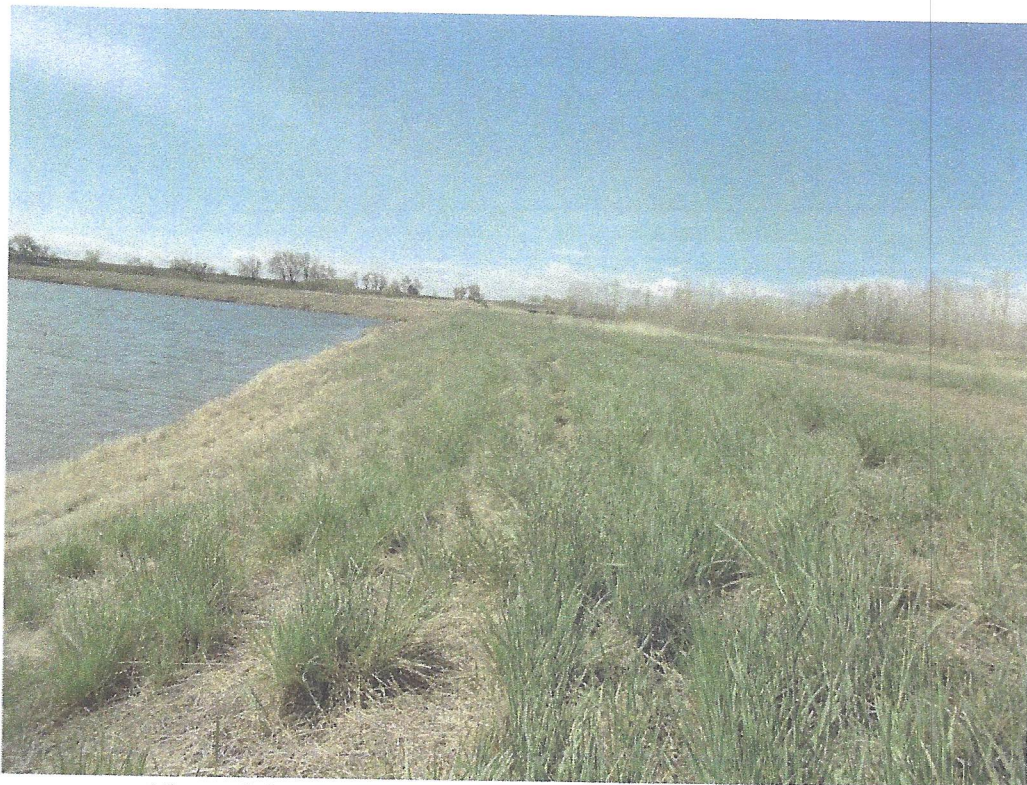
View of the vegetation in the southwest corner of Cell 4

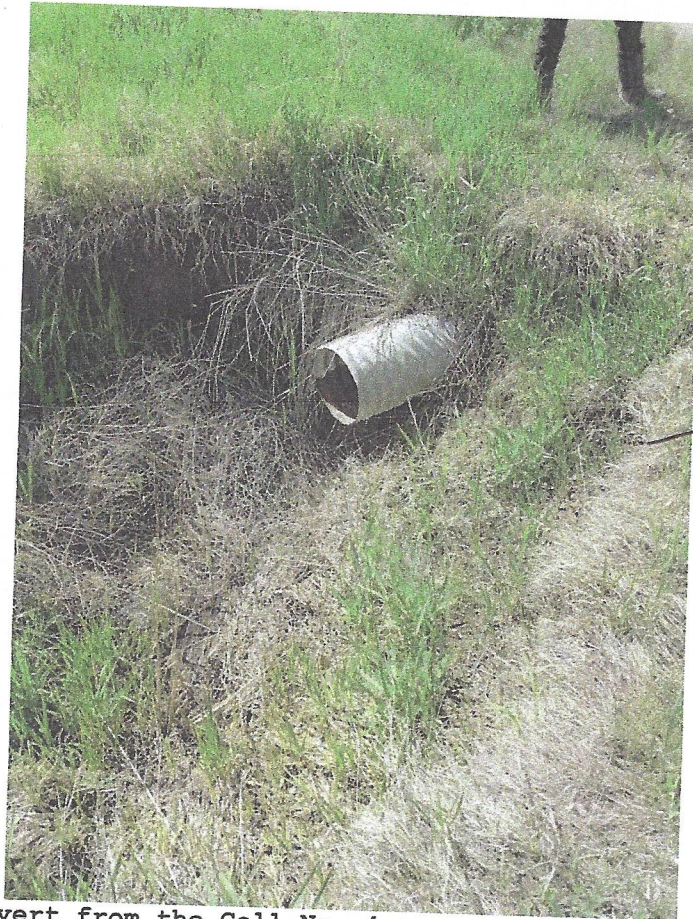
Figure 9. Culvert from the Cell No. 4 area to the Big Thompson River.

This was
caused by
mining is
open to river
was wondering
why it is not
being filled
in?

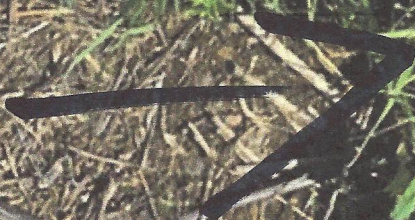
More
Shore
ready to
Break
off
