**NEW ELK MINE**  
**Permit No. C-1981-012**

**QUARTERLY COAL WASTE BANK INSPECTION REPORT**  
**June 30, 2021**

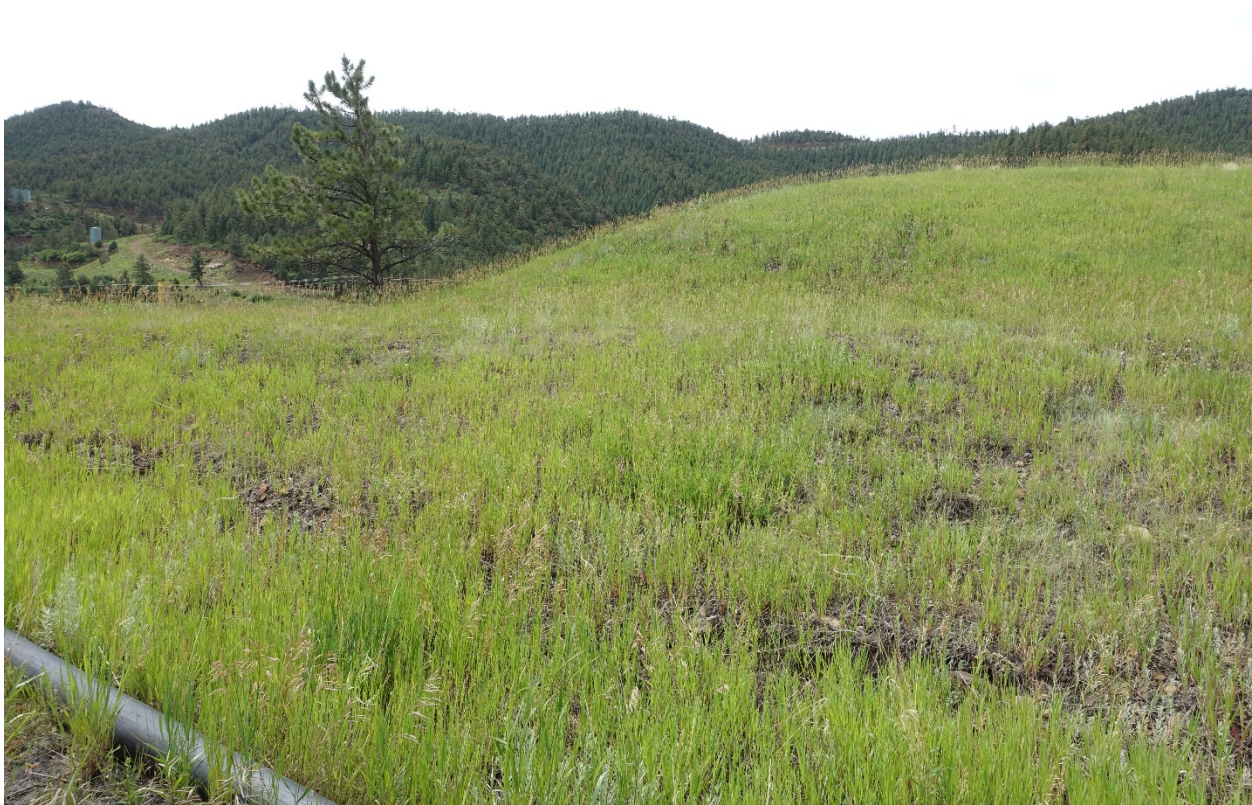
Overall the disposal area is in good condition.

**DWDA #1 – North Facing Slope**

None at this time.

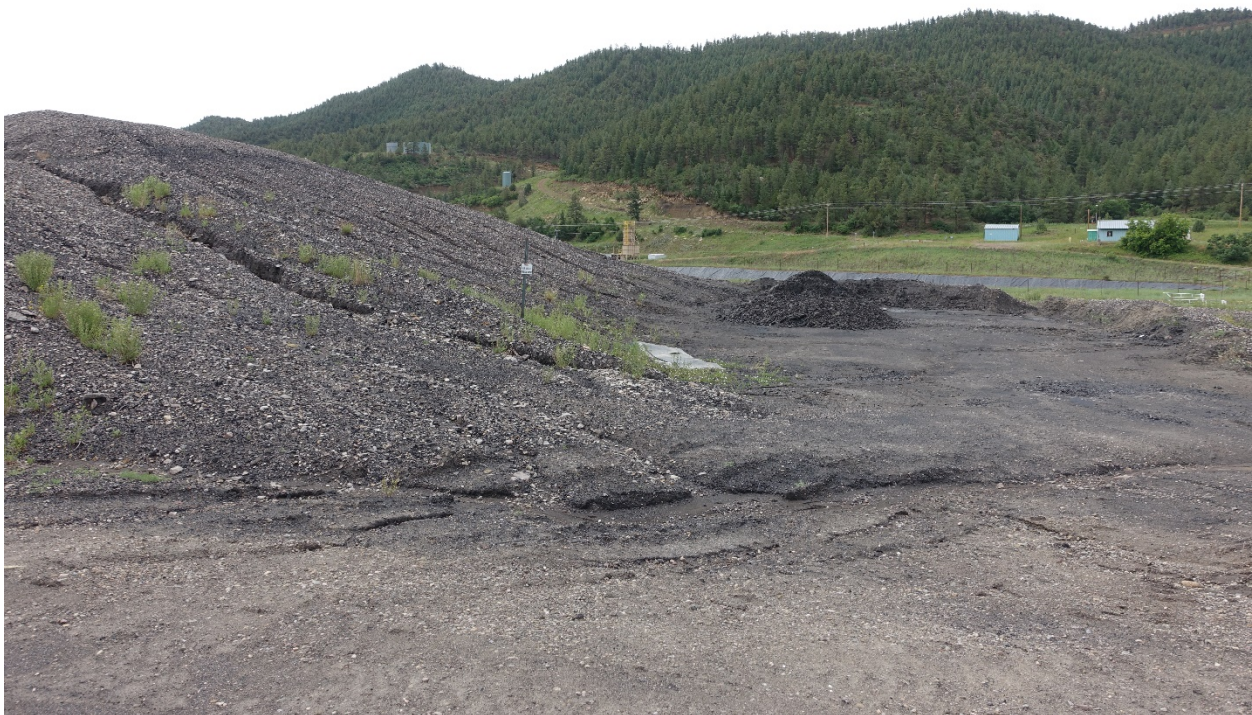
Surface and out slopes of the pile were inspected for visible signs of potential failure or instability. There was some surface erosion but not enough to make the area unstable. In all no signs of failure or instability were observed.

Overall the disposal area is in good condition. The sign with the name of the area was recently replaced.

**DWDA #2 – West Facing Slope**

The Rills are being monitored and have not gotten any bigger and there is no sediment loading. Operator is evaluating either reclamation of the area or permitting alternative uses of the land north of the Purgatoire River and south of Highway 12.

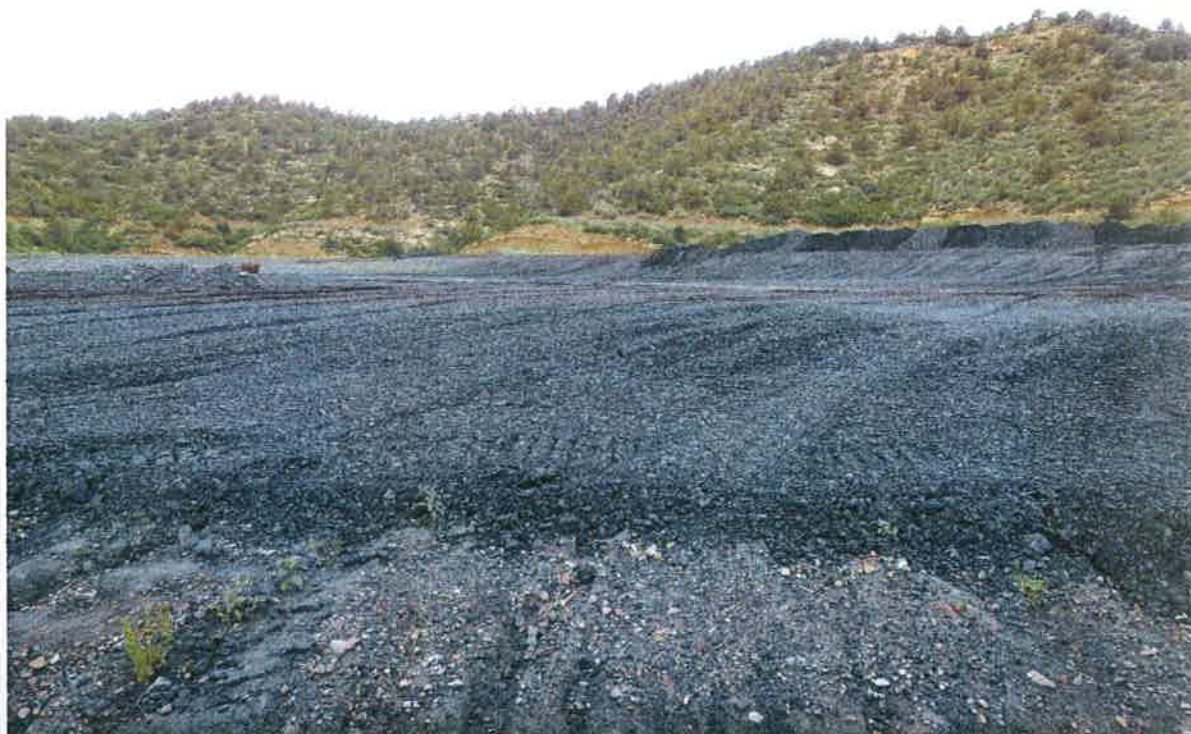
Overall the site is in good condition.

**Top of Refuse Disposal Area – Recent refuse spread**

None required at this time.
