QUARTERLY SEDIMENTATION POND INSPECTION REPORT

Mine: New Elk

Inspection Period: Second Quarter 2021

QUARTERLY SEDIMENTATION POND INSPECTION REPORT
New Elk Mine- June 30. 2021

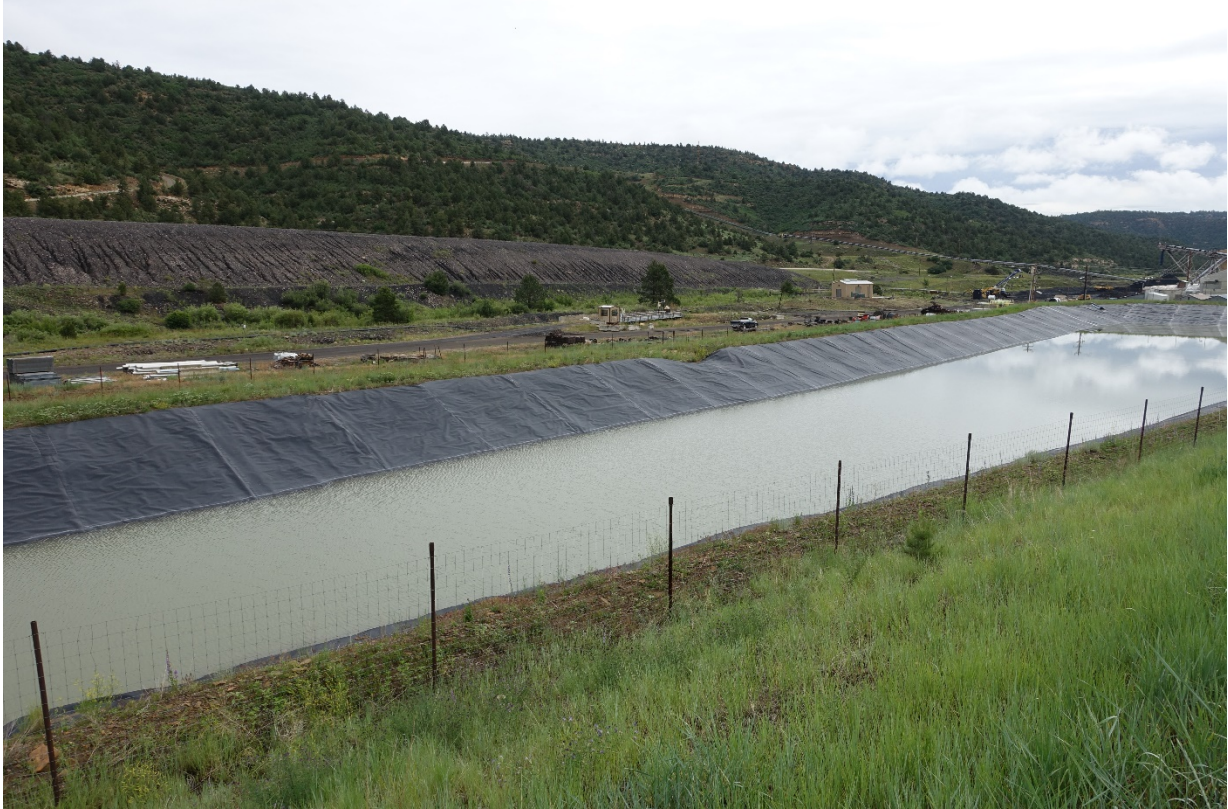
Pond 1

Pond liner is in good working condition at time of inspection. Pond was holding water at time of
inspection. The mine seldomly pumps into pump as water has not risen much since mining began
in late May.

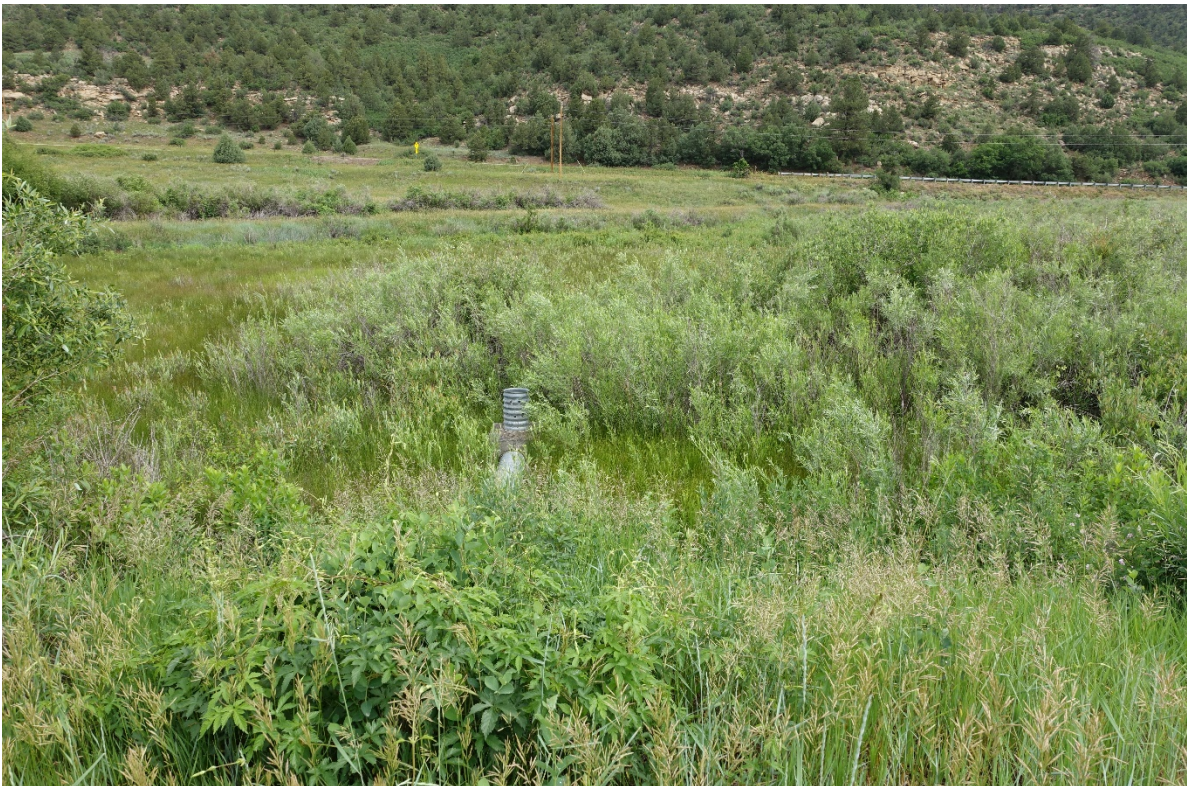
Pond 4

Pond is holding a very little amount water and is not close to discharging.

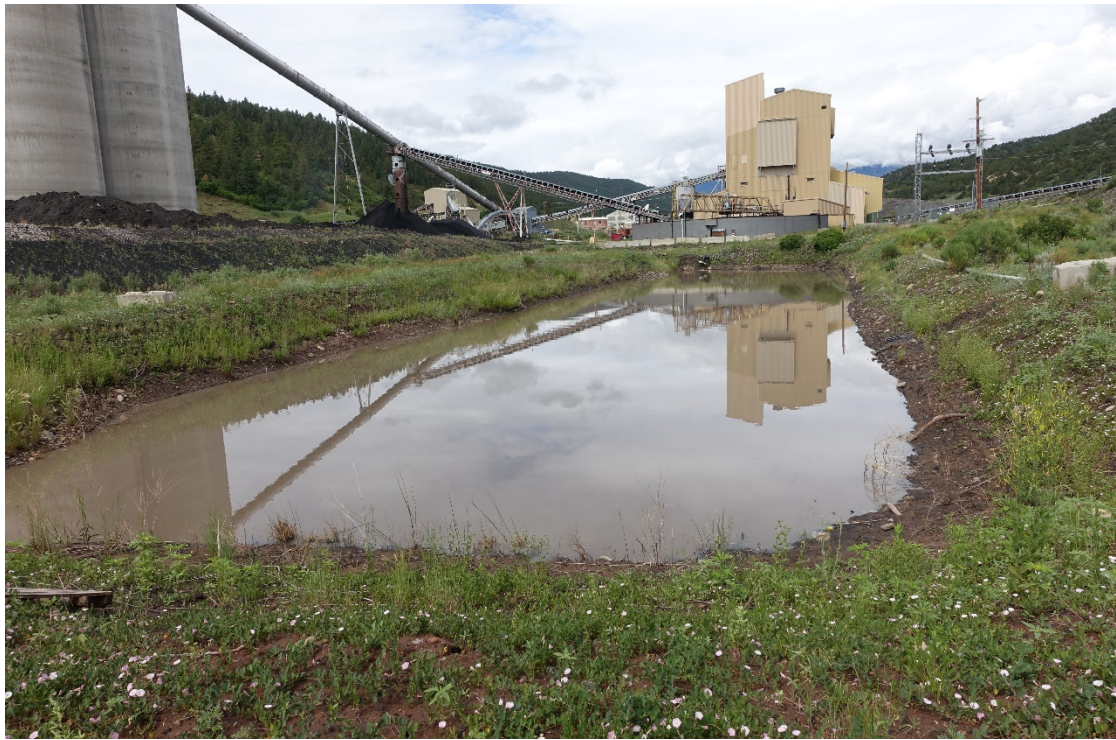
Pond 6

Pond is holding water, but it is not close to full.

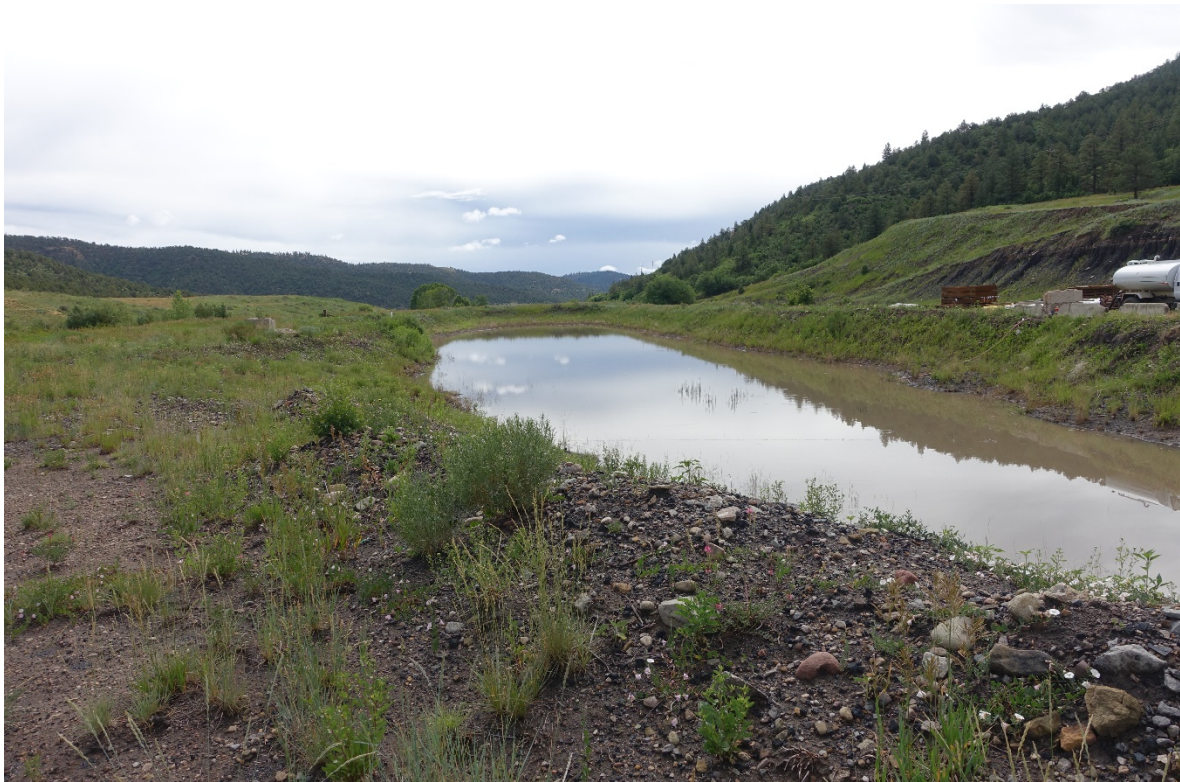
Pond 7

Pond is holding water, not near the decant level. The pond has about 6 inches of sediment.

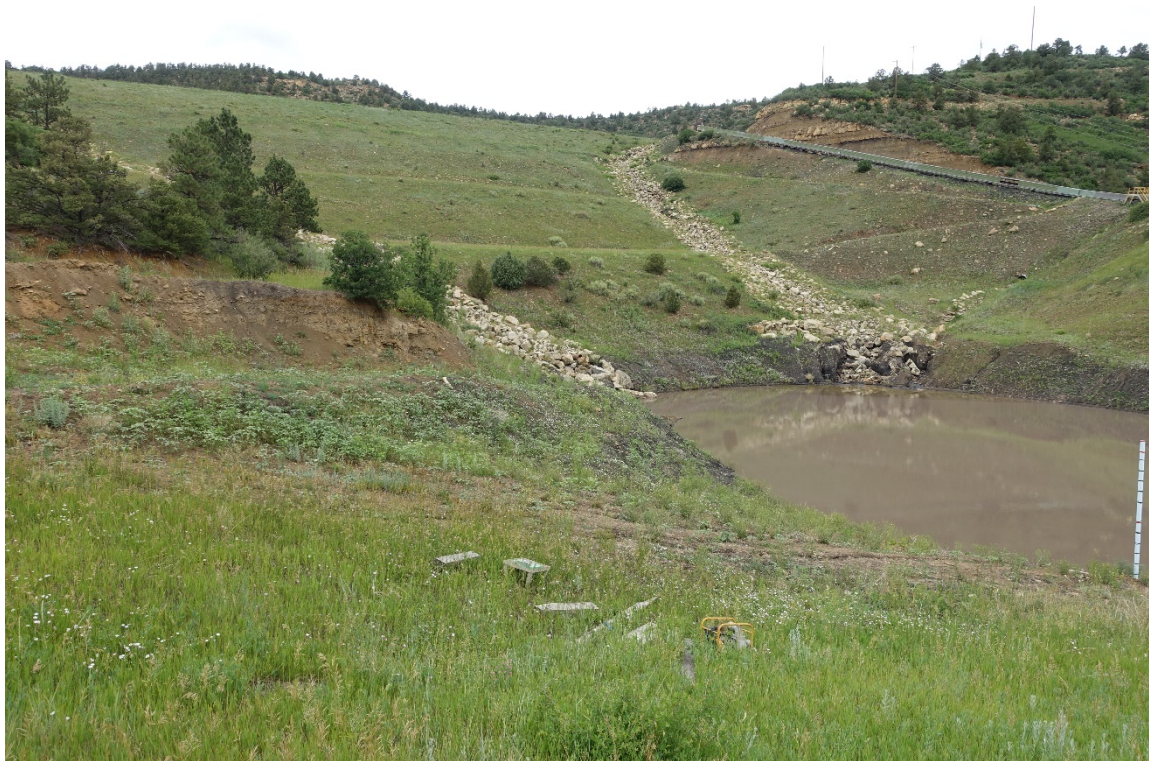
Pond 8

Pond is holding water, not near the decant level. No new sediment has been deposited.

There is very little sediment in the pond.

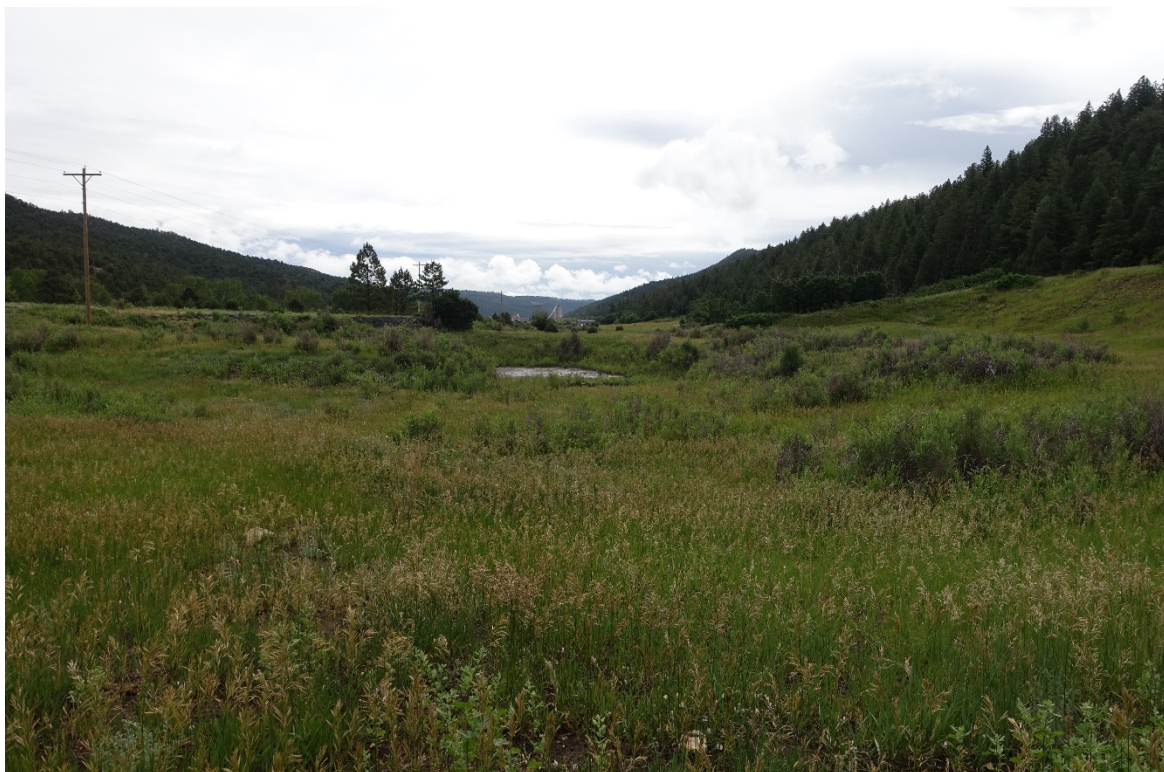
Containment Area #1

Containment area had little water to no at time of inspection.

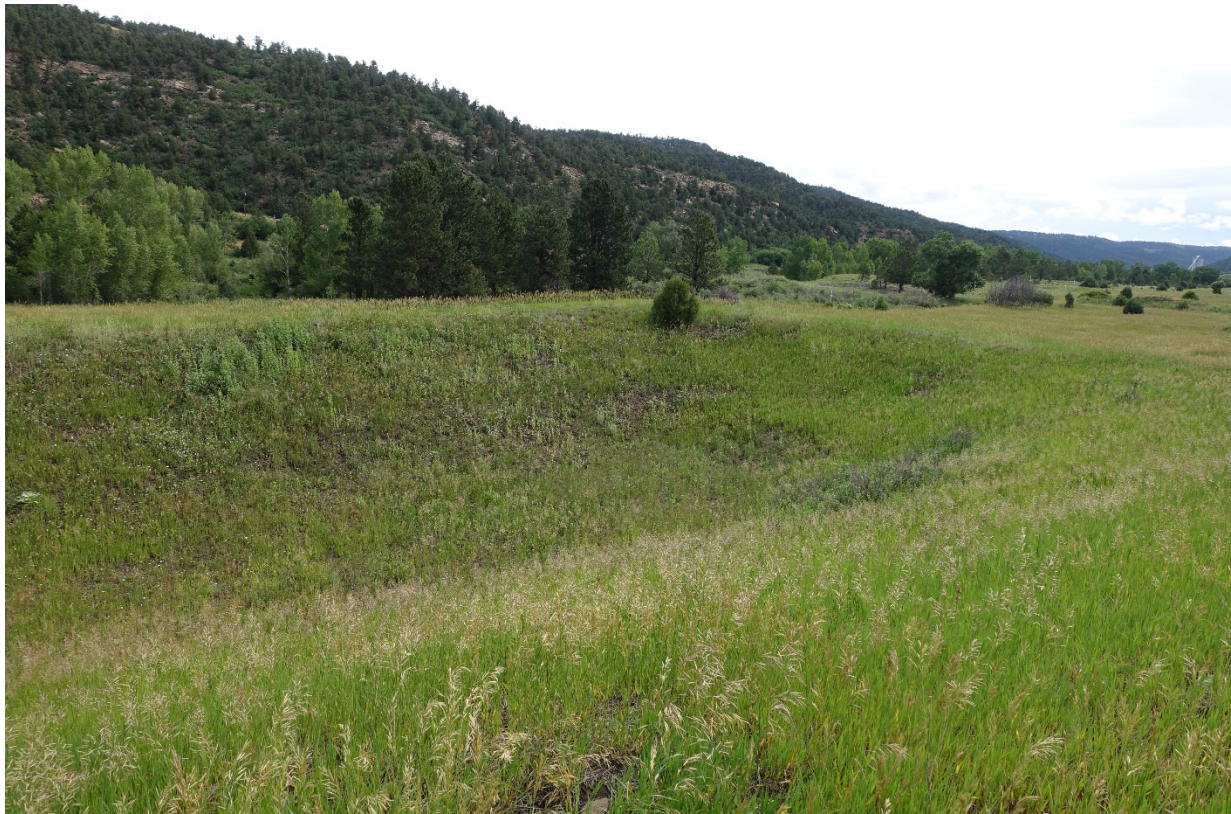
Containment Area #2

Containment was empty at time of inspection.

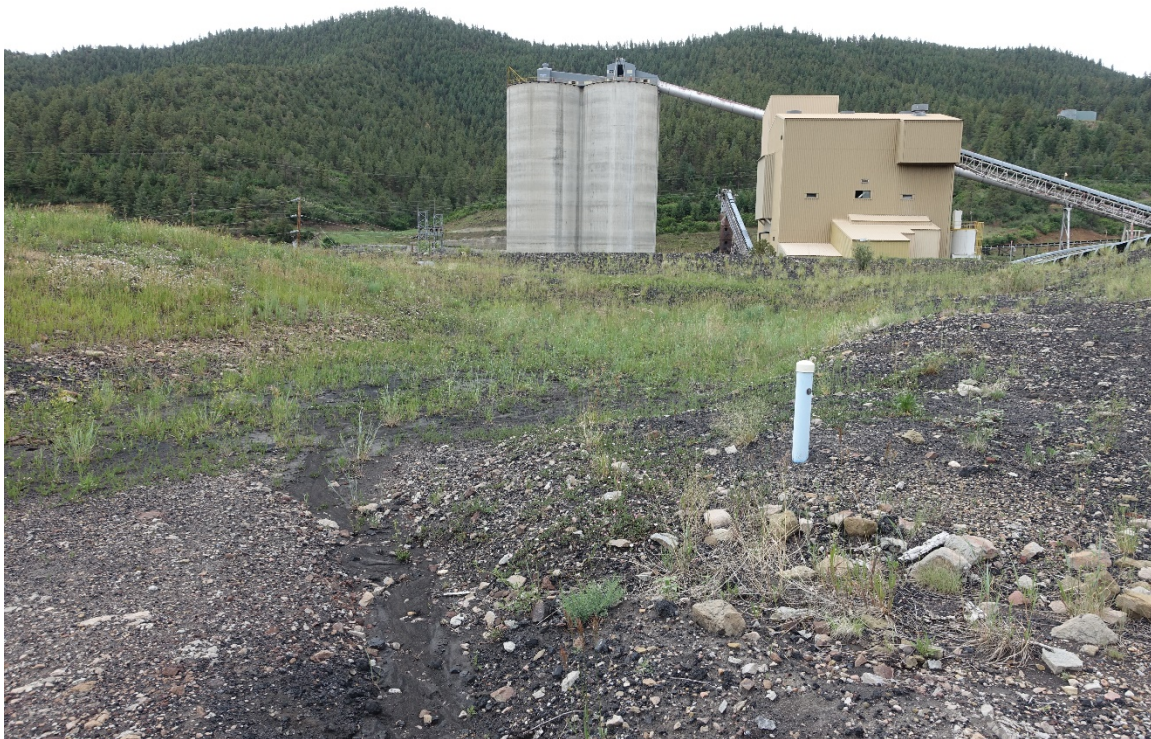
Containment Area #3

Containment Area was dry at time of inspection.

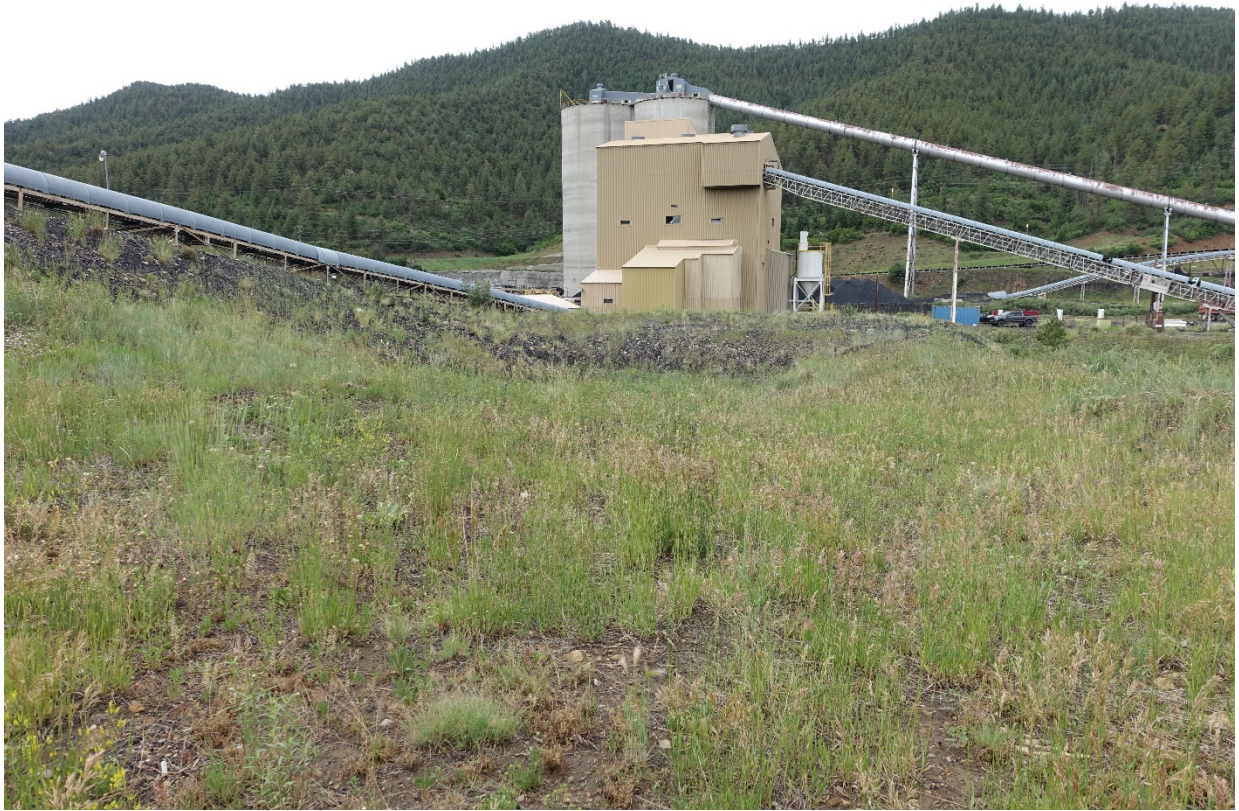
Containment Area #4

Containment Area was dry at time of inspections

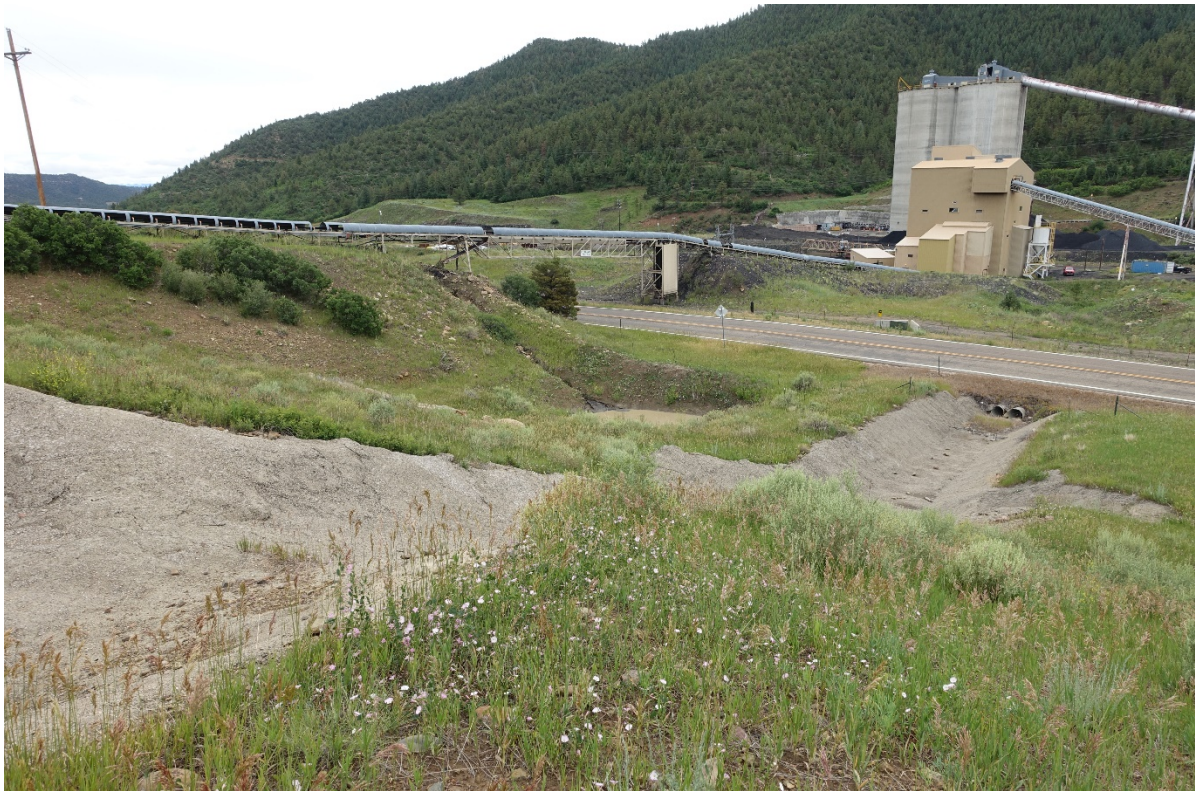
Containment Area #5

Containment Area was holding some water. Sediment was cleaned in quarter 2 of 2020.
