**LORENCITO CANYON MINE**  
**Permit No. C-1996-084**

**INSPECTION OF EXCESS SPOIL-FILLS 7, 8, & 9**  
**June 30, 2021**

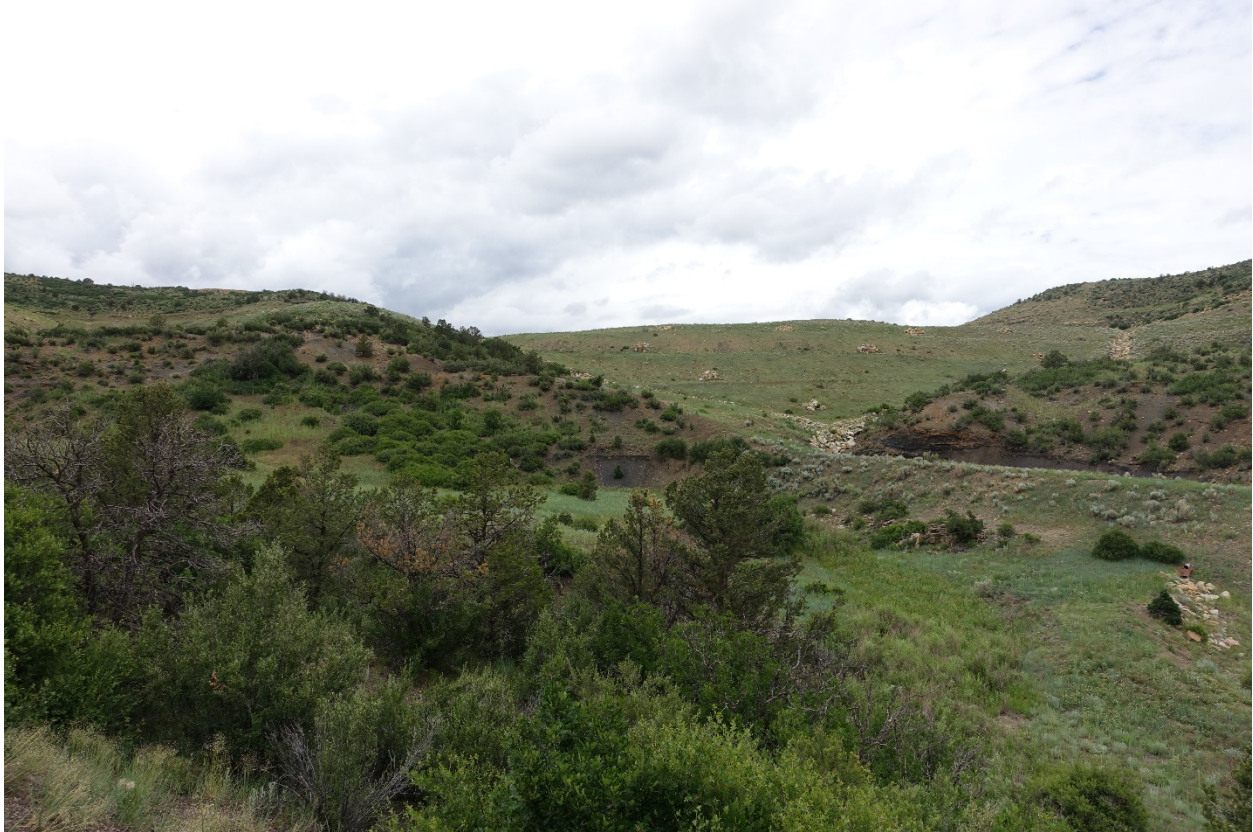
**Fill #7**

The entire excess spoil fill facility was examined for signs of failure and instability such as tension cracks, ground movement, springs and seeps, and standing water. There was no indication of potential instability at time of inspection.

Overall the site is in good condition. The vegetation on the fill is encouraging.
