Re: Sandy Acres Pit, DRMS Permit No. M-1980-110  
Hydrologic Balance response

# MEMORANDUM

To: Derek Slack, P.E. and Neil Thomson, P.E.  
E-470 Public Highway Authority (E-470)  
From: Austin Malotte, P.E.  
Subject: Sandy Acres Ponding – June 2021 Status  
Job: 9607.00  
Date: June 29, 2021

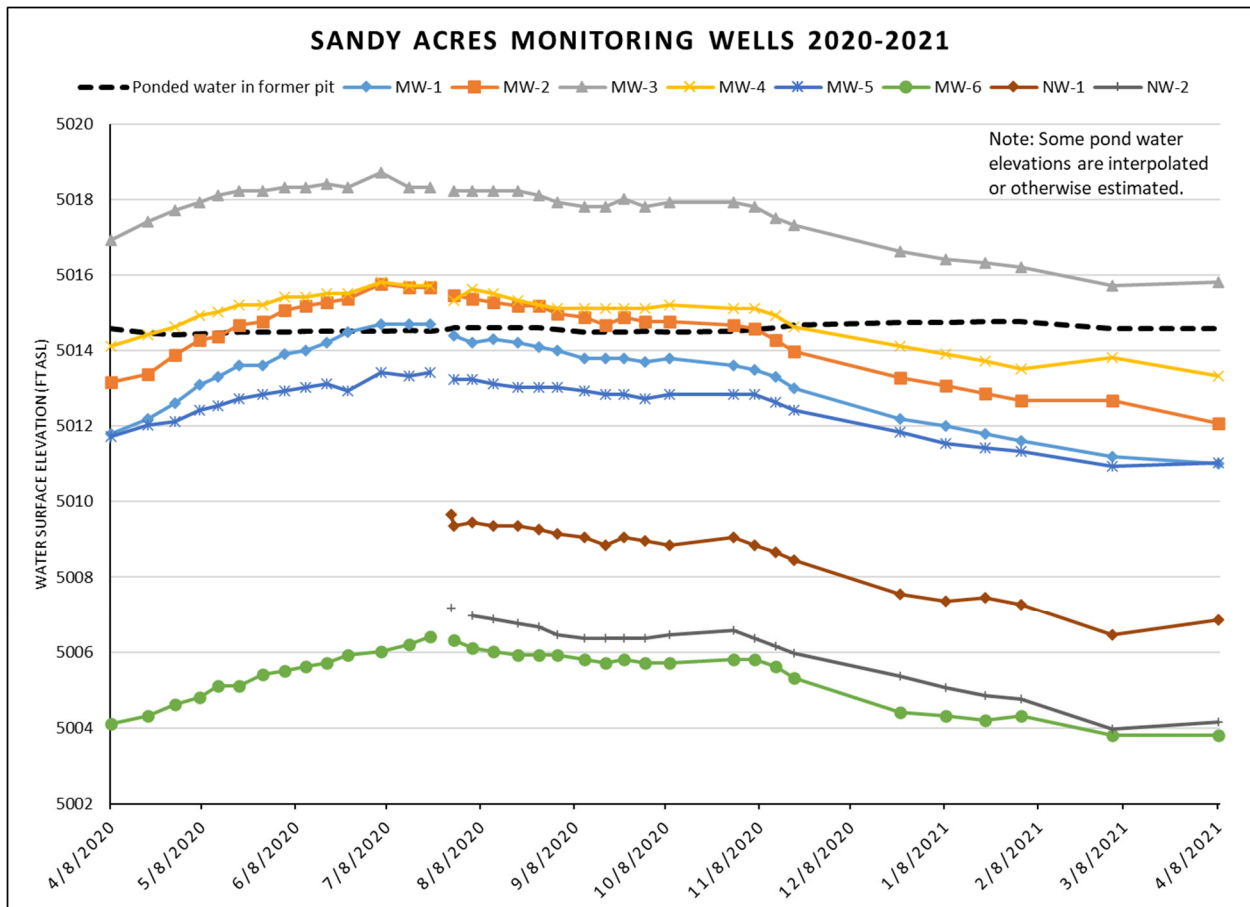
Water levels were collected regularly at each of the monitoring wells and at the ponded surface in the backfilled pit since April 2020. Water level elevations for April 8, 2020 through April 8, 2021 are illustrated graphically below.

The water level data illustrated in the above chart reflect a local ground water gradient from the southeast (Well MW-3) toward the northwest (Wells MW-6, NW-1 and NW-2) across the Sandy Acres property. However, the relatively consistent surface water level in the former Sandy Acres Pit compared with nearby ground water levels that are variable and at times lower than the surface water elevation indicates the ponded water is likely fed in part by ground water but is not necessarily an expression of ground water across the pit. That is, the water in the pit is not in connection with the ground water table throughout the pit; rather, it appears ground water discharges into the pit near its southern end then becomes perched on top of the low-permeability fill material used to backfill the Sandy Acres Pit in 2016.

Although the monitoring well data appear to confirm at least a portion of the ponded water in the former Sandy Acres Pit is the result of ground water discharge to the pit from the south and east, the proportional contributions of such ground water inflows versus surface water inflows remains unclear. Regardless, the presence of ground water inflows to the pit will inform the development of alternatives for mitigation of ponding at Sandy Acres.

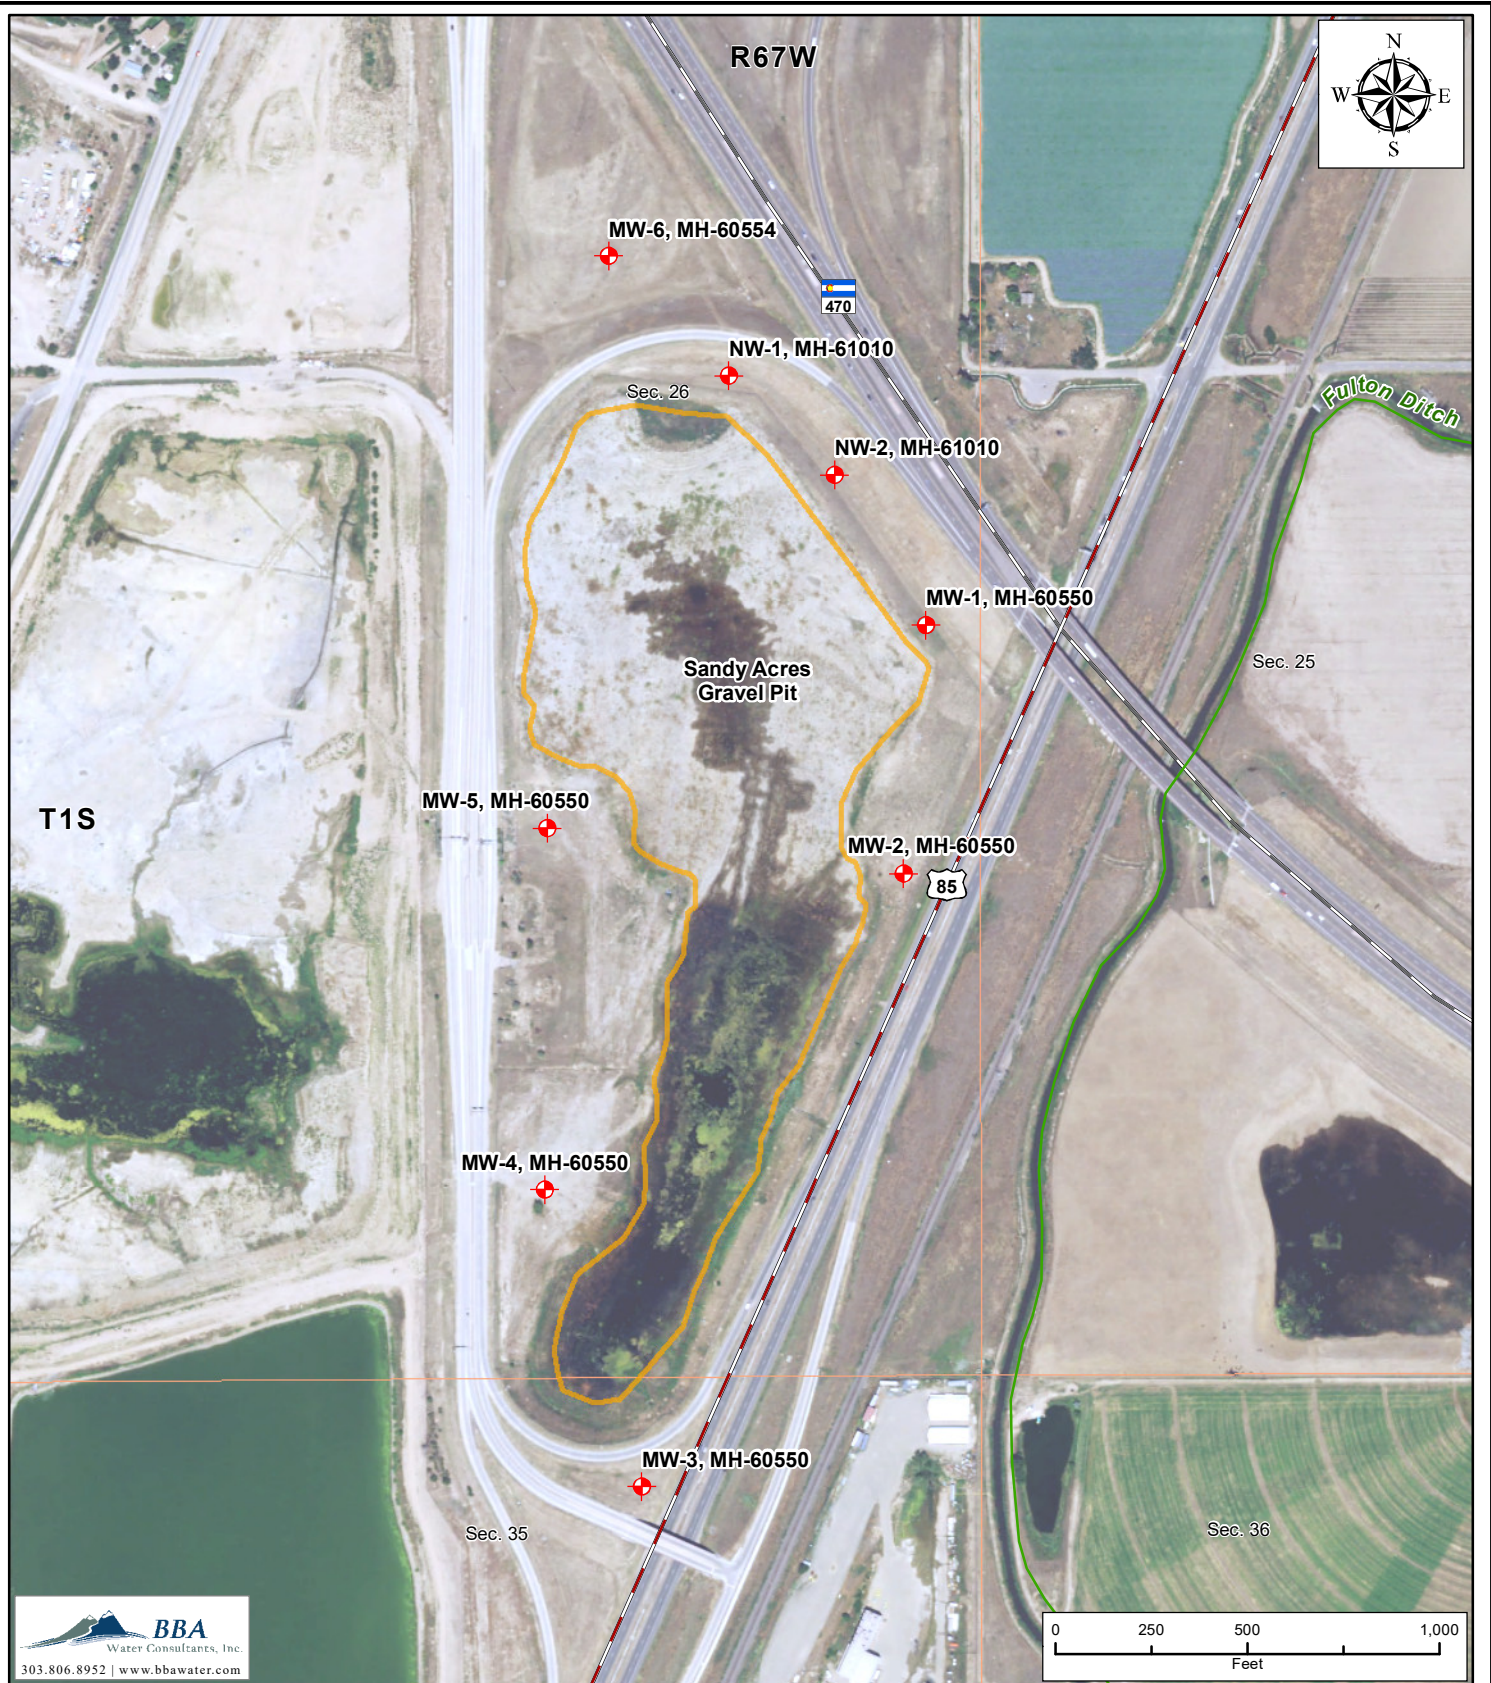
**Figure 1**  
**E-470**  
**Sandy Acres Pit**  
**Monitoring Well Locations**

The locations of these eight monitoring wells are shown on Figure 1, attached. E-470 regularly collected water level readings from each of the eight monitoring wells after their construction, and from the surface of the ponded water in the pit. Data and initial conclusions from the first year of the Sandy Acres Monitoring Well Program are presented in the following sections.

Some of the alternatives would likewise be implemented in a phased approach. For example, E-470 may construct a sump at the north end of the former pit to infiltrate ponded water at a location where ground water levels tend to be lower than the existing ground surface (and ponded water surface) in the pit. It would be reasonable to test the functionality and capacity of such a sump prior to construction of a perimeter trench drain, drain channel or other structure that would ultimately rely upon the sump to dispose of intercepted flows.
