MINERALS PROGRAM INSPECTION REPORT
PHONE: (303) 866-3567

MINE NAME: Nahcolite Project	MINE/PROSPECTING ID#: M-1983-194	MINERAL: Carbonates	COUNTY: Rio Blanco
INSPECTION TYPE: Monitoring	INSPECTOR(S): Amy Yeldell	INSP. DATE: June 28, 2021	INSP. TIME: 13:30
OPERATOR: Natural Soda LLC	OPERATOR REPRESENTATIVE: Kirk Daehling	TYPE OF OPERATION: 112d-3 - Designated Mining Operation	
REASON FOR INSPECTION: Normal I&E Program	BOND CALCULATION TYPE: None	BOND AMOUNT: \$3,671,965.00	
DATE OF COMPLAINT: NA	POST INSP. CONTACTS: None	JOINT INSP. AGENCY: None	
WEATHER: Clear	INSPECTOR'S SIGNATURE:

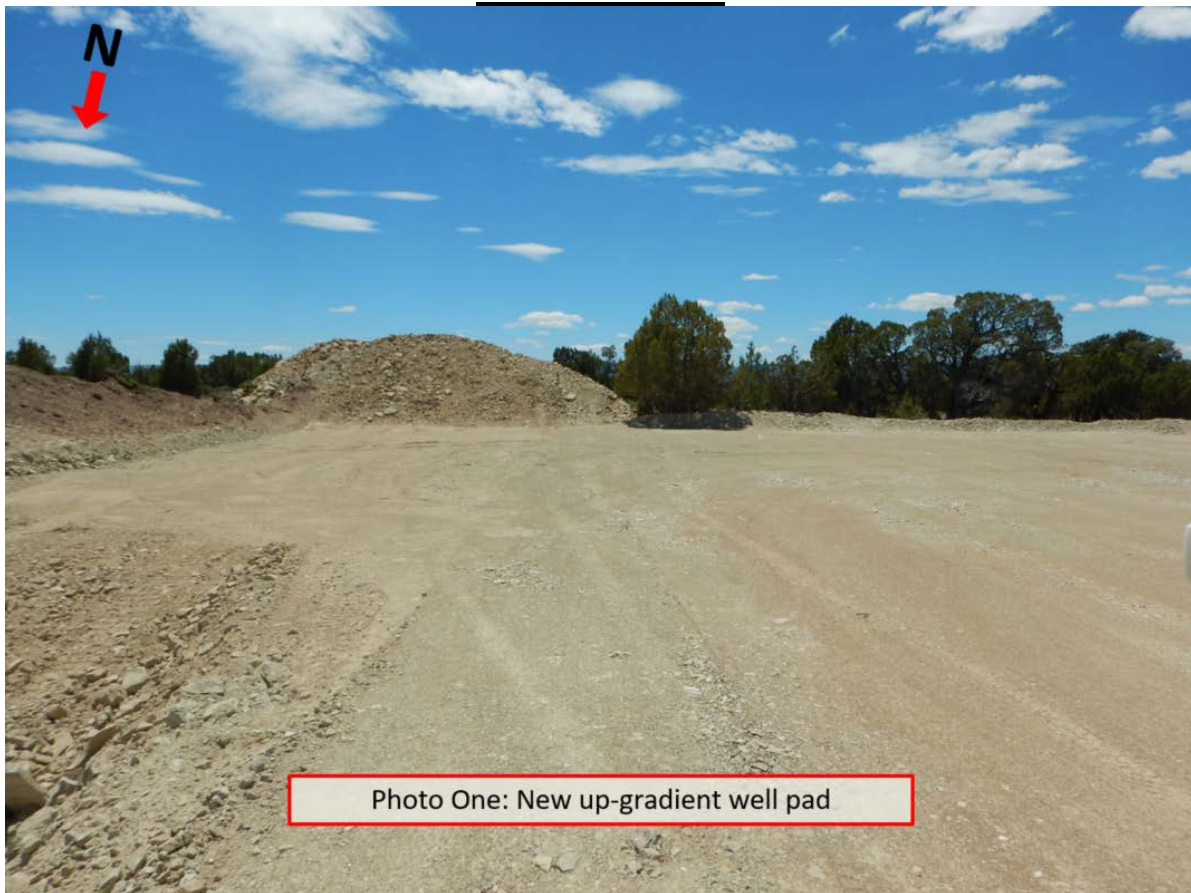
The new up-gradient well pad approved under TR-46 has been constructed. The pit is excavated and ready for use. It is anticipated that drilling will commence on July 20, 2021 with all three wells being completed by mid-August. BG-10 is slated to be drilled first followed by AG-2 then PA-1.

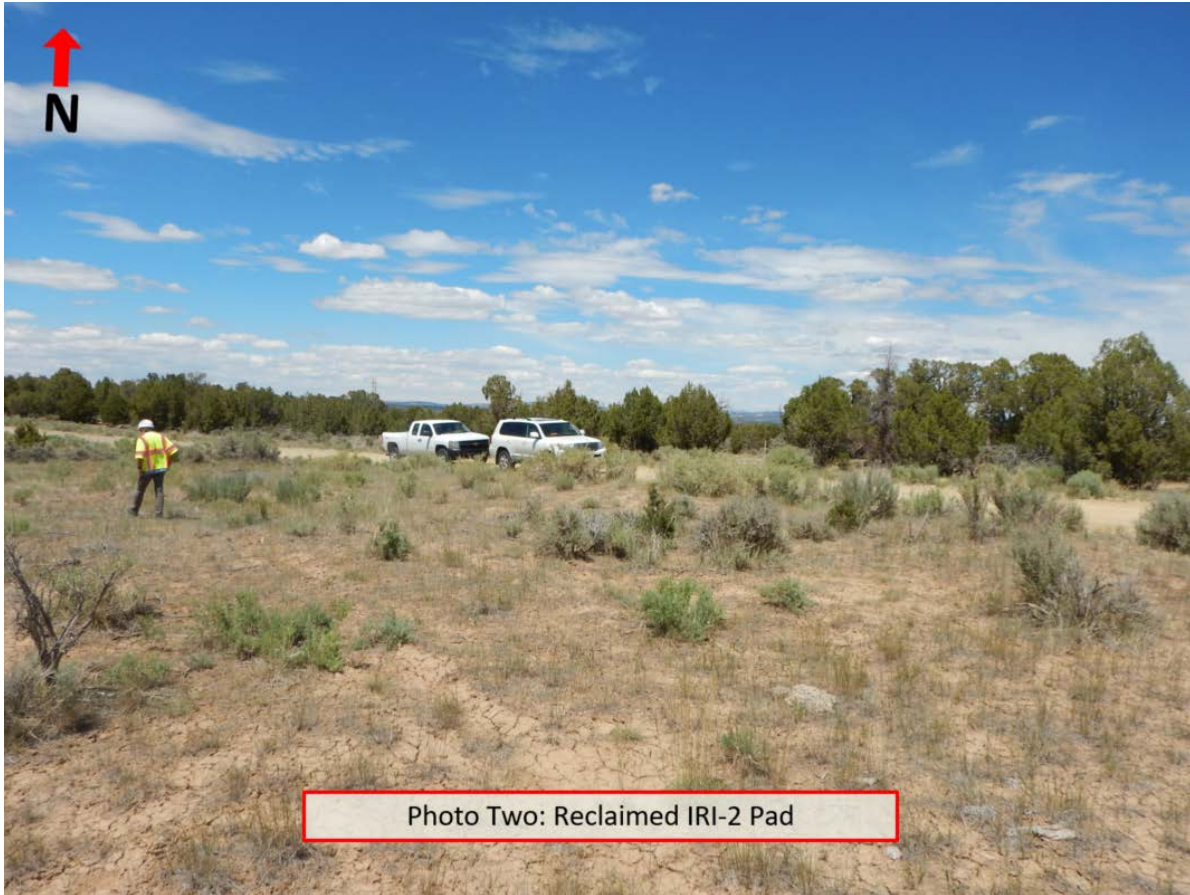
Photo Two: Reclaimed IRI-2 Pad

The reclaimed IRI-2 pad was observed. It blends naturally with the surroundings and is virtually undetectable.

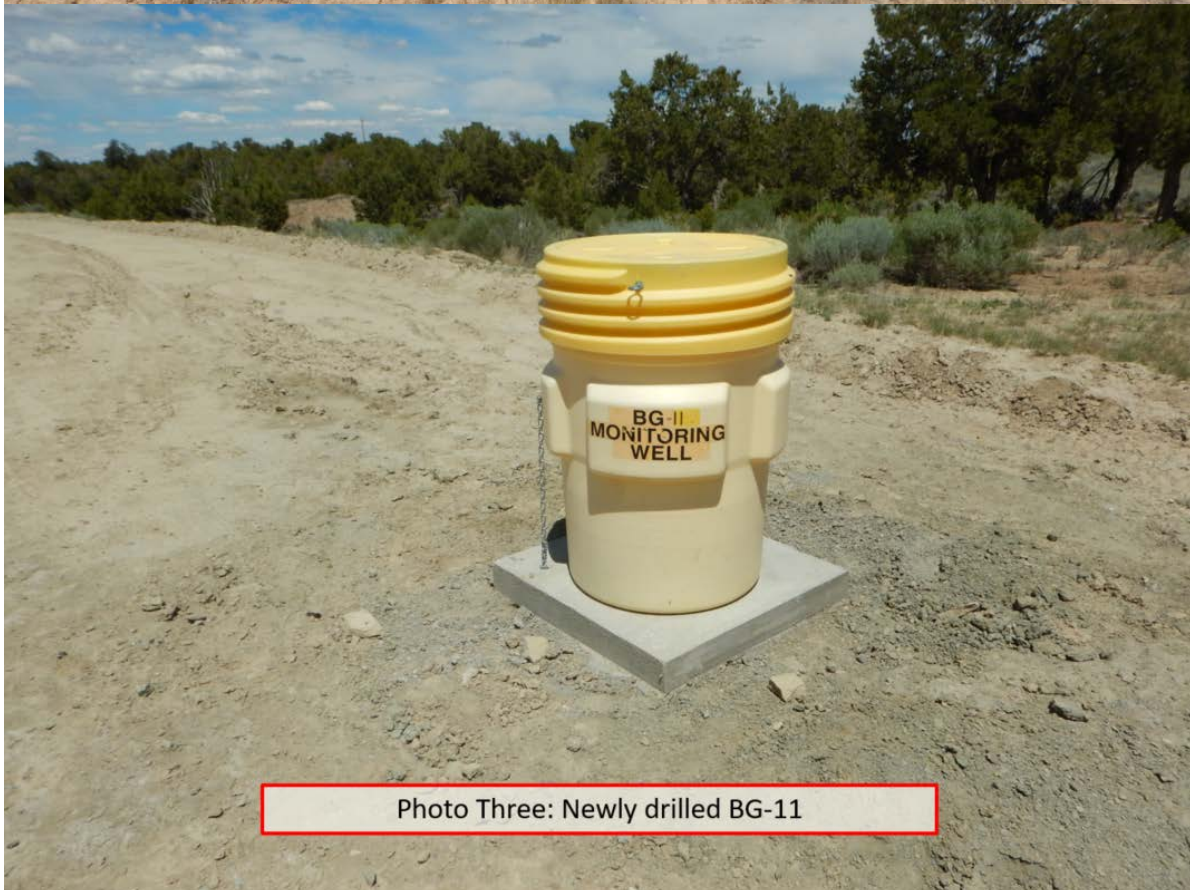
Photo Three: Newly drilled BG-11

The newly drilled monitoring well BG-11 which is located on pad 10H was observed. It is adjacent to AG-1. The wells are secured with a plastic tote and clearly labeled.

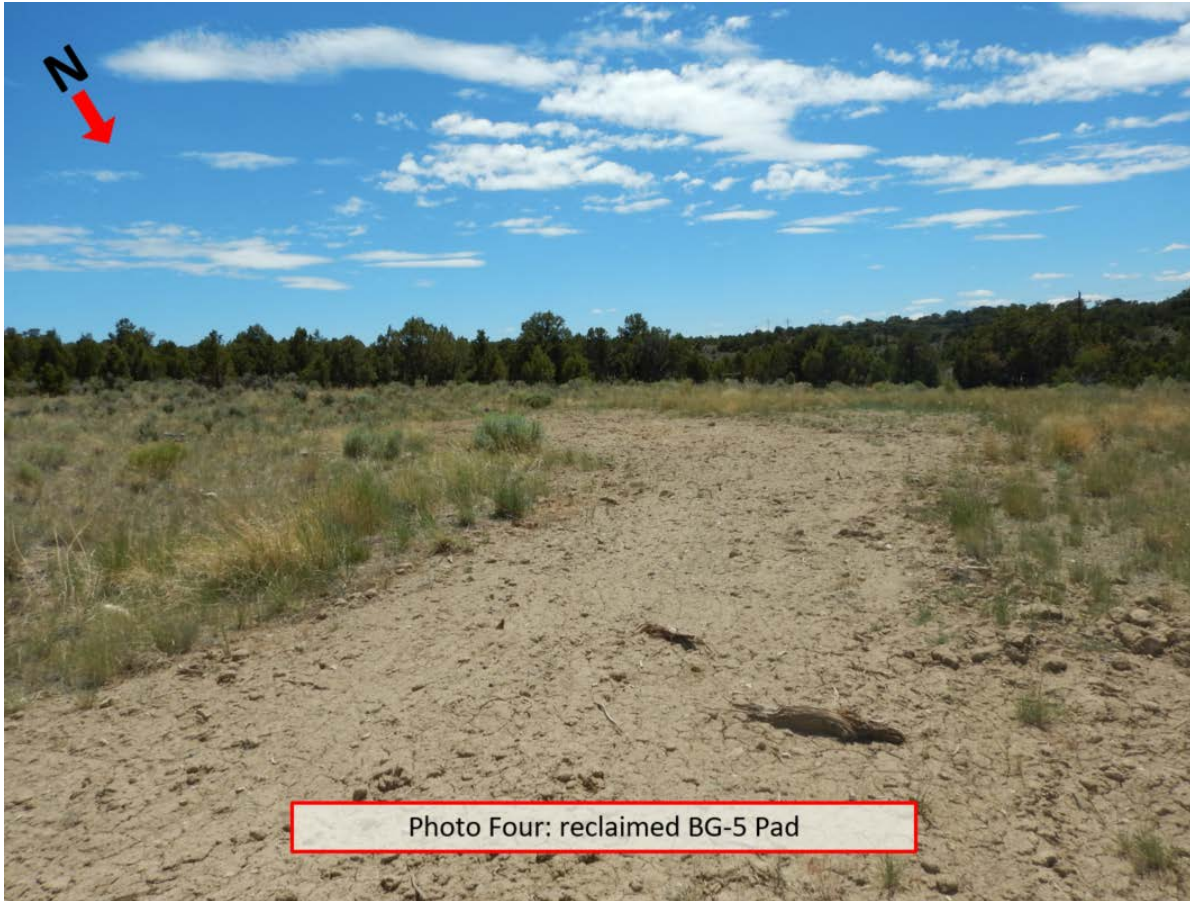
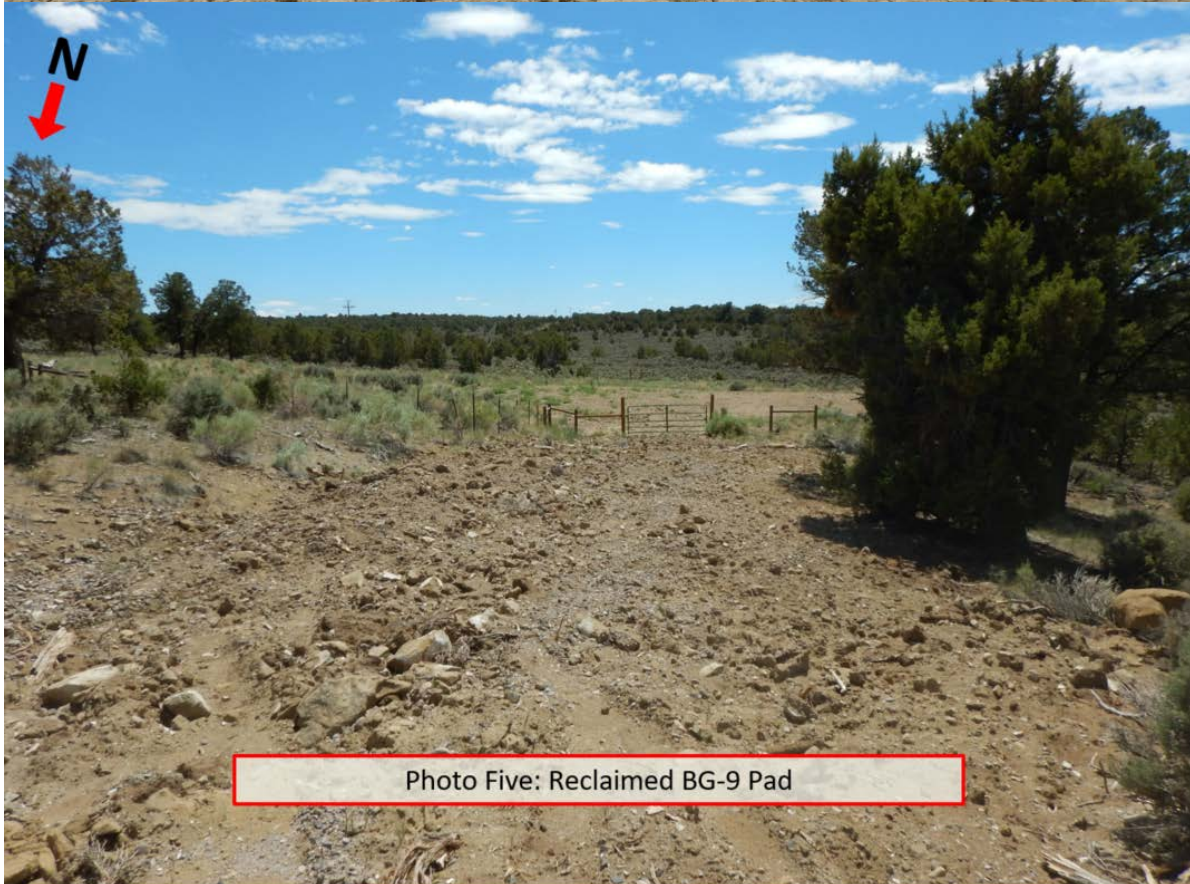
Well pads BG-5 and BG-9 were plugged last fall and the pads reclaimed. The exclusion fencing around the pads remains in place. Overall the civil work blends nicely into the surrounding topography. Unfortunately given the drought conditions the fall seeding did not appear to take. It is anticipated that pads will be reseeded this fall. Surrounding interim reclaimed areas will also help volunteer and stabilize the recently reclaimed areas.

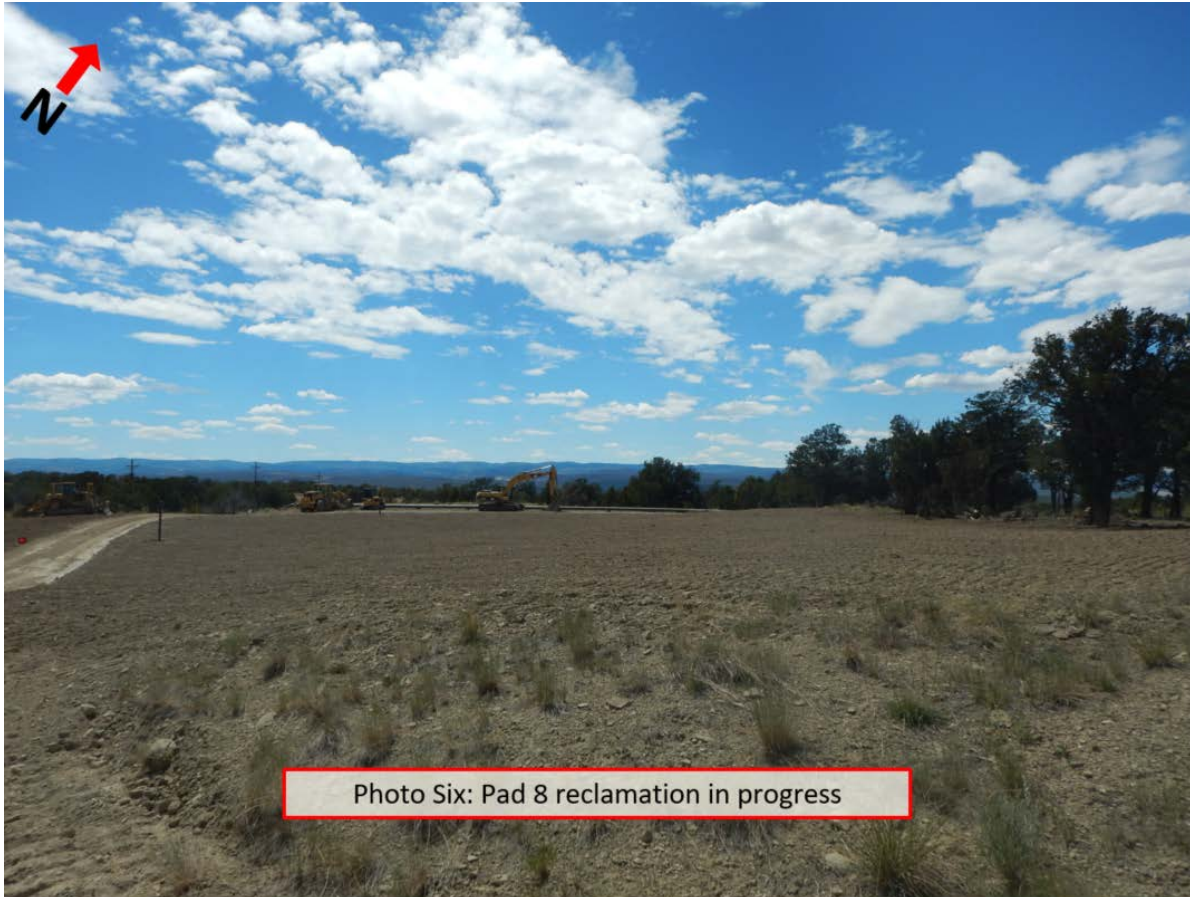
Photo Six: Pad 8 reclamation in progress

Pad 8 has also been reclaimed. Civil work is nearly completed. The access road to the pad 15-17 will remain and bisect the reclaimed areas. Additionally the access road to the 4-3H(V) pad will remain. The pad is slated to be reseeded this fall.

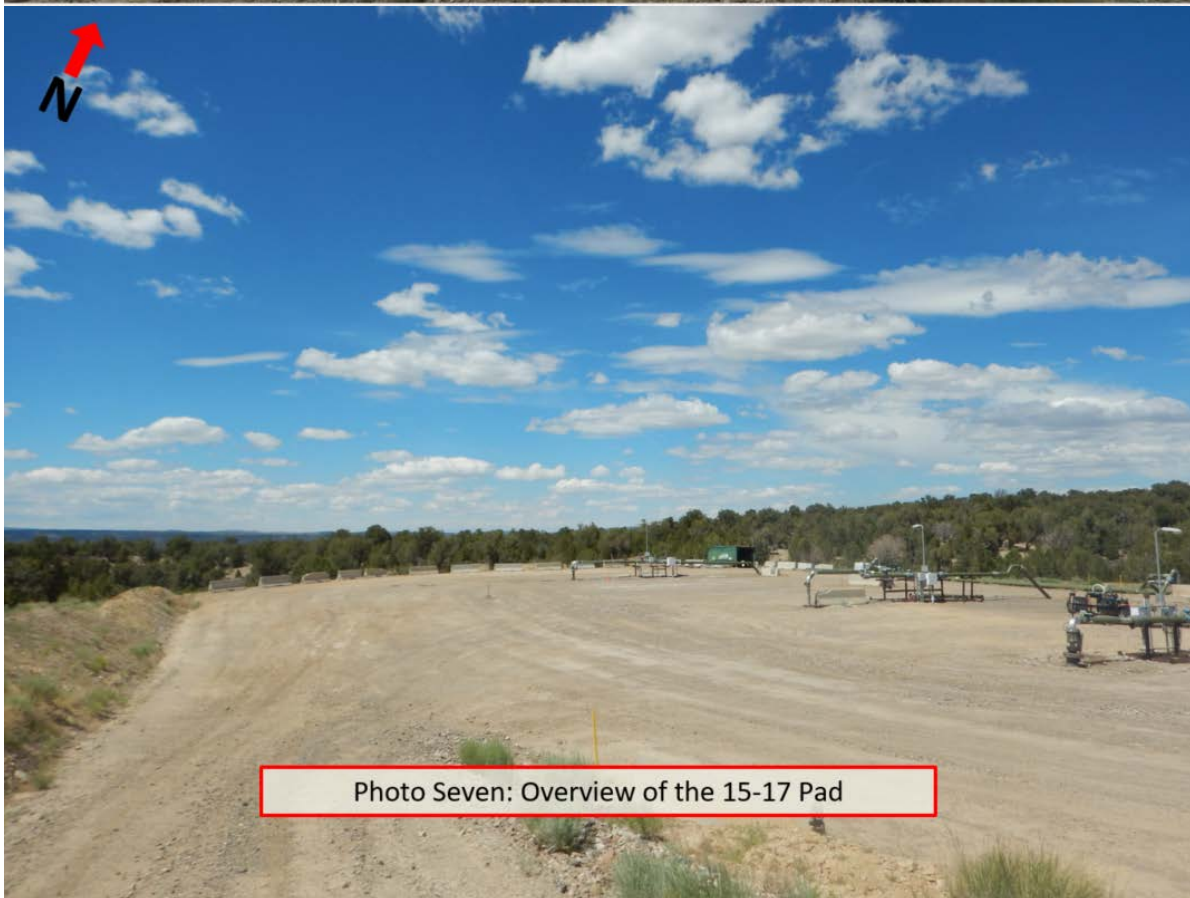
Photo Seven: Overview of the 15-17 Pad

The pit on pad 15-17 has been removed. The pad remains in good working order, free of excess debris with no signs of excessive erosion. All woody debris has been distributed.
