MINERALS PROGRAM INSPECTION REPORT
PHONE: (303) 866-3567

MINE NAME: Mahogany Research Project – Prospecting on SFOGI Land	MINE/PROSPECTING ID#: P-2003-022	MINERAL: Oil shale	COUNTY: Rio Blanco
INSPECTION TYPE: Monitoring	INSPECTOR(S): Amy Yeldell	INSP. DATE: July 1, 2021	INSP. TIME: 08:00
OPERATOR: Shell Frontier Oil & Gas Inc.	OPERATOR REPRESENTATIVE: Samantha Baker	TYPE OF OPERATION: MP - Mineral Prospecting	
REASON FOR INSPECTION: Normal I&E Program	BOND CALCULATION TYPE: None	BOND AMOUNT: \$6,666,003.00	
DATE OF COMPLAINT: NA	POST INSP. CONTACTS: None	JOINT INSP. AGENCY: None	
WEATHER: Clear	INSPECTOR'S SIGNATURE:

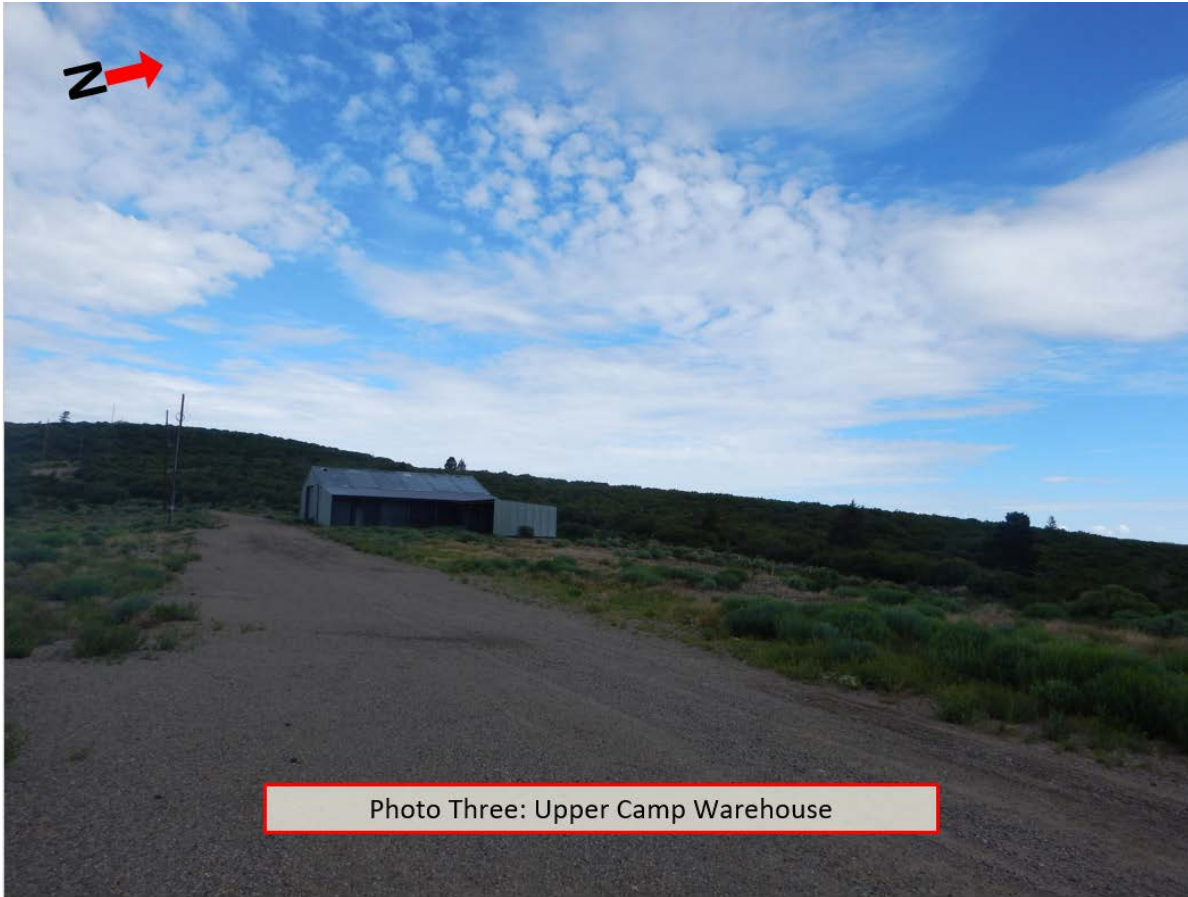
Photo Three: Upper Camp Warehouse

Upper Camp: Warehouse building with cistern and septic system remains on site. Upper camp warehouse was permitted to remain in MD-5. All portable trailers have been removed. The communication/ radio building remains in place. Roads are stabilized with gravel. Surrounding areas are stabilized with vegetation. Weed management treatments appears to be appropriate.

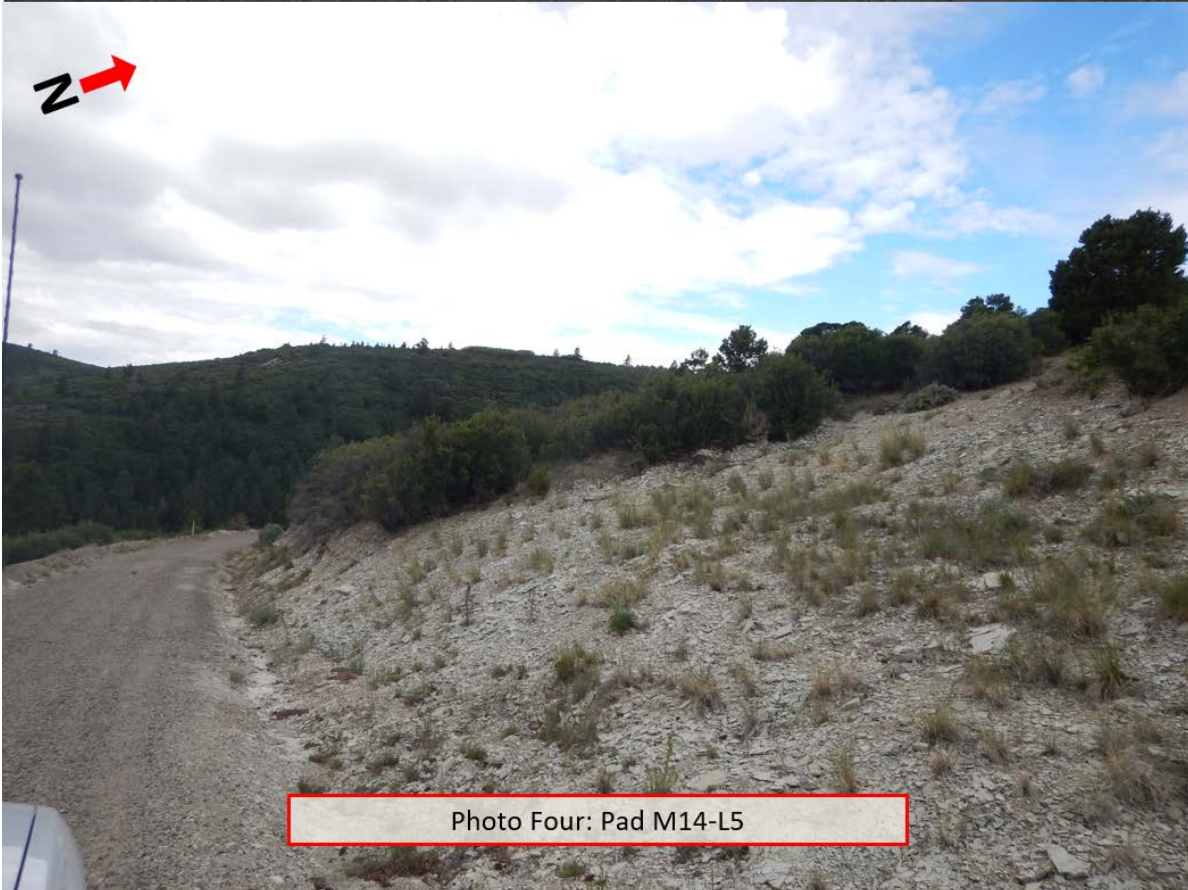
Photo Four: Pad M14-L5

*M14-L5: Located on the side of the upper camp facility loop road. Bank has been properly graded and appears stable. Vegetation is sufficient considering the location. Shrubs and trees will volunteer with time. This pad has achieved final reclamation.

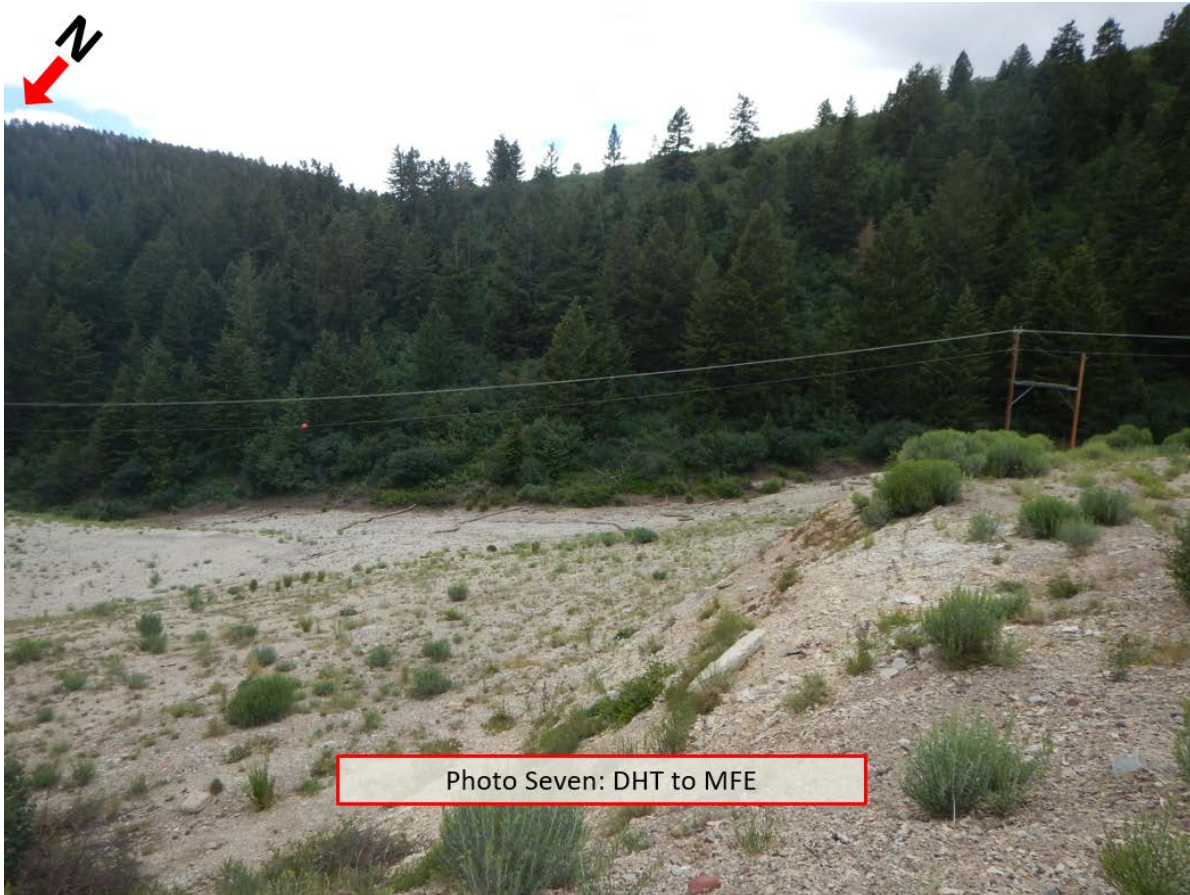
Photo Seven: DHT to MFE

MDP and DHT: Lower camp control room warehouse and electrical room remain in place per MD-5. The pad area has been graded and vegetation is starting to volunteer, establishment is not required per MD-5. Slopes have been contoured and naturally blend with vegetation at approximate 50%. Weeds are being effectively managed and soils appear stable.

MFE: The pad area has been graded and vegetation is starting to volunteer, establishment is not required per MD-5. Slopes have been contoured and naturally blend with vegetation at approximate 50%. Weeds are being effectively managed and soils appear stable.

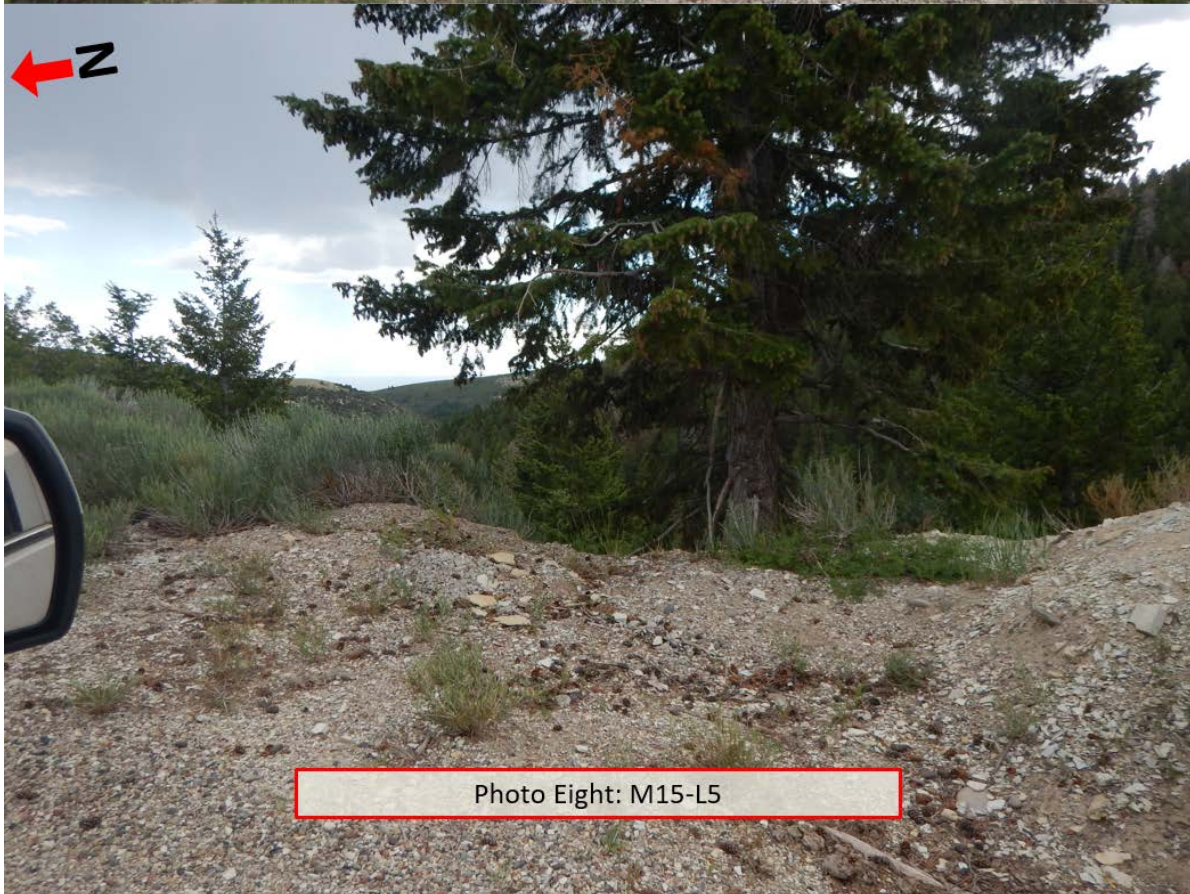
Photo Eight: M15-L5

*M15-L5: Extremely small pad (5ft x 5ft) area next to road exiting the upper camp facility. Blends naturally with surrounding topography and has self-reclaimed. No noxious weeds were observed. This pad has achieved final reclamation.
