MINERALS PROGRAM INSPECTION REPORT
PHONE: (303) 866-3567

MINE NAME: 2005-06 Geo-hydrology Drilling and Coring - Public	MINE/PROSPECTING ID#: P-2005-001	MINERAL: Oil shale	COUNTY: Rio Blanco
INSPECTION TYPE: Monitoring	INSPECTOR(S): Amy Yeldell	INSP. DATE: June 29, 2021	INSP. TIME: 08:00
OPERATOR: Shell Frontier Oil & Gas Inc.	OPERATOR REPRESENTATIVE: Samantha Baker	TYPE OF OPERATION: MP - Mineral Prospecting	
REASON FOR INSPECTION: Normal I&E Program	BOND CALCULATION TYPE: None	BOND AMOUNT: \$1,579,882.00	
DATE OF COMPLAINT: NA	POST INSP. CONTACTS: None	JOINT INSP. AGENCY: U.S.BLM	
WEATHER: Clear	INSPECTOR'S SIGNATURE:

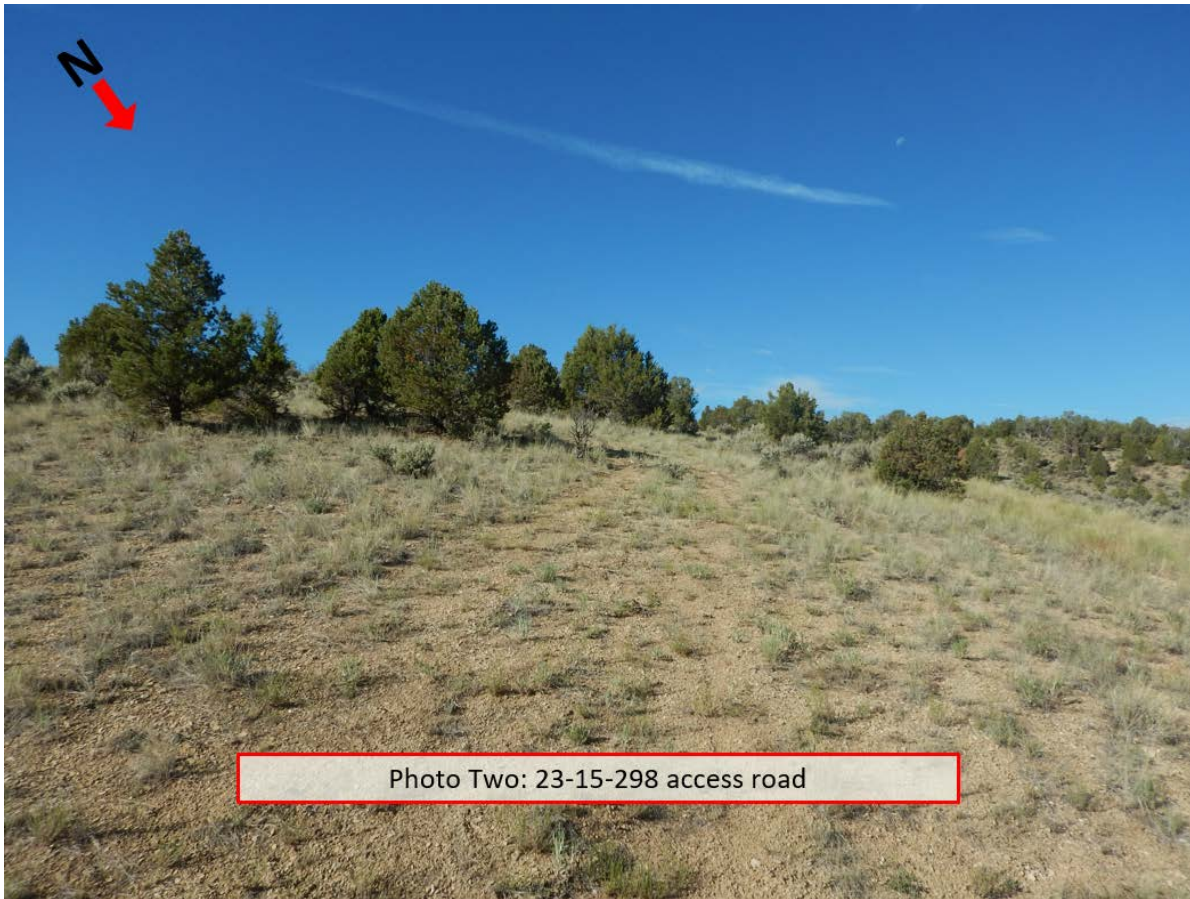
Photo Two: 23-15-298 access road

*Pad 23-15-298: Long access road coming from pad 25. The road is free of erosion and coming in very well considering rocky dry soils. Pad has diverse vegetation with very few spots of cheatgrass (which have been treated). Native vegetation is outcompeting noxious weeds and thriving. Final reclamation has been achieved.
