MINERALS PROGRAM INSPECTION REPORT
PHONE: (303) 866-3567

MINE NAME: 2005-06 Geo-hydrology Drilling and Coring - Private	MINE/PROSPECTING ID#: P-2005-002	MINERAL: Oil shale	COUNTY: Rio Blanco
INSPECTION TYPE: Monitoring	INSPECTOR(S): Amy Yeldell	INSP. DATE: July 1, 2021	INSP. TIME: 08:00
OPERATOR: Shell Frontier Oil & Gas Inc.	OPERATOR REPRESENTATIVE: Samantha Baker	TYPE OF OPERATION: MP - Mineral Prospecting	
REASON FOR INSPECTION: Normal I&E Program	BOND CALCULATION TYPE: None	BOND AMOUNT: \$369,361.00	
DATE OF COMPLAINT: NA	POST INSP. CONTACTS: None	JOINT INSP. AGENCY: None	
WEATHER: Clear	INSPECTOR'S SIGNATURE:

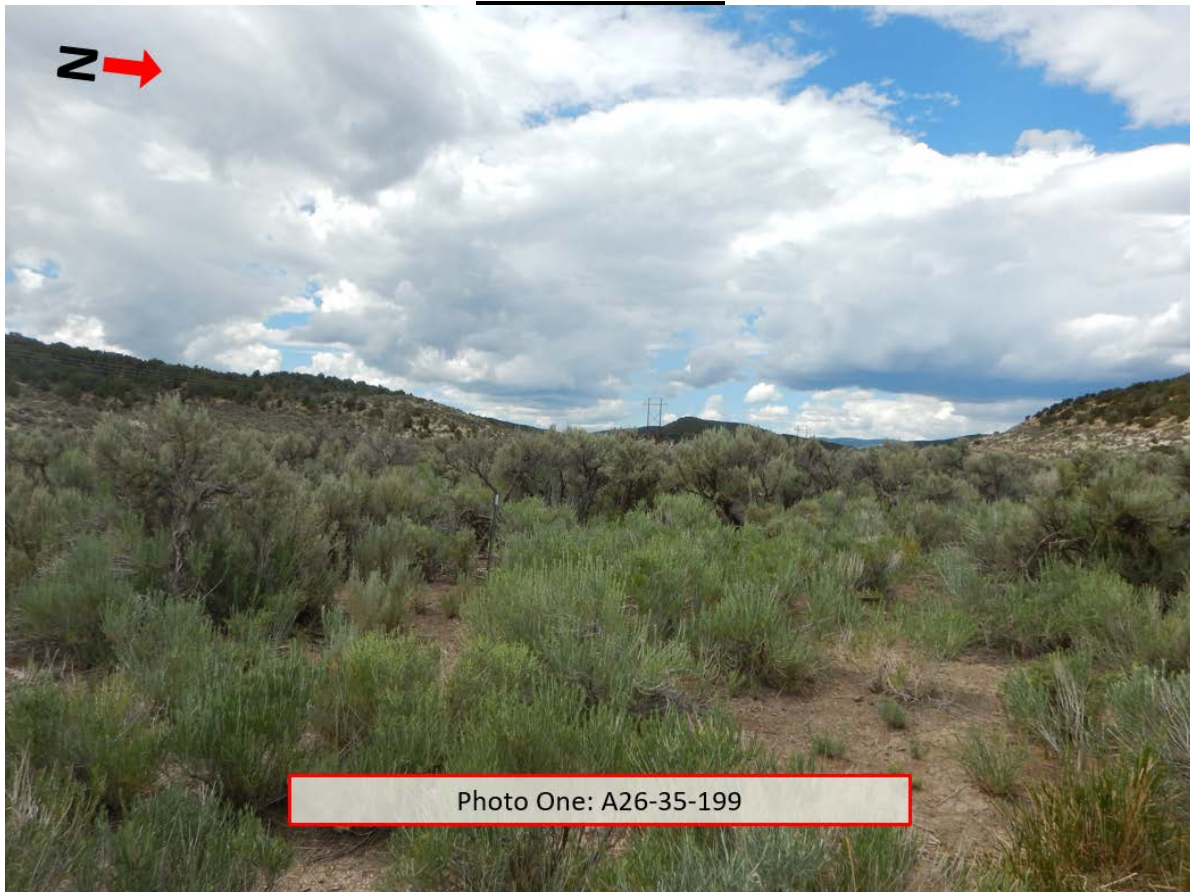
*A26-35-199: On the corner of the released pad 54-35-199. Mostly all mature sagebrush. Very little grass understory but blends naturally with surroundings. Final reclamation has been achieved.

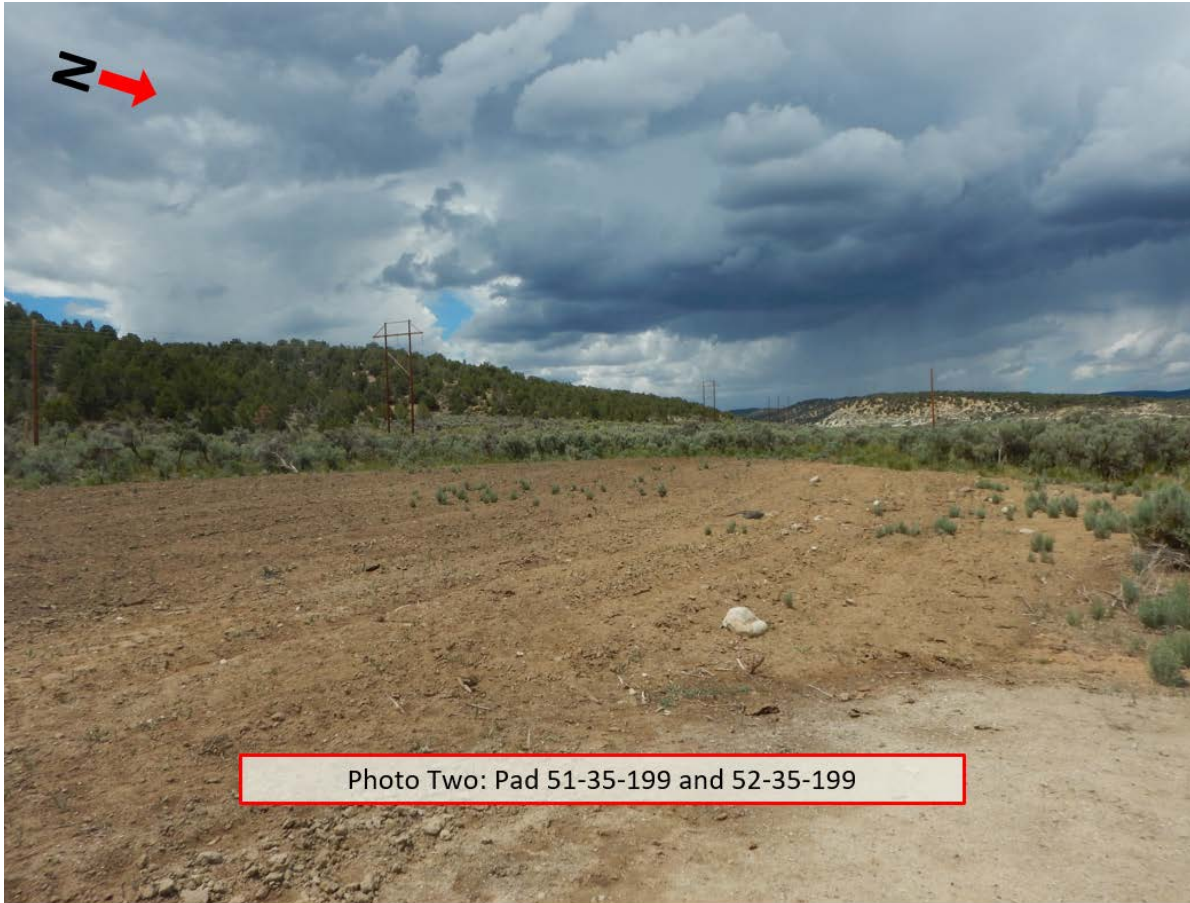
Photo Two: Pad 51-35-199 and 52-35-199

Pad 51-35-199: Pad is generally bare. Significant cheatgrass infestation in the past so the pad was treated with 'bare ground'. Reseeding in fall of 2020. Shrubs remain with some grasses beginning to emerge. Generally cover is less than 20%.

Pad 52-35-199: Pad is generally bare. Significant cheatgrass infestation in the past so the pad was treated with 'bare ground'. Reseeding in fall of 2020. Shrubs remain with some grasses beginning to emerge. Generally cover is less than 20%.

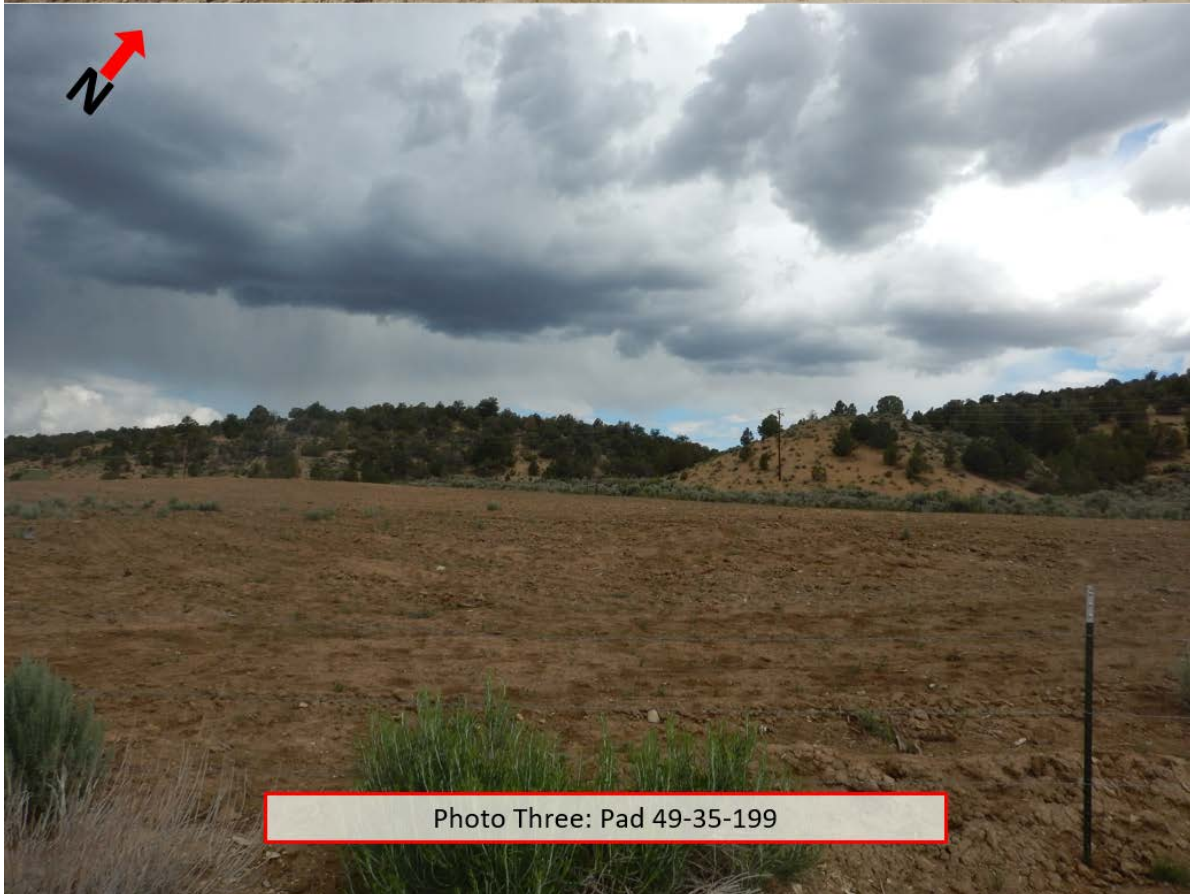
Photo Three: Pad 49-35-199

Pad 49-35-199: Pad is generally bare. Remaining topsoil pad was flattened and disturbed to areas lacking topsoil. Significant cheatgrass infestation in the past so the pad was treated with 'bare ground'. Reseeding in spring of 2021. Shrubs remain with some grasses beginning to emerge. Generally cover is less than 20%.

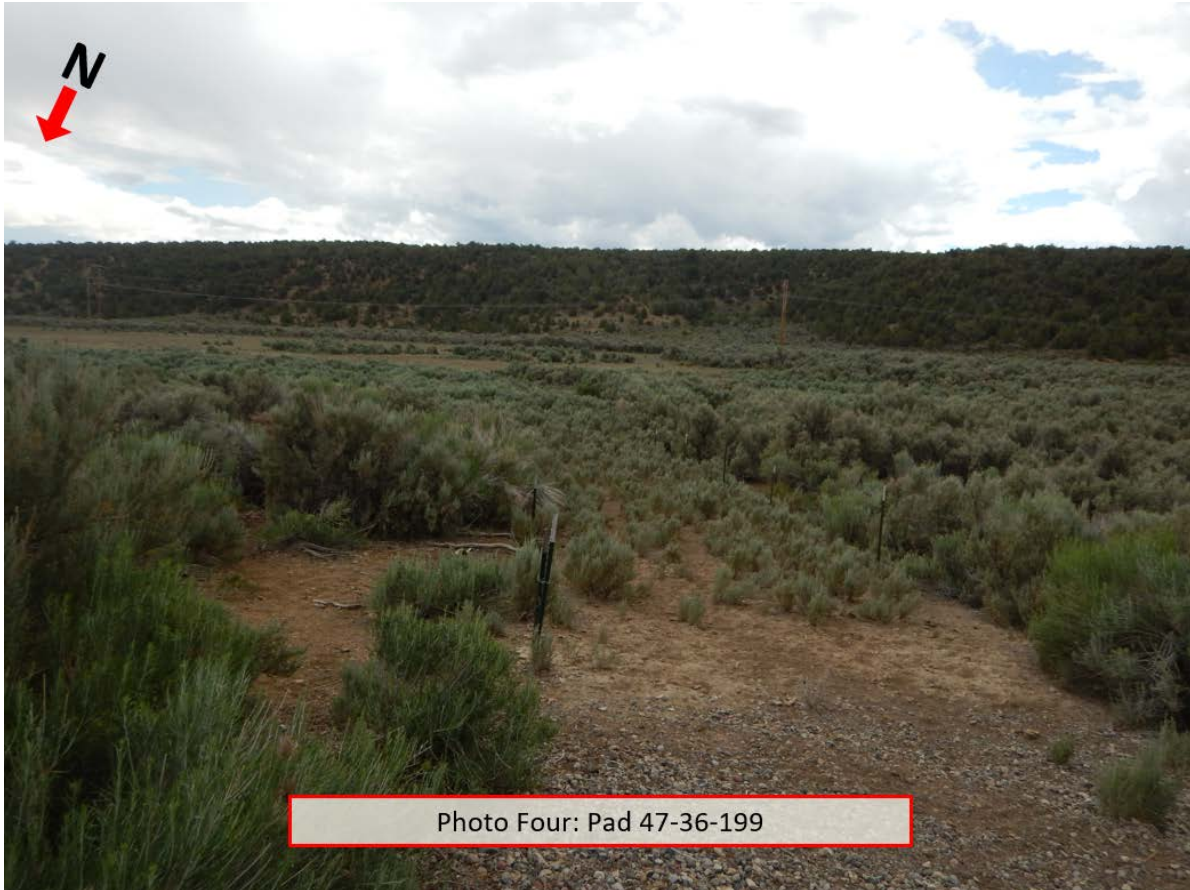
*Pad 47-36-199: Mostly all mature sage brush. Grazed have been grazed hard and are stunted as a result. Overall cover is at 60% or higher and blends naturally with the surrounding areas. Final reclamation has been achieved.

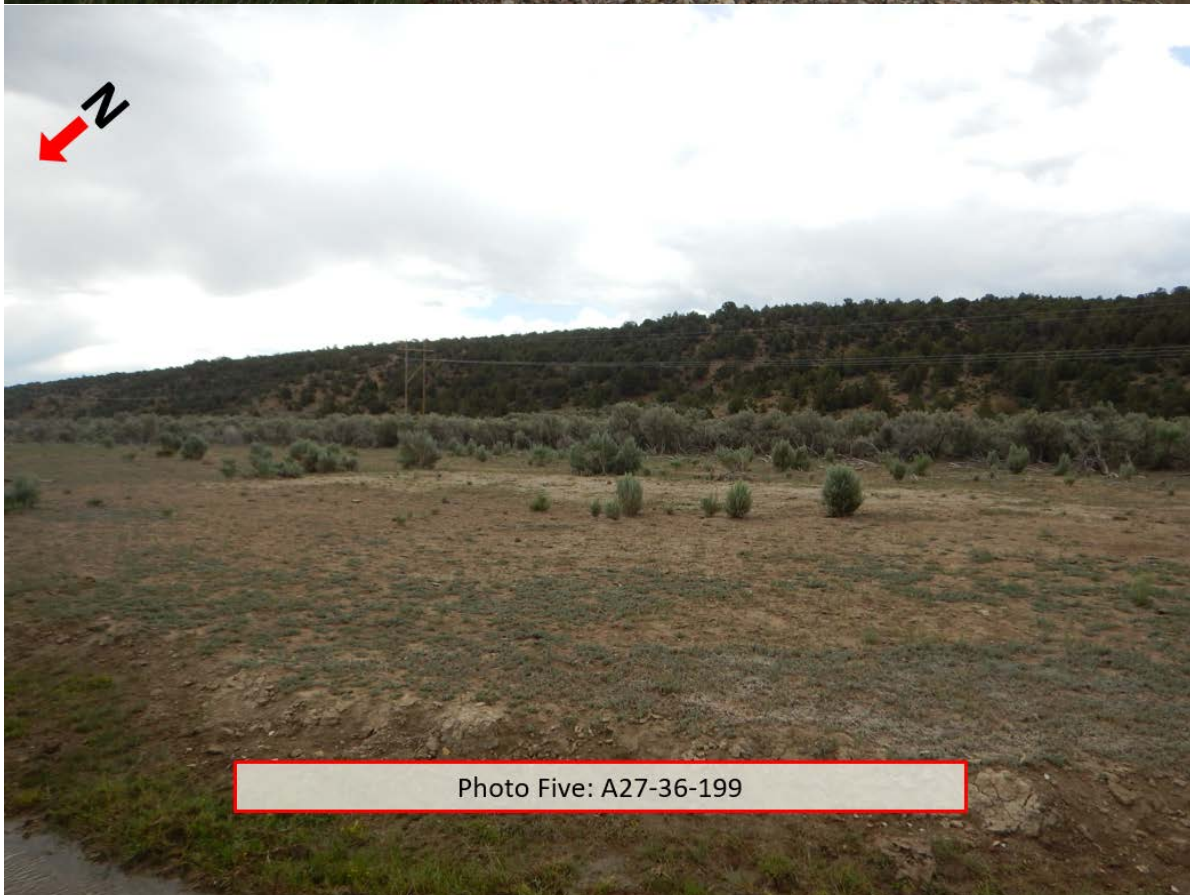
*A27-36-199: On the side of Pas 47-36-199. Mostly all mature sagebrush. Very little grass understory but blends naturally with surroundings. Final reclamation has been achieved.

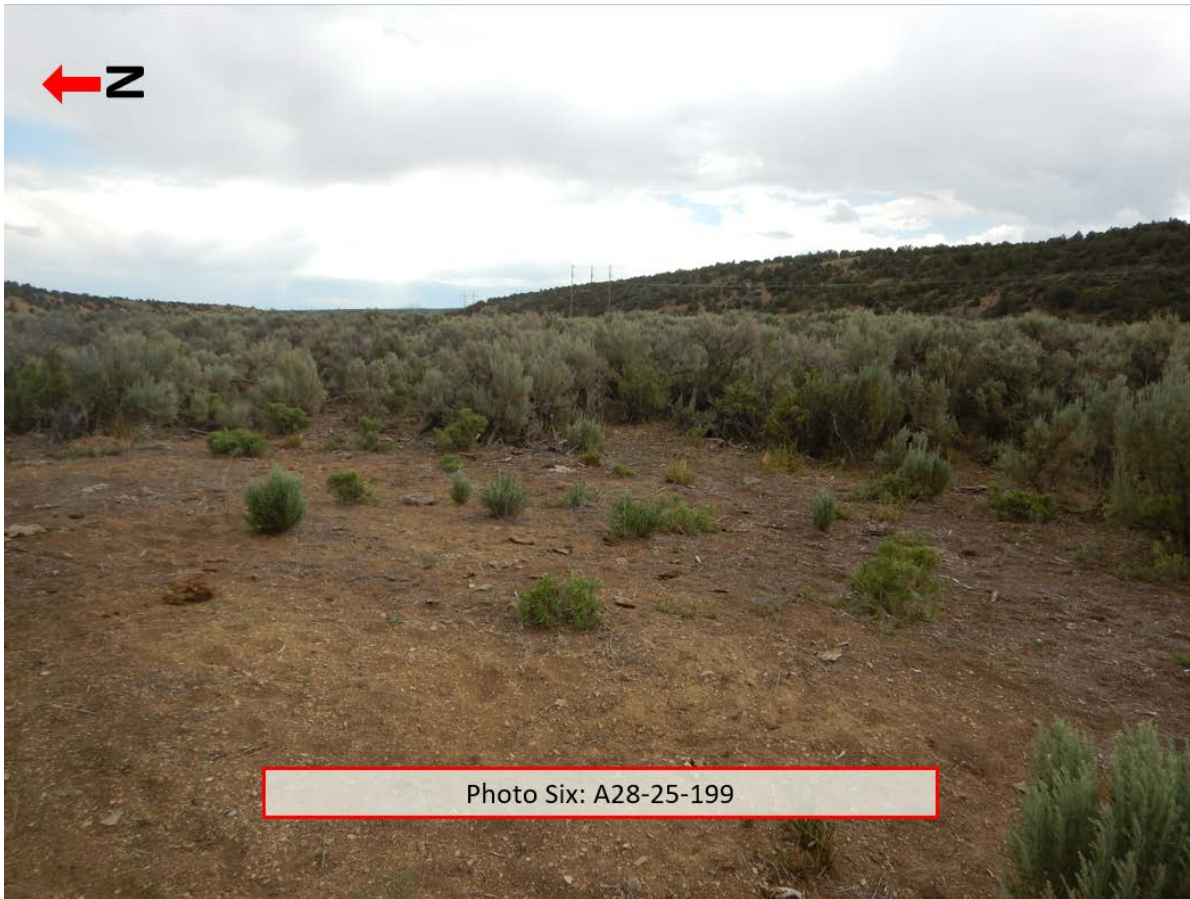
Photo Six: A28-25-199

A28-25-199: Very little vegetation, area has been heavily grazed by cattle and horses. In a natural opening so grasses are sparse. Little to no weeds observed.

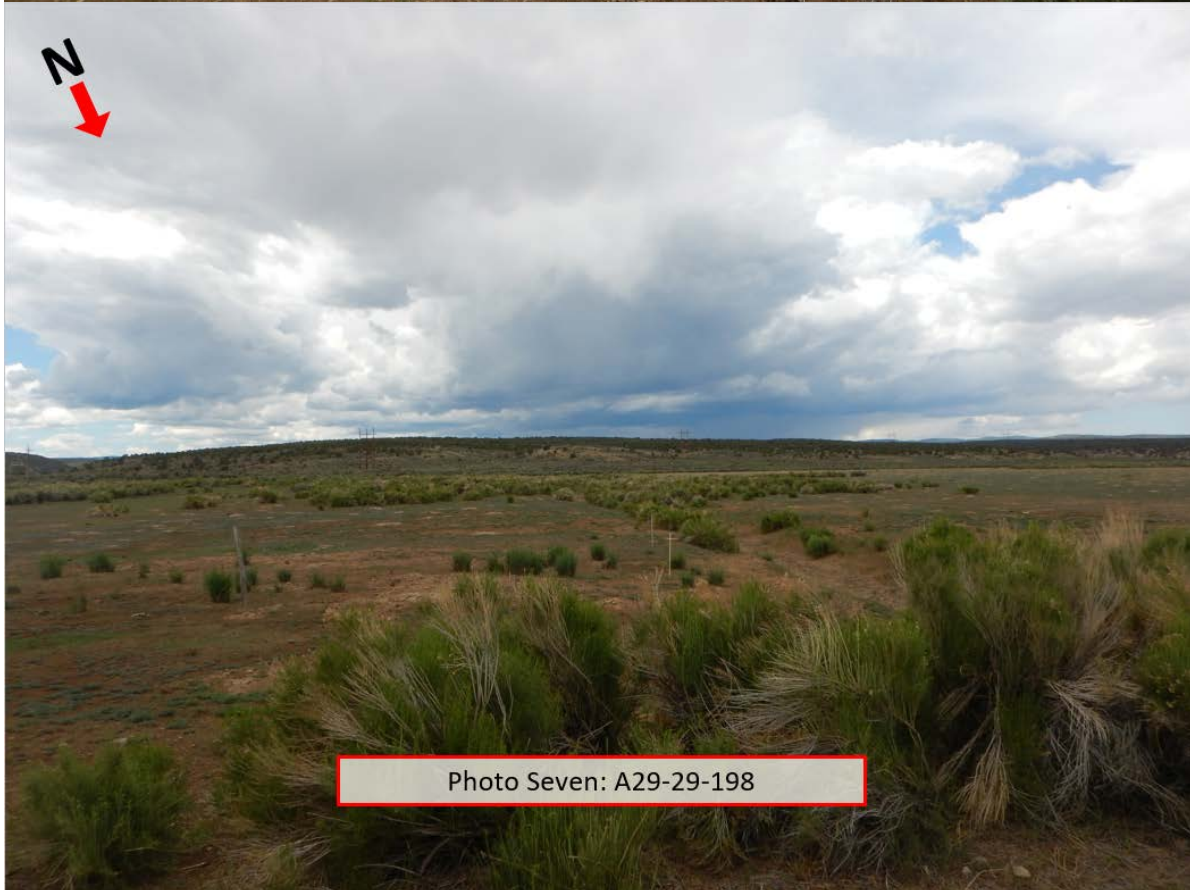
Photo Seven: A29-29-198

*A29-29-198: In a natural opening. Grasses on the pad and surrounding are generally low and sparse due to grazing. Unable to distinguish where disturbance was compared to surroundings. Final reclamation has been achieved.

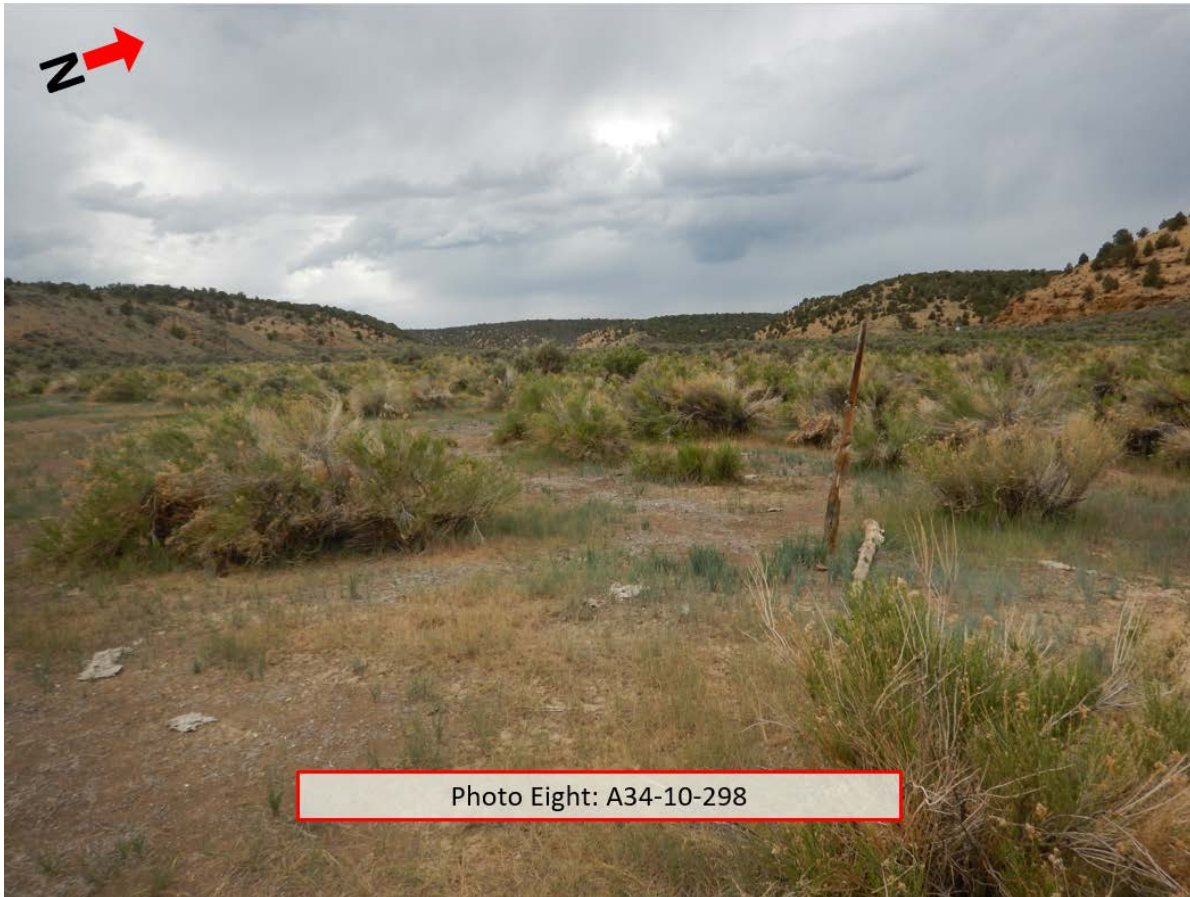
*A34-10-298: Vegetation is hit or miss within a natural opening that is subject to grazing. Blend of mature sage and understory grasses. Unable to distinguish where disturbance was compared to surroundings. Final

reclamation has been achieved.

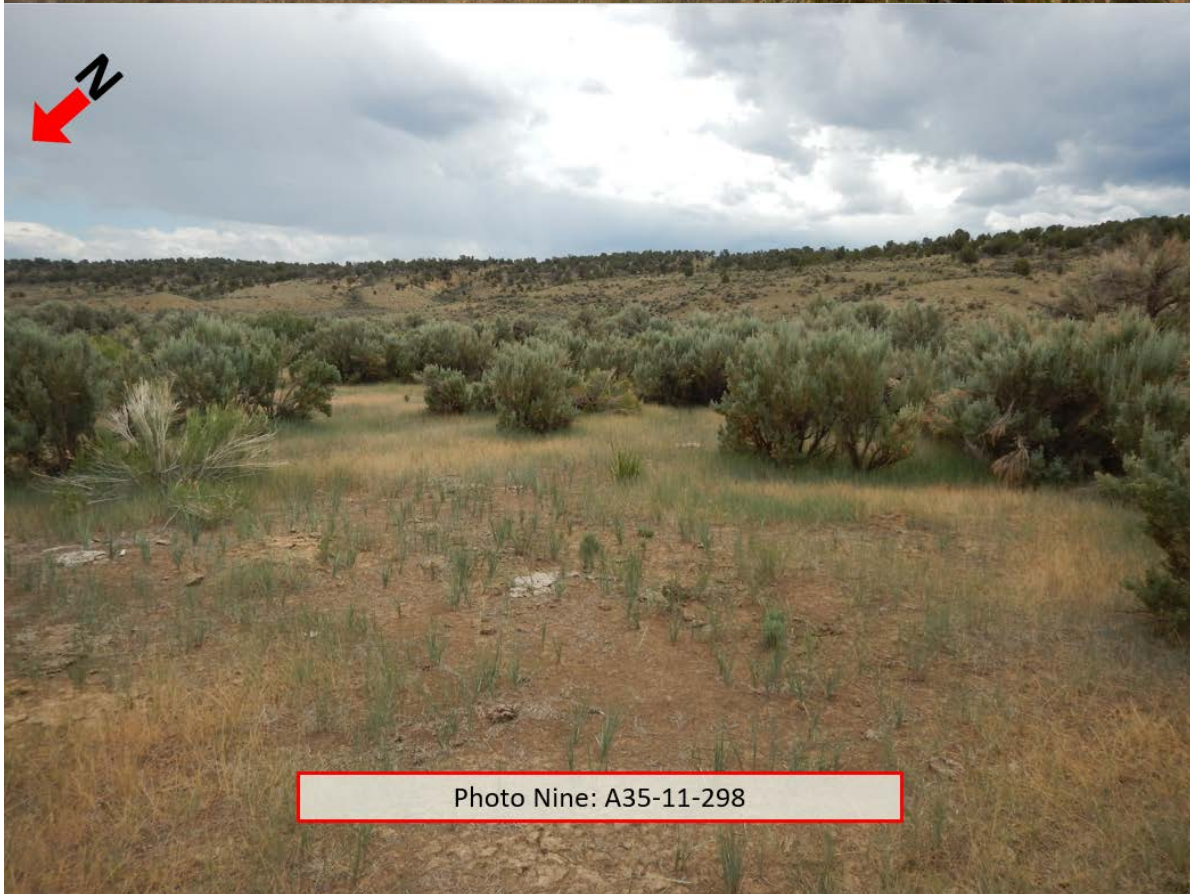
*A35-11-298: Vegetation is hit or miss within a natural opening that is subject to grazing. Blend of mature sage and understory grasses. Unable to distinguish where disturbance was compared to surroundings. Final reclamation has been achieved
