MINERALS PROGRAM INSPECTION REPORT
PHONE: (303) 866-3567

MINE NAME: Mahogany Research-Freeze Wall Test	MINE/PROSPECTING ID#: P-2005-017	MINERAL: Oil shale	COUNTY: Rio Blanco
INSPECTION TYPE: Monitoring	INSPECTOR(S): Amy Yeldell	INSP. DATE: July 1, 2021	INSP. TIME: 08:00
OPERATOR: Shell Frontier Oil & Gas Inc.	OPERATOR REPRESENTATIVE: Samantha Baker	TYPE OF OPERATION: MP - Mineral Prospecting	
REASON FOR INSPECTION: Normal I&E Program	BOND CALCULATION TYPE: None	BOND AMOUNT: \$2,158,429.00	
DATE OF COMPLAINT: NA	POST INSP. CONTACTS: None	JOINT INSP. AGENCY: None	
WEATHER: Clear	INSPECTOR'S SIGNATURE:

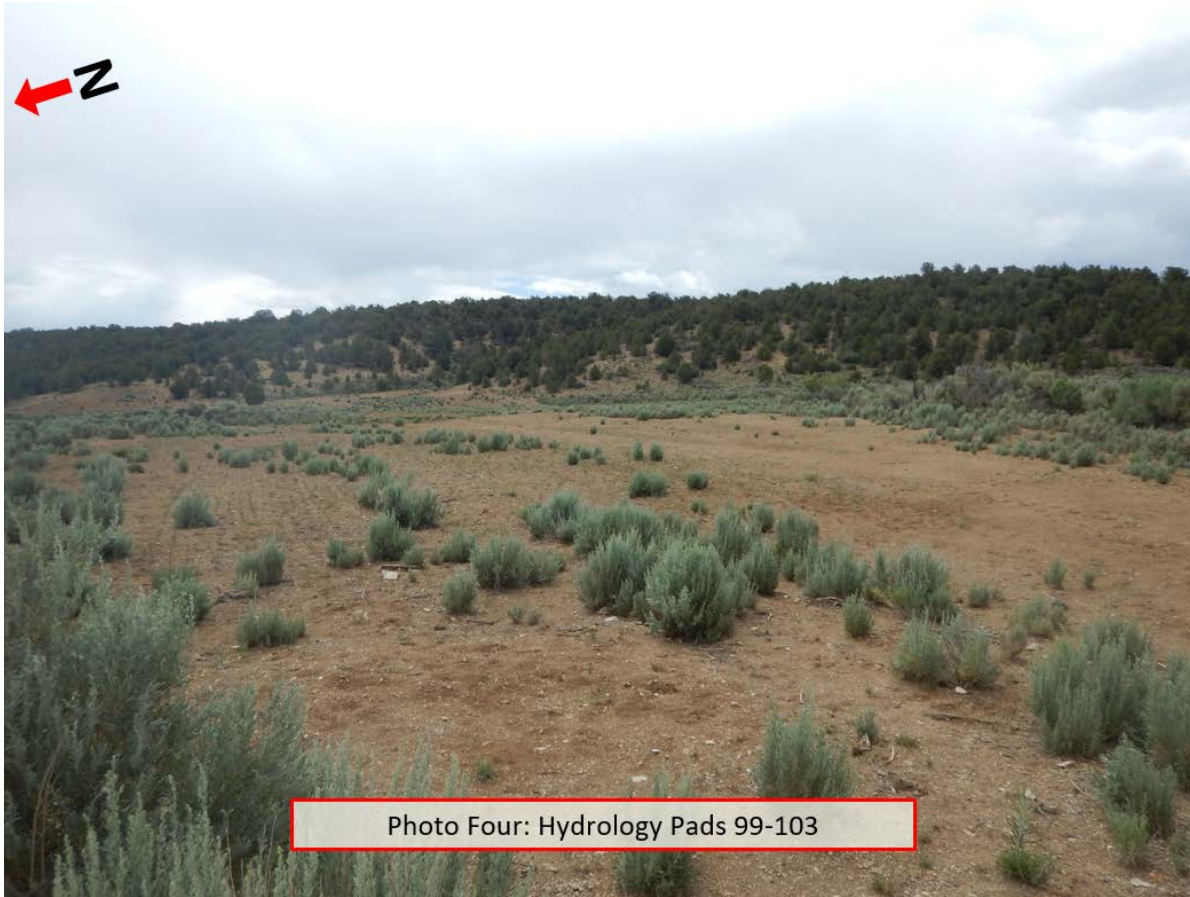
Photo Four: Hydrology Pads 99-103

Hydrology pads: Due to an extensive cheatgrass infestation pads were cleared using 'bare ground' and allowed to rest. They were reworked in the spring of 2021. Sage and shrubs were left in place. No weeds were observed and grass is beginning to germinate.
