BOWIE RESOURCES, LLC
Bowie No. 2 Mine
Coal Mine Waste Bank Nos. 1, 2, & 3 Inspections –2nd Quarter 2021

On June 29, 2021, a visual inspection of the Bowie No. 2 Mine coal mine waste banks was performed by the undersigned in accordance with Rule 4.10.2. This inspection includes Gob Pile Nos. 1, 2, and 3. Pile No. 1 is considered inactive. Pile no. 2 is located north of Bowie Road and is currently idle. Pile no. 3 is located south of Bowie Road. Pile No.4 has been reclaimed and is inactive.

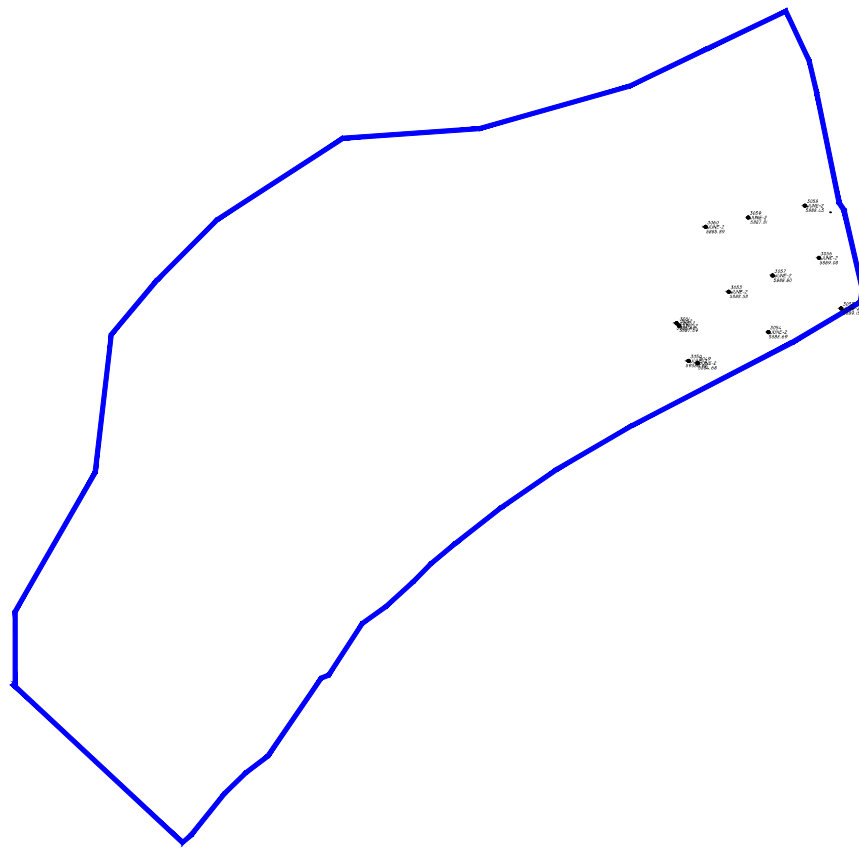
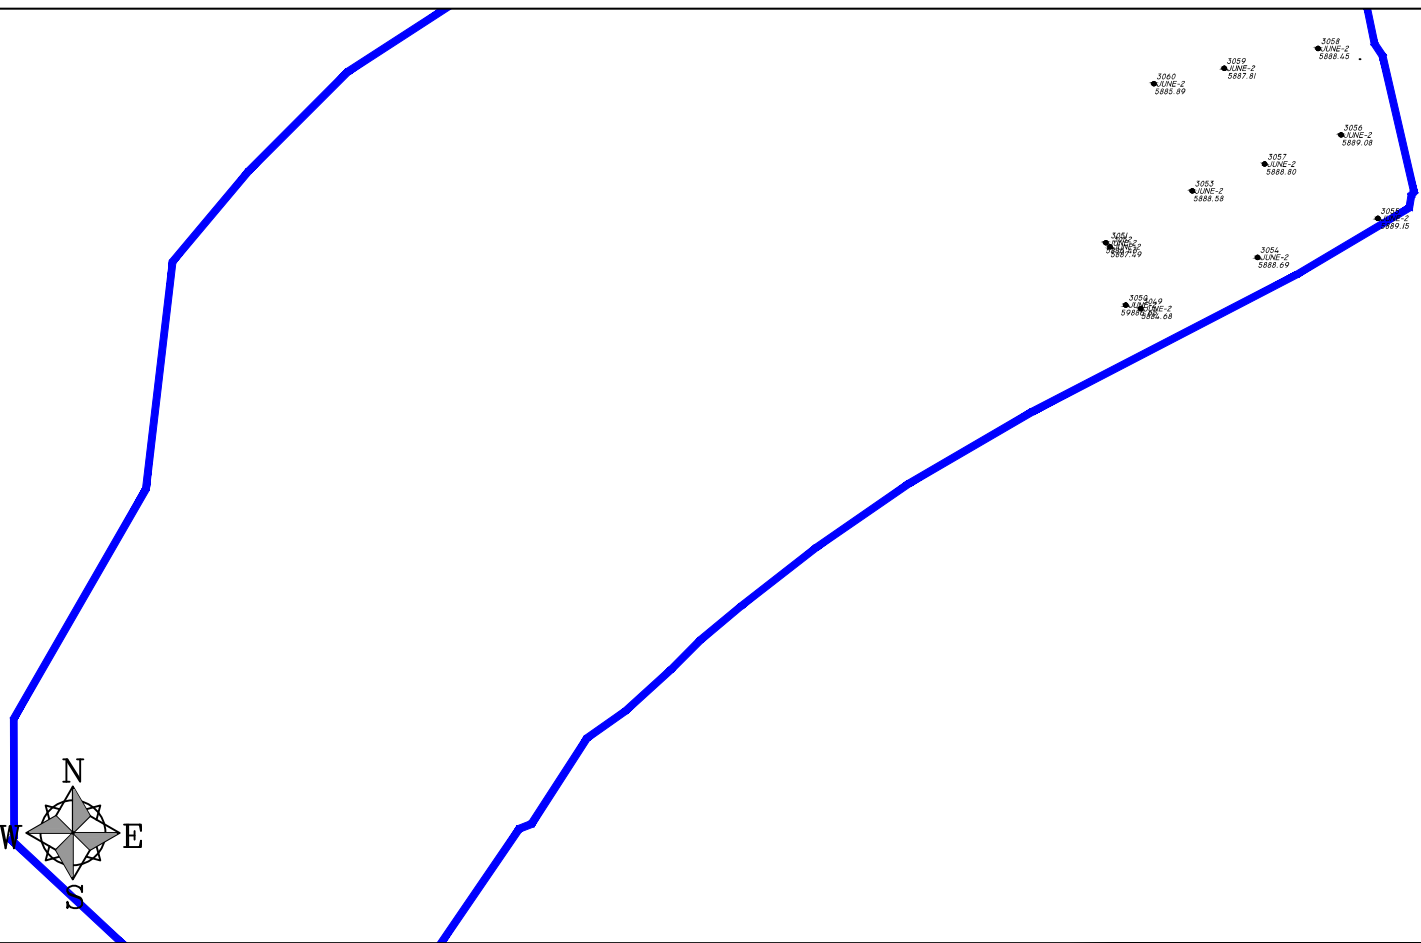
GOB PILE #3 COMPACTION TEST LOCATIONS

There was no coal mine waste generated from the preparation plant during the quarter. Coal mine waste is to be placed in the piles in approximately horizontal lifts no more than 24-inches thick. The coal mine waste is dried and then spread and compacted by self propelled sheepsfoot compactors. There were thirty-six (36) compaction tests were taken at gob pile #3 during the quarter. There were no compaction tests taken at gob pile #2 during the quarter.
