MINERALS PROGRAM INSPECTION REPORT
PHONE: (303) 866-3567

MINE NAME: 2006/07 Geo-Hydro Drill & Core Prgm- Public-PRL's	MINE/PROSPECTING ID#: P-2006-037	MINERAL: Oil shale	COUNTY: Rio Blanco
INSPECTION TYPE: Monitoring	INSPECTOR(S): Amy Yeldell	INSP. DATE: June 29, 2021	INSP. TIME: 08:00
OPERATOR: Shell Frontier Oil & Gas Inc.	OPERATOR REPRESENTATIVE: Samantha Baker	TYPE OF OPERATION: MP - Mineral Prospecting	
REASON FOR INSPECTION: Normal I&E Program	BOND CALCULATION TYPE: None	BOND AMOUNT: \$168,818.66	
DATE OF COMPLAINT: NA	POST INSP. CONTACTS: None	JOINT INSP. AGENCY: U.S.BLM	
WEATHER: Clear	INSPECTOR'S SIGNATURE:

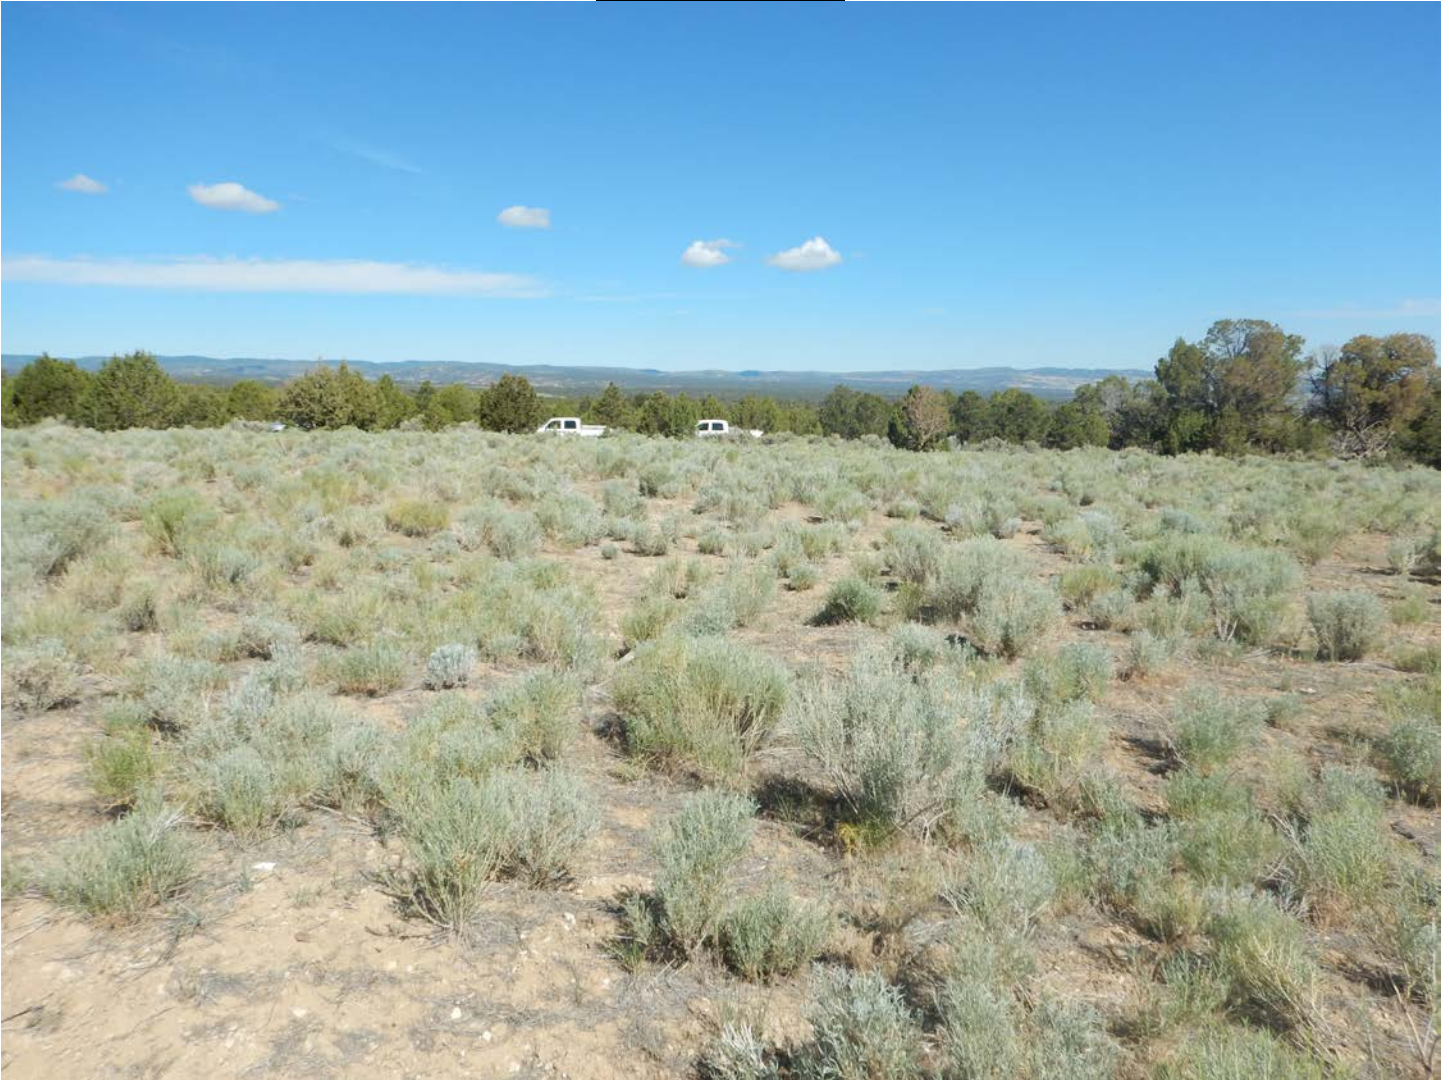
Pad 71-8-298: There is a culvert at the pad access from the county road that needs to be removed and reclaimed. Overall the pad has sufficient cover. Cheatgrass populations appear to be increasing and pushing out the already limited desirable grass species. The pad remains predominantly Rabbit Brush with some grasses beginning to establish. Very little grazing pressure was observed this year however vegetation continues to show signs of drought stress.
