MINERALS PROGRAM INSPECTION REPORT
PHONE: (303) 866-3567

MINE NAME: Biesemeier State Pit	MINE/PROSPECTING ID#: M-2021-029	MINERAL: Gravel and clay (gen	COUNTY: Phillips
INSPECTION TYPE: Preoperation Inspection	INSPECTOR(S): Brock Bowles	INSP. DATE: July 1, 2021	INSP. TIME: 10:00
OPERATOR: Phillips County	OPERATOR REPRESENTATIVE: Mike Salyards	TYPE OF OPERATION: 112c - Construction Regular Operation	
REASON FOR INSPECTION: Preoperation Inspection	BOND CALCULATION TYPE: None	BOND AMOUNT: No Bond Held	
DATE OF COMPLAINT: NA	POST INSP. CONTACTS: None	JOINT INSP. AGENCY: None	
WEATHER: Clear	INSPECTOR'S SIGNATURE:

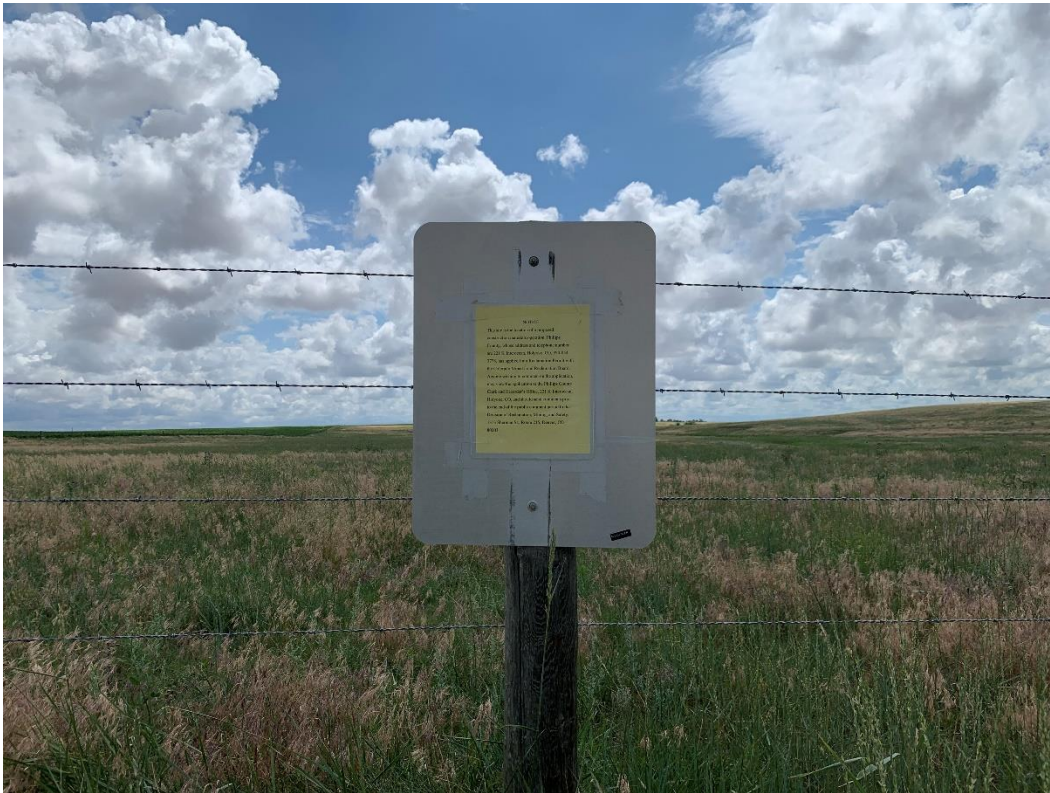
Photo 1 – Public notice sign facing CR 17

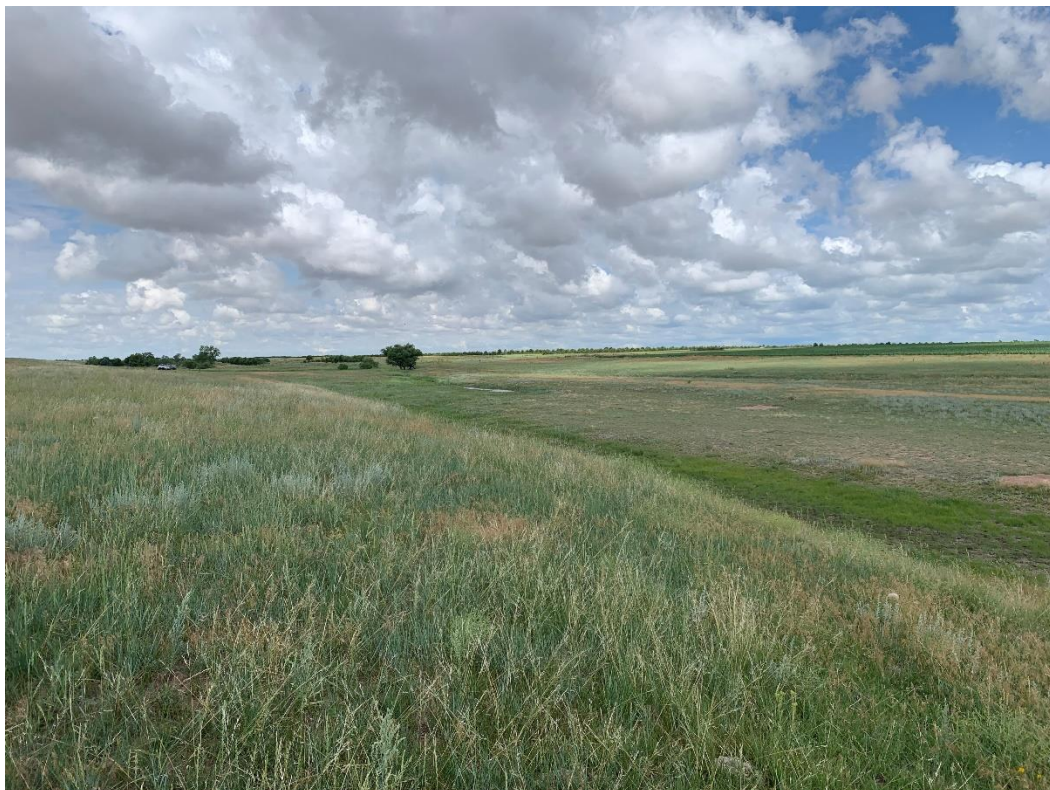
Photo 2 – South boundary of permit are facing northwest

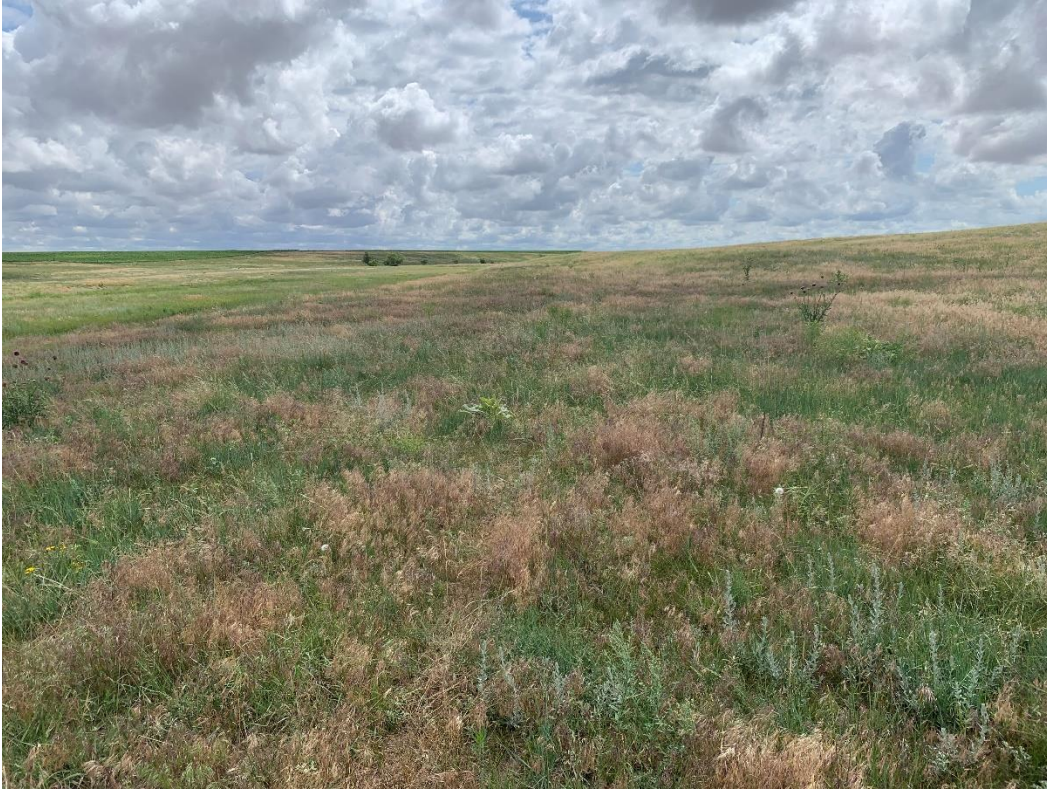
The vegetation in the creek bottom, on the creek benches, creek slopes and on the upland areas was mostly comprised of shortgrass prairie species. Cheatgrass was scattered throughout the site. A few musk thistle plants (*Carduus nutans*) were also noted (photo 3). Cheatgrass and musk thistle are noxious species and should be monitored and treated throughout the life of mine operation.

Photo 3 – Southern permit boundary facing northeast

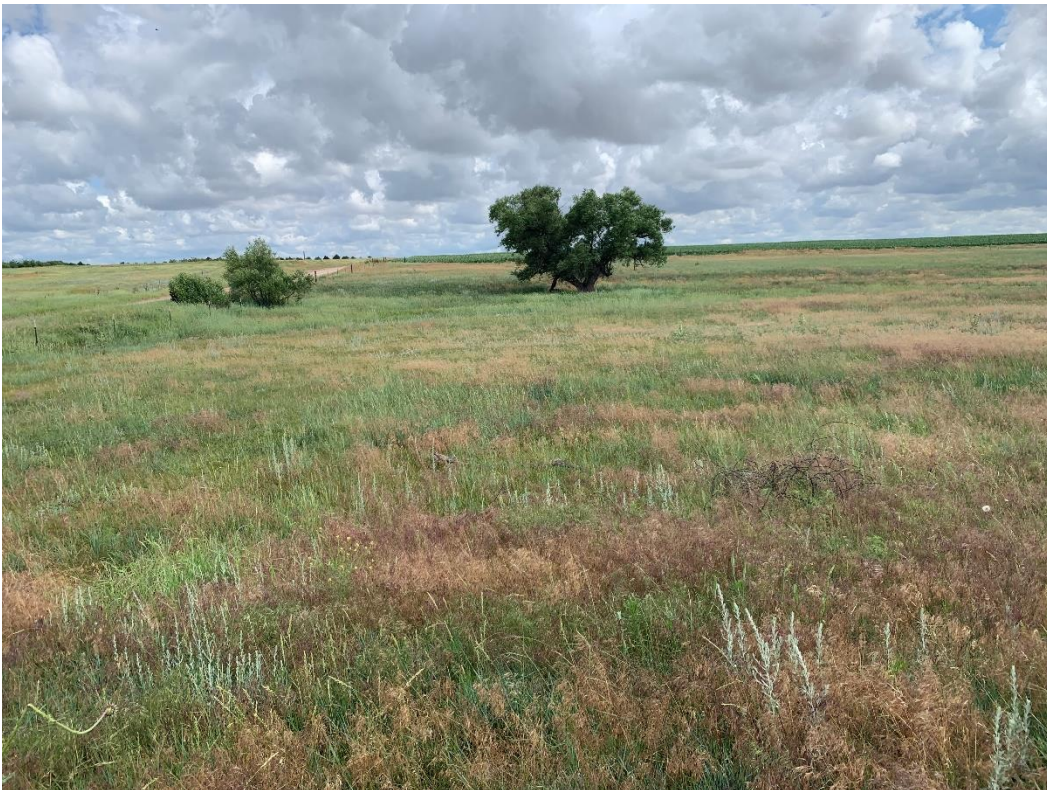
Photo 4 – Eastern boundary facing north
