COLORADO
Division of Reclamation,
Mining and Safety
Department of Natural Resources

Permit Number: C-1992-081 Mine Name: Hayden Gulch Loadout Operator: Hayden Gulch Terminal, LLC Operator Address: Ms Miranda Kawcak P.O. Box 670 Hayden, CO 81639	County: Routt Operation Type: Loadout Permit Status: Active Ownership: Private Operator Representative Present: None
Operator Representative Signature: (Field Issuance Only)

Inspection Start Date: June 14, 2021 Inspection Start Time: 08:30 Inspection End Date: June 16, 2021 Inspection End Time: 02:00		Inspection Type: Coal Complete Inspection Inspection Reason: Normal I&E Program Weather: Clear	
Joint Inspection Agency: None		Joint Inspection Contacts:	
Post Inspection Agency: None		Post Inspection Contacts:	
Inspector(s): Tabetha Lynch	Inspector's Signature:

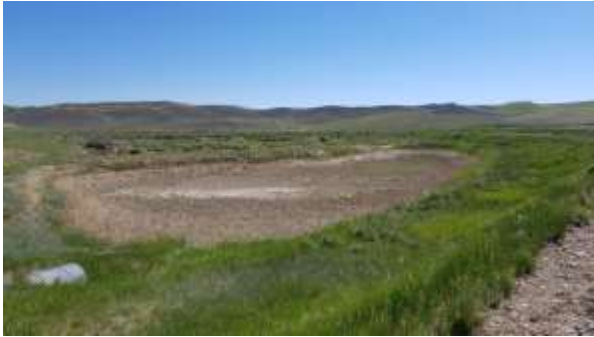
Truck pond was holding a small amount of water. The Rail pond was dry at the time of inspection (photo below). No issues were noted. Culverts appeared clear and functional.

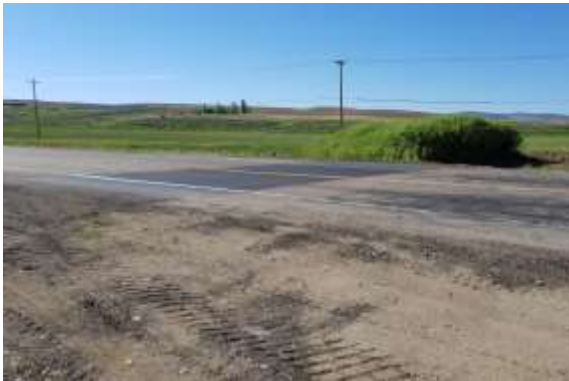
The remaining tracks crossing Hwy 40 have been removed. The area north of Hwy 40 appears to have been graded. The trail was being used by runners at the time of inspection.

Hwy 40 patch where tracks were removed

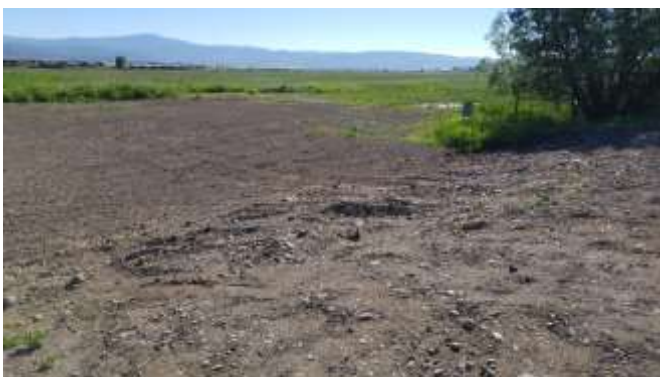
Looking north from Hwy 40.
