July 9, 2021

Job Number: 99-3983

Subject: Quarterly Observation Report, Refuse
Pile, Foidel Creek Mine, Routt County, Colorado.

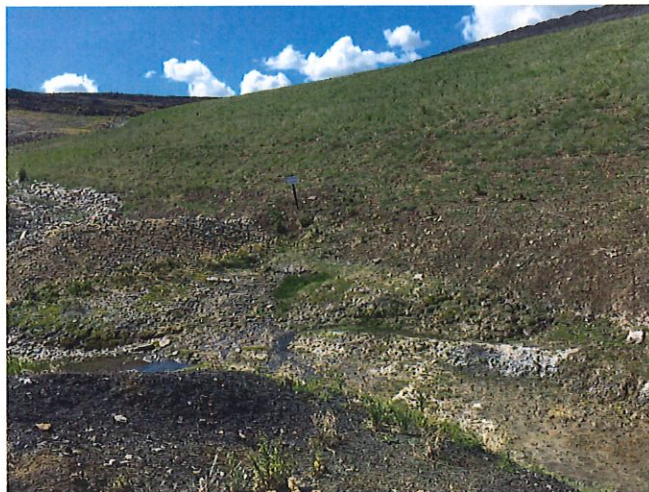
A seepage area at the toe of the northeast end of the refuse pile expansion area, approximately 30 feet northwest of the outlet of the underdrain, developed in fall 2014. At the time of our observations, the seepage was surfacing at the toe of the slope and flowing into the drainage from the undrain outlet then into the existing pond east of the Refuse Pile Expansion Area. The discharge was clear, with no evidence of sediment. No signs of washout, slumps or slope instability were observed at this time. The seepage area

will be monitored during future inspections and noted in our inspection reports. Photographs of the seepage area taken at the time of our inspection on June 30, 2021 are attached.

June 30, 2021-Drain Outlet and Seepage Area

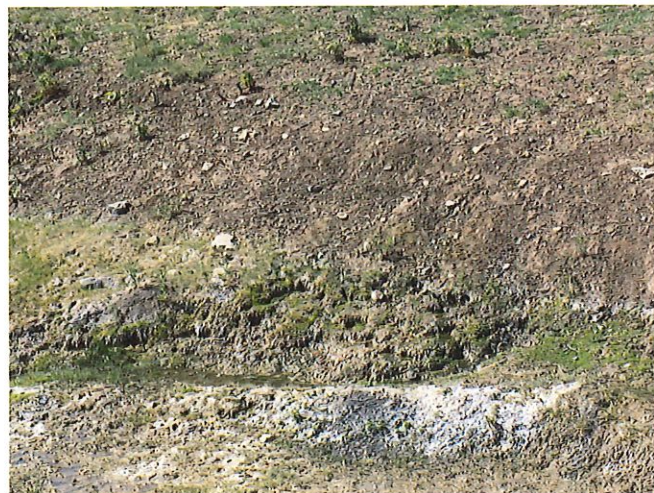
June 30, 2021-Seepage Area

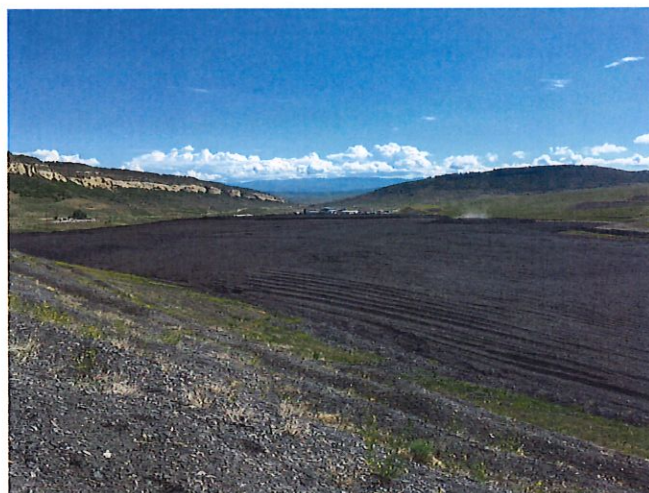
At the time of our site visit on June 30, 2021, NWCC completed a site inspection of the existing refuse pile. Based on our observations made during this visit, it appeared that the contractor was presently stockpiling and compacting refuse coal in the new Expansion Area. At the time of our site visit, the refuse coal had been placed and compacted to an elevation above the third bench situated along the east side of the stockpile.

The internal roadways in the new expansion area of the pile are in good condition. The upper haul road to Areas 2, 3 and 4 of the refuse pile was accessible at the time of our site visit and in good condition. No refuse coal has been placed recently in Areas 2, 3 and 4.

June 30, 2021- Expansion Area

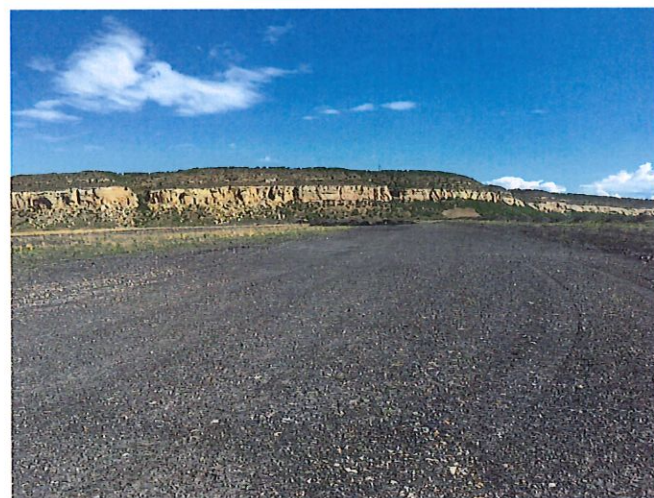
June 30, 2021-Area 2,3 4

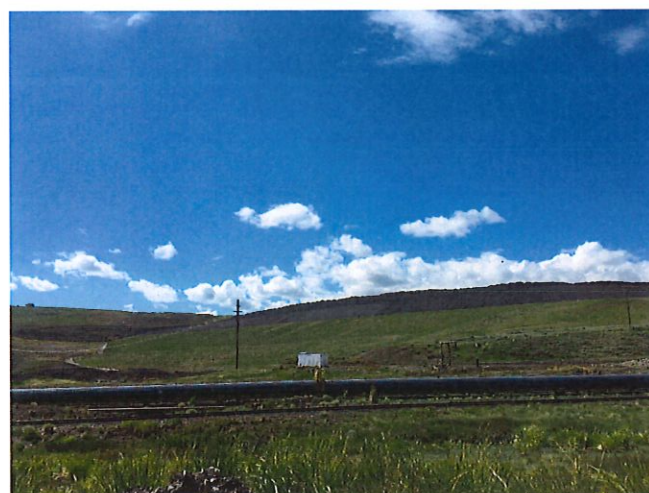
June 30, 2021-Benches on East Side of Refuse Pile

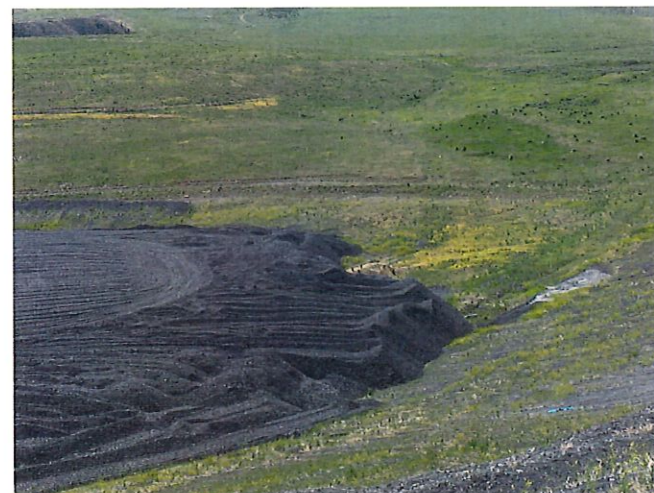
June 30, 2021- Underdrain-Southwest End
