MINERALS PROGRAM INSPECTION REPORT
PHONE: (303) 866-3567

MINE NAME: Thorson Mine	MINE/PROSPECTING ID#: M-1981-020	MINERAL: Anhydrite, gypsum	COUNTY: Fremont
INSPECTION TYPE: Monitoring	INSPECTOR(S): Timothy Cazier, P.E.	INSP. DATE: June 15, 2021	INSP. TIME: 15:55
OPERATOR: Indian Springs Ranch, LLP	OPERATOR REPRESENTATIVE: B. J. Thorson	TYPE OF OPERATION: 110c - Construction Limited Impact	
REASON FOR INSPECTION: Normal I&E Program	BOND CALCULATION TYPE: Partial Bond	BOND AMOUNT: \$2,500.00	
DATE OF COMPLAINT: NA	POST INSP. CONTACTS: None	JOINT INSP. AGENCY: None	
WEATHER: Cloudy	INSPECTOR'S SIGNATURE:

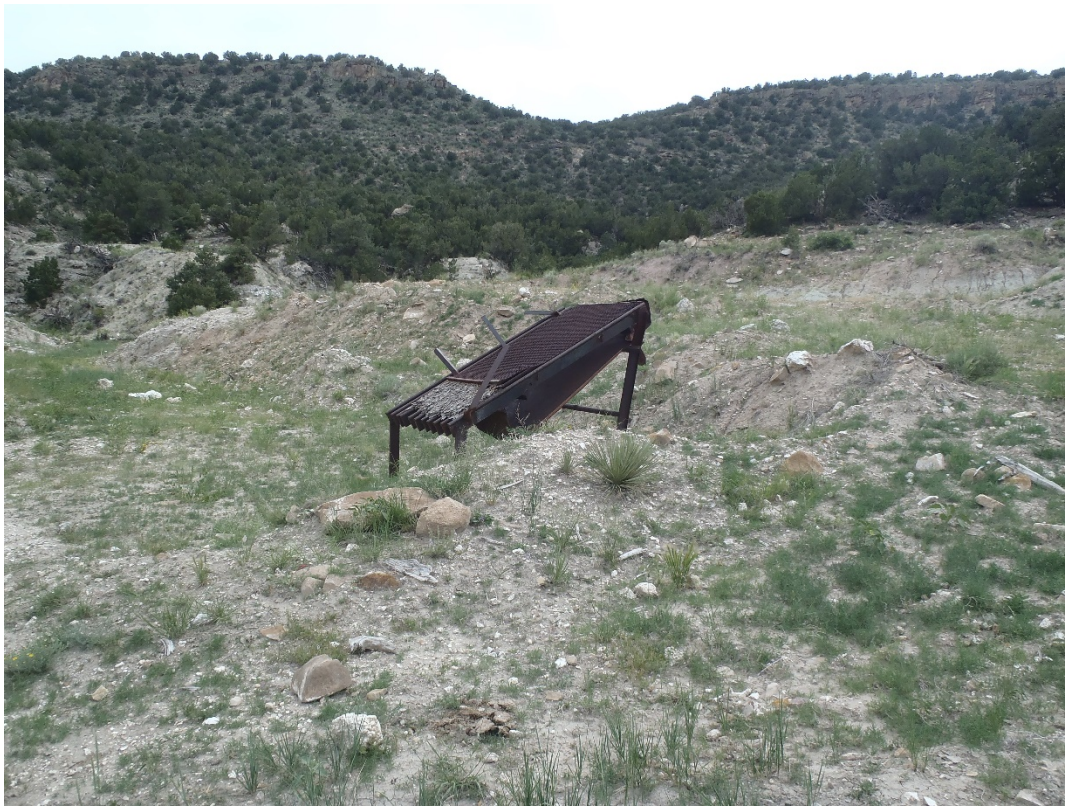
Backfilling and Grading: Sufficient backfill material appeared to be available as there is ample room to push material down to fill the few benches (see **Photo 1**).

Gen. Compliance with Mine Plan: The operation appeared to be in compliance with the approved mine plan. Benches are to be no higher than 20 feet. Observed benches are estimated between 8 and 10 feet high (see **Photos 1 and 2**). The maximum allowed disturbed area is 9.8 acres. Google Earth was used to measure the disturbed area, which was estimated to be slightly less than one acre, based on 2019 imagery.

Support Facilities On-site: A screen (see **Photo 1**) and conveyor (see **Photo 3**) were observed on site.

Photo 1. Screen and existing benches (looking south).

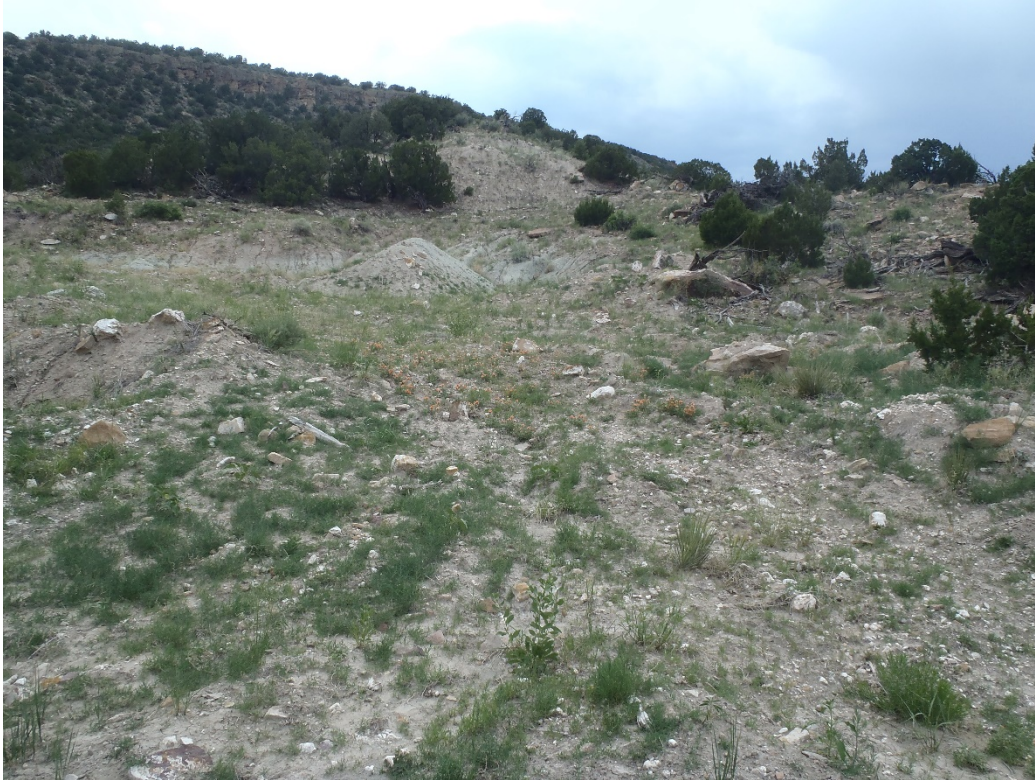
Photo 2. Additional benches west of Photo 1 benches (looking SW).

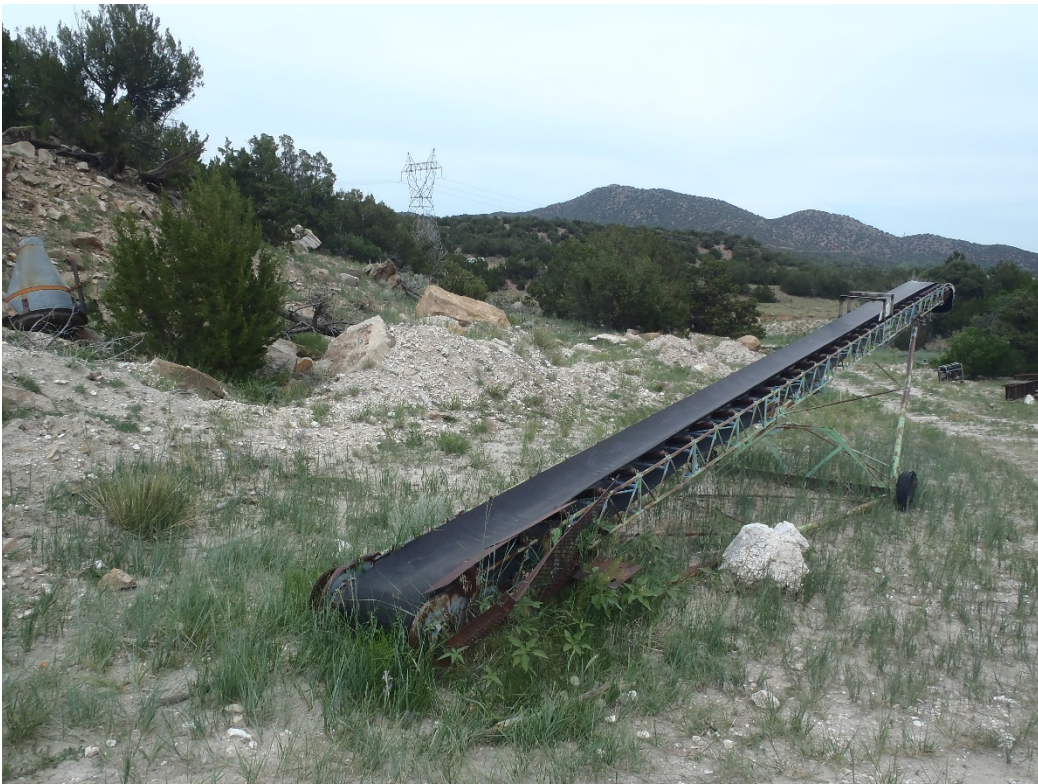
Roads: The access road did not appear to be a source of sediment that could be tracked offsite (see **Photo 3**).

Structures: The closest structure is a power line (see **Photo 3**), north of the adjacent ephemeral drainage, but it is over 500 feet away the affected area boundary.

Photo 3. Conveyor along entrance road (looking NE – note powerline in background).

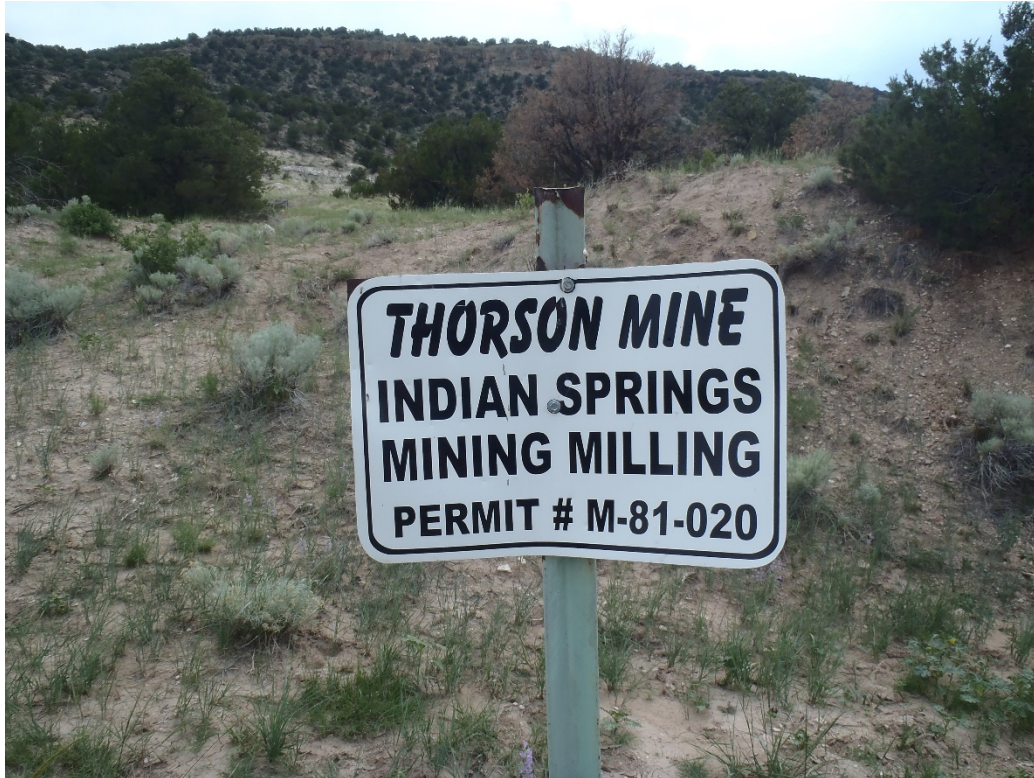
Signs and Markers: The permit sign was properly posted (see **Photo 4**) and Mr. Thorson stated boundary markers were in place along the permit boundary, well away from the observed disturbance.

Photo 4. Permit sign Screen (looking south from NW corner on access road).
