PERMIT INFORMATION

Permit Number: C-1981-014 Mine Name: Southfield Mine Operator: Energy Fuels Coal, Inc. Operator Address:	County: Fremont Operation Type: Underground Permit Status: Revoked Ownership: Private			
Mr John Adams				
P.O. Box 773457	Operator Representative Present:			
Steamboat Springs, CO 80477	NT			
	None			
Operator Representative Signature: (Field Issuance Only)

INSPECTION INFORMATION

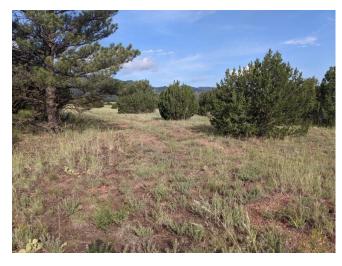
The two track road off County Road 51 was inspected. Vegetation continues to establish itself along the road. No signs of use was observed on the road.

Two track road.

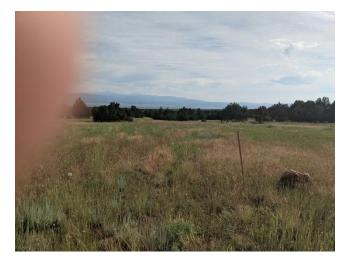
The reclaimed road spur and access road to the NW-MW well were inspected. The road spur is established with great vegetation and blends well with adjacent undisturbed land. The access road for the NW-MW well shows signs of increased vegetation growth. No issues were observed.

Road spur.
