MINERALS PROGRAM INSPECTION REPORT
PHONE: (303) 866-3567

MINE NAME: Climax Mine	MINE/PROSPECTING ID#: M-1977-493	MINERAL: Molybdenum	COUNTY: Lake, Summit
INSPECTION TYPE: Monitoring	INSPECTOR(S): Dustin Czaplá	INSP. DATE: July 6, 2021	INSP. TIME: 10:00
OPERATOR: Climax Molybdenum Company	OPERATOR REPRESENTATIVE: Dianna Kelts	TYPE OF OPERATION: 112d-3 - Designated Mining Operation	
REASON FOR INSPECTION: Normal I&E Program	BOND CALCULATION TYPE: Complete Bond	BOND AMOUNT: \$91,011,850.00	
DATE OF COMPLAINT: NA	POST INSP. CONTACTS: None	JOINT INSP. AGENCY: None	
WEATHER: Clear	INSPECTOR'S SIGNATURE:

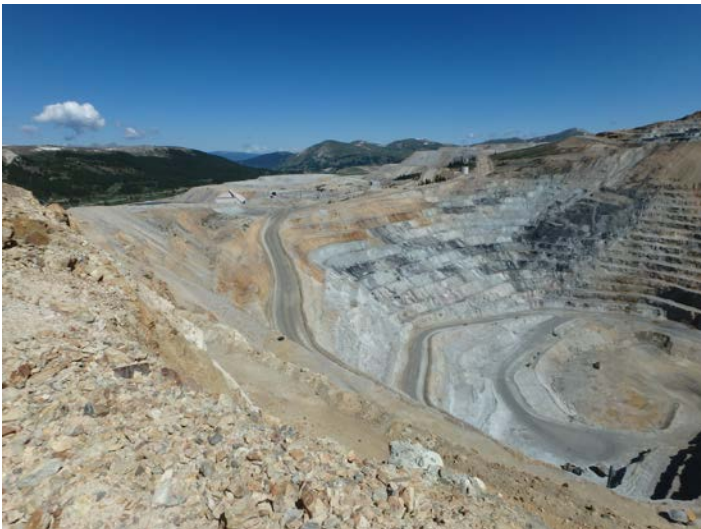
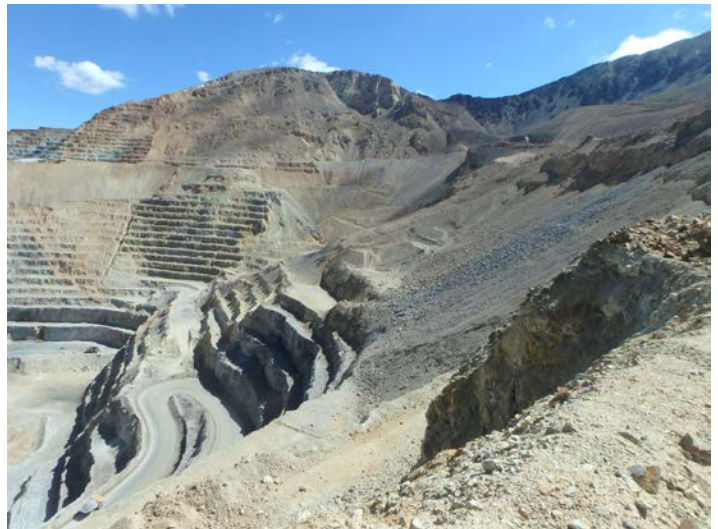
Pit Area

The pit area was observed. Mining was active within the pit. No problems were noted.

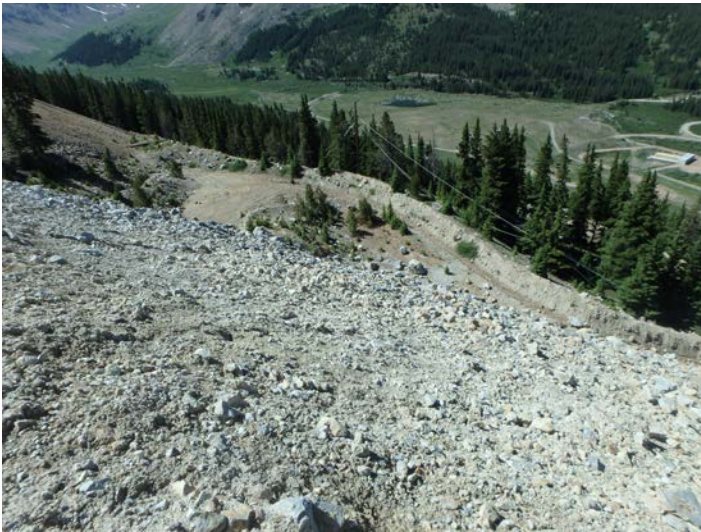
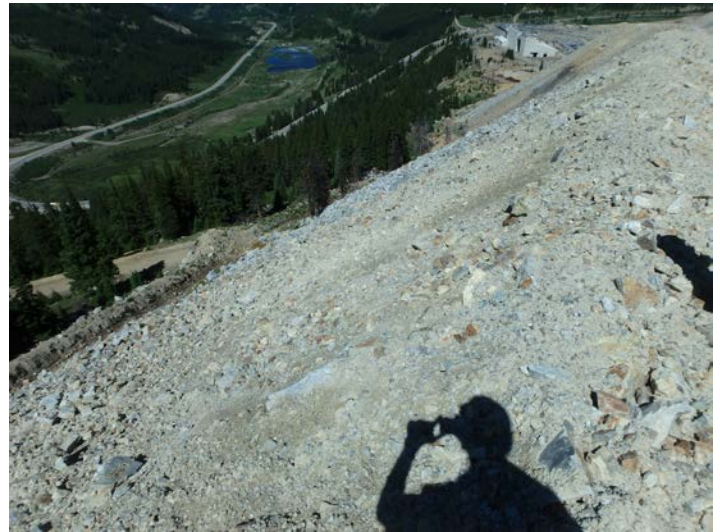
The Ceresco Seepage Collection System consists of a ditch constructed below the Ceresco Ridge haul road. The collection ditch intercepts potentially impacted water and routes it to the Camp drainage, and then to water treatment. The ditch was observed from above, viewed from the Ceresco Ridge haul road. No flowing water was observed in the ditch. The ditch appeared free of debris or obstructions. No problems were noted in this area.

Ceresco drainage ditch viewed from the Ceresco haul road

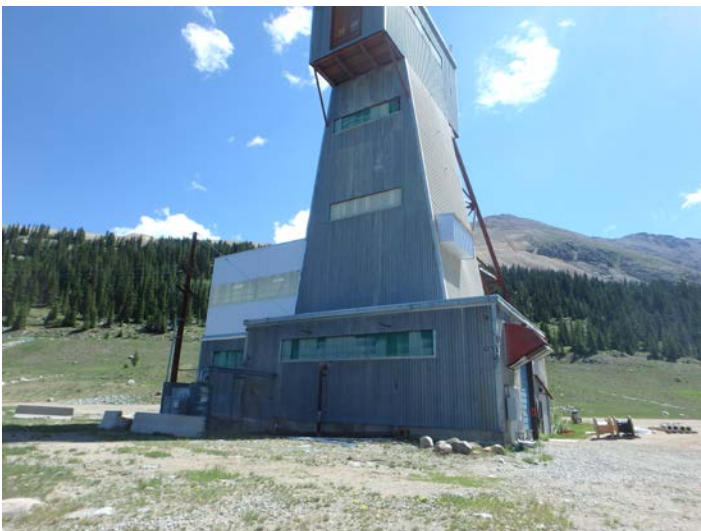
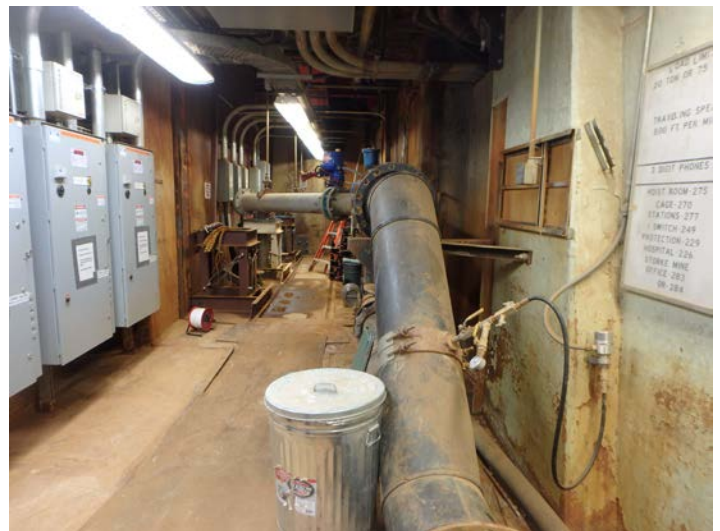
The 5-Shaft Pump System serves to maintain the water level in the underground workings at a level below which could impact the Arkansas Basin. Storm water becomes impacted as it passes through the open pit area and collects in the underground mine workings. The level of water in 5-Shaft is kept below the apex of the Mosquito Fault in order to prevent mine impacted water from potentially impacting the Arkansas River. Impacted water is pumped from 5-Shaft through the Storke Pipeline to the ETDL and water treatment/process circuit in the Tenmile Creek watershed. No problems were noted in this area.

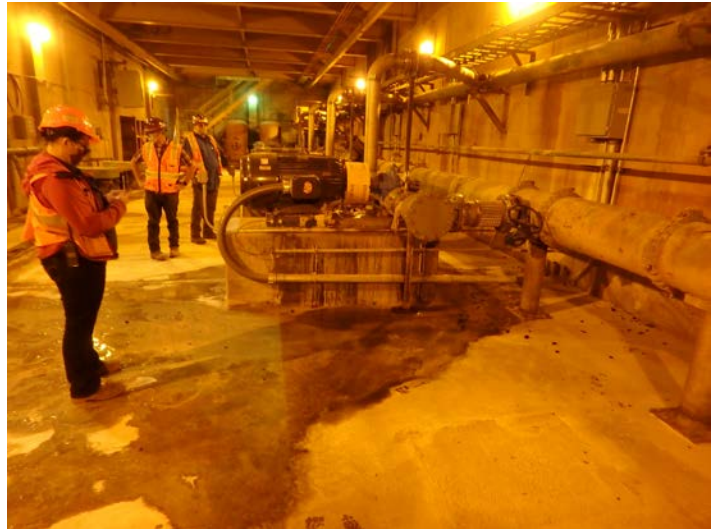
The Storke Wastewater Pump Station is located just below the Storke Yard and acts as a seepage and storm water collection and return system where collected impacted water is pumped to the water treatment/process water circuit in the Tenmile Creek drainage. Two concrete lined ponds serve to collect seepage and storm water/snowmelt run-off from the yard area and it is pumped to the ETDL where it mixes with other mine water prior to treatment. The Storke Wastewater Pump System appeared to be functioning as designed. A minor water leak was observed at one of the pumps within the pump station. Mrs. Kelts made note of the leak and stated it would be repaired right away. No other problems were noted.

Storke Wastewater Pump Station-water leak

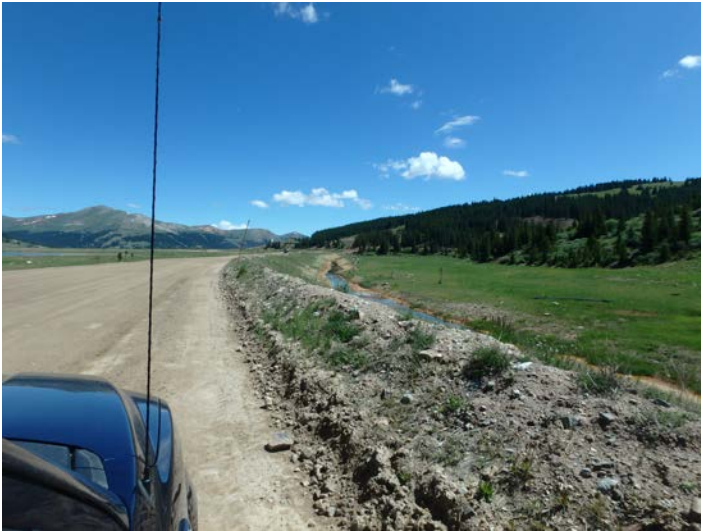
Eastside Channel-Robinson Section

The Robinson Section of the East Side Channel conveys water from the Robinson Pond water pool and areas tributary to the Robinson Pond through the 2 Dam Spillway to Tenmile TSF. No problems were noted with Eastside Channel-Robinson Section.

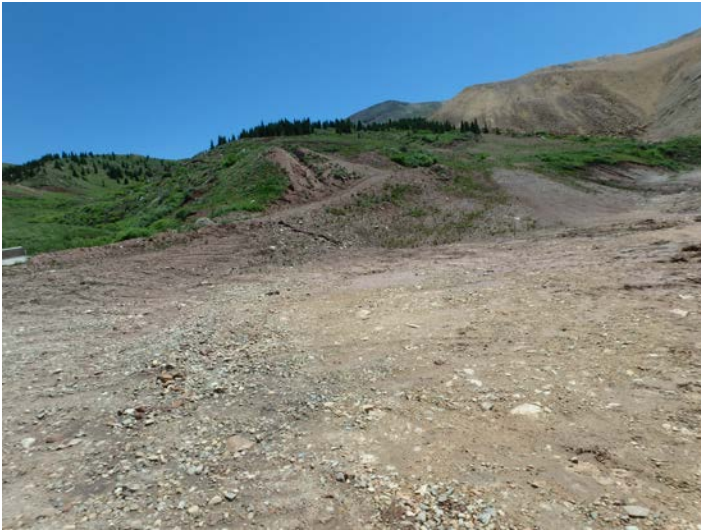
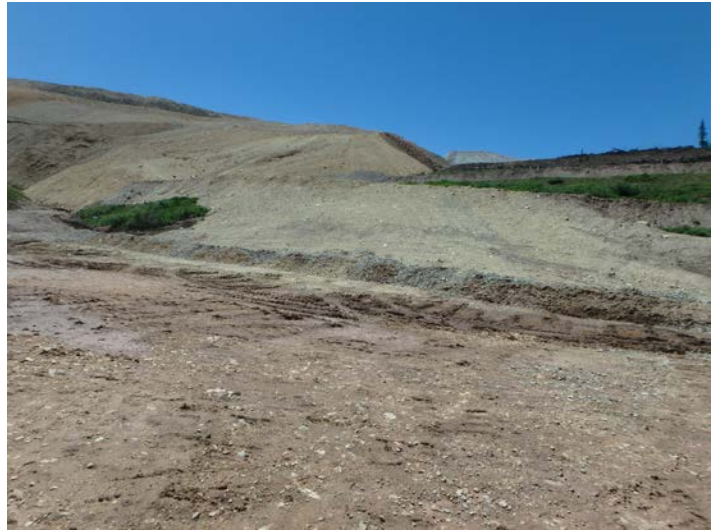
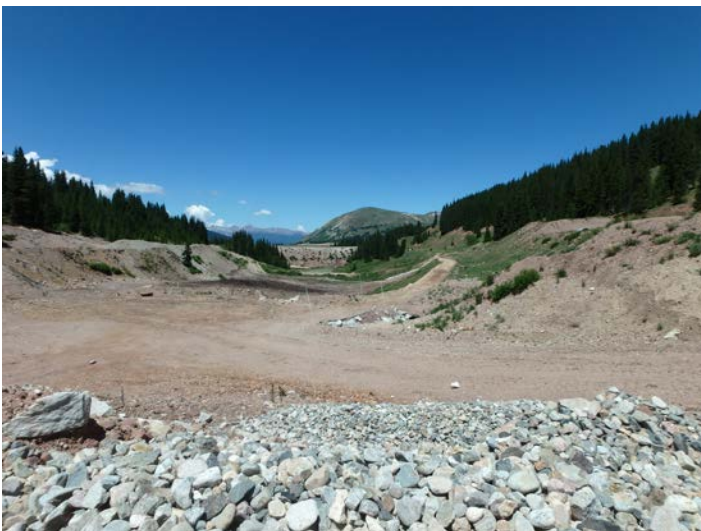
The McNulty Overburden Facility was observed. Deposition is active on the McNulty OSF. No signs of instability were noted. On June 4, 2020 Climax reported to the Division that the then newly installed McNulty OSF underdrain system had failed to convey water as intended. The underdrain system was designed to collect contact water from the McNulty OSF and convey it through pipe to the McNulty Ditch, and then on to the SDP for first stage water treatment. It was found, by Climax staff, that contact water was bypassing the underdrain pipe and flowing into a secondary collection system, which collects other incidental contact water and flows through culvert under Hwy 91 and into the Tenmile tailings pond. The underdrain failure did not result in any discharge of contact water leaving the site and was contained within the greater Climax water treatment system. Climax redirected flow into the McNulty ditch by constructing a small trench. Temporary repairs made by Climax thus far appear to be functioning properly route water to the McNulty ditch. No problems were noted in this area.

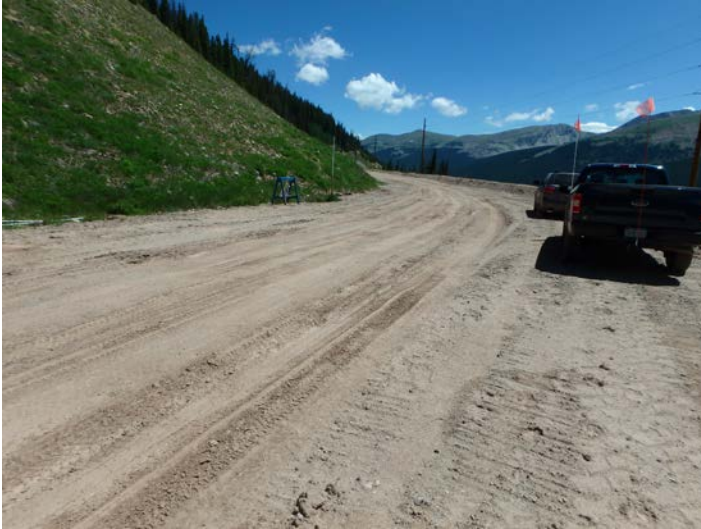
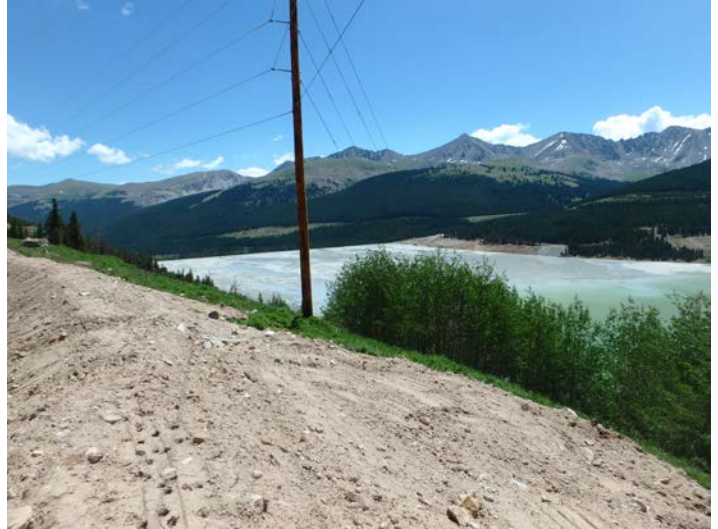
Repair area

On April 27, 2021 Climax notified the Division of a small leak discovered in one of the PDWTP influent pipes. The incident occurred on April 27, 2021. The leak resulted from a crack in the pipe at a welded joint. The leak location was observed during this inspection. Climax has replaced the pipe and backfilled the repair area. No problems were noted.
