MINERALS PROGRAM INSPECTION REPORT
PHONE: (303) 866-3567

MINE NAME: Miami Road Properties	File #: M-2021-038	MINERAL: Sand and Gravel	COUNTY: Montrose
INSPECTION TYPE: Unpermitted Operation	INSPECTOR(S): Dustin Czapla	INSP. DATE: July 2, 2021	INSP. TIME: 10:00
OPERATOR: Matt Miles, Leadership Circle, LLC	OPERATOR REPRESENTATIVE: Matt Miles	TYPE OF OPERATION: IM - Is it Mining	
REASON FOR INSPECTION: Citizen Complaint	BOND CALCULATION TYPE: None	BOND AMOUNT: No Bond Held	
DATE OF COMPLAINT: NA	POST INSP. CONTACTS: None	JOINT INSP. AGENCY: None	
WEATHER: Clear	INSPECTOR'S SIGNATURE:

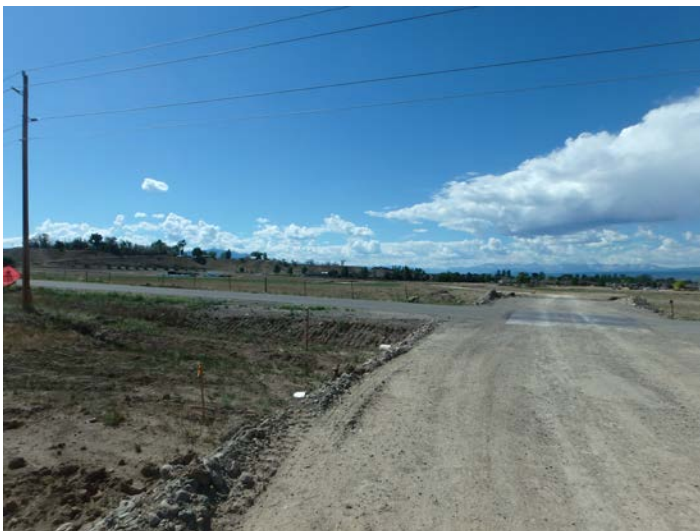
View looking south across Sunnyside Drive toward subdivision development area
