RE: New Hay Camp Pit, Permit # M-2013-031, Unresolved Problem(s) Noted in a Past Inspection Report

MINERALS PROGRAM INSPECTION REPORT
PHONE: (303) 866-3567

MINE NAME: New Hay Camp Pit	MINE/PROSPECTING ID#: M-2013-031	MINERAL: Sand and gravel	COUNTY: Montezuma
INSPECTION TYPE: Monitoring	INSPECTOR(S): Dustin Czapla	INSP. DATE: April 28, 2021	INSP. TIME: 08:00
OPERATOR: McStone Aggregates, LLC	OPERATOR REPRESENTATIVE:	TYPE OF OPERATION: 112c - Construction Regular Operation

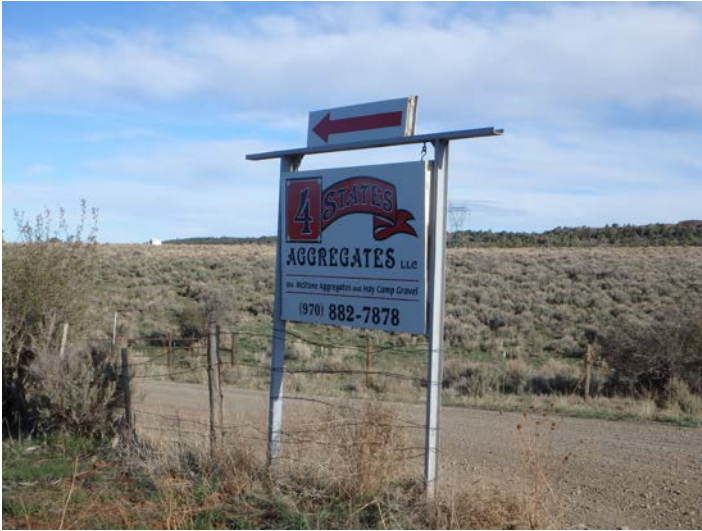
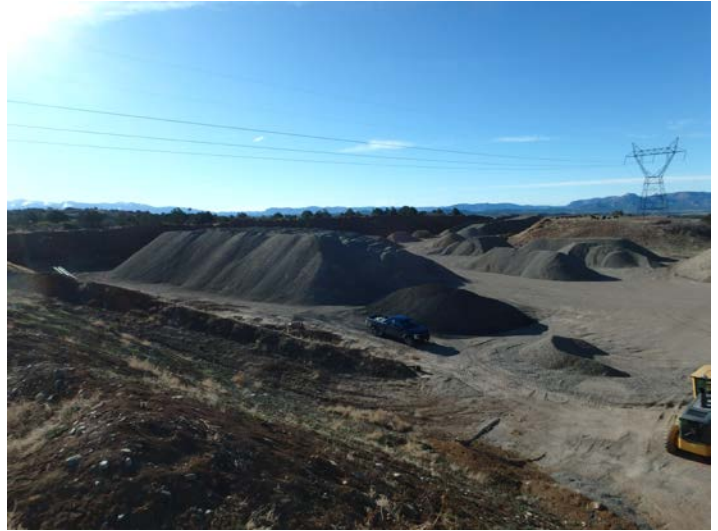
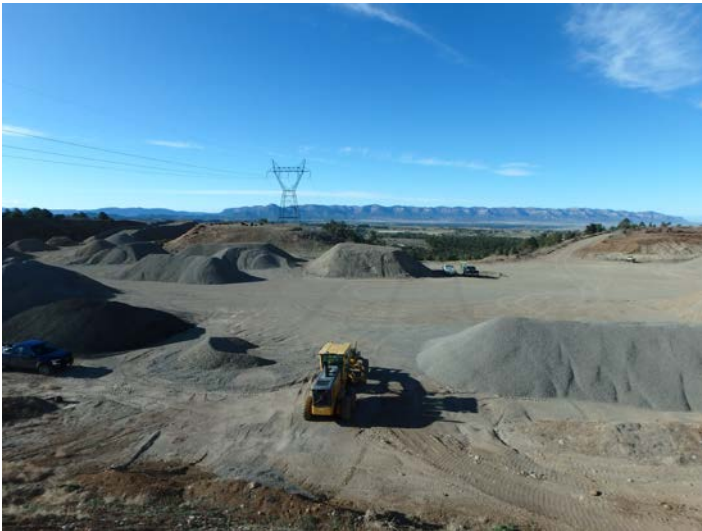
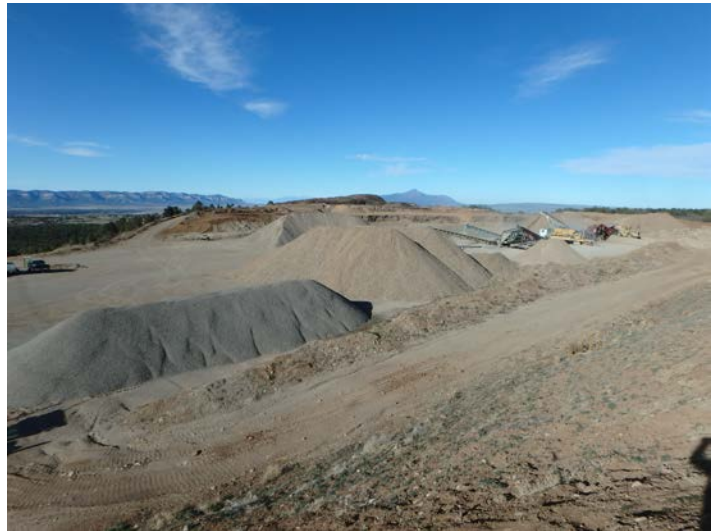
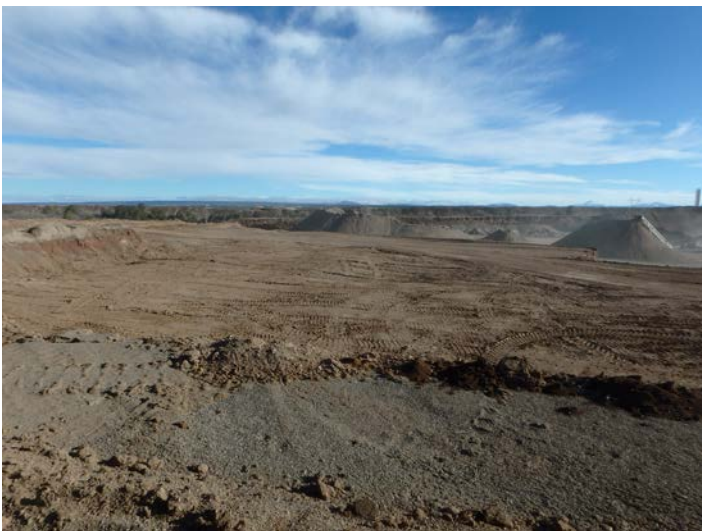
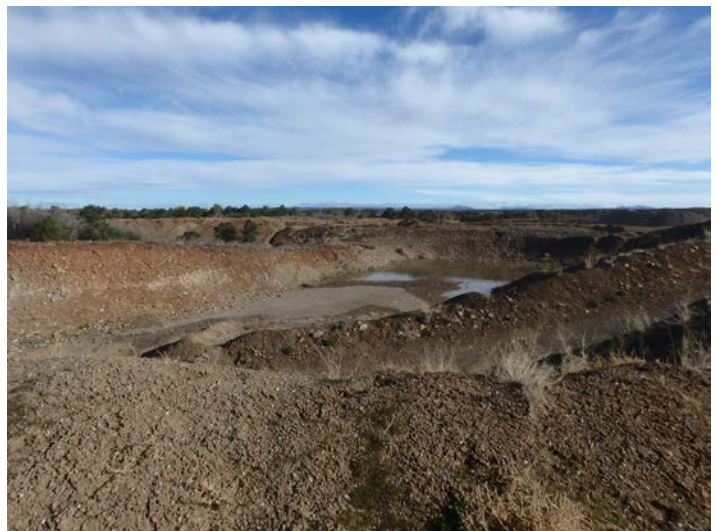
The mine identification sign noted at the entrance gate is not in compliance with Rule 3.1.12(1) because it does not contain the required information. Rule 3.1.12(1) states that at the entrance of the mine site the Operator shall post a sign, which shall be clearly visible from the access road, with a minimum size equaling one hundred and eighty-seven (187) square inches, such as eleven (11) inches in height and seventeen (17) inches in width, with appropriate font size, with the following: **(a) the name of the Operator and the operation name; (b) a statement that a reclamation permit for the operation has been issued by the Colorado Mined Land Reclamation Board; and (c) the permit number.** This has been noted as a problem on page one of this report.

The operation is active. Mining and crushing were occurring during this inspection. Mined slopes on the east and north sides of the pit are graded to approximately 2H:1V and appear stable. No erosional or stability issues were noted. Mining is progressing to the west. A vertical highwall exists in the active mining area. Topsoil has been salvaged from the area above the active mine face. Various materials stockpiles are located throughout the pit floor.

CORRECTIVE ACTIONS: Pursuant to Rule 3.1.12(1) the Operator shall post a sign, which shall be clearly visible from the access road, with a minimum size equaling one hundred and eighty-seven (187) square inches, such as eleven (11) inches in height and seventeen (17) inches in width, with appropriate font size, with the following: (a) the name of the Operator and the operation name; (b) a statement that a reclamation permit for the

operation has been issued by the Colorado Mined Land Reclamation Board; and (c) the permit number. Once posted the Operator shall submit to the Division photographic evidence that the sign has been posted.
