# GROUND ENGINEERING

Subject: Geotechnical Observation Summary  
Report, March 11, 2021 Site Visit , **Ralston  
Quarry**, Jefferson County, Colorado

Job No. 18-3046

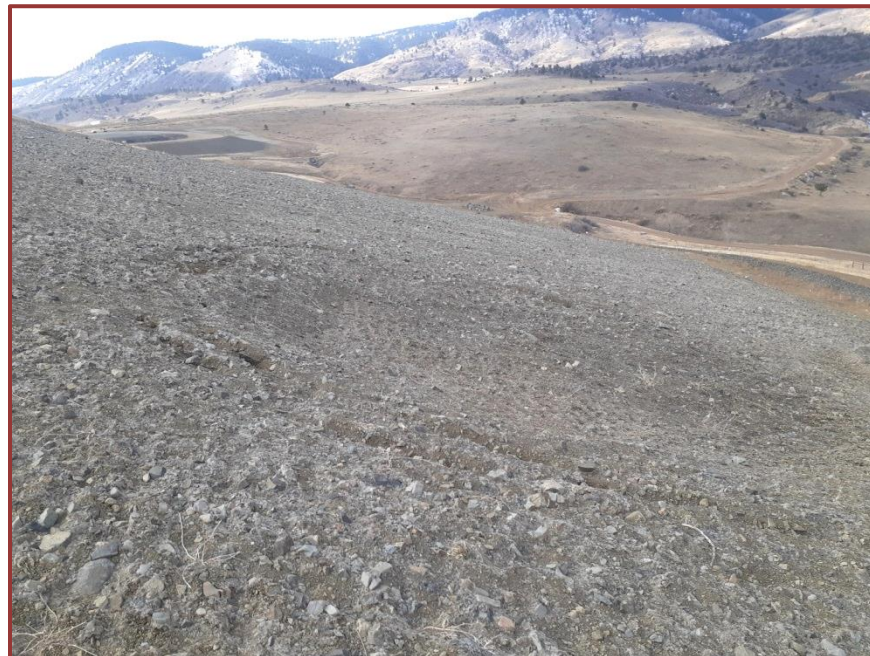
A relatively small depression also was observed in the lower third of the northern portion of the remediated slope (Zone 4). The depression (pictured below) was about 15 to 20 in length (parallel to slope dip) and about 10 to 15 feet in width (perpendicular to slope dip). This depression may have resulted from the consolidation of fill soils, although other factors could be involved. The affected area should be filled with properly compacted fill to restore the design slope grades, and monitored for additional settlement.
