## MINERALS PROGRAM INSPECTION REPORT

<b>MINE NAME:</b> Henderson Mine	<b>MINE/PROSPECTING ID#:</b> M-1977-342	<b>MINERAL:</b> Molybdenum	<b>COUNTY:</b> Clear Creek, Grand
<b>INSPECTION TYPE:</b> Monitoring	<b>INSPECTOR(S):</b> Peter Hays	<b>INSP. DATE:</b> June 22, 2021	<b>INSP. TIME:</b> 10:00
<b>OPERATOR:</b> Climax Molybdenum Company	<b>OPERATOR REPRESENTATIVE:</b> Geoff Niggeler	<b>TYPE OF OPERATION:</b> 112d-3 - Designated Mining Operation	
<b>REASON FOR INSPECTION:</b> Normal I&E Program	<b>BOND CALCULATION TYPE:</b> None	<b>BOND AMOUNT:</b> \$134,155,028.00	
<b>DATE OF COMPLAINT:</b> NA	<b>POST INSP. CONTACTS:</b> None	<b>JOINT INSP. AGENCY:</b> None	
<b>WEATHER:</b> Clear	<b>INSPECTOR'S SIGNATURE:</b>

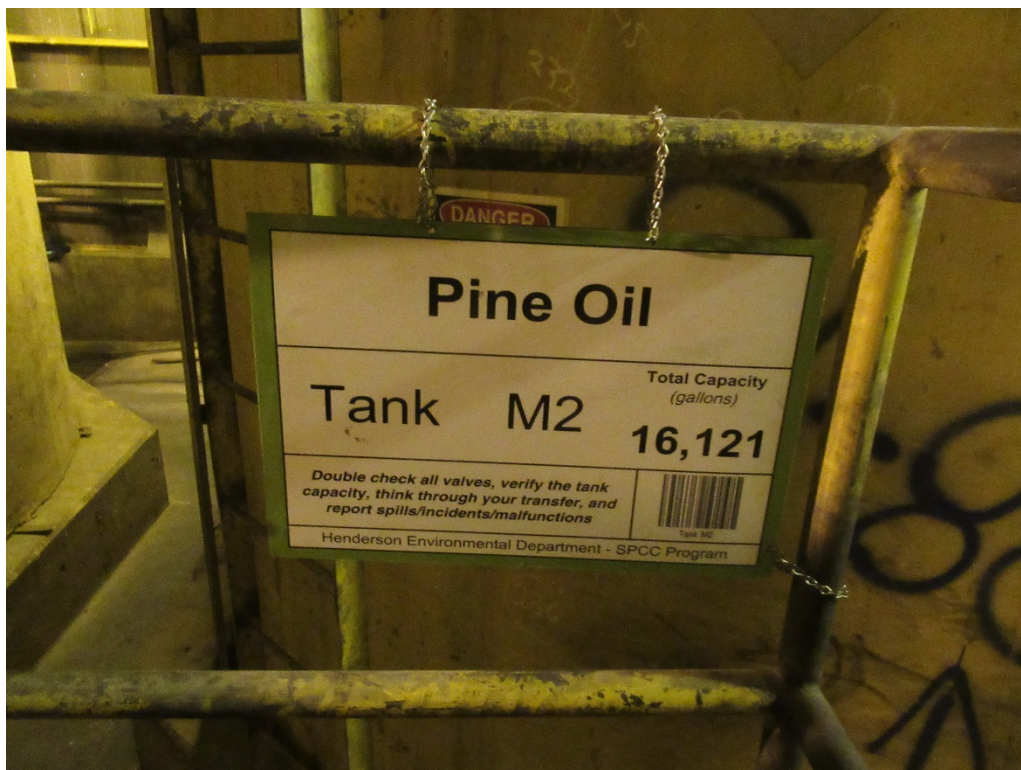
As noted during the April 6, 2021 inspection, the pine oil tank (Mill EPF 2.4) has a capacity of 16,121 gallons as listed in the EPP, however the tank was labeled as 32,000 gallons on the tank sign. An updated sign was installed by Henderson and observed during the inspection.

View of corrected Pine Oil tank capacity sign

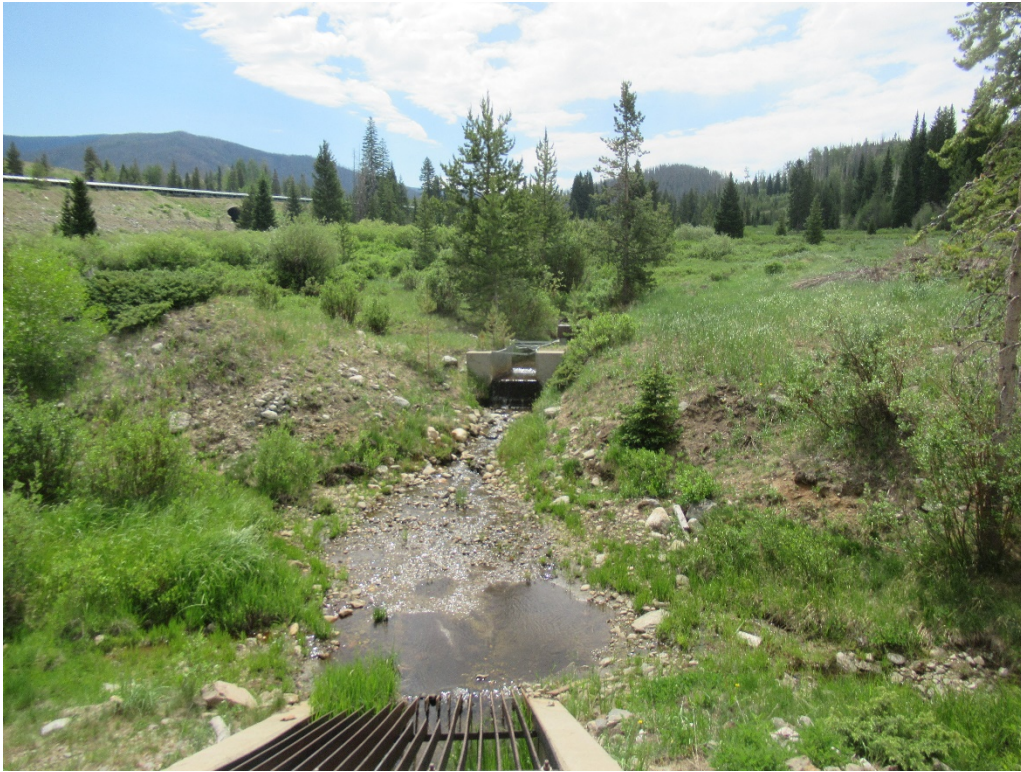
The Upper Bypass Pipeline which is part of Mill EPF 3.1 - Stormwater Diversion System was observed during the inspection. The pipeline diverts water from the southwest portion of the Mill property through an underground pipeline. The pipeline was as described in the revised EPP.

View of Mill EPF 3.1 - Upper Bypass Pipeline looking upstream

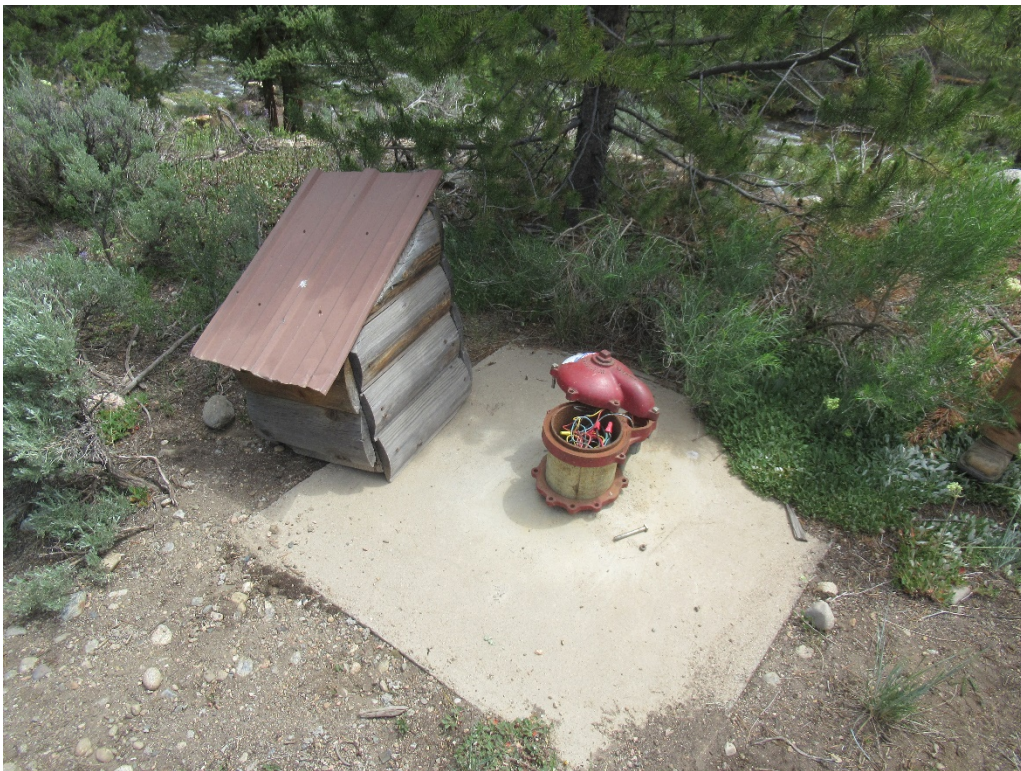
The current point of compliance (POC) wells, MLGW-7 and MLGW-ARC (Aspen Canyon Ranch), and the proposed POC wells, MLGW-15 and MLGW-17 and MLGW-20, were observed. The Operator stated the MLGW-ARC was scheduled for additional rehabilitation work soon.

View of the MLGW-ACR wellhead

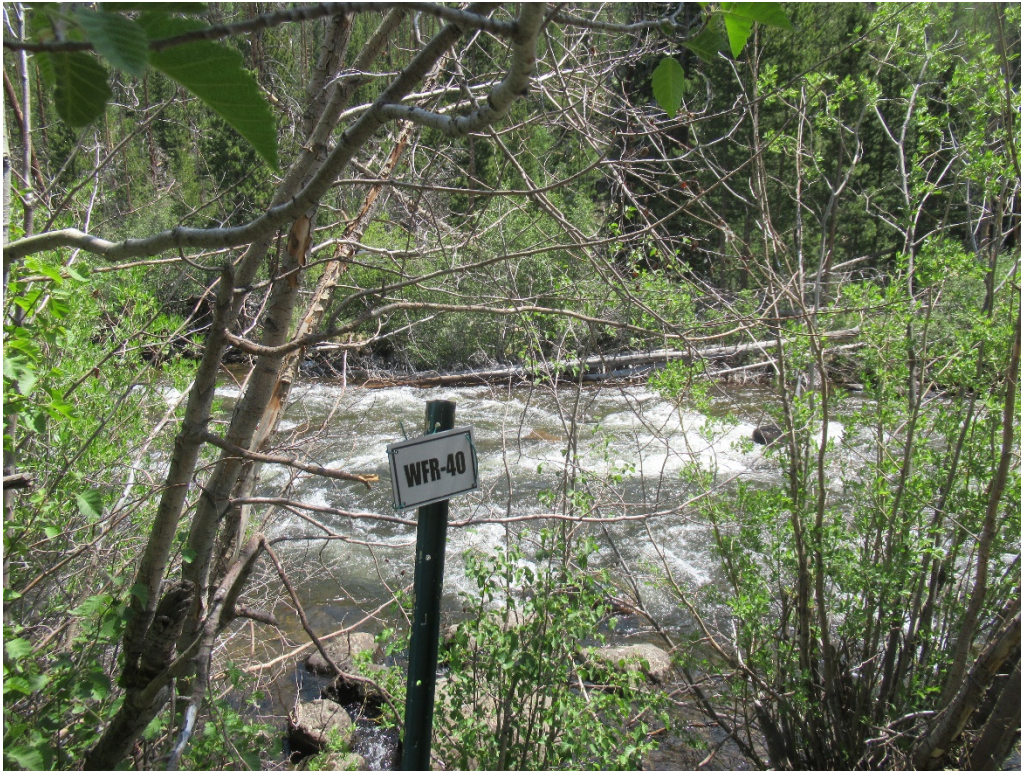
View of WFR-40

The two surface water sampling points on the Williams Fork River, WFR-20 and WFR-40, were observed and the procedure was discussed for the sampling events.

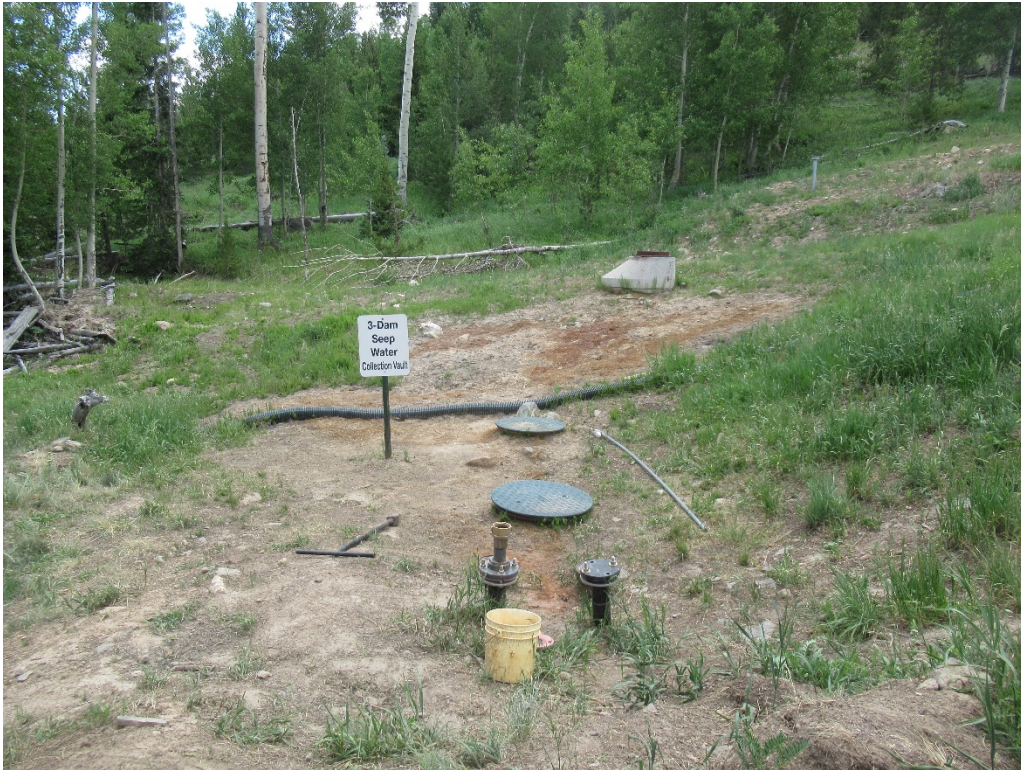
On June 8, 2021, Henderson provided a written follow-up letter for an overflow event of the 3-Dam seepage collection system. Henderson staff noticed surface water draining from the engineered overflow pipe on June 3, 2021. The cause of the incident was determined to be a clogged in the pipeline between the upper dosing vault and the lower pump station. On June 4, 2021, a sump pump and water truck were used to pump water from the dosing vault ending the flow from the discharge pipe. The pipeline was cleaned and working as designed at the time of the inspection. Henderson stated the maintenance schedule for the pipeline would be

View of the 3-Dam Seep Water Collection overflow area

evaluated to prevent discharges from the system in the future.
