MINERALS PROGRAM INSPECTION REPORT
PHONE: (303) 866-3567

MINE NAME: M. Larson Pit #1	MINE/PROSPECTING ID#: M-2018-006	MINERAL: Sand and gravel	COUNTY: Logan
INSPECTION TYPE: Monitoring	INSPECTOR(S): Brock Bowles	INSP. DATE: July 1, 2021	INSP. TIME: 13:00
OPERATOR: Ritchey's Redi-Mix Concrete, Inc.	OPERATOR REPRESENTATIVE: Jerry Ritchey	TYPE OF OPERATION: 112c - Construction Regular Operation	
REASON FOR INSPECTION: Normal I&E Program	BOND CALCULATION TYPE:	BOND AMOUNT: \$15,700.00	
DATE OF COMPLAINT: NA	POST INSP. CONTACTS: None	JOINT INSP. AGENCY: None	
WEATHER: Cloudy	INSPECTOR'S SIGNATURE:

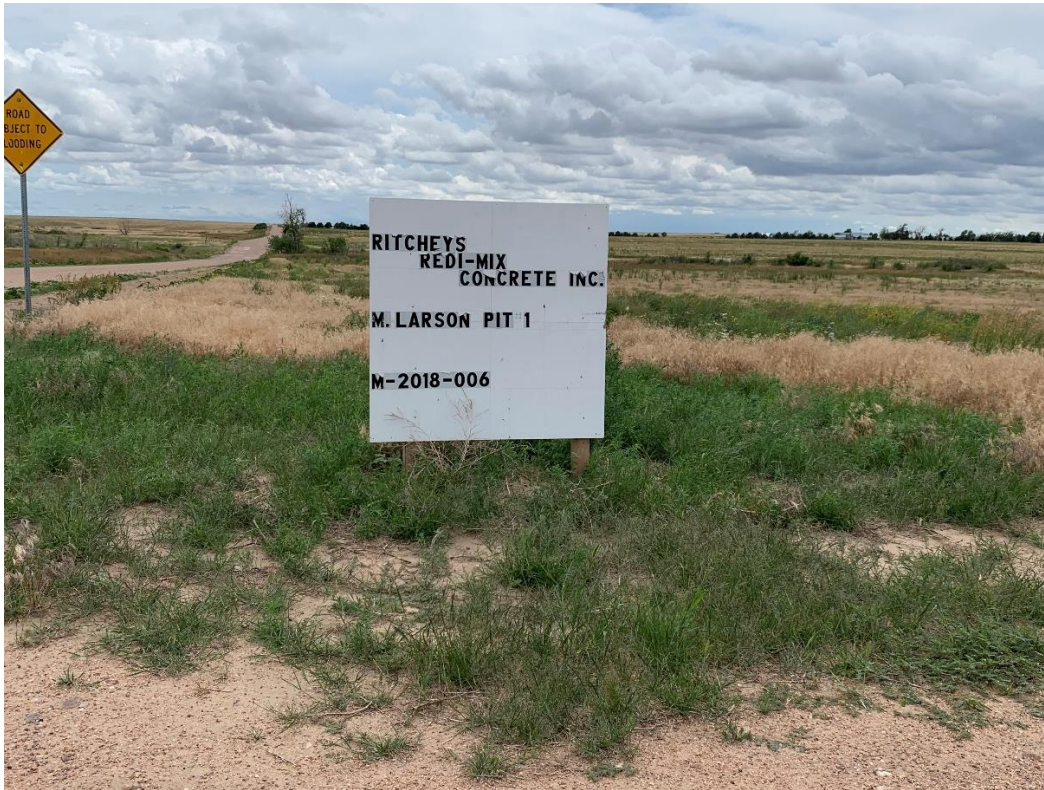
The permit identification sign was in place at the mine entrance and legible (photo 1). The permit boundary markers were in place. Mining was not taking place at the time of the inspection, but a front end loader and bulldozer were on-site.

Photo 1 – Mine entrance sign

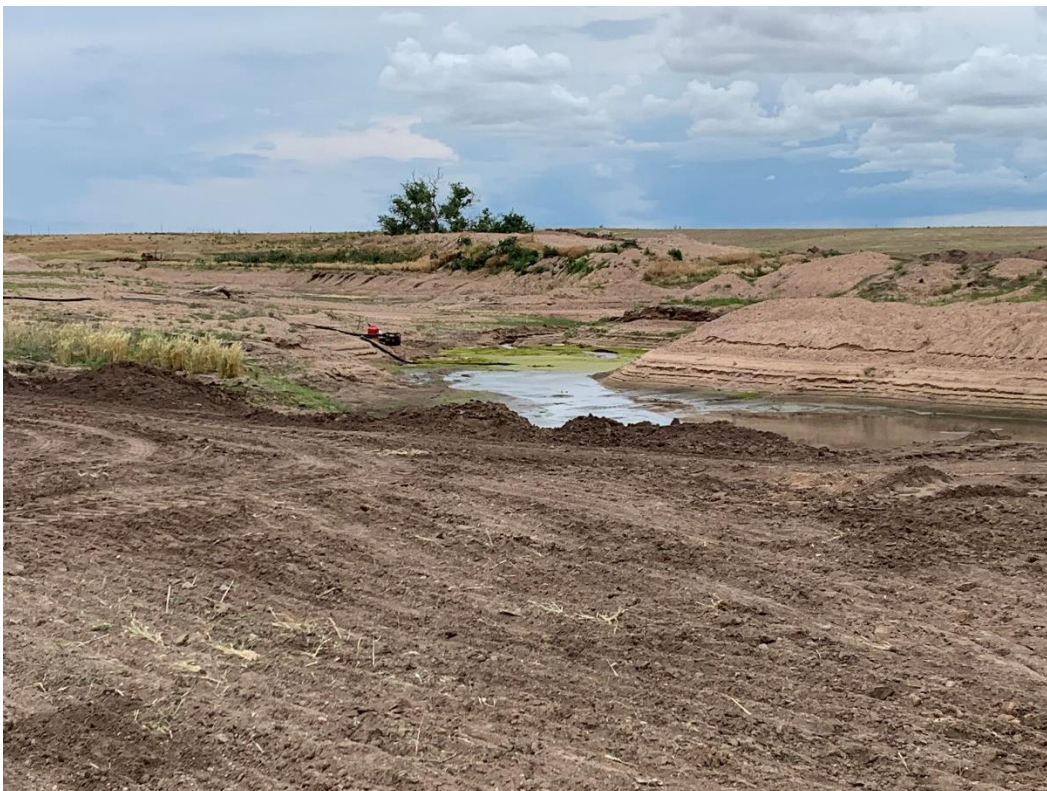
Coyote Creek had some water in the bottom of the creek (photo 2). A water pump was pumping water out of the bottom of the pit further downstream in Coyote Creek. Jerry Ritchie said that there has been several large rain events in the last few months and it had rained the previous night. As a reminder, the Div. of Water Resources requires any storm water runoff intercepted by this operation must infiltrate into the ground or be release to the stream system within 72 hours.

Photo 2 – Water in Coyote Creek with pump removing water

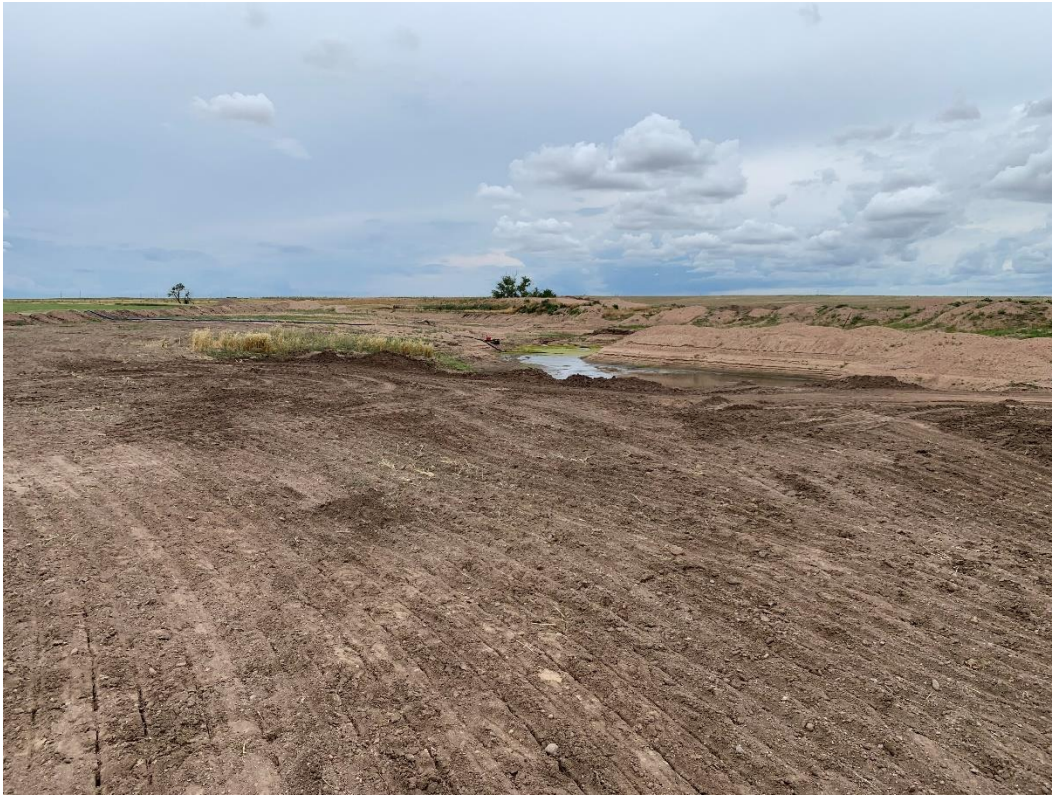
The water level in Coyote Creek had exceeded the banks during the recent rain events. The excessive amount of water pushed gravel outside the pit area to the south. The pit area is currently bonded, but the area to the south is within the permit area but it is not bonded. Mr. Ritchie has been working on the unbonded area in an attempt to fix the damage caused by the flood (photo 3). Most of the soil has been re-graded and seeded.

Photo 3 – Foreground and left, south side of Coyote Creek repaired and seeded after flooding, facing west

The current mine plan has the mining area divided into 5 phases. Only Phase 1 is bonded at this time. After looking at the flood damage and Mr. Ritchie's future gravel needs, it was decided that the best solution was to post an additional warranty bond for Phases 2-4. This will allow for additional mining area and space for stockpiles and equipment. Mr. Ritchie will submit a technical revision to expand the bonded area. TR-1 was received by the Division on July 13, within 2 weeks of the inspection and before this report was written. TR-1 is currently being reviewed.
