MINERALS PROGRAM INSPECTION REPORT
PHONE: (303) 866-3567

MINE NAME: Cresson Project	MINE/PROSPECTING ID#: M-1980-244	MINERAL: Gold	COUNTY: Teller
INSPECTION TYPE: Monitoring	INSPECTOR(S): Patrick Lennberg	INSP. DATE: June 24, 2021	INSP. TIME: 08:30
OPERATOR: Cripple Creek & Victor Gold Mining Company	OPERATOR REPRESENTATIVE: Justin Raglin, Jeana Ratcliff	TYPE OF OPERATION: 112d-3 - Designated Mining Operation	
REASON FOR INSPECTION: Normal I&E Program	BOND CALCULATION TYPE: None	BOND AMOUNT: \$159,491,188.00	
DATE OF COMPLAINT: NA	POST INSP. CONTACTS: None	JOINT INSP. AGENCY: None	
WEATHER: Cloudy	INSPECTOR'S SIGNATURE:

PHOTOGRAPHS

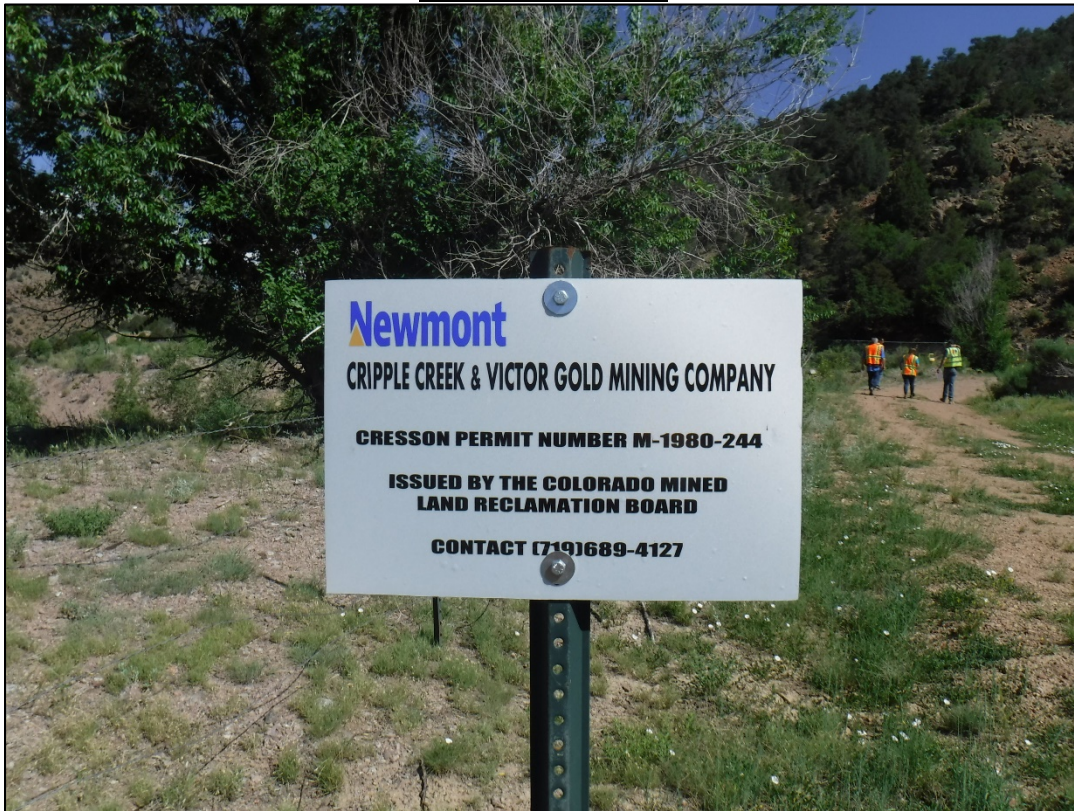
Photo 1: Permit boundary sign at Carlton Tunnel Area

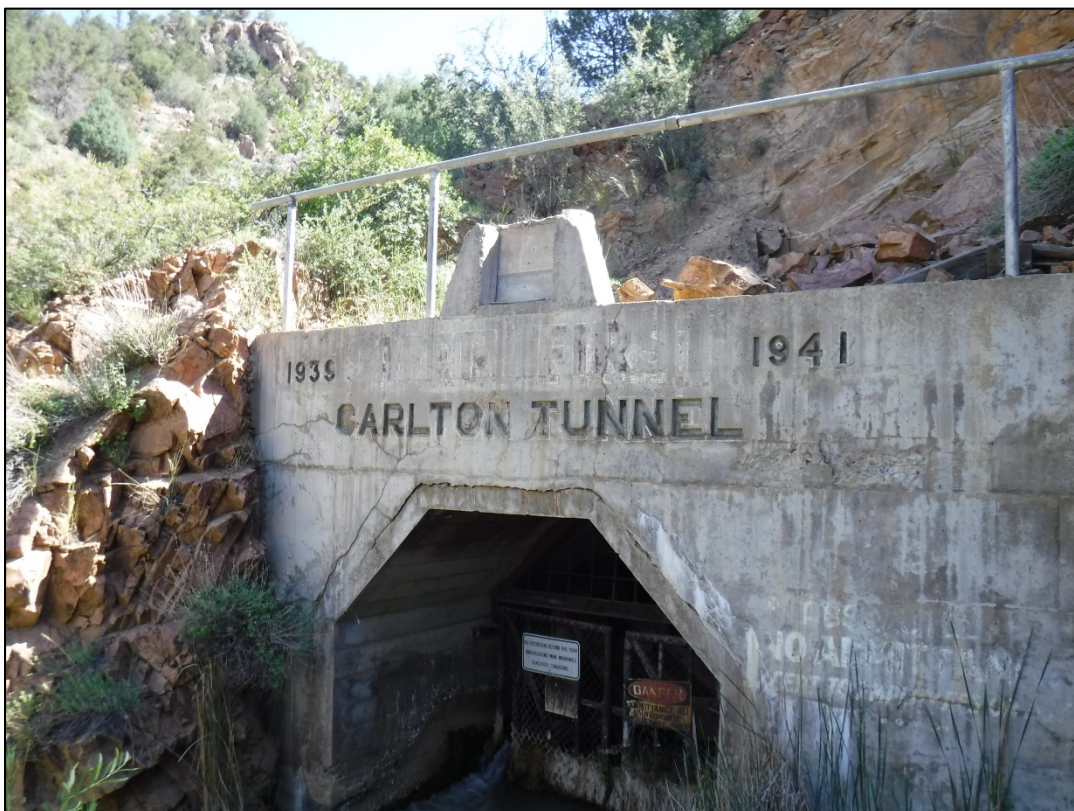
The Division inspected the Carlton Tunnel and associated ponds. The tunnel was constructed between 1939 and 1941 to lower the groundwater level within the mining district to make mining in the district easier. A recent collapse near the tunnel entrance appeared stable. The tunnel empties into a collection pond which then in turn is routed to five sedimentation ponds. The sedimentation ponds are cleaned out every three years or so depending on field conditions. The ponds were last cleaned out in 2019. Sediment from the clean out is stored in a fenced off area located approximately 300 feet south of the main tunnel. There are two springs located at the toe of slope with Shelf Road (County Road 88) and they are named the Fourmile Creek Spring #1 and #2. Fourmile Creek Spring #1 expresses where the Carlton Tunnel flow is discharging and routed under Shelf Road. Spring #2 expresses upgradient of #1 and flows along Shelf road for 200-300 feet before crossing under the road. Each spring has a flume to measure flow.

Photo 2: Carlton Tunnel entrance/exit

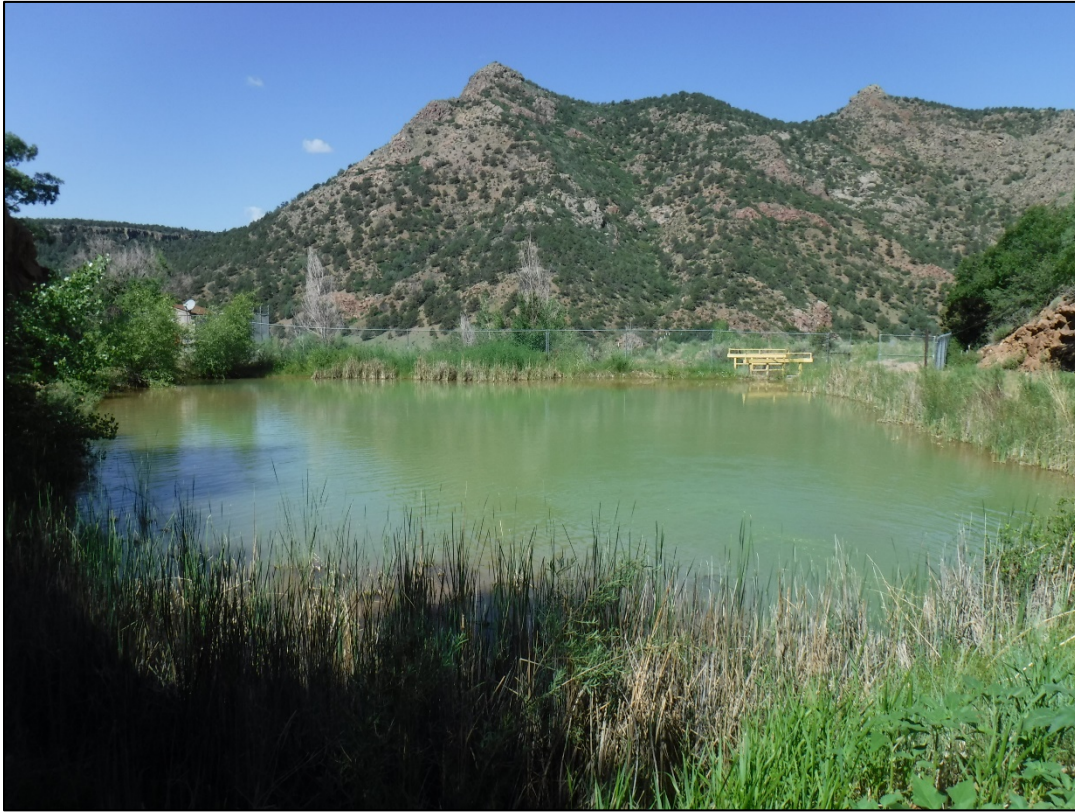
Photo 3: Initial pond for water exiting the tunnel looking southwest

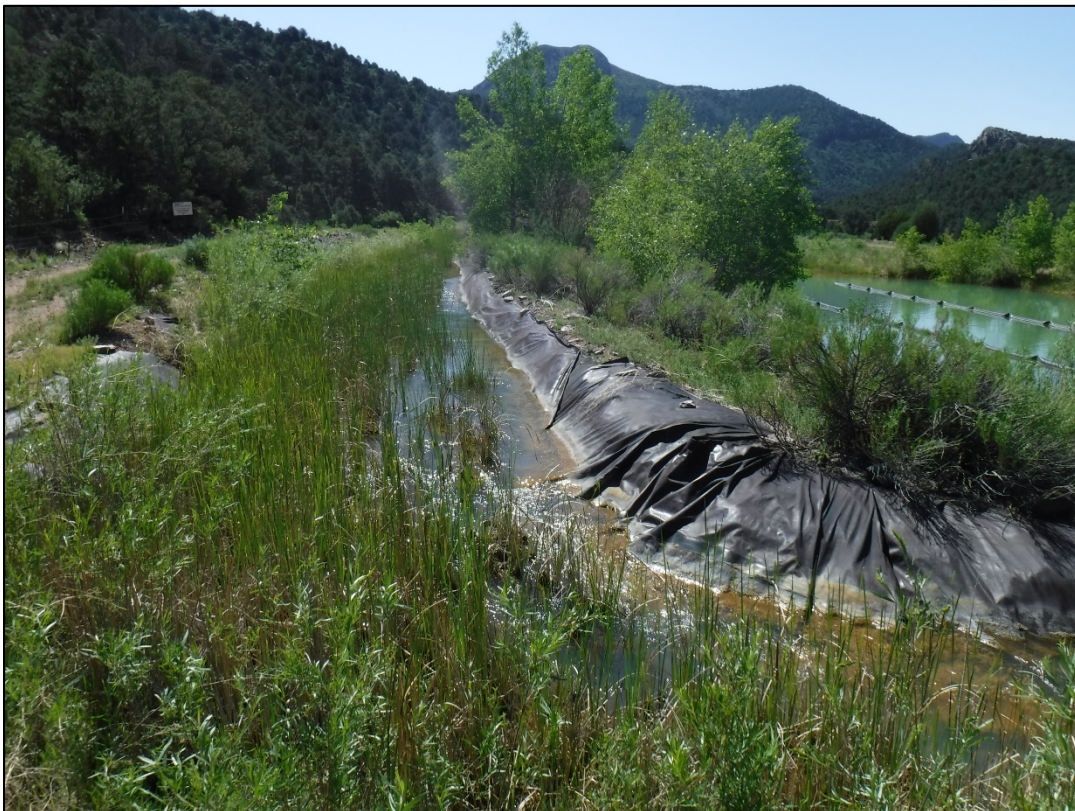
Photo 4: The lined channel coming from the initial holding pond to the sedimentation ponds, flow is towards viewer

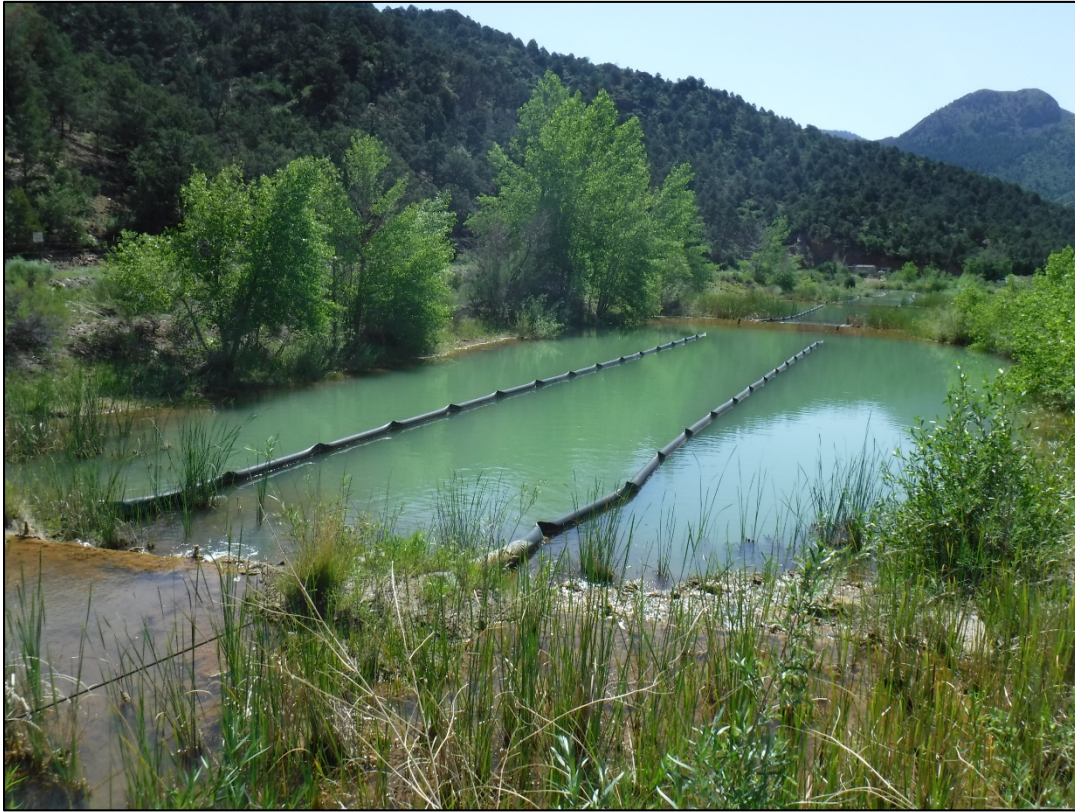
Photo 5: The first of five sedimentation cells, flow away from viewer

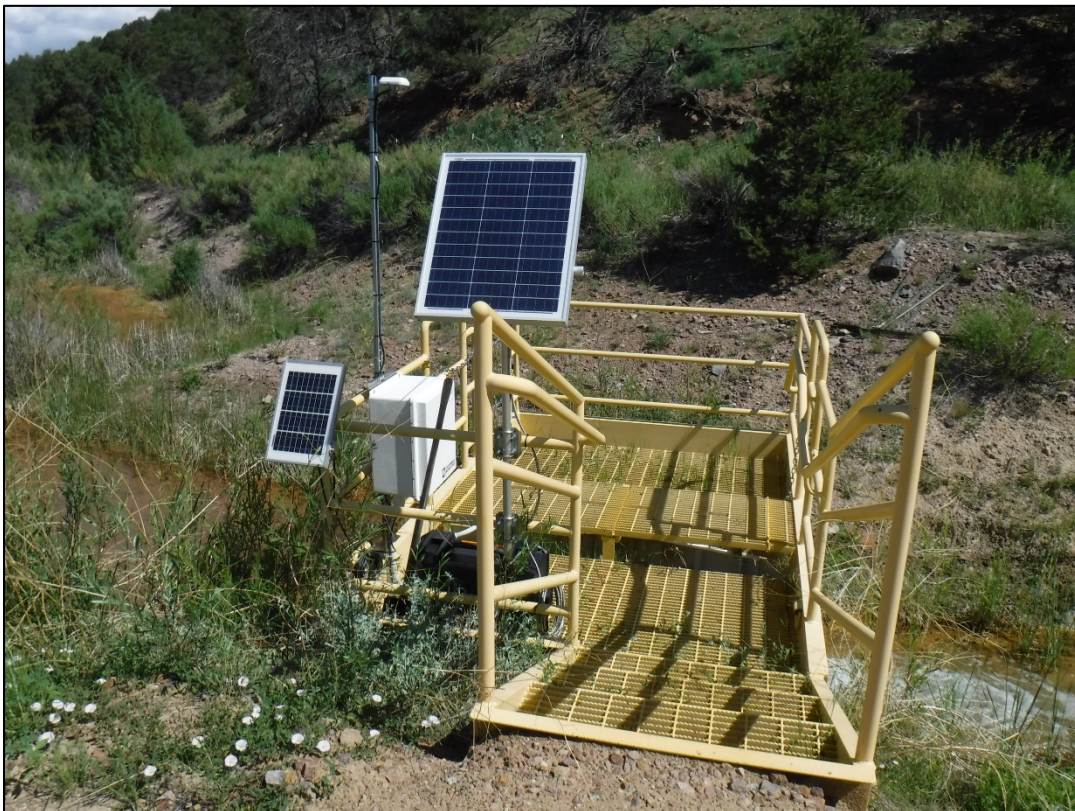
Photo 6: Flow recording station downgradient of last sedimentation cell

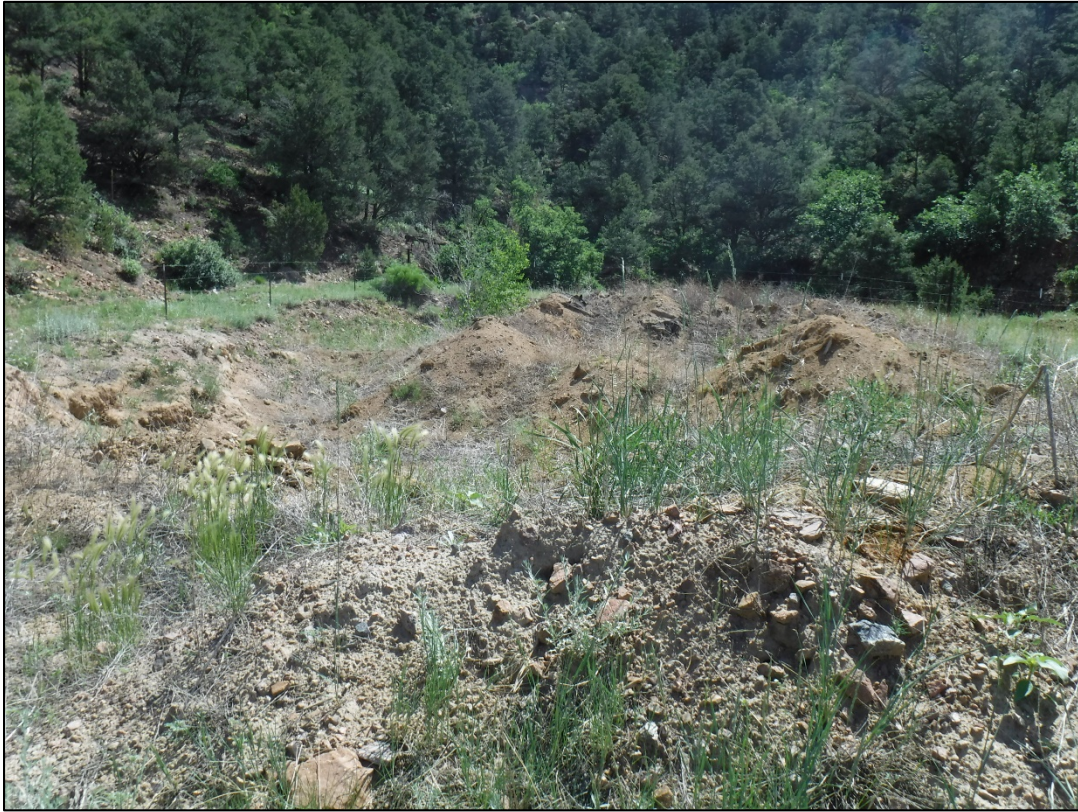
Photo 7: Sediment removed from the last clean out of cells in 2019

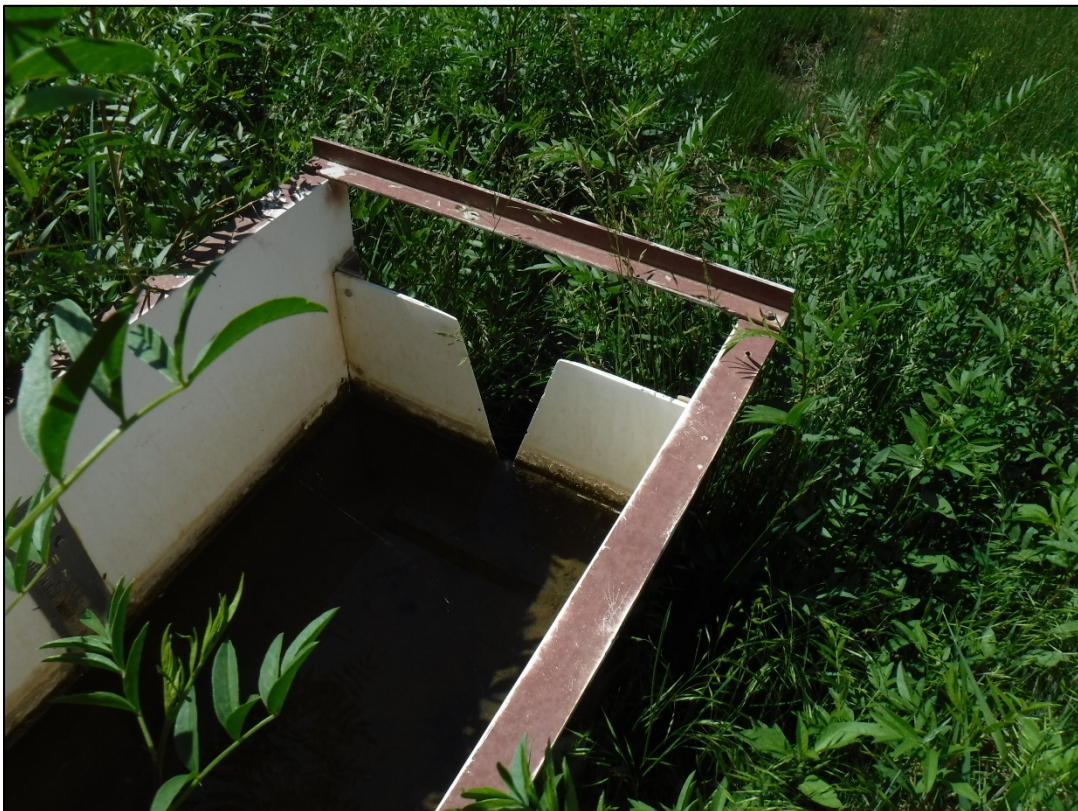
Photo 8: Flume to measure flow from Fourmile Spring #2, downhill from Shelf Road

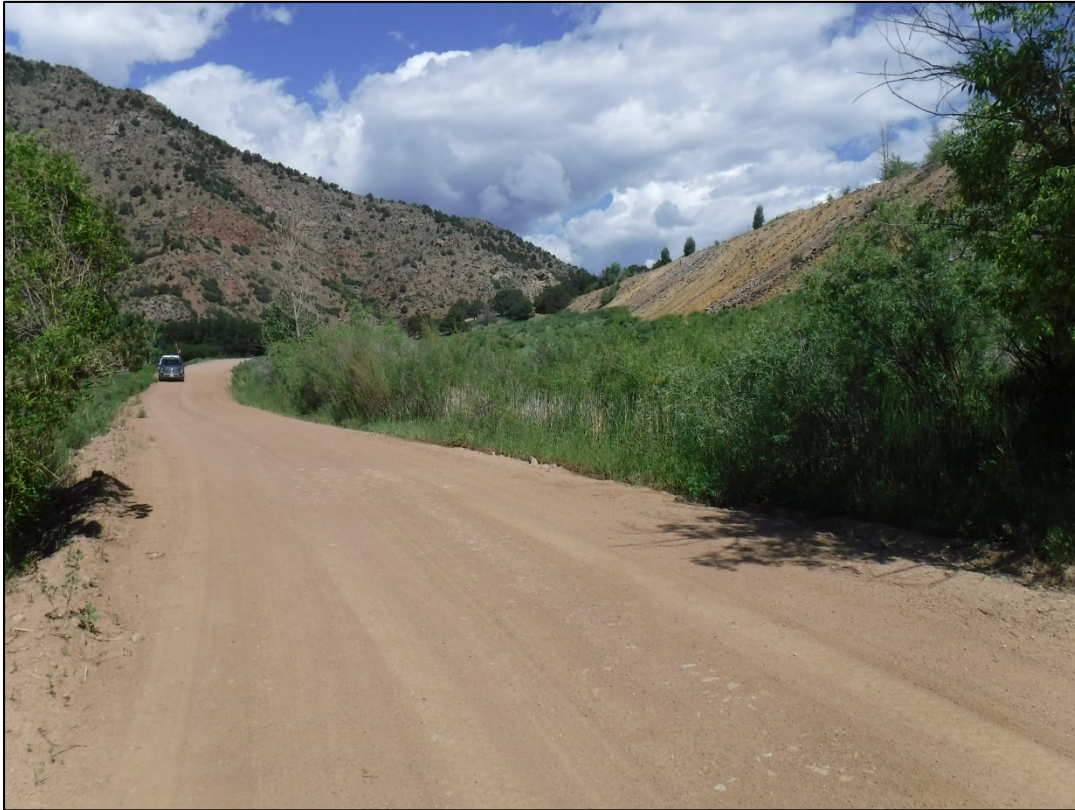
Photo 9: The expression of Fourmile Spring #2 is to the center right of the picture, the trucks are located where the spring is routed under Shelf Road where the flume is located

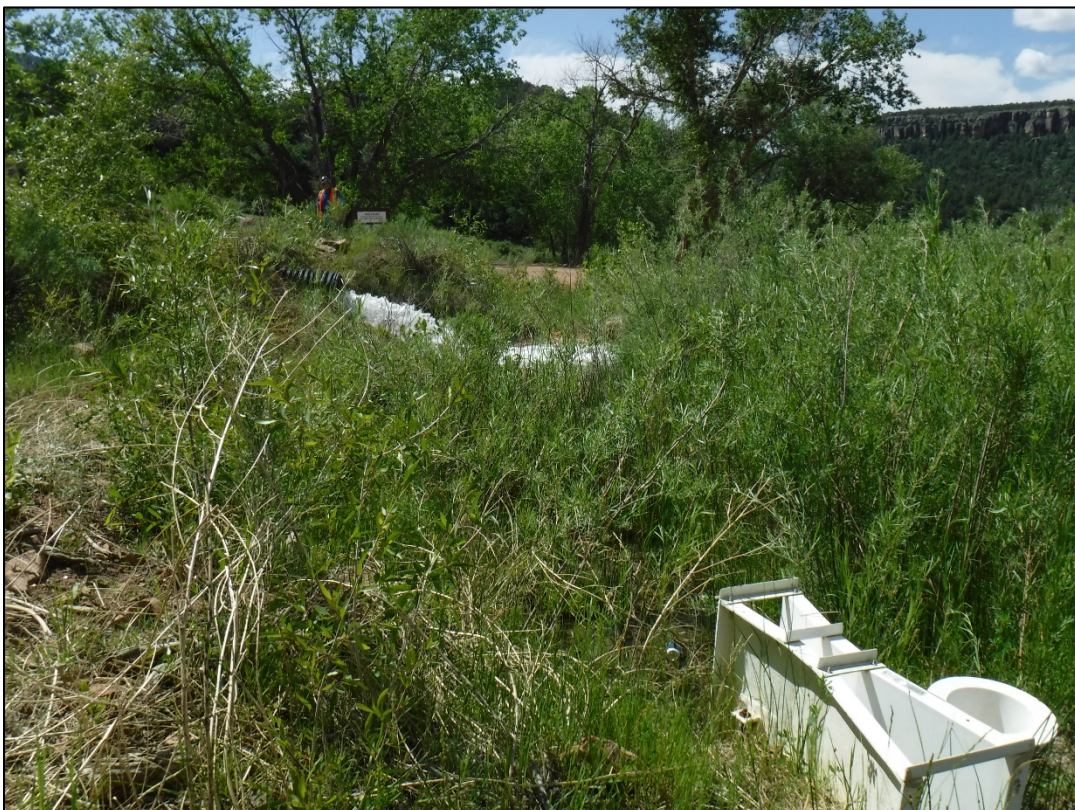
Photo 10: The flume is located at the discharge for Fourmile Spring #1 and the other discharge is from the Carlton Tunnel after it has gone through the sedimentation ponds

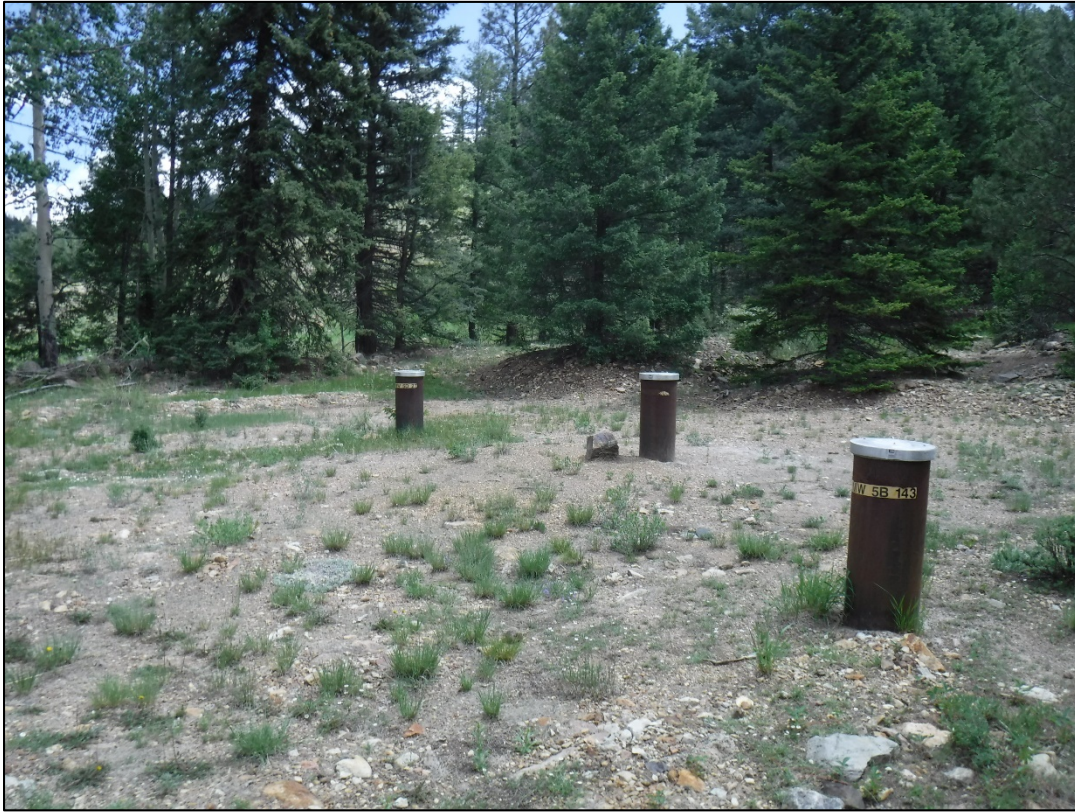
Photo 11: CRMW-5A (center), CRMW-5B (right) and CRMW-5D (left)

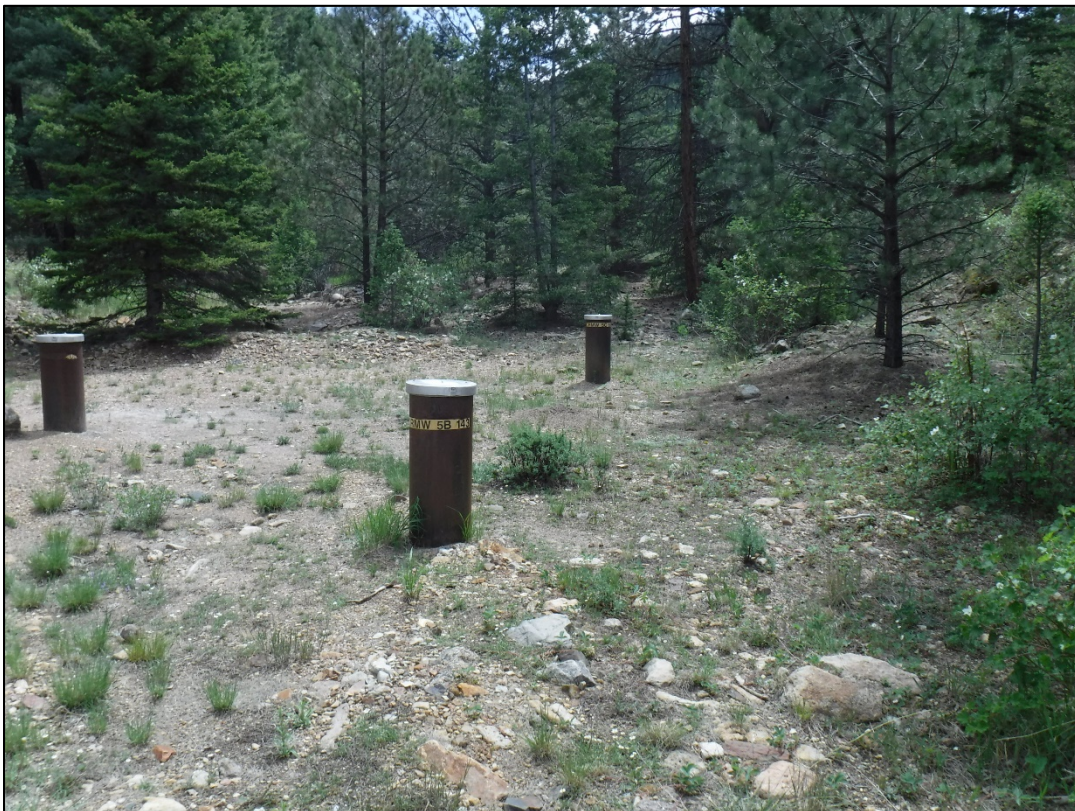
Photo 12: CRMW-5A (left), CRMW-5B (center) and CRMW-5C (right)

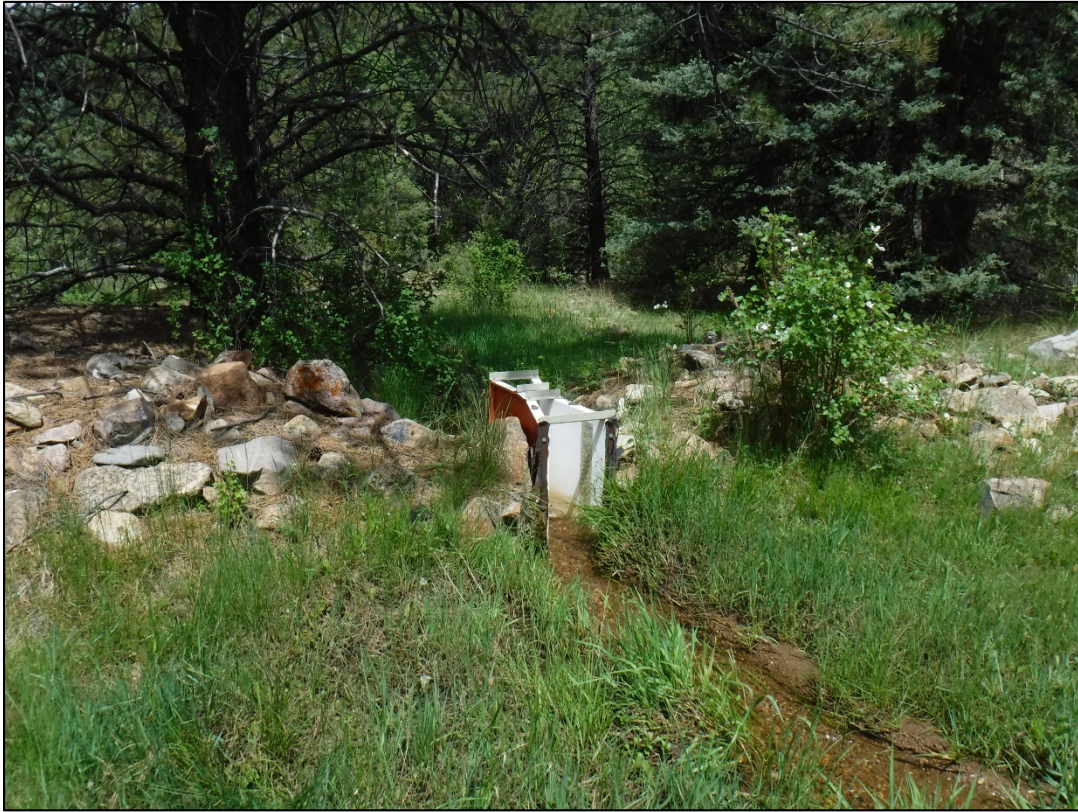
Photo 13: AG 2.0 surface water sampling location and flume

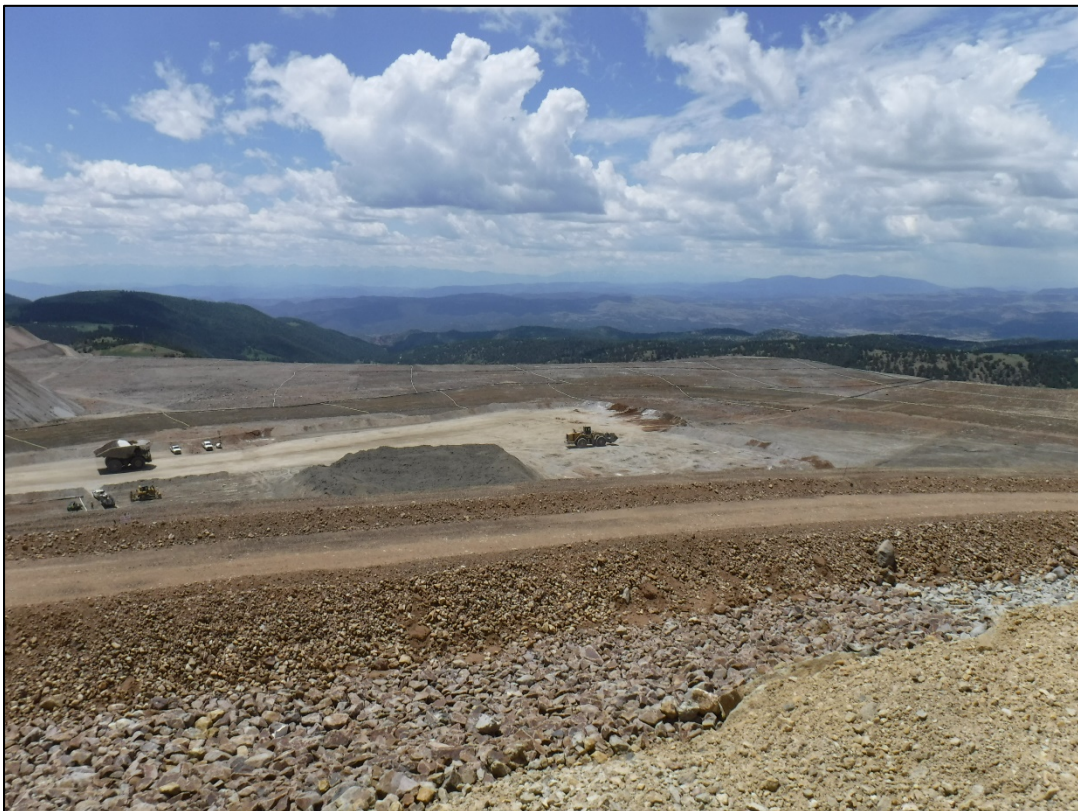
The Division observed VLF2 area from near the Brahma Warehouse. The operation is currently placing lifts, 10,050 foot level, with run of mine material mixed with cement material, which is dispensed directly into the truck beds. Additionally, crushed material is also being placed in lifts. The Division inspected active leaching surfaces, 10,000 foot level, on the SGVLF. The operation is required to minimize ponding of leaching solution to less than 3 feet by 3 feet in area. This is to prevent the ponds from being a wildlife attractant. Active leaching areas appeared to be well-ripped to minimize ponding. No ponding was observed.

Photo 14: VLF2 current dumping area

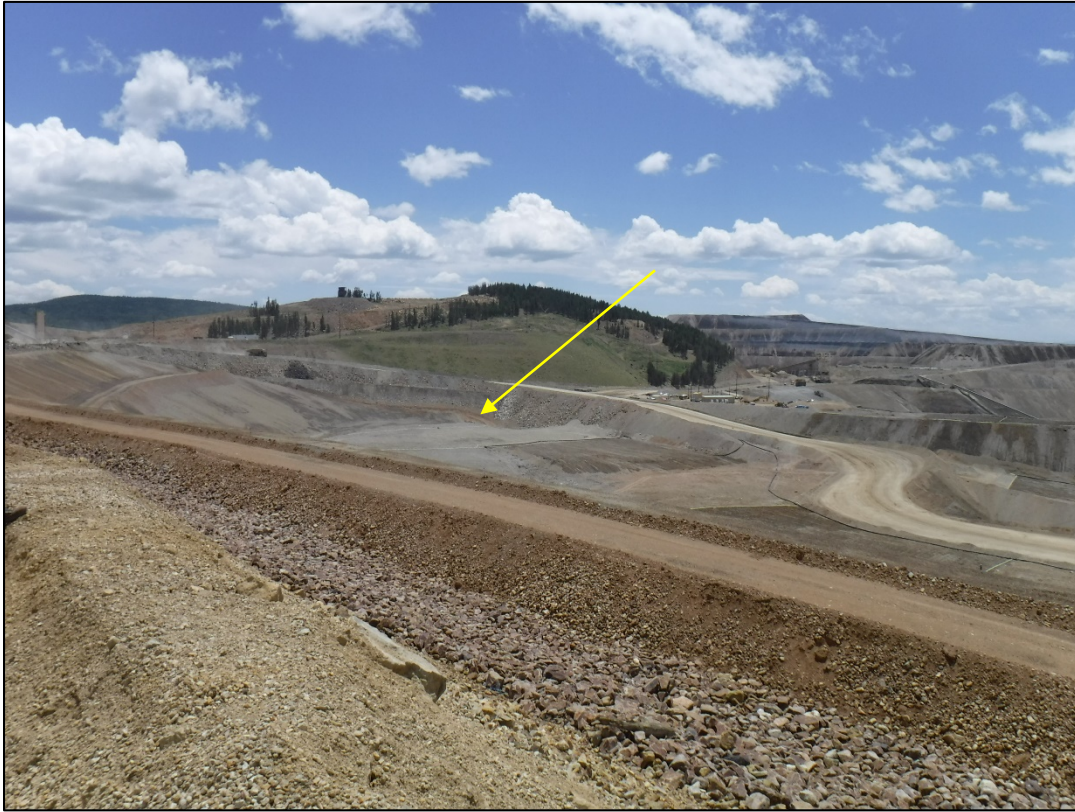
Photo 15: VLF2 area being actively leached, arrow indicates the location of SG LDS4

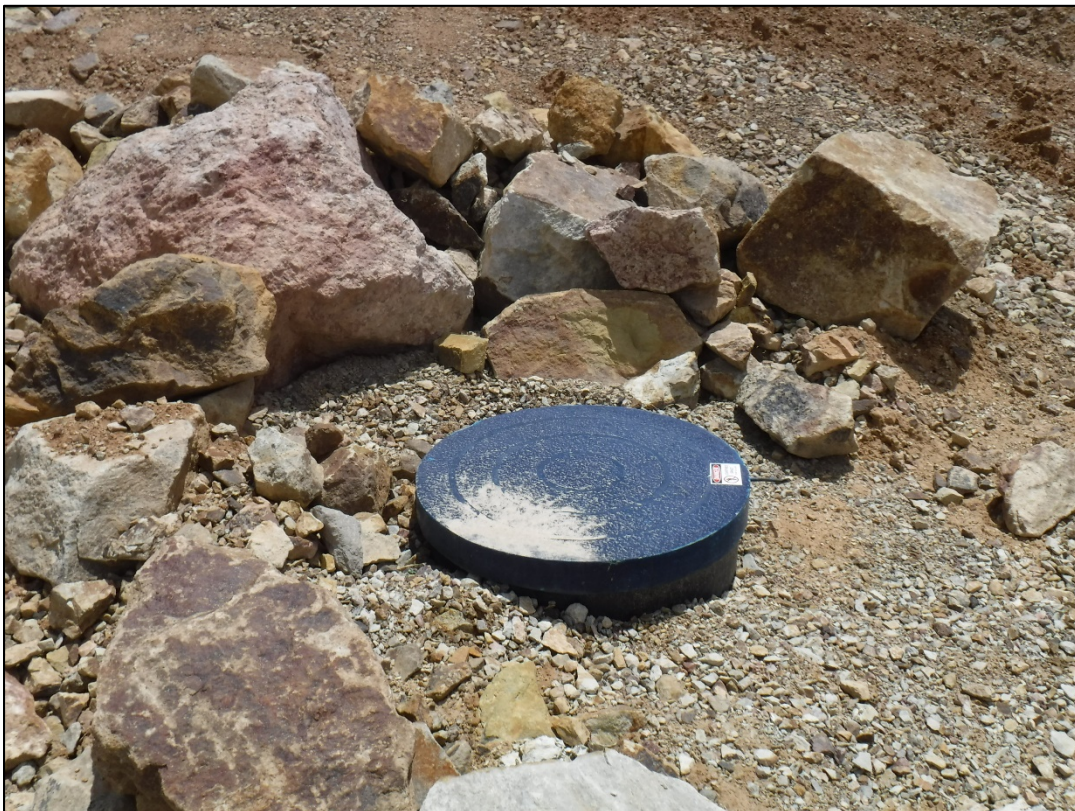
The Division inspected the Leak Detection Sump #4, this sump is scheduled to begin operation when leaching begins on the 10,100 foot level estimated to start sometime between September and November. The sump has no ladder on the inside to discourage unauthorized entry. The lid is made of fiberglass material which makes it lighter so one person can remove it for inspection. The Division re-iterated its concern of lids on other sumps allowing precipitation from outside migrating inside the sump making it difficult to determine if the sump is collecting outside water or solution water. The fiberglass lids may be a possible solution to those other leaking lids.

Photo 16: VLF2 SG LDS4

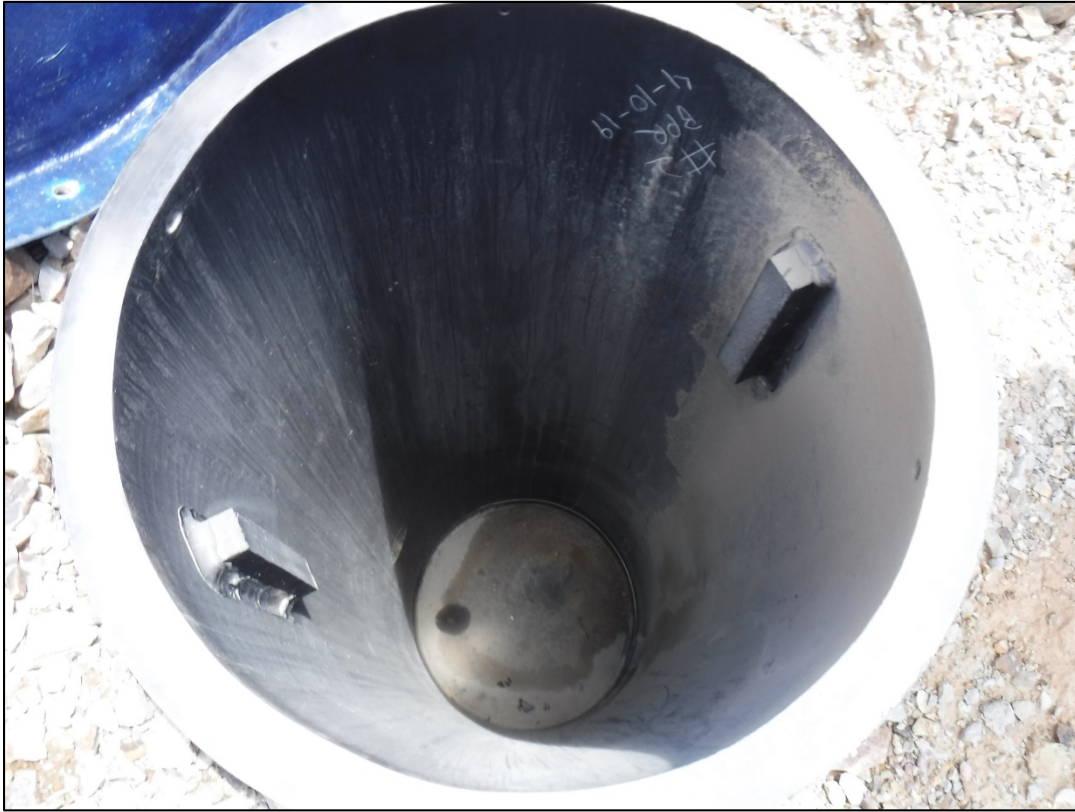
Photo 17: VLF2 SG LDS4, inside

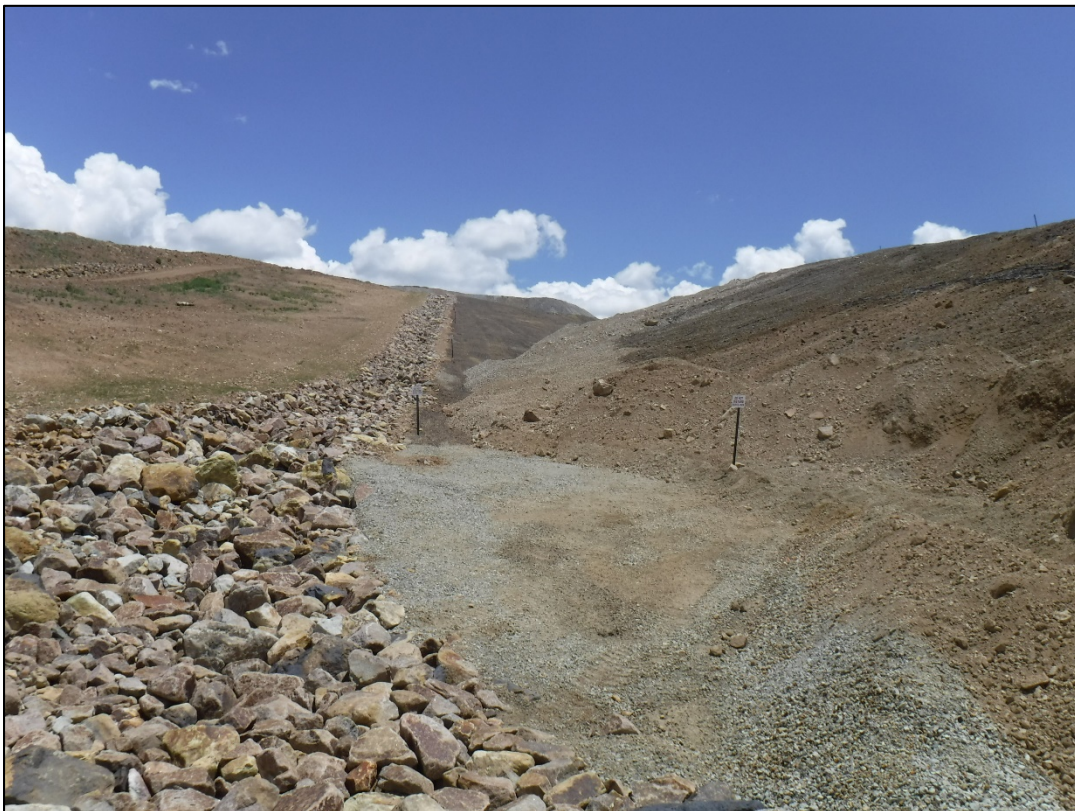
The Division inspected a portion of the VLF2 Phase 2B liner to evaluate actions taken to address questions during the May 2021 inspection. During the May inspection the edge of liner markers appeared to be improperly positioned and there was a concern that ore material and possibly solution, during a weather event, may be able to leave the liner. Since the May inspection a survey was performed to verify the correct placement of the edge of liner signs, all signs were in the correct position. A berm was constructed near the edge of liner as a physical barrier to stop material from going off liner. In conjunction with the berm a compacted trench on the leaching side of the berm was installed to direct any surface runoff away from the edge of liner and back towards the lined area.

Photo 18: VLF2 Phase 2B edge of liner area, looking east

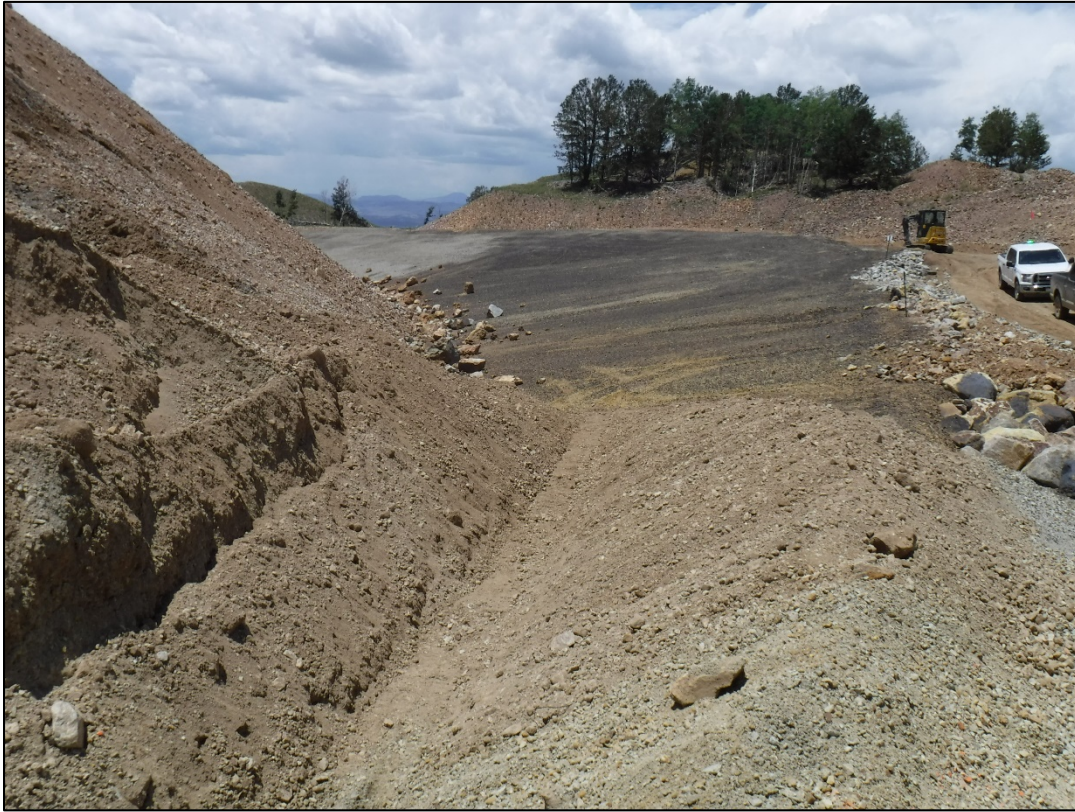
Photo 19: VLF2 Phase 2B edge of liner area, looking west

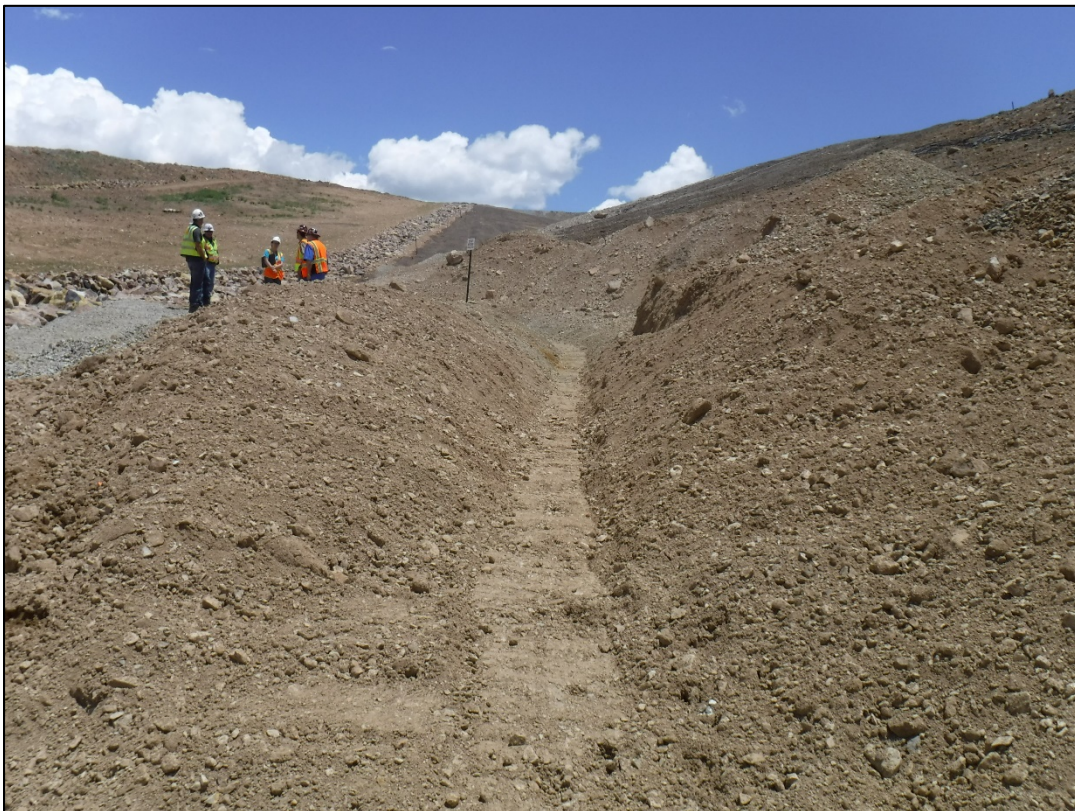
Photo 20: Berm and compacted trench to help prevent material and solution from migrating off liner

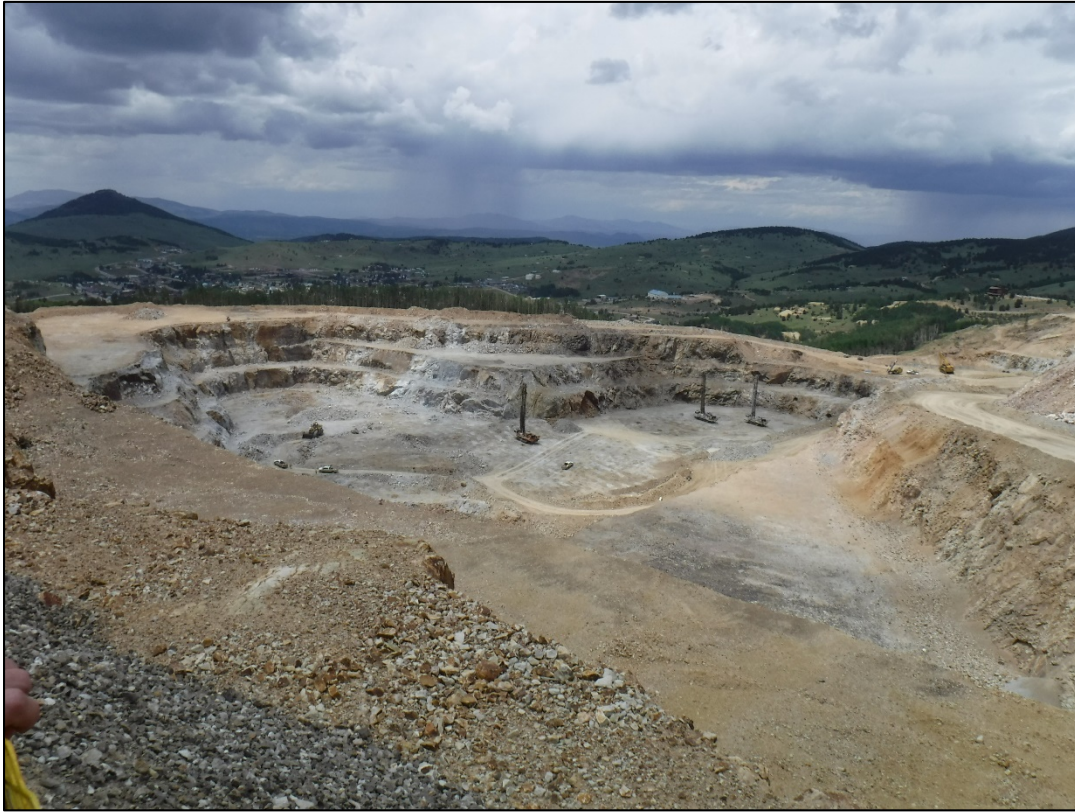
The Division observed the ongoing mining activities in the Schist Island Pit area. Mining activities in the area are scheduled to be completed in the next month, end of July or early August. Backfilling is tentatively scheduled to begin in late August in accordance with AM-13.

Photo 21: Continued mining operation at Schist Island Pit

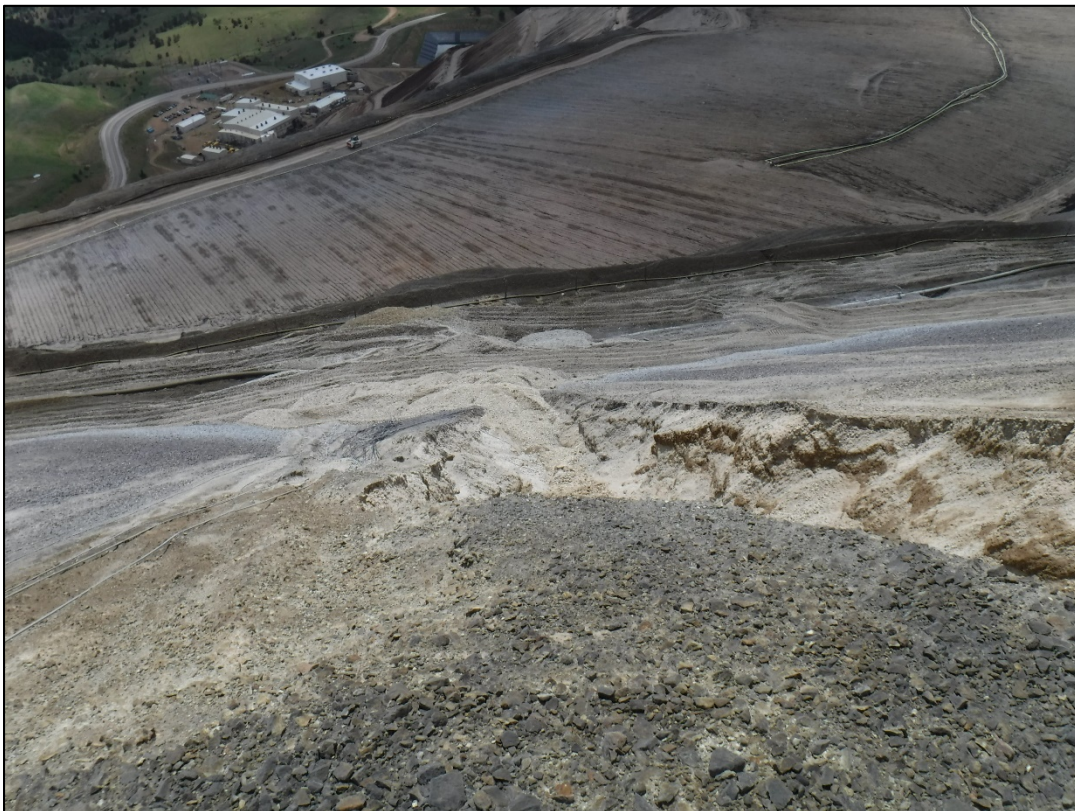
The Division observed the washout on the 10,400 foot level of VLF1. The washout was caused by a plug failure on a 4-inch plastic pipe. The plug was facing down into the ore material and thus was not easily identifiable.

Photo 22: Washout area on the 10,400 foot level looking down to the 10,300 foot level

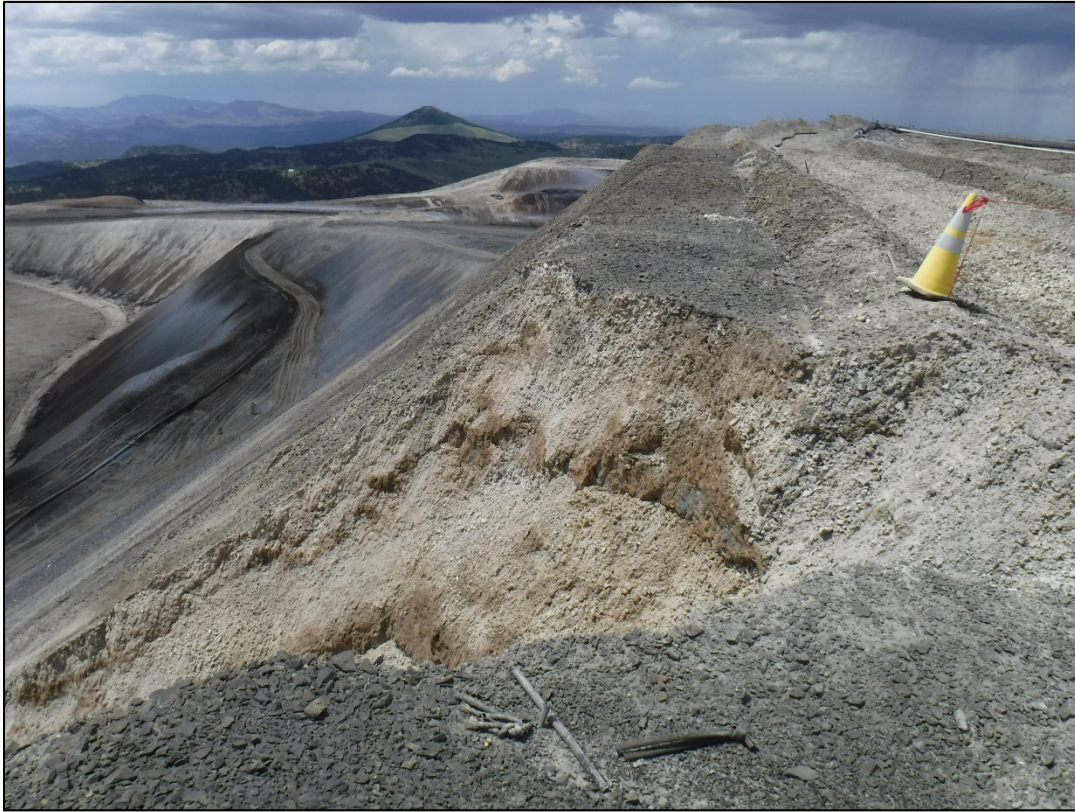
The approximately 700 gallons of solution escaped from the failed plug which in turn washed material downslope to the 10,300 foot level. The scarp created is approximately 10-15 feet across on the surface and 10 feet deep from the surface. The scarp appears to be stable. The operator is in the process of scheduling to repair the scarp and move the material back to the 10,400 foot level. The plugs will no longer be used to repair the line. Moving forward the operator will fuse/weld the pipe back together once the failed area is removed.

Photo 23: Scarp created by the washout area on the 10,400 foot level

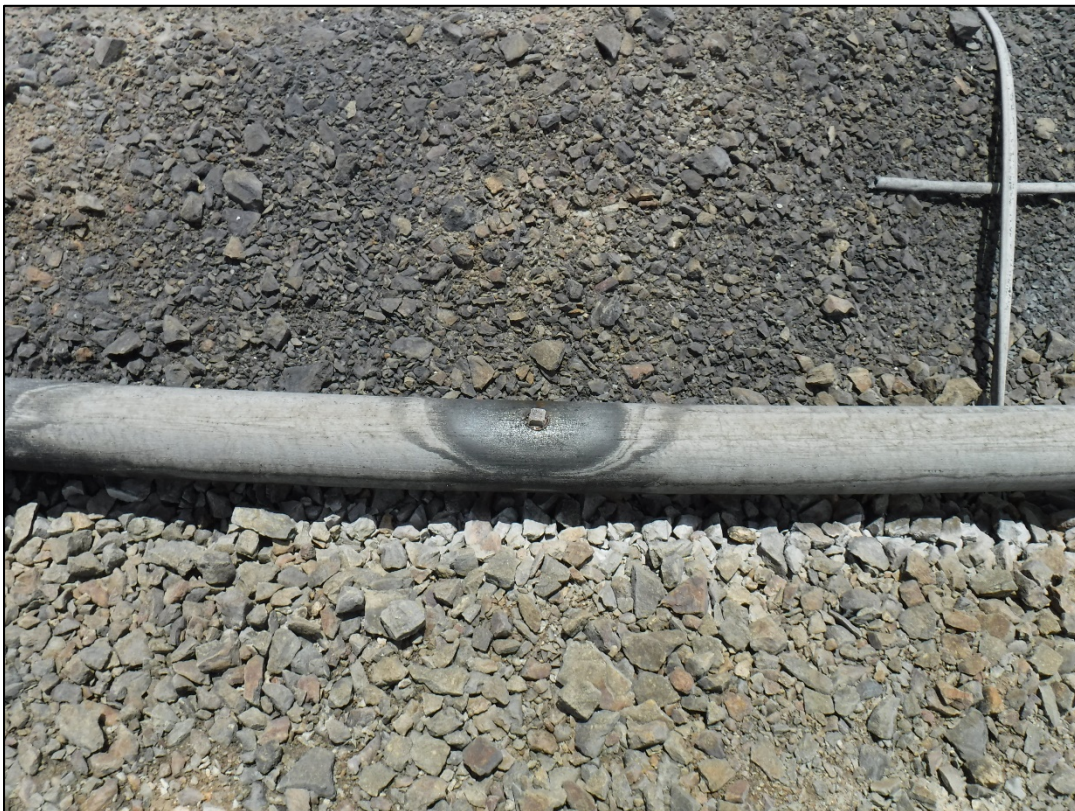
Photo 24: Typical plug that failed, all plugs are gradually being cut out and replaced by fusion welds
