MINERALS PROGRAM INSPECTION REPORT

MINE NAME: Henderson Mine	MINE/PROSPECTING ID#: M-1977-342	MINERAL: Molybdenum	COUNTY: Clear Creek, Grand
INSPECTION TYPE: Monitoring	INSPECTOR(S): Peter Hays	INSP. DATE: July 13, 2021	INSP. TIME: 10:00
OPERATOR: Climax Molybdenum Company	OPERATOR REPRESENTATIVE: Miguel Hamarat	TYPE OF OPERATION: 112d-3 - Designated Mining Operation

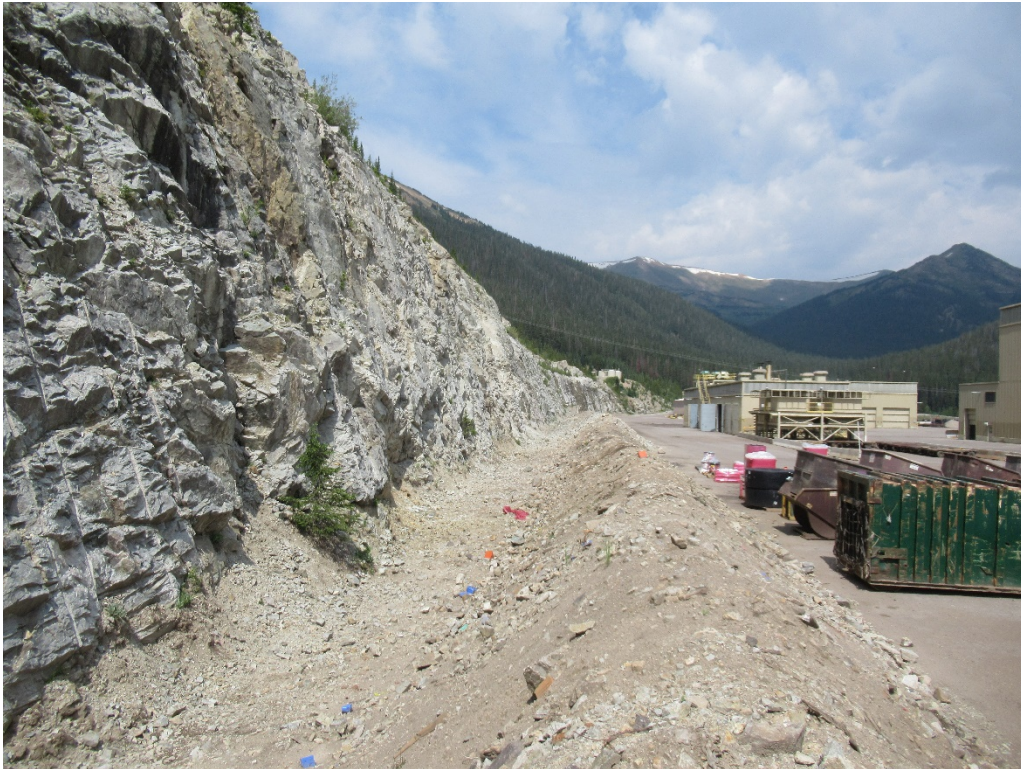
the West Fork of Clear Creek to the east. The western portion of the ditch from the old adit to Butler Gulch contained standing water. The middle portion of the ditch from the old adit to No Name Creek was dry or mostly dry. The eastern portion of the ditch from No Name Creek to Clear Creek contained flowing water.

The Revised EPP states all water is conveyed to the east, however during the inspection it appeared the old adit divided the ditch with water flowing west from the adit to Butler Gulch and east from the adit to Clear Creek. The Division requests the Operator review the construction of the ditch and revise the wording in the Revised EPP if required.

View of Mine EPF 1.2 looking west toward the old adit

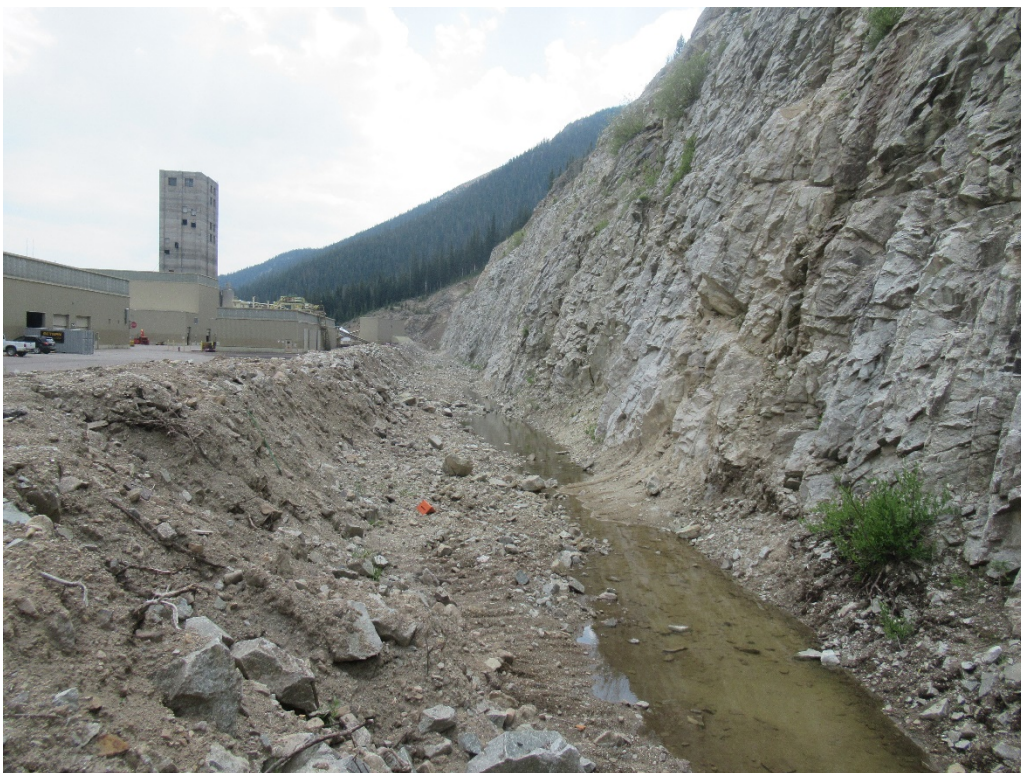
View of Mine EPF 1.2 looking east from the old adit

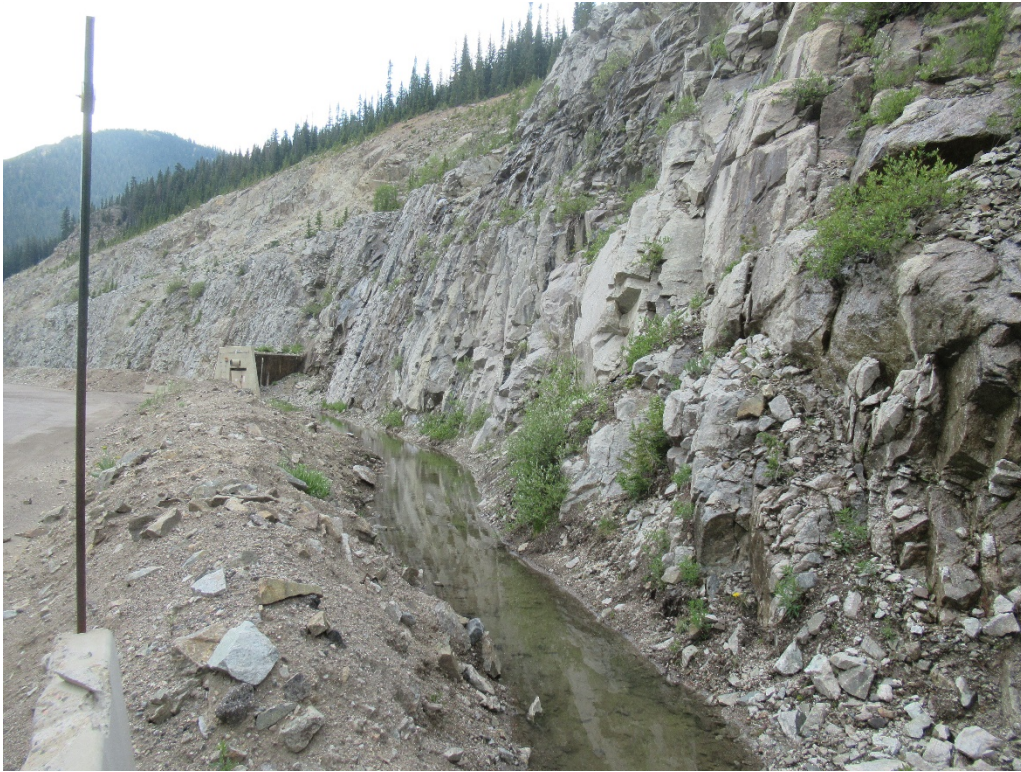
View of Mine EPF 1.2 looking east toward the old adit

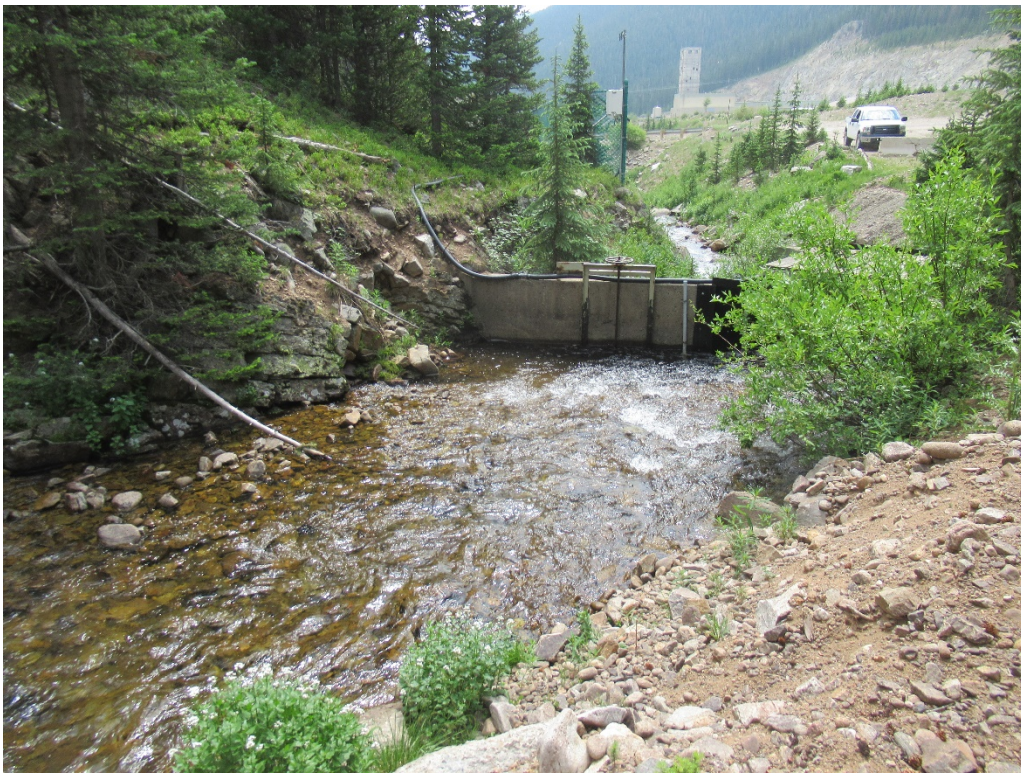
The two surface water sampling points on the West Fork of Clear Creek, CC-10 and CC-40, were observed during the inspection. The signage for the sample points was either outdated or missing, however the locations are well defined.

View of CC-10 location

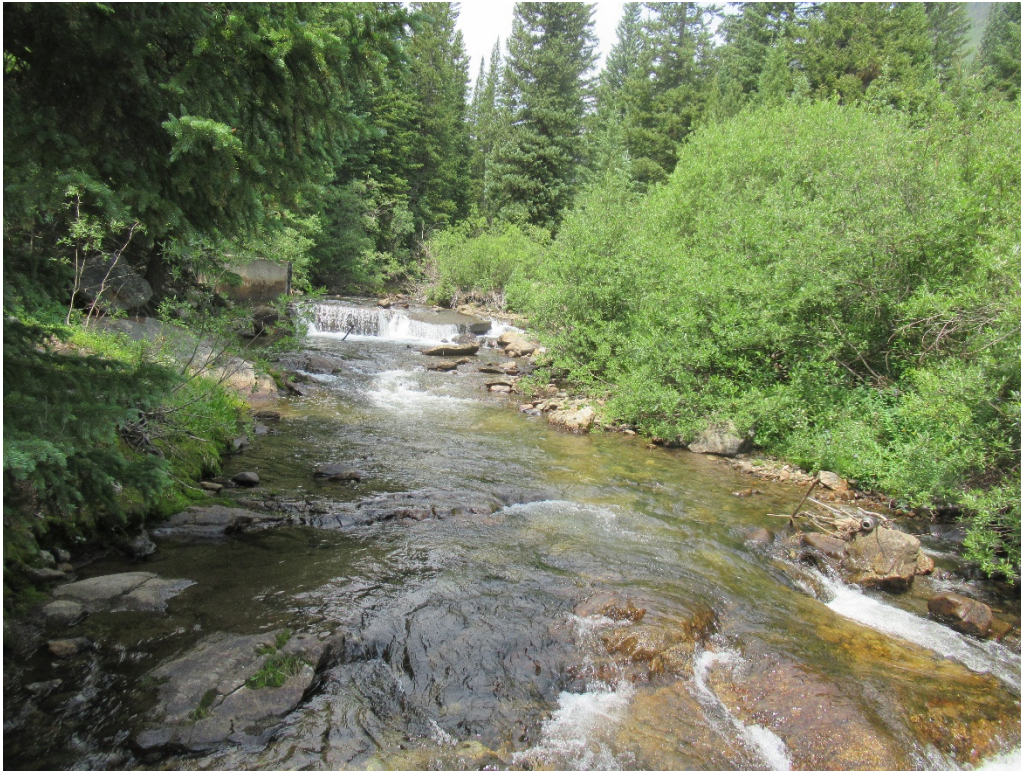
View of CC-30 location

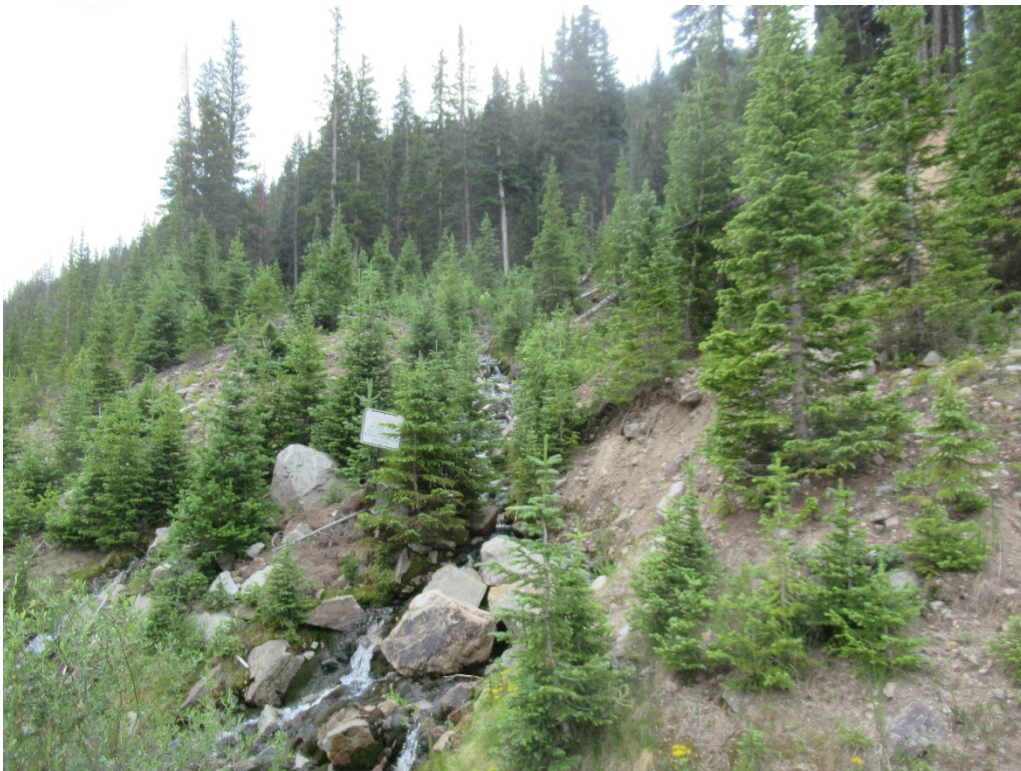
View of No Name Creek at intersection with the division canal

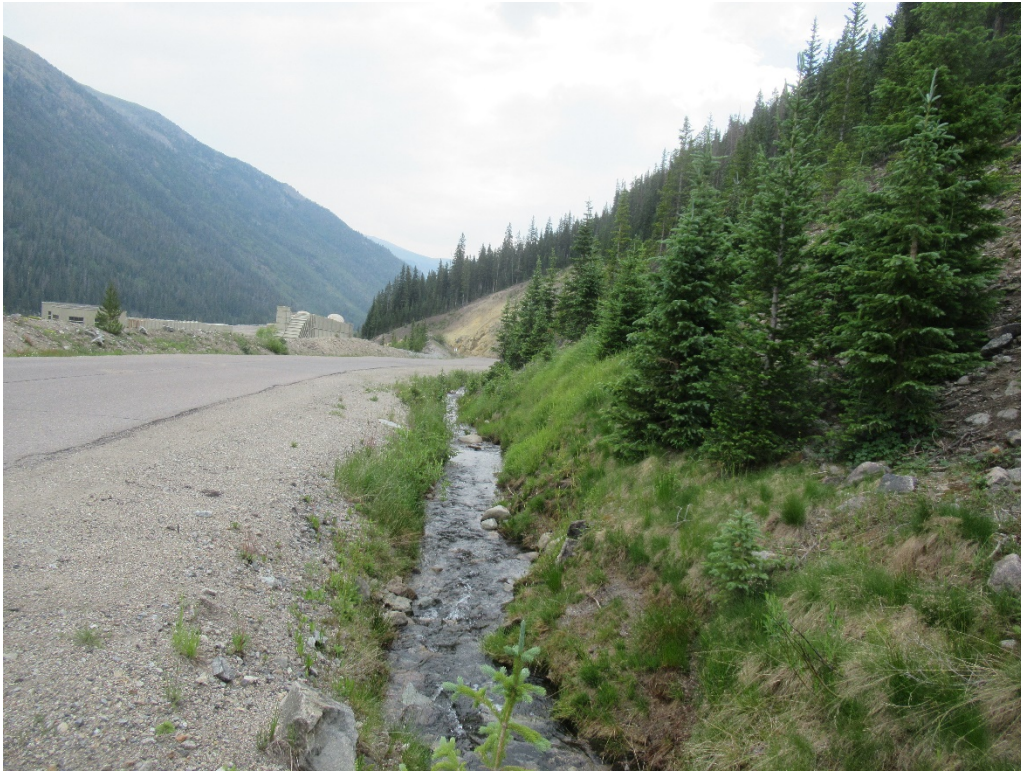
View of Mine EPF 1.2 east of No Name Creek looking east

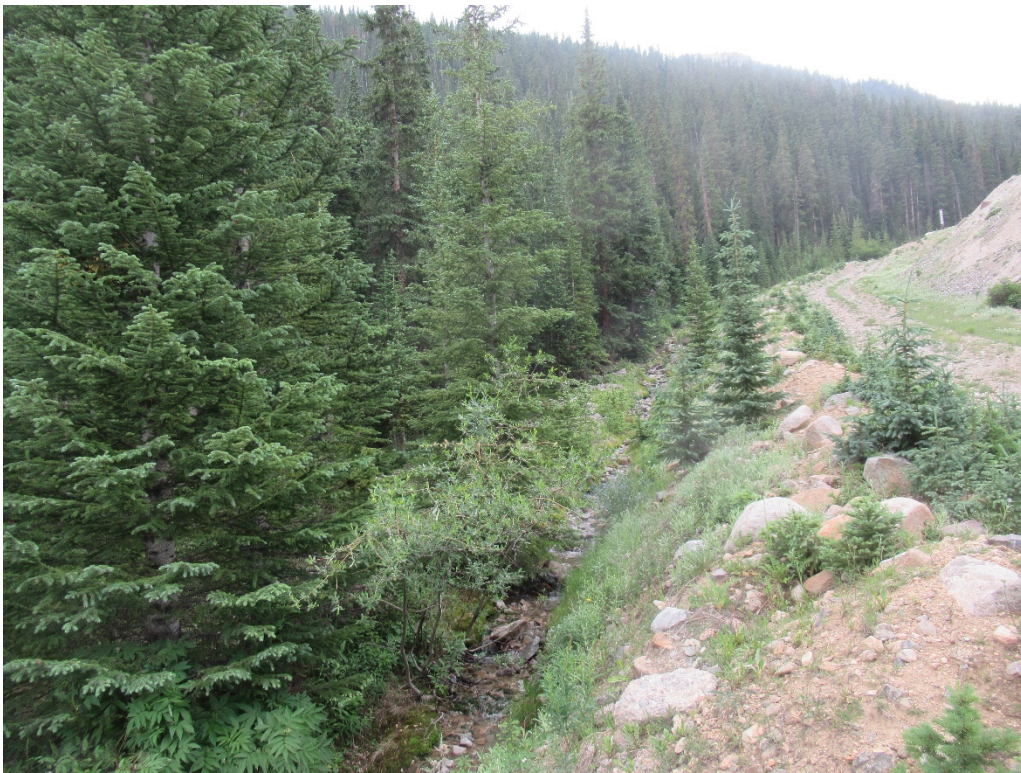
View of Mine EPF 1.2 adjacent to MNGW-1

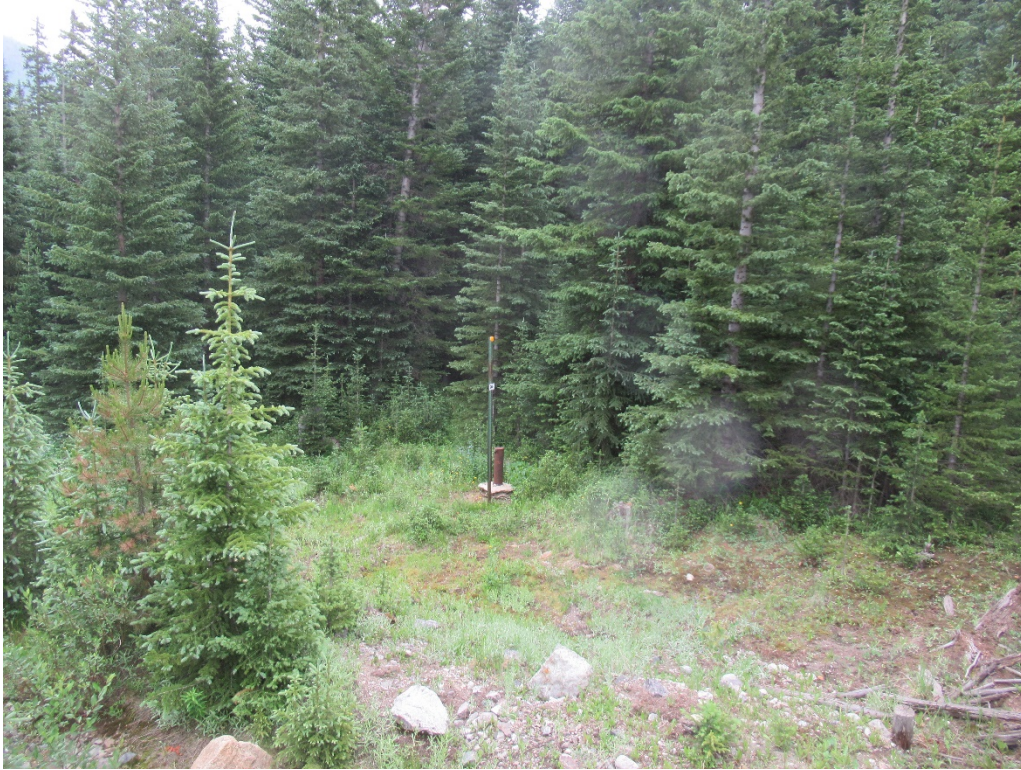
Henderson submitted a status update report for the Henderson Mine Point of Compliance (POC) Well MNGW-1 dated April 7, 2021. The monitoring of MNGW-1 in accordance with the Henderson Groundwater Monitoring Plan (GWMP), approved under TR-16, identified low pH levels beginning in early 2012. Henderson initiated additional water quality monitoring and investigations due to the low pH levels. In 2013, Henderson increased the monitoring frequency at MNGW-1 to monthly to better evaluate pH trends and the underlying groundwater chemistry. In 2014, Henderson continued the investigation with the installation of two additional monitoring wells in the area, MNGW-3 and MNGW-4. In 2015, Henderson expanded the investigation and started to monitor No Name Gulch.

The results of the addition testing and investigations was Henderson submitting the status update which included a report from Ajax and Clear Creek Associates. The report concludes the naturally occurring low pH water conveyed by No Name Gulch off of Red Mountain contributes to or is the direct cause of the low pH conditions in MNGW-1. Henderson stated their intent to return to triannual monitoring of MNGW-1 as required by the GWMP beginning in April 2021 and will no longer perform confirmation sampling, which is currently required by the GWMP. The Division reviewed the report and provided an adequacy review memo by Patrick Lennberg dated June 21, 2021. No Name Creek, the division channel and MNGW-1 were observed during the inspection. The contents of the memo were also discussed during the inspection. Henderson stated they would submit a response to the Division's April memo.

View of MNGW-1

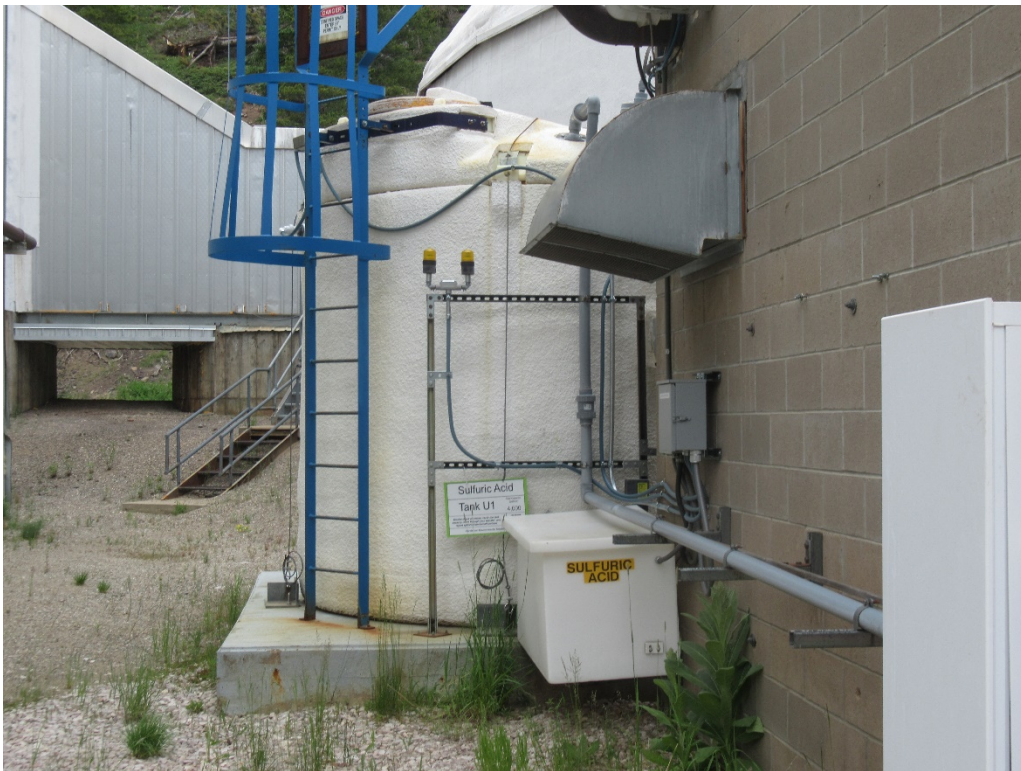
The designated chemicals including; lime, a chemical flocculant and sulfuric acid were observed during the inspection. Henderson stated the revised EPP would be updated to include the designated chemicals used at the URAD WTP and the proposed Mill WTP.

View of the URAD WTP sulfuric acid tank

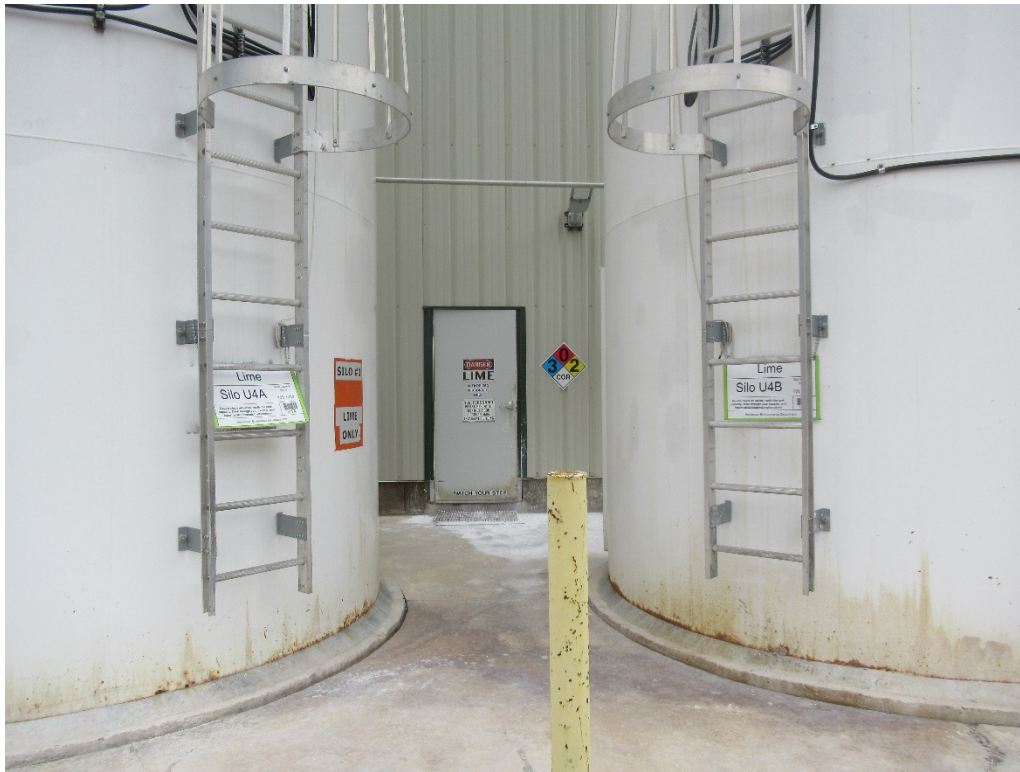
View of the URAD WTP lime silos

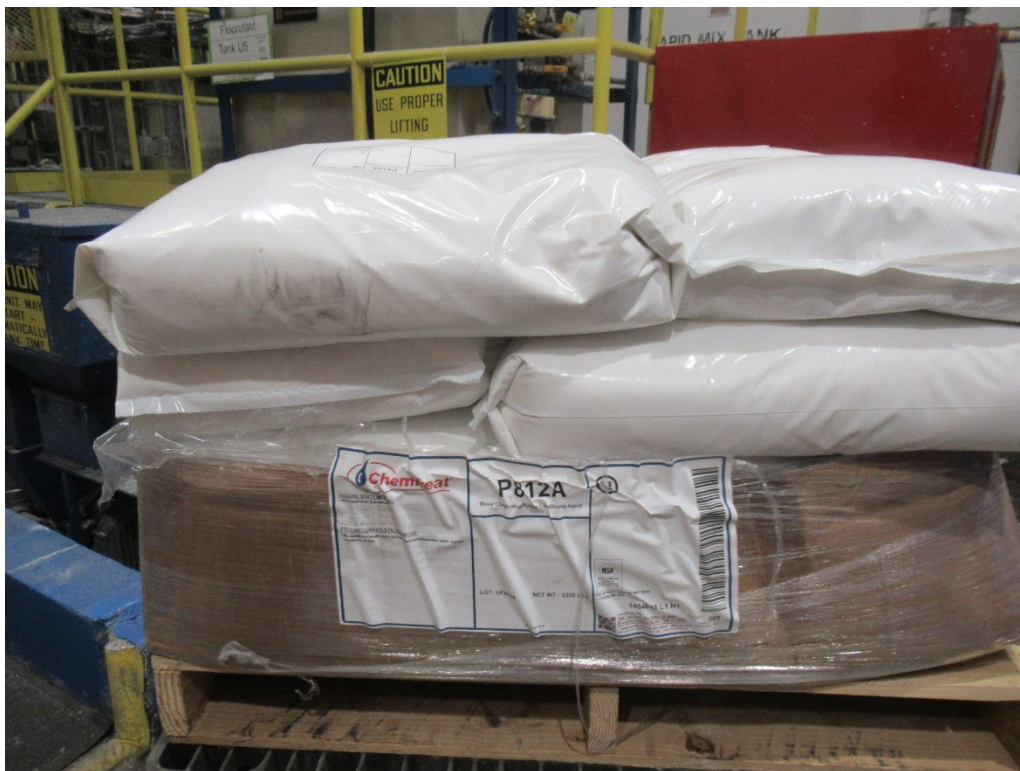
View of chemical flocculant storage inside the URAD WTP
