C1981014 July Coal Partial Inspection

PERMIT INFORMATION

Permit Number: C-1981-041 Mine Name: Roadside Portals Operator: Snowcap Coal Company, Inc. Operator Address: Ms. Tonya Hammond P.O. Box 1430 Palisade, CO 81526	County: Mesa Operation Type: Underground Permit Status: Active Ownership: Private
	Operator Representative Present: Tonya Hammond
Operator Representative Signature: (Field Issuance Only)

Inspection Start Date: July 20, 2021 Inspection Start Time: 10:00 Inspection End Date: July 20, 2021 Inspection End Time: 13:30		Inspection Type: Coal Partial Inspection Inspection Reason: Normal I&E Program Weather: Clear	
Joint Inspection Agency: None		Joint Inspection Contacts: 	
Post Inspection Agency: None		Post Inspection Contacts: 	
Inspector(s): Jason Musick	Inspector's Signature:

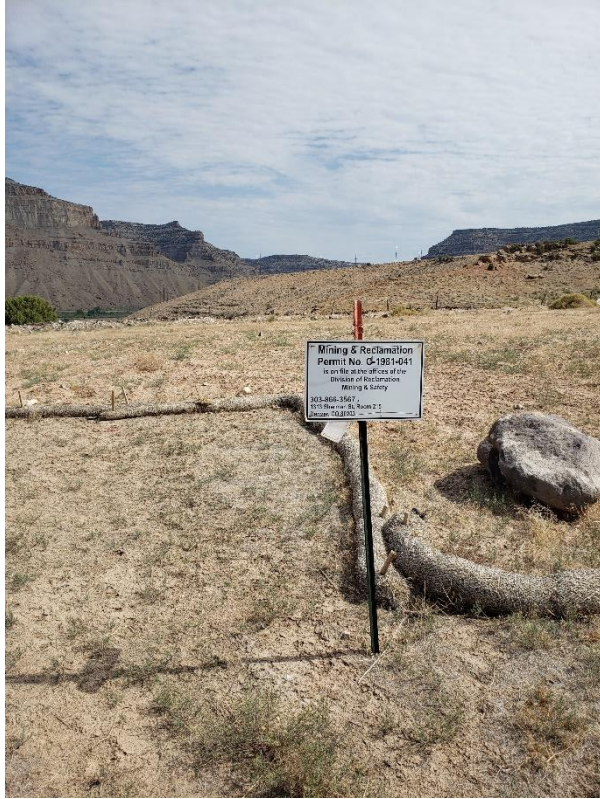
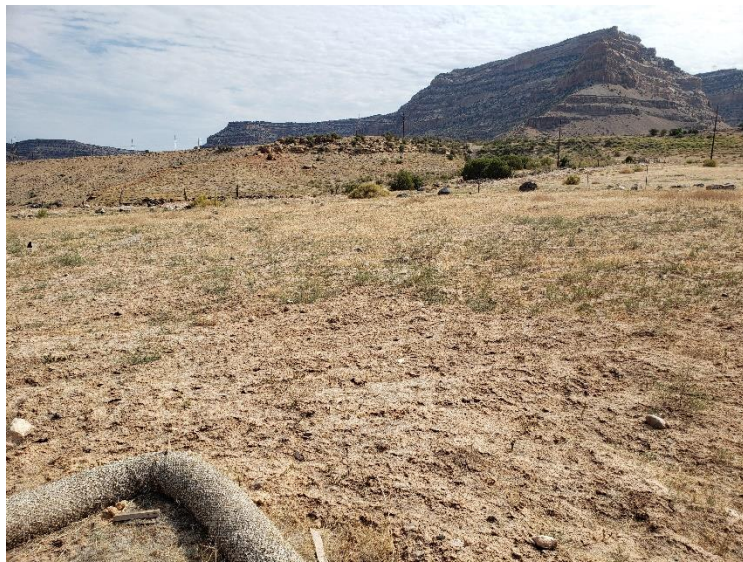
The area of the TR69 repairs and reclamation was stable at the time of the inspection. The area was devoid of a strong stand of vegetation; however, this area was reflective of the surrounding native/undisturbed area. The lack of any measurable moisture continues to contribute to the dry conditions of the site. No issues were noted with regard to instability, erosion, or non-native or noxious vegetation within the disturbance area.

Remaining 0.4 Acres of TR69 Repair Permitted Area
