MINERALS PROGRAM INSPECTION REPORT
PHONE: (303) 866-3567

MINE NAME: Red Rock Pit	MINE/PROSPECTING ID#: M-1978-315	MINERAL: Sand and gravel	COUNTY: Routt
INSPECTION TYPE: Monitoring	INSPECTOR(S): Tabetha Lynch	INSP. DATE: June 15, 2021	INSP. TIME: 13:00
OPERATOR: Peabody Williams Fork Mining, LLC	OPERATOR REPRESENTATIVE: Miranda Kawcak	TYPE OF OPERATION: 112c - Construction Regular Operation	
REASON FOR INSPECTION: Normal I&E Program	BOND CALCULATION TYPE: Complete Bond	BOND AMOUNT: \$31,550.00	
DATE OF COMPLAINT: NA	POST INSP. CONTACTS: None	JOINT INSP. AGENCY: None	
WEATHER: Clear	INSPECTOR'S SIGNATURE:

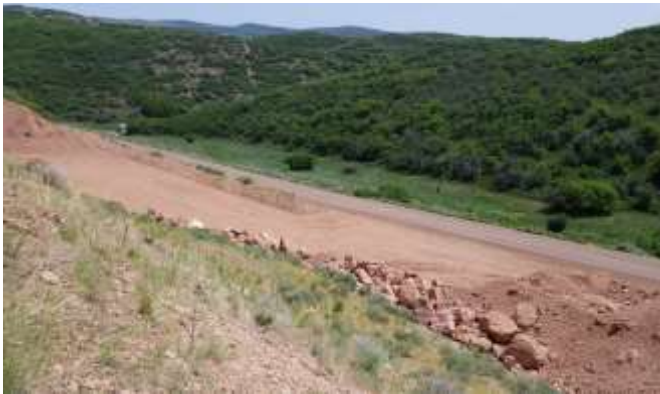
Overlooking phase 2 and CR53

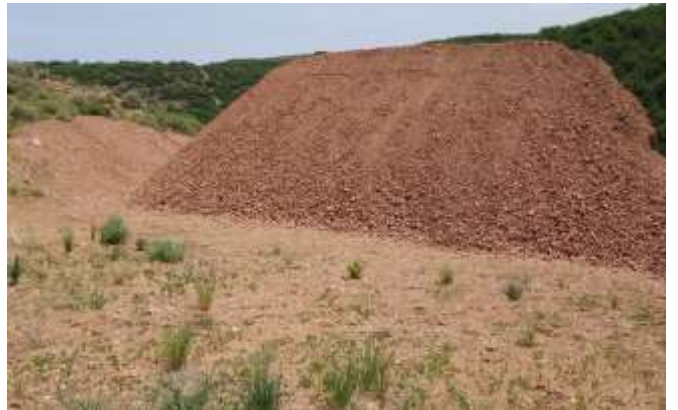
The site was inactive at the time of the inspection. It was indicated by Ms. Kawcak that the county has been utilizing the gravel pit. Approximately five acres are currently disturbed. No equipment was on site the day of inspection. A stockpile of gravel was present at approximately 15-20ft high. There are no buildings or fuel storage areas on site. A bench cut is located at the center of the pit, where it appears excavation is occurring. The western portion of the permit area appears to have been reclaimed and vegetation is well established. Weeds that were noted in the previous inspection in 2016 did not appear to be an issue during this inspection. No marked topsoil piles are on site. The operator is encouraged to salvage all topsoil encountered or fines produced through crushing for reclamation.

Stockpile at east end of excavation

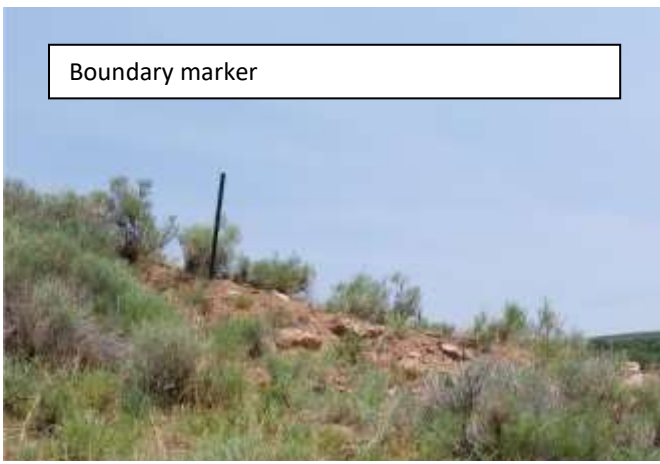
The mine identification sign and affected area boundary markers are in place and in compliance with Rule 3.1.12. The sign is located at both ends of the permit boundary along CR 53.

Boundary marker

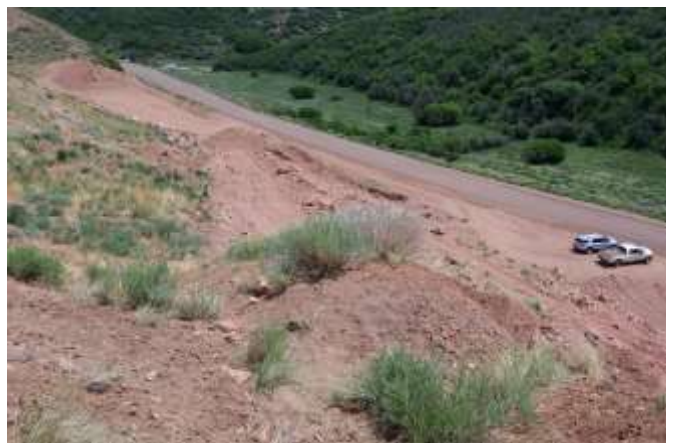
Overlooking active excavation area and bench

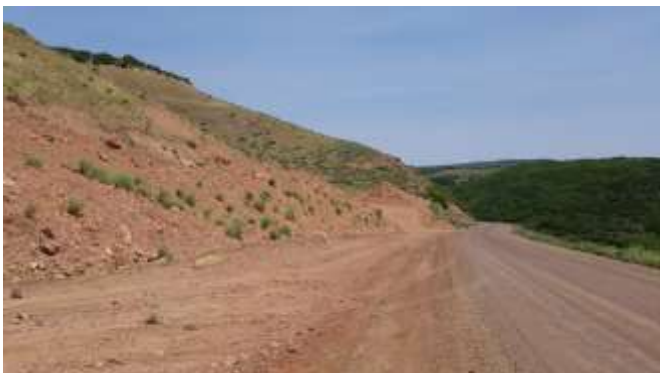
Looking east from CR 53

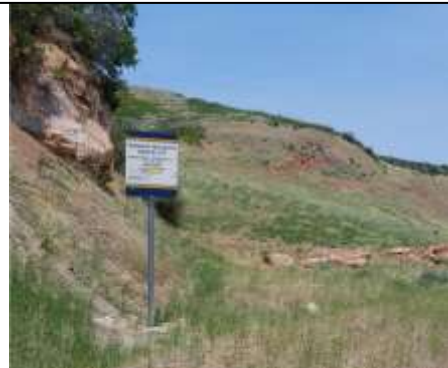
Mine ID sign with correct information. 2 signs present at each end of site along CR 53
