MINERALS PROGRAM INSPECTION REPORT
PHONE: (303) 866-3567

MINE NAME: Empire Pit	MINE/PROSPECTING ID#: M-1977-534	MINERAL: Sand and gravel	COUNTY: Clear Creek
INSPECTION TYPE: Monitoring	INSPECTOR(S): Peter Hays	INSP. DATE: July 13, 2021	INSP. TIME: 13:30
OPERATOR: City of Golden	OPERATOR REPRESENTATIVE: Anne Beierle	TYPE OF OPERATION: 112c - Construction Regular Operation	
REASON FOR INSPECTION: Normal I&E Program	BOND CALCULATION TYPE: None	BOND AMOUNT: \$0.00	
DATE OF COMPLAINT: NA	POST INSP. CONTACTS: None	JOINT INSP. AGENCY: None	
WEATHER: Clear	INSPECTOR'S SIGNATURE:

M-1977-534
July 13, 2021 Inspection Map

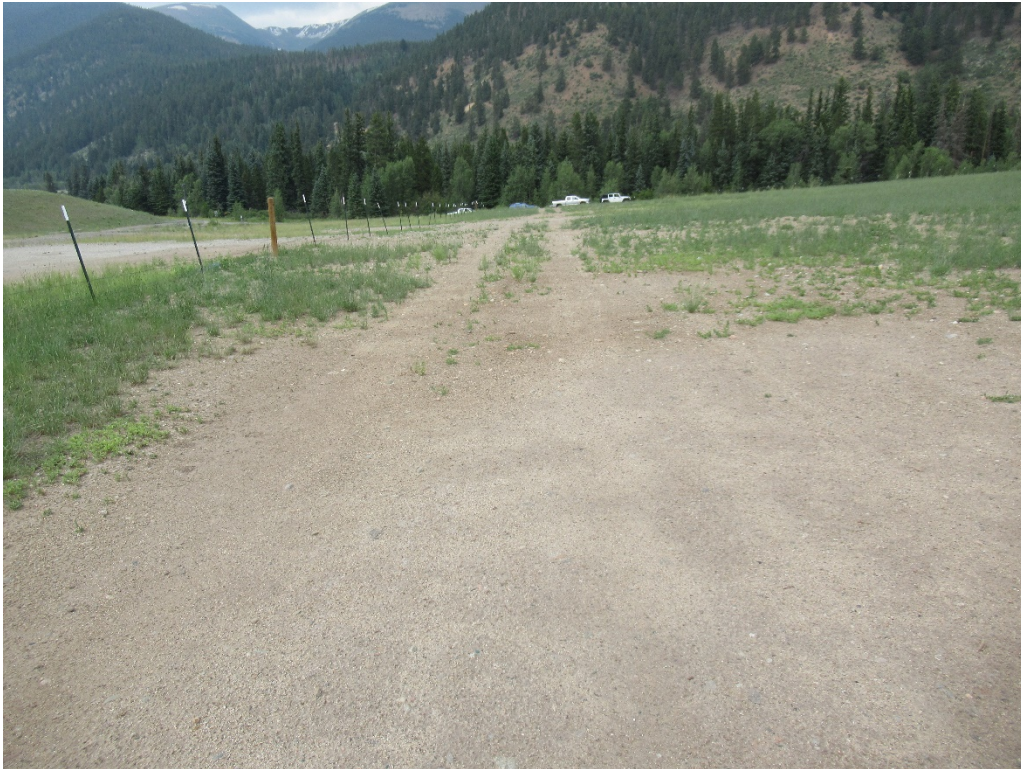
The approved post-mining land use for the remaining portion of the site is pastureland. The Operator requested the inspection to discuss alternatives to the approved Reclamation Plan for the high alkalinity area with the Division and the landowners. The Operator stated they have been unable to obtain the subsoil and topsoil due to the delays associated with finding the material sources, testing the materials and the materials still being available when the testing is complete. The Operator and the landowners discussed the possibility of re-contouring a portion of the site to produce the required materials from the remaining permitted area. The Operator stated aerial maps of the site would be provided to the landowner for them to identify any possible areas for re-contouring. The possibility of using a Geotech fabric in-place of the 6 inch capillary (clay) barrier was also discussed during the inspection.

View of the high alkalinity area and two-track road from the south looking north

The Division does not recommend disturbing the existing vegetation by re-contouring a portion of the site due to the maturity of the grasses. The Division recommends revising TR-03 to remove the testing and notification requirements of the currently approved plan for the high alkalinity area to allow the Operator to obtain the materials needed to complete reclamation. The high alkalinity area was observed to be very hard packed with a crust-like surface. The landowners stated they were using a portion of the area as a two-track road to access a building located in the southwest corner of the site. The Operator and landowners discussed the possibility

of building a road to the structure. The Operator stated they would contact the Division after discussing options for the high alkalinity area with the landowners. The Operator will be required to submit a technical revision, pursuant to Rule 1.9, if the currently approved Reclamation Plan is changed based on the discussions with the landowners prior to performing any reclamation work.

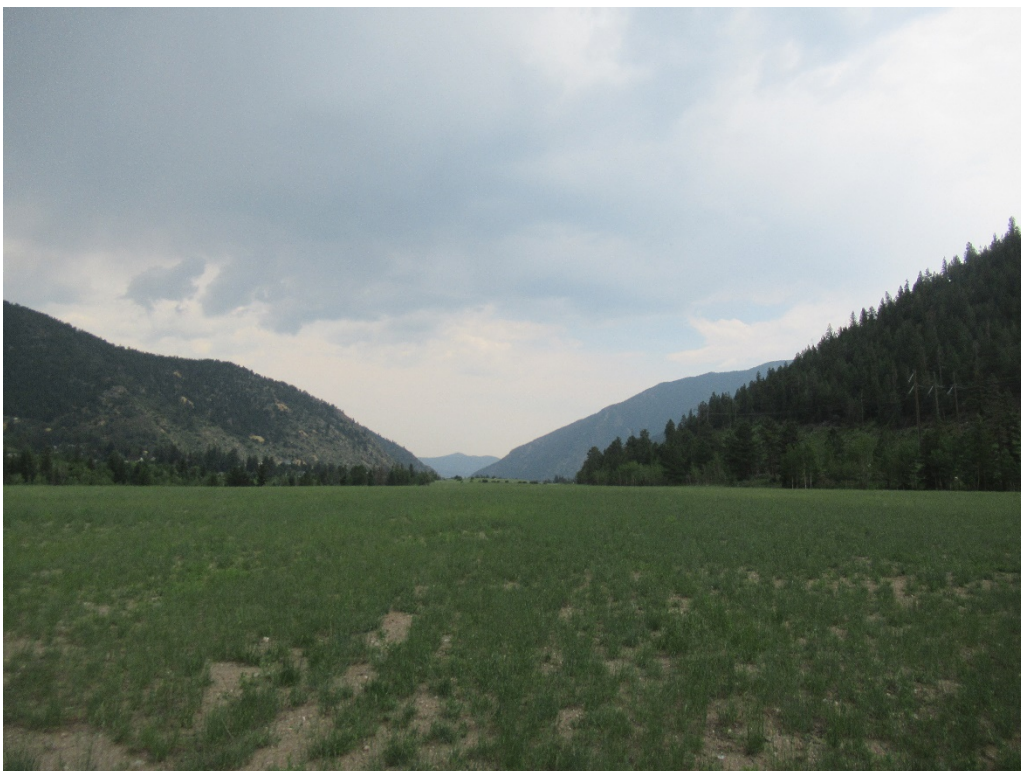
The existing vegetation consisted primarily of well-established crested wheatgrass with lesser amounts of perennial ryegrass, Canada bluegrass and fescue. A few Canada thistle, a Colorado Noxious Weed List B species, were observed along the perimeter of the area. The Canada thistle appeared to have been recently chemically treated by the Operator. Kochia, an annual weed, was also observed in small patches at the site. The kochia was not outcompeting the native vegetation, but should continue to be monitored by the Operator.

View of the site vegetation from the west side of the site looking east

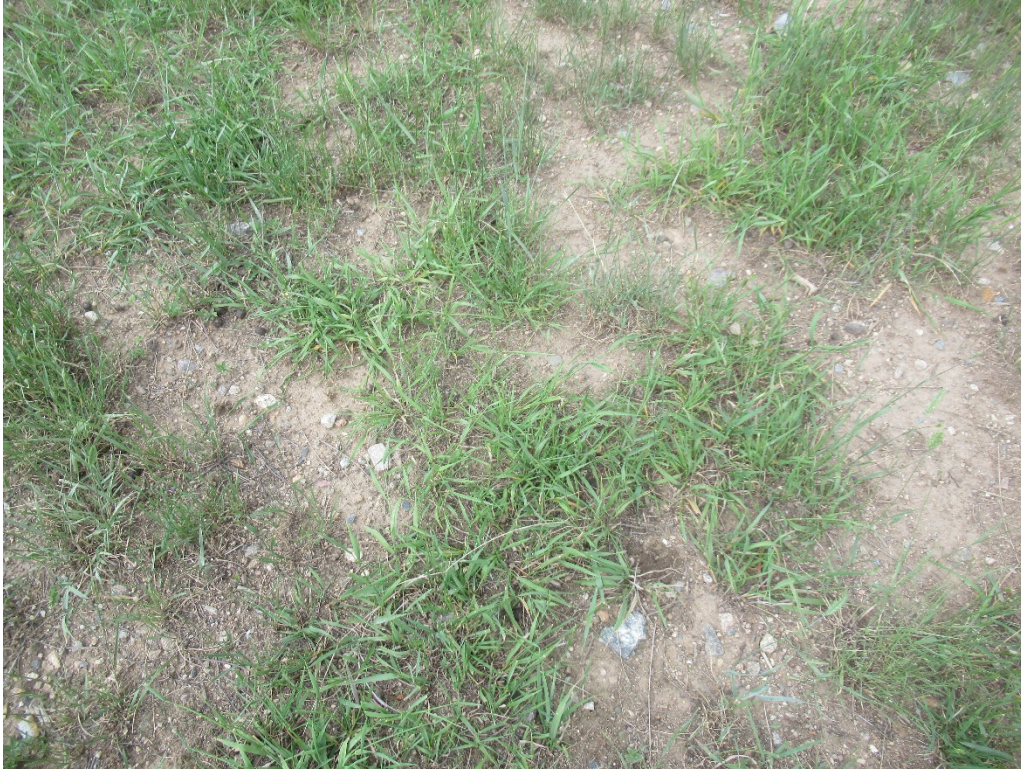
View of the site vegetation

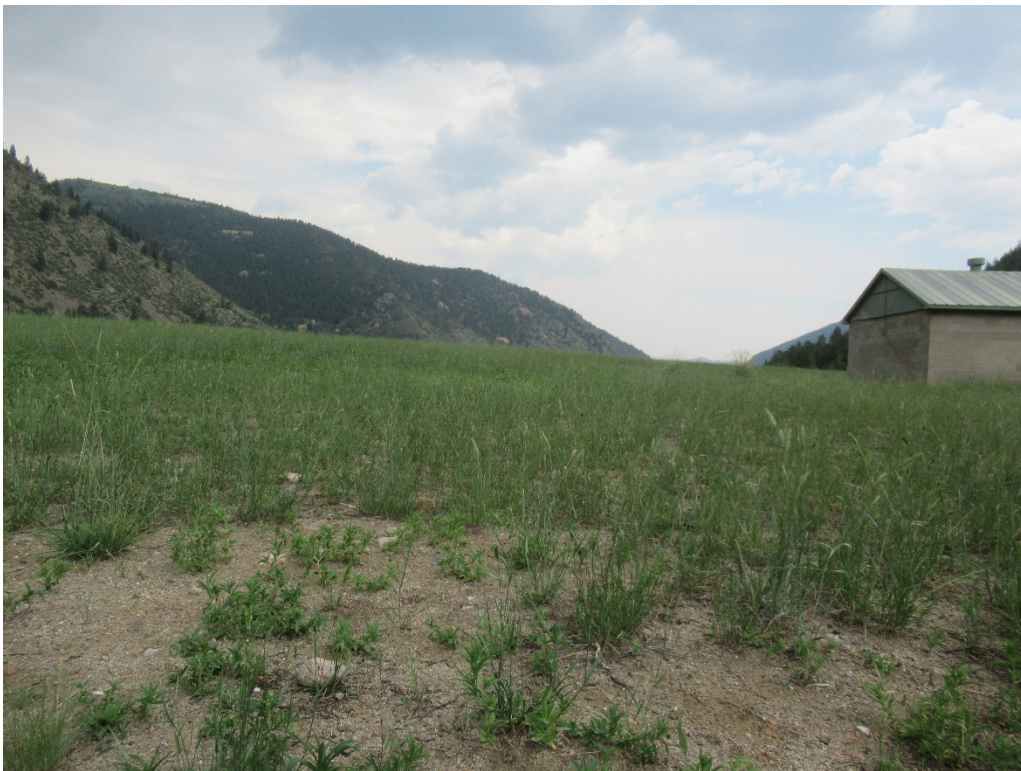
View of the site vegetation
