MINERALS PROGRAM INSPECTION REPORT
PHONE: (303) 866-3567

MINE NAME: Antero Gravel	MINE/PROSPECTING ID#: M-2000-088	MINERAL: Sand, Aggregate, Gravel	COUNTY: Park
INSPECTION TYPE: Monitoring	INSPECTOR(S): Elliott Russell	INSP. DATE: July 13, 2021	INSP. TIME: 12:30
OPERATOR: R & R/Regester Enterprises, Incorporated	OPERATOR REPRESENTATIVE: None	TYPE OF OPERATION: 112c - Construction Regular Operation

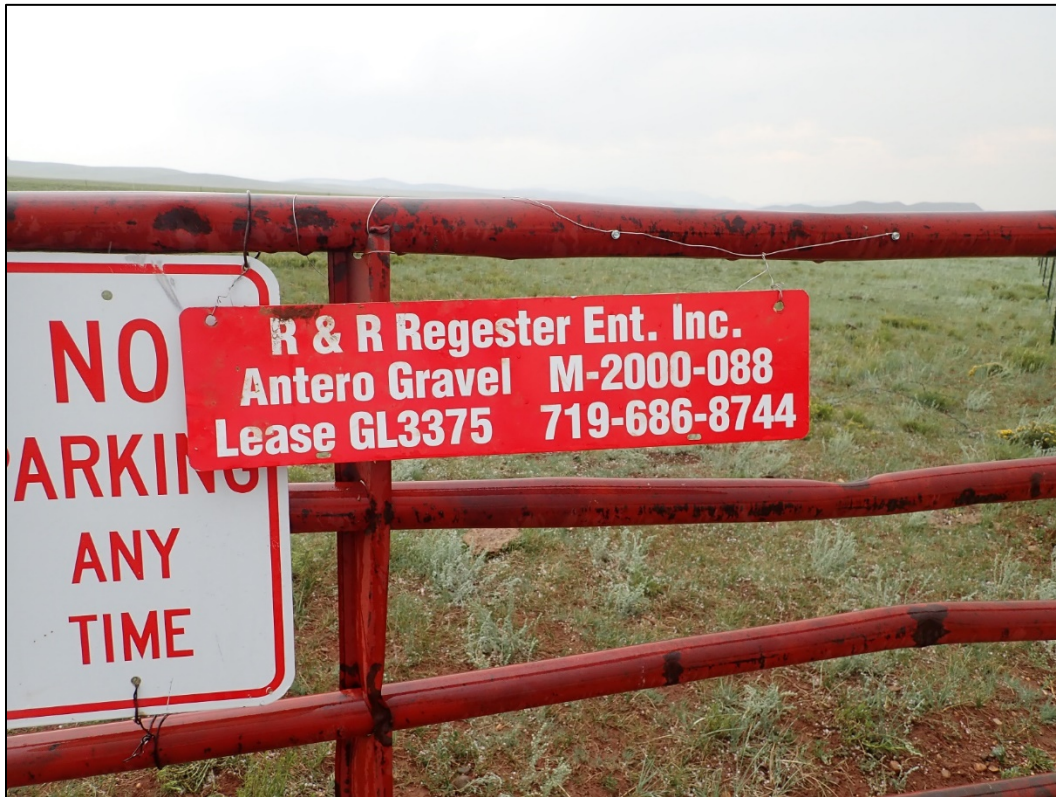
Signs and Markers: The permit sign was posted at the access gate along County Road 80 and is in compliance with Rule 3.1.12(1). The permit boundary was delineated by t-posts and the southwest and southeast corners also had survey monuments.

Photo 1. Permit identification sign; looking east.

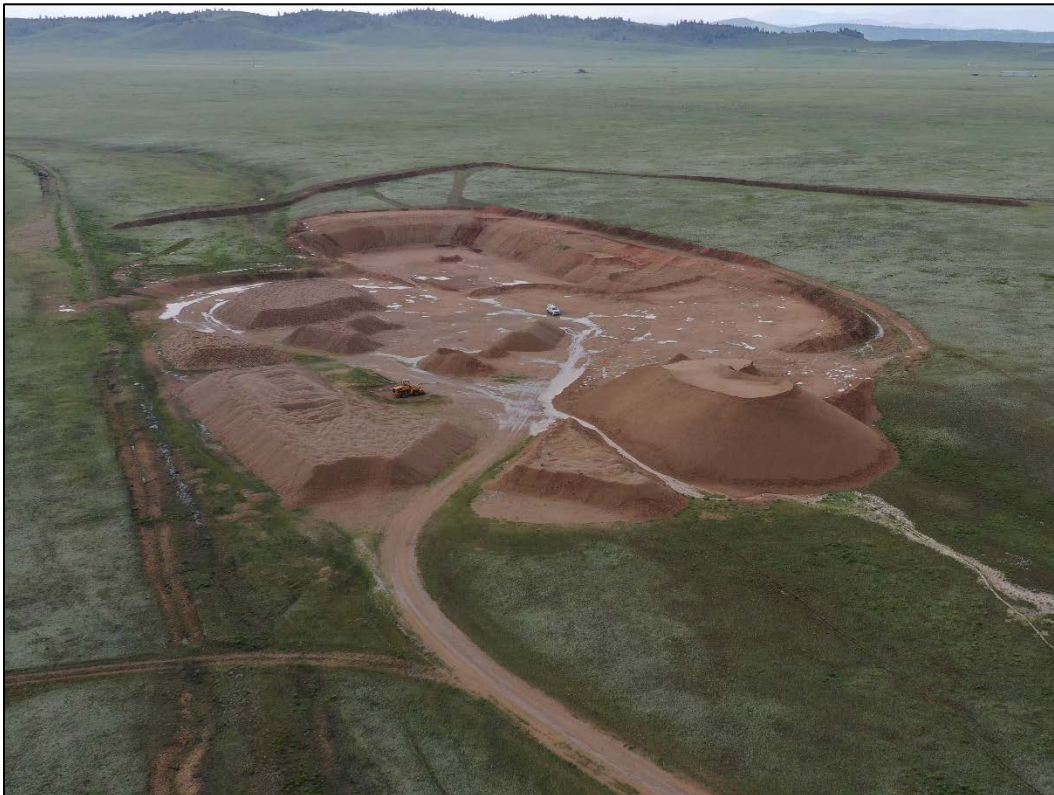
COMPLIANCE PROBLEM #2: Uncontrolled storm water was observed leaving the southern portion of the affected lands. Pursuant to Rule 3.1.5(10), all mined material must be handled in such a manner as to prevent any unauthorized release of pollutants to the surface drainage system and pursuant to C.R.S. 34-32.5-116 (4) (j), all surface areas of the affected lands shall be stabilized and protected so as to effectively control erosion.

Sediment Control: It was raining during the inspection and the Division observed uncontrolled storm water leaving the disturbance between the large fines stockpile and another stockpile located in the southern portion of the site. This has been cited as Compliance Problem #2. The Operator will need to regrade the site or construct storm water containment features to control storm water and sedimentation. Please note, the Division of Water Resources only allows storm water to be impounded for up to 72 hours. The Operator may also provide a copy of an approved storm water discharge permit from CPDHE and demonstrate storm water is being discharged in accordance with the approved permit. The Operator will also need to ensure storm water and sediment is controlled from other areas within the permit boundary that has a potential to leave the affected lands boundary; for example the Operator could install straw waddles, silt fencing, or a catch ditch/berm around the base of the fines stockpile's southern slope.

Photo 2. Mine site overview, storm water pictured leaving the disturbance; looking northeast.

CORRECTIVE ACTIONS: The Operator shall either provide a copy of an approved storm water discharge permit and appropriate photo documentation demonstrating storm water is being handled in accordance with the permit or provide photo documentation that appropriate measures have been constructed on site to control and contain storm water by the corrective action date.

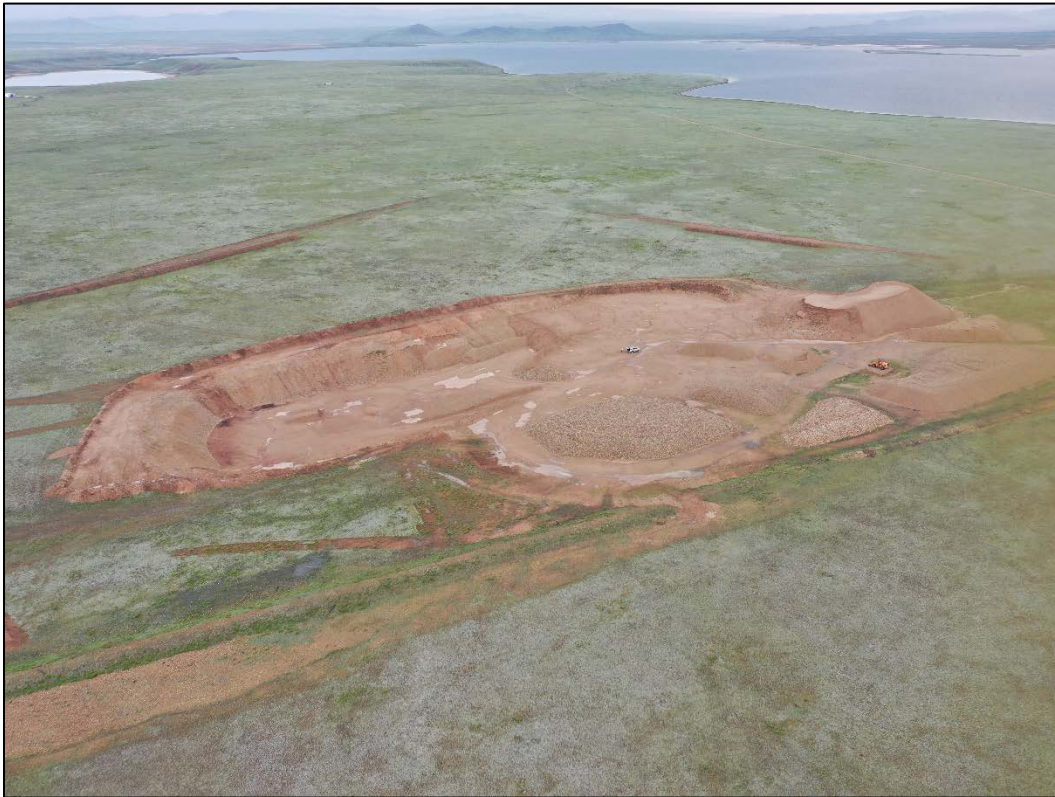
Photo 3. Mine site overview, Antero Reservoir in background; looking southeast.

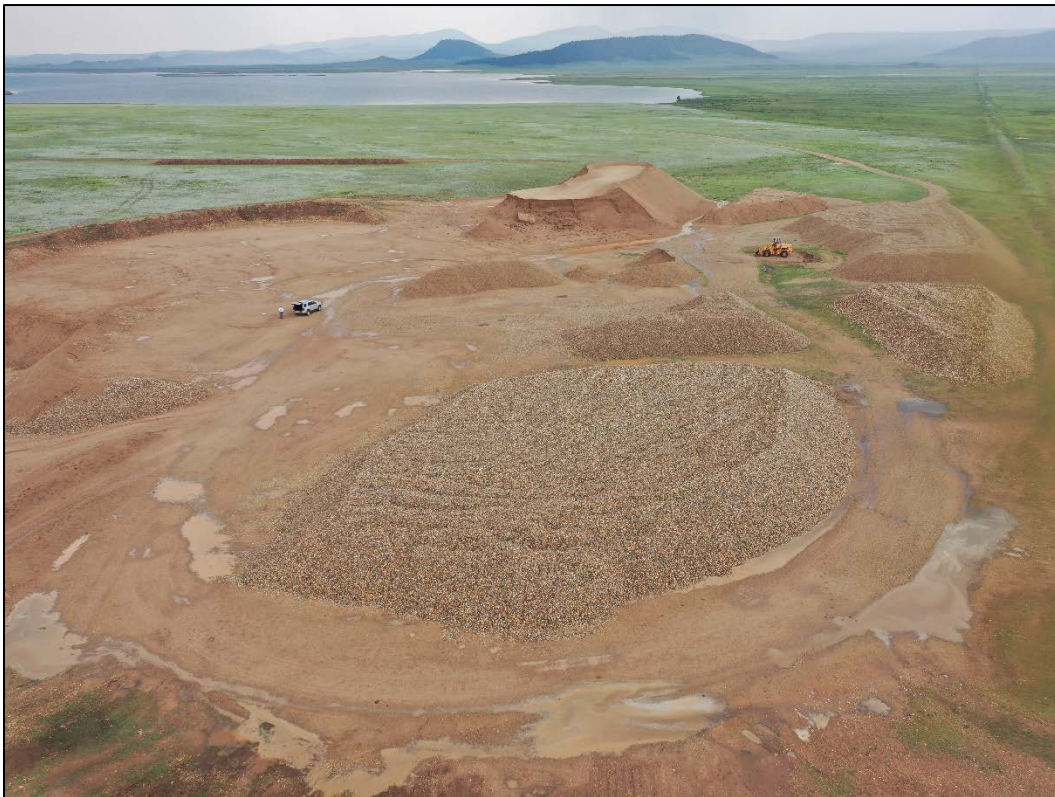
Photo 4. Overview product stockpile area; looking south.

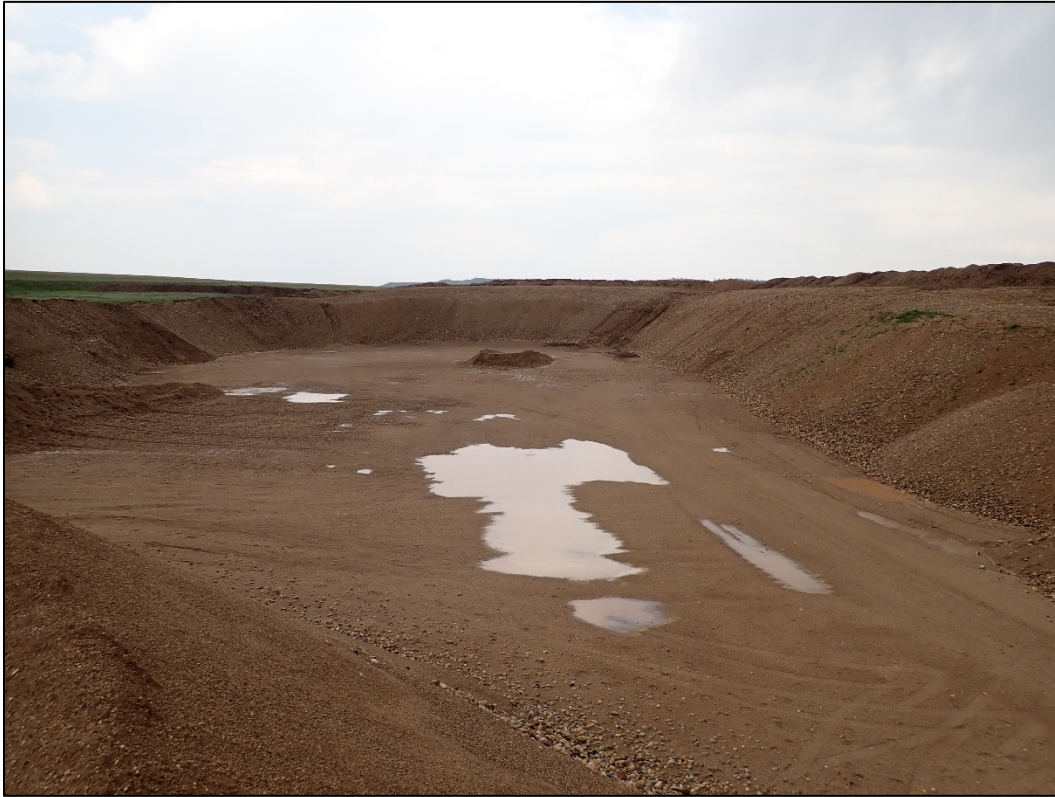
Photo 5. Excavation; looking north.

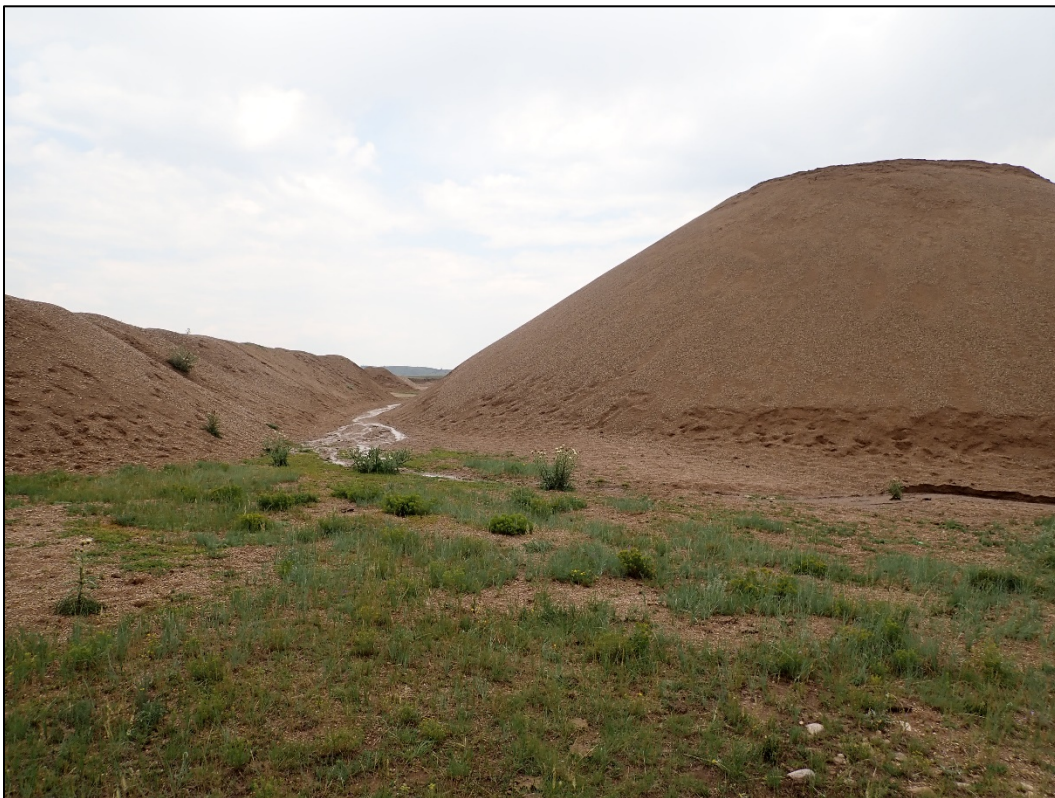
Photo 6. Fines stockpile (right) with storm water channel issue; looking north.

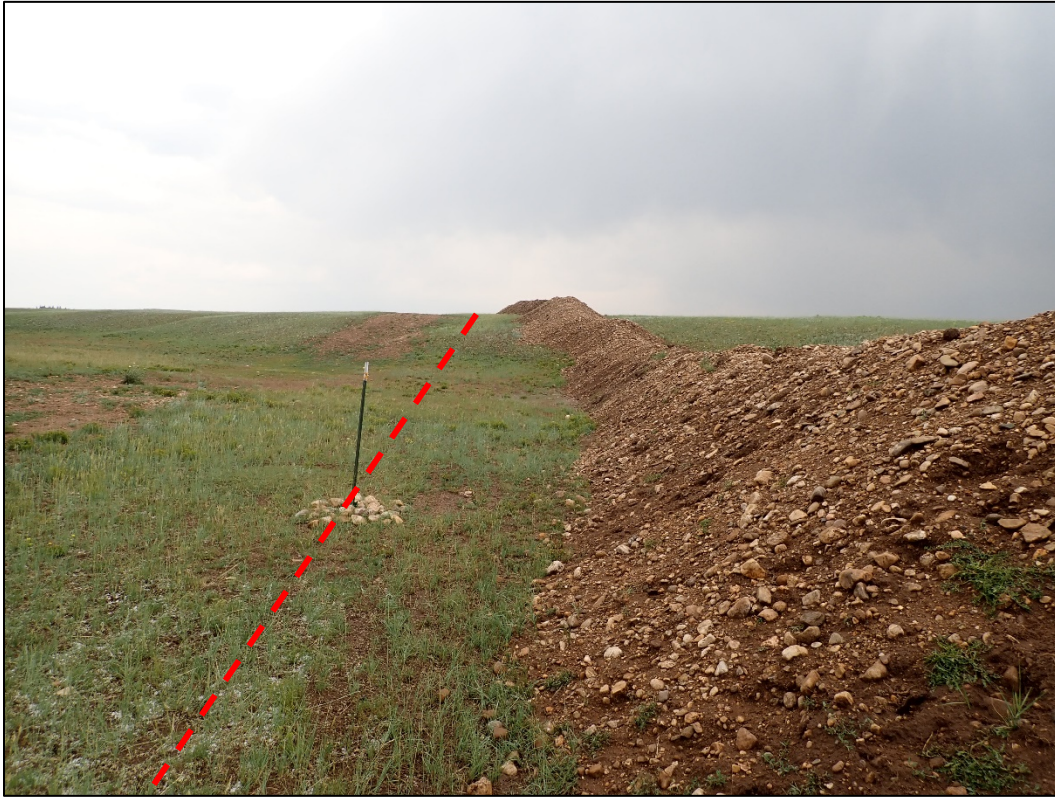
COMPLIANCE PROBLEM #3: The topsoil stockpiles do not have established vegetation on them and are therefore susceptible to erosion. Rule 3.1.9(1) states if topsoil is not replaced into the backfill area within a time short enough to avoid deterioration of the topsoil, vegetative cover or other means shall be employed so that the topsoil is protected from erosion.

Topsoil: It appears the topsoil berms near the permit boundary have recently been placed in these locations and are yet to be stabilized with vegetation in accordance with Rule 3.1.9(1). This has been cited as Compliance Problem #3 requiring the Operator to seed the topsoil stockpiles with the approved reclamation seed mixture, summarized below. The corrective action deadline has been set for November 22, 2021 to allow for ideal early winter seeding.

Photo 7. Topsoil berm along northern permit boundary; looking east.

CORRECTIVE ACTIONS: The Operator shall seed the stockpiles with the seed mix that was submitted as part of the approved Reclamation Plan. The Operator shall demonstrate compliance by submitting seed tags, a bill of sale or photographs of seeding activities.

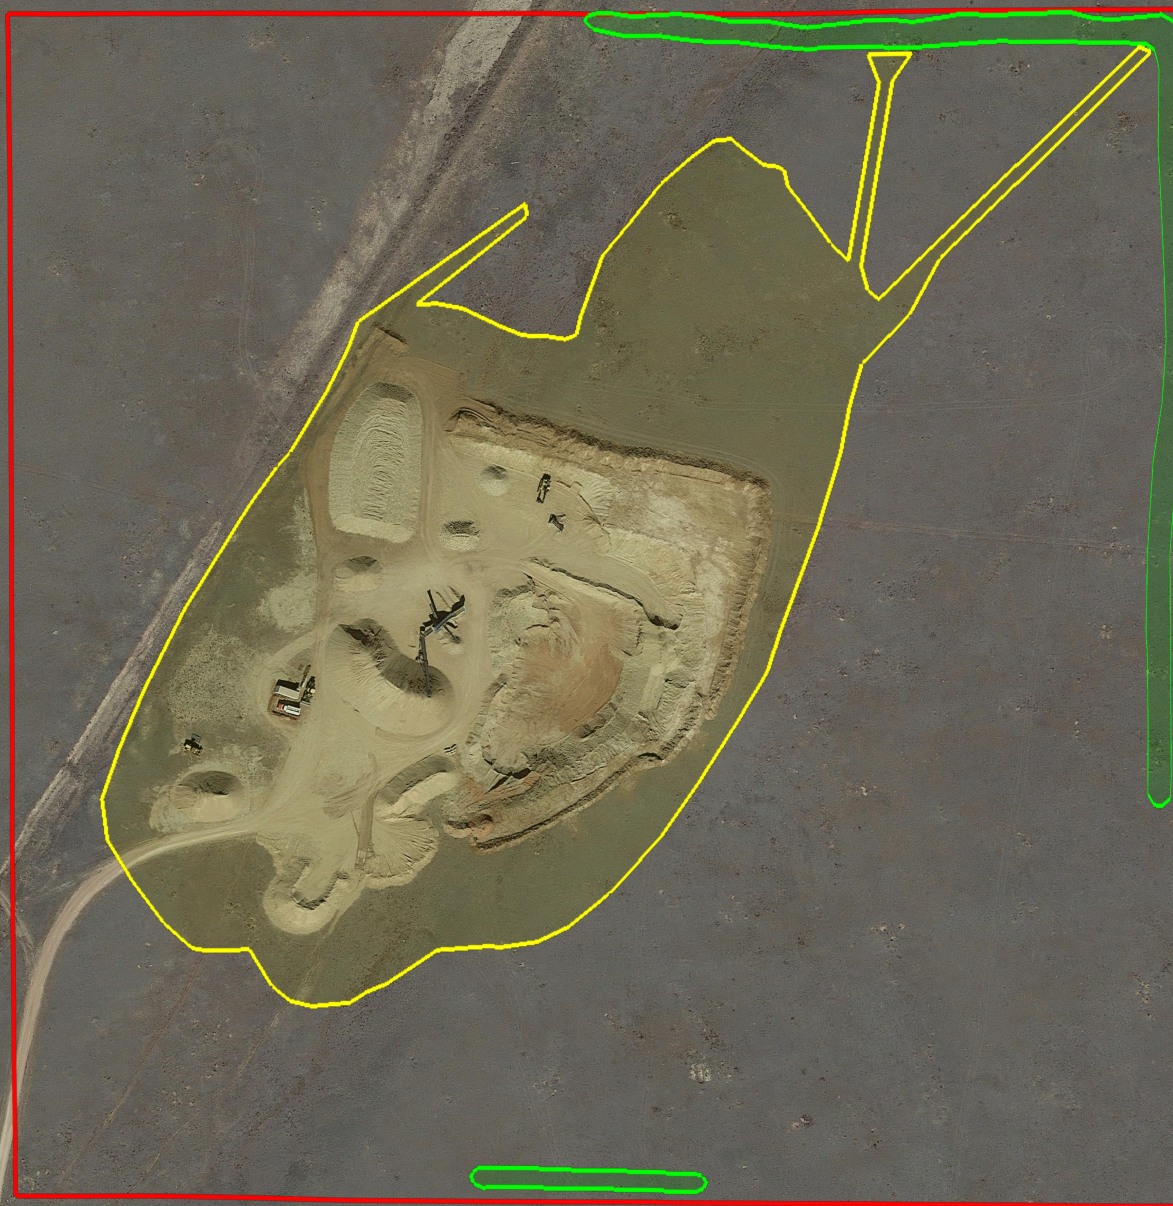
7-13-2021 Inspection Report Map

Gen. Compliance With Mine Plan: The approved mining plan has divided the permit into eight 5-acre phases. Technical Revision TR1 set the maximum disturbance to 5 acres of extraction area (one phase) and 5 acres in reclamation (an additional phase). The Division acquired GPS data with a Trimble Juno 3B unit and used the data, observations made during the inspection, and Google Earth to determine the Operator has disturbed approximately 13 acres; please see the attached *7-13-2021 Inspection Report Map M2000088*. The Operator is currently not following the phased mining plan and the current disturbance is located in portions of several mine phase blocks. This has been cited as Compliance Problem #1 requiring the operator to submit a Technical Revision to update the approved mining plan. After the inspection, the Division discussed the issue with Mr. Regester. It is the Division's understanding that the required Technical Revision will remove the phases and the Operator will now commit to an acreage-limited plan, setting the maximum allowed disturbance at any one time within the permit boundary to 15 acres.
