MINERALS PROGRAM INSPECTION REPORT
PHONE: (303) 866-3567

MINE NAME: Revenue Mine	MINE/PROSPECTING ID#: M-2012-032	MINERAL: Lead, silver and gold	COUNTY: Ouray
INSPECTION TYPE: Monitoring	INSPECTOR(S): Lucas West	INSP. DATE: July 6, 2021	INSP. TIME: 10:45
OPERATOR: Ouray Silver Mines Inc.	OPERATOR REPRESENTATIVE: Todd Jesse, Michelle Robbins	TYPE OF OPERATION: 112d-1 - Designated Mining Operation	
REASON FOR INSPECTION: Normal I&E Program	BOND CALCULATION TYPE: None	BOND AMOUNT: \$476,269.41	
DATE OF COMPLAINT: NA	POST INSP. CONTACTS: None	JOINT INSP. AGENCY: None	
WEATHER: Clear	INSPECTOR'S SIGNATURE:

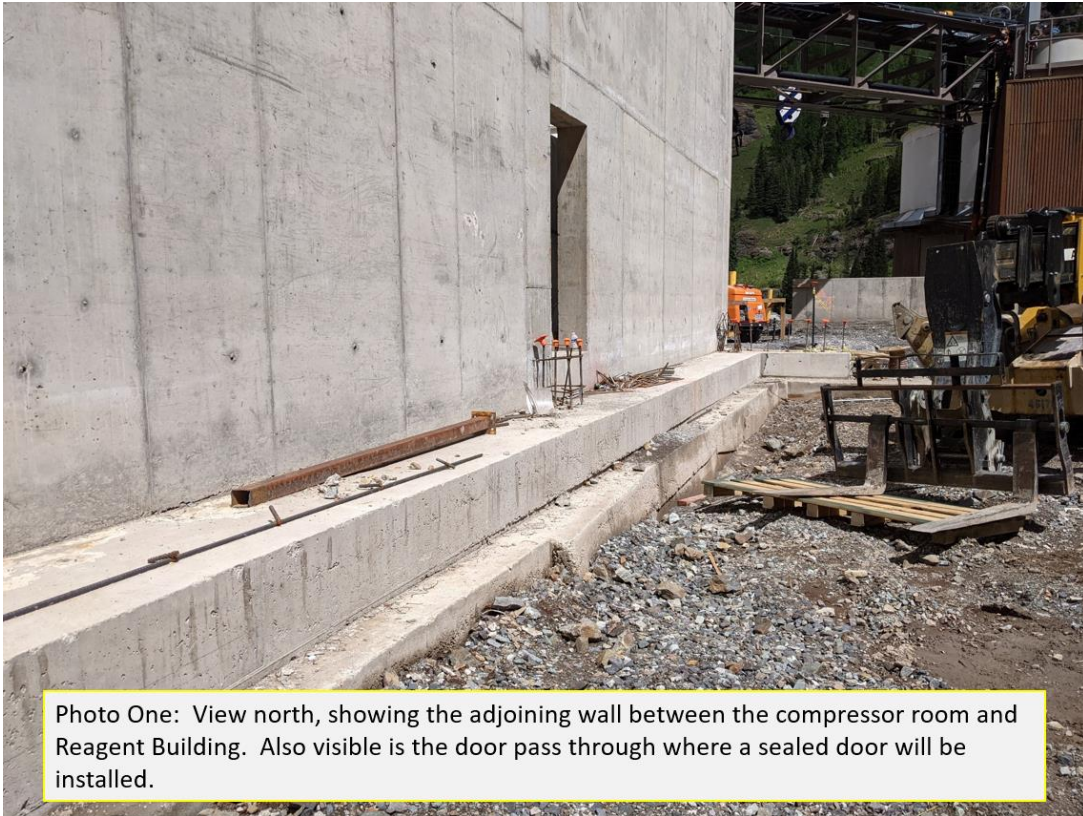
Photo One: View north, showing the adjoining wall between the compressor room and Reagent Building. Also visible is the door pass through where a sealed door will be installed.

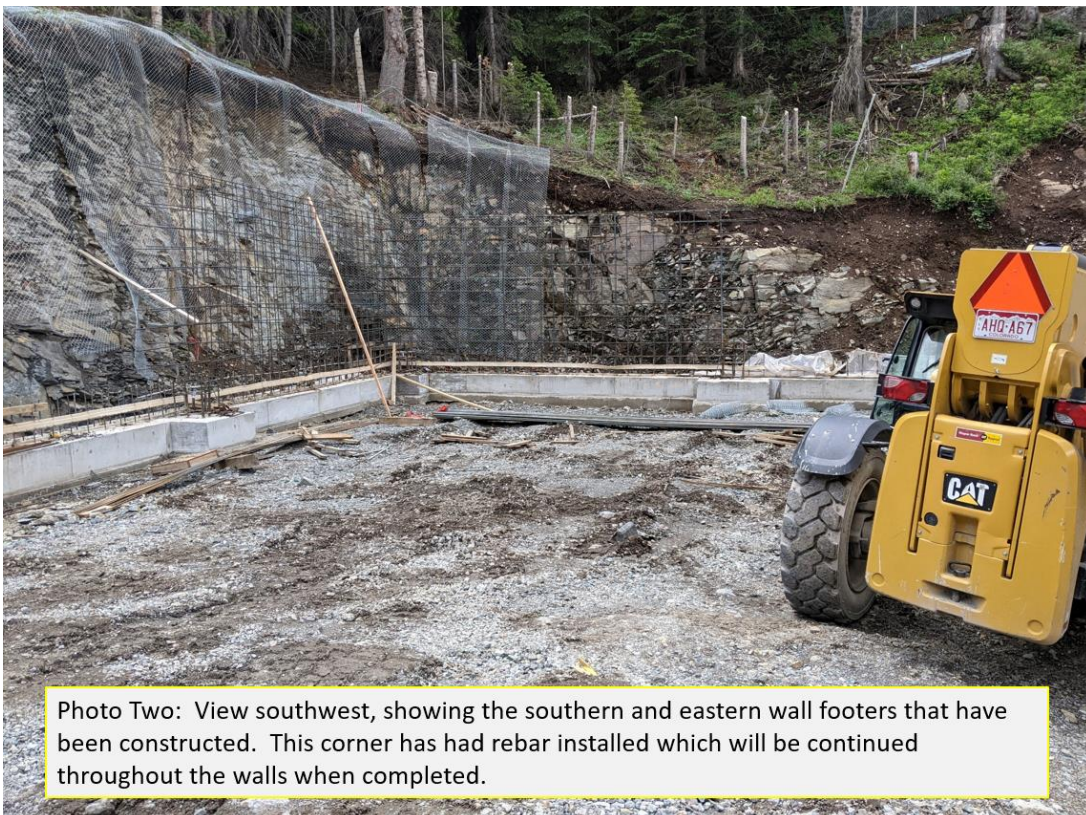
TR-14 was submitted by the Operator for the construction and certification of the Reagent Room, a designated Environmental Protection Facility. The Room will be a concrete floored, steel and concrete framed containment room used for the storage and mixing of reagent chemicals to be used in the milling process. The Reagent Room abuts the partially constructed Compressor Room. This inspection focused on the pre-existing disturbance prior to the approval of TR-14. Those disturbances included the excavation of native material for location preparation, wall footers partial re-bar installation for the walls. As seen in Photos One through Three, footers for the exterior walls have been poured. The west wall between the compressor room and reagent room has been sealed in accordance with the approved designs. Along the southern and eastern walls, the re-bar has partially been constructed and appears to meet the design specifications.

Photo Two: View southwest, showing the southern and eastern wall footers that have been constructed. This corner has had rebar installed which will be continued throughout the walls when completed.

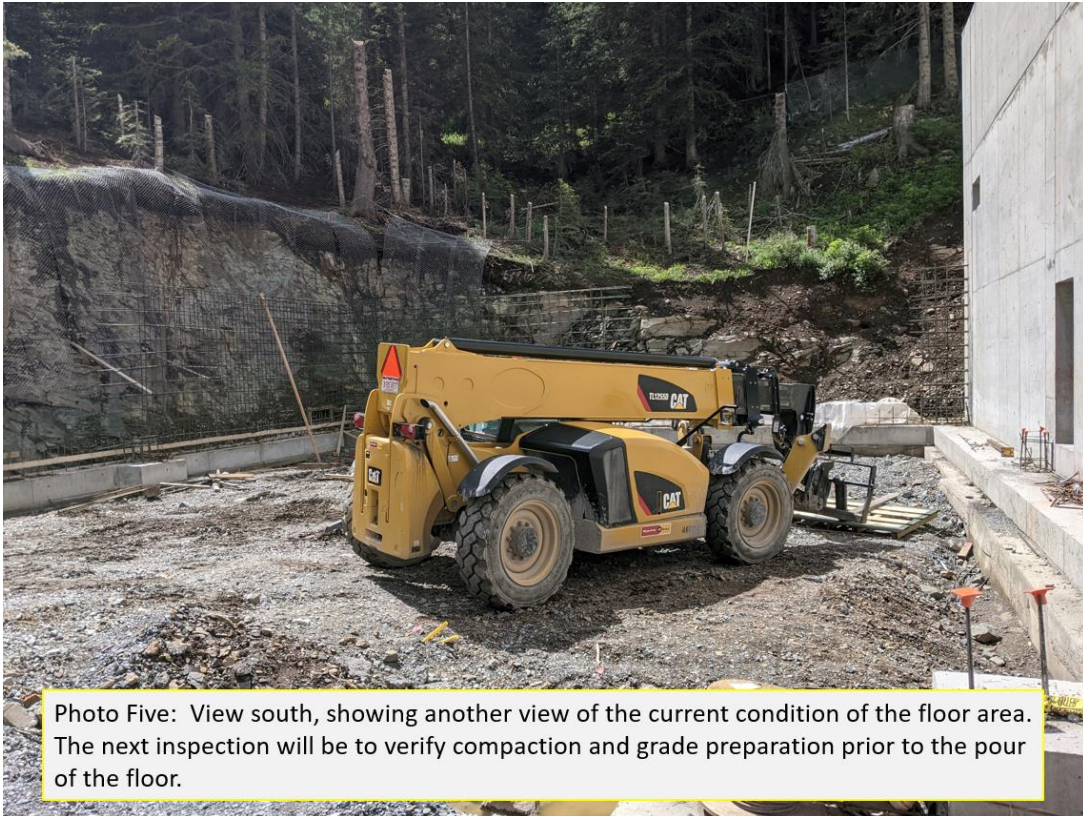
At the time of the inspection, materials were being stored in the area that will become the floor of the building and the proper excavations and concrete preparations for the slab have not been completed. In accordance with the plans the materials is to be excavated to bedrock, backfilled and compacted in preparation for the slab pour. Photos Four and Five show the floor in its current state at the time of the inspection. On site discussion with the Operator indicate that the floors and exterior walls will be poured at one time with all necessary QA/QC checks on the concrete to be completed and documented.

Photo Five: View south, showing another view of the current condition of the floor area. The next inspection will be to verify compaction and grade preparation prior to the pour of the floor.

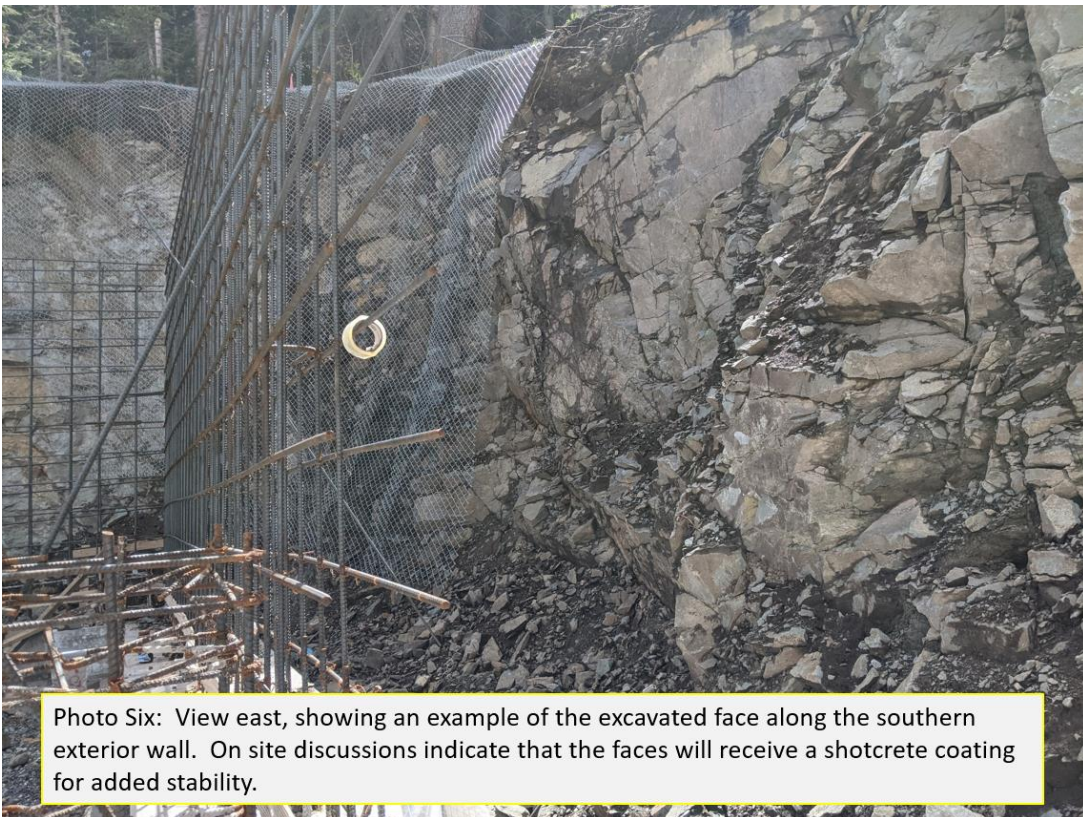
Along the East and South exterior walls, excavations were completed for site prep for the Reagent Room. The excavated hillslope is secured with chain link material to prevent material from falling down in the construction area. At the time of the inspection, no material was observed sloughing from the excavated face. On site discussions with the Operator indicate that the faces will receive a shotcrete coating for added stability. Photo Six shows an example of the excavated faces.

Photo Six: View east, showing an example of the excavated face along the southern exterior wall. On site discussions indicate that the faces will receive a shotcrete coating for added stability.
