MINERALS PROGRAM INSPECTION REPORT
PHONE: (303) 866-3567

MINE NAME: San Luis Project	MINE/PROSPECTING ID#: M-1988-112	MINERAL: Gold and silver	COUNTY: Costilla
INSPECTION TYPE: Multi Person Inspection	INSPECTOR(S): Lucas West	INSP. DATE: July 7, 2021	INSP. TIME: 09:00
OPERATOR: Battle Mountain Resources, Inc.	OPERATOR REPRESENTATIVE: Devon Horntvedt, Julio Madrid	TYPE OF OPERATION: 112d-3 - Designated Mining Operation	
REASON FOR INSPECTION: Normal I&E Program	BOND CALCULATION TYPE: None	BOND AMOUNT: \$7,400,000.00	
DATE OF COMPLAINT: NA	POST INSP. CONTACTS: None	JOINT INSP. AGENCY: None	
WEATHER: Clear	INSPECTOR'S SIGNATURE:

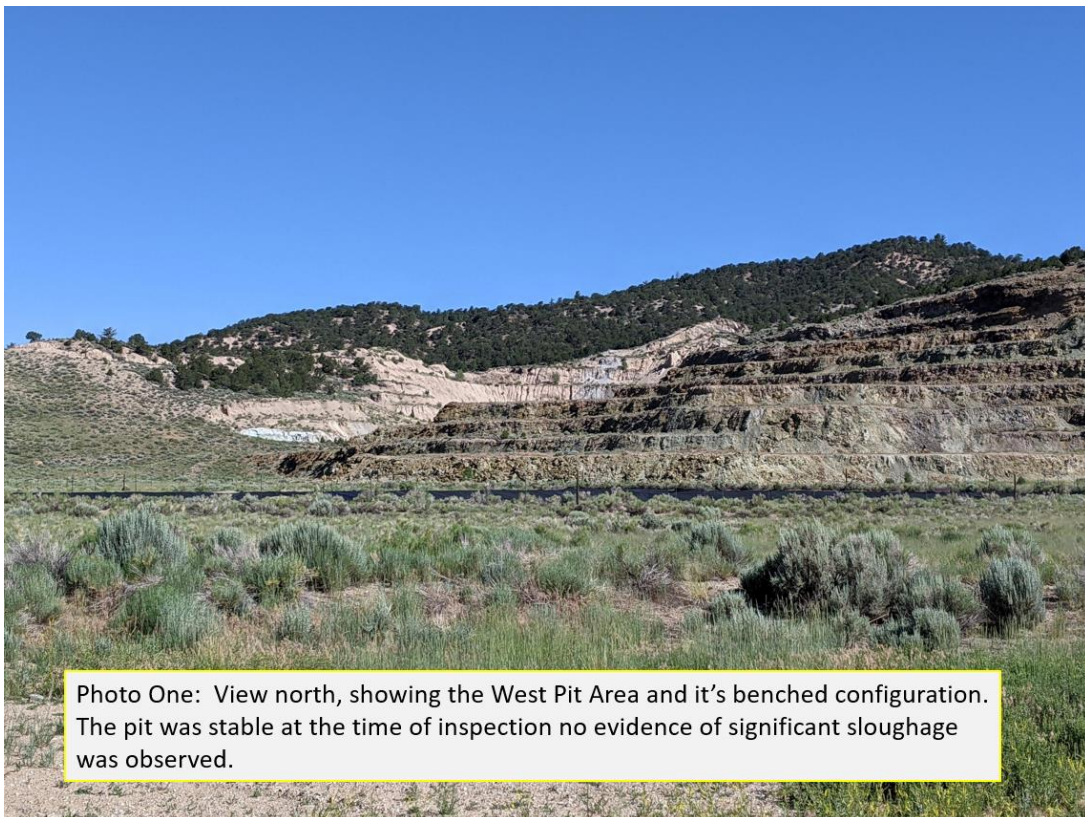
The West Pit area was observed and appeared to be stable at the time of the inspection. The pit area can be seen in Photo One. Adjacent to the West Pit area is the portion of the pit referred to as the Pink Gneiss Area. The walls of the area were stable at the time of the inspection and in good condition. The pit floor has been revegetated and is in excellent condition. The Pink Gneiss portion of the pit and the well vegetated pit floor can be seen in Photos Two and Three.

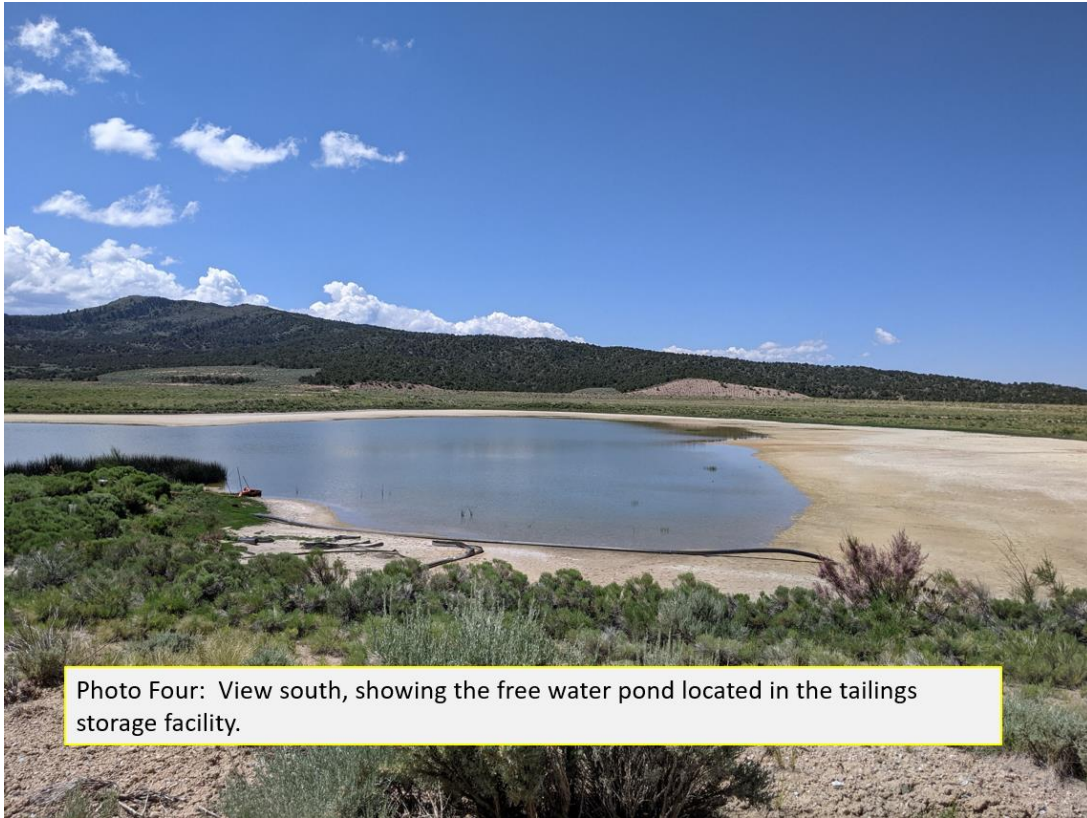
The tailings impoundment area appeared to be stable and in good condition. The free water pond located on top of the impoundment was observed, and the water levels are far below the maximum waterline that is outlined in the permit conditions. Photo Four shows the free water pond and surrounding vegetation. The other areas of the tailings impoundment are very well vegetated and appear to meet or exceed the conditions of the adjacent undisturbed areas. The maximum water line is designed to protect the main embankment from saturation which could lead to stability issues. The main embankment is well vegetated, appears to be stable and in good condition as seen in Photo Five. The tailings impoundment is a lined facility, complete with under drains and an HDPE Liner that extends from under the impoundment and the main embankment to the collection pond immediately down gradient. The underdrains, shown in Photo Six, convey water that has percolated through the tailings impoundment down to the collection pond, where it is then recirculated back to the free water pool. The under drain was observed discharging water into the collection pond, which indicates the liner, and all of its components are functioning as designed.

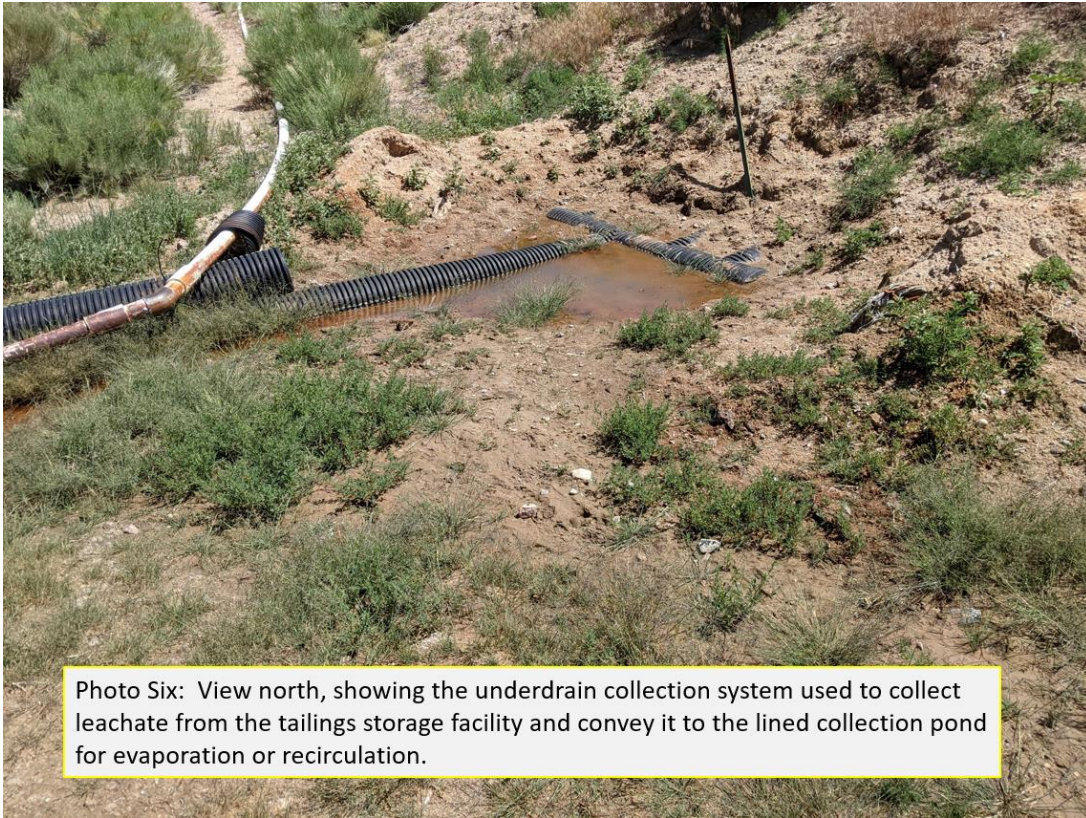
Photo Six: View north, showing the underdrain collection system used to collect leachate from the tailings storage facility and convey it to the lined collection pond for evaporation or recirculation.

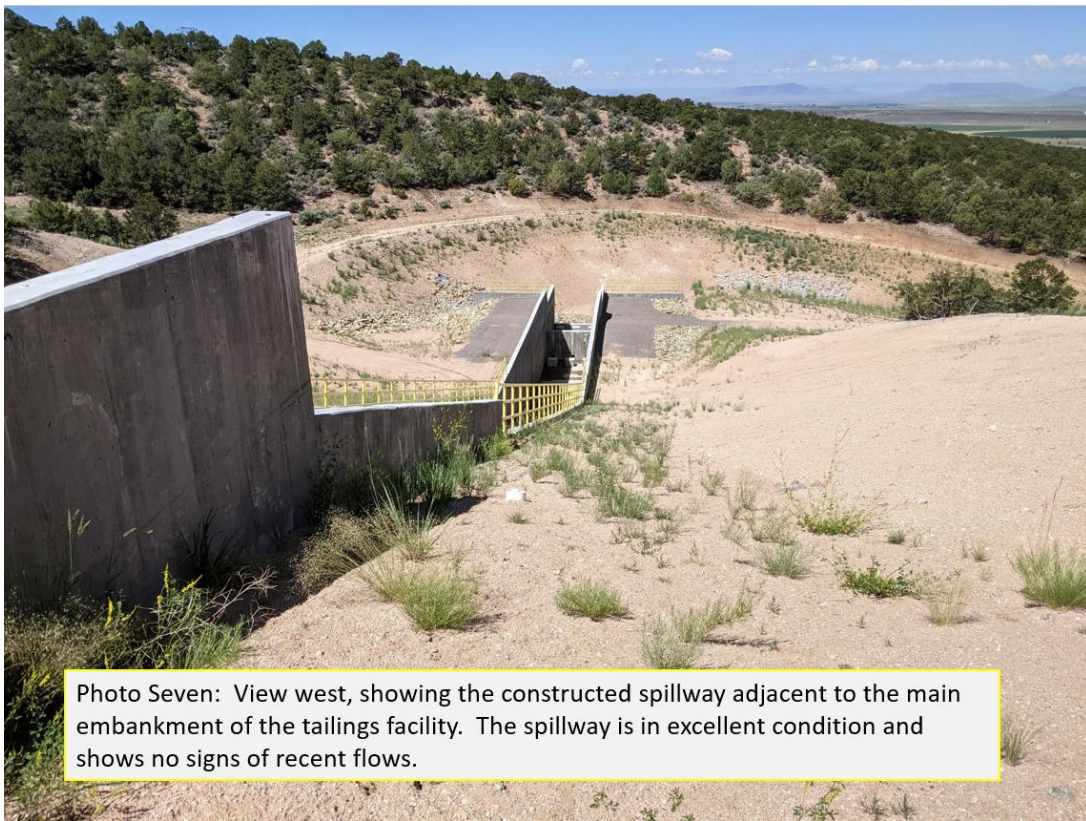
Adjacent to the tailings dam is the constructed spillway designed to convey storm water from the diversion ditch around the tailings storage facility and away from the main embankment. The spillway can be seen in Photo Seven. The spillway is in good condition and shows no evidence of recent flows. In the Arroyo,

Photo Seven: View west, showing the constructed spillway adjacent to the main embankment of the tailings facility. The spillway is in excellent condition and shows no signs of recent flows.
