July 22, 2021

RE: Specification Aggregates Quarry M-1974-004

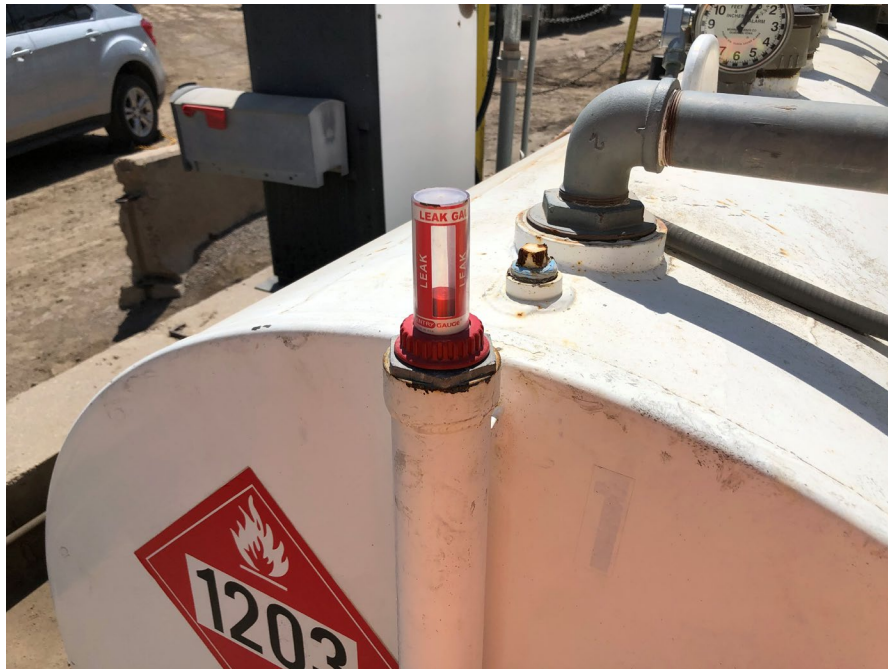
Leak detection on 1,000 gallon double-walled AST

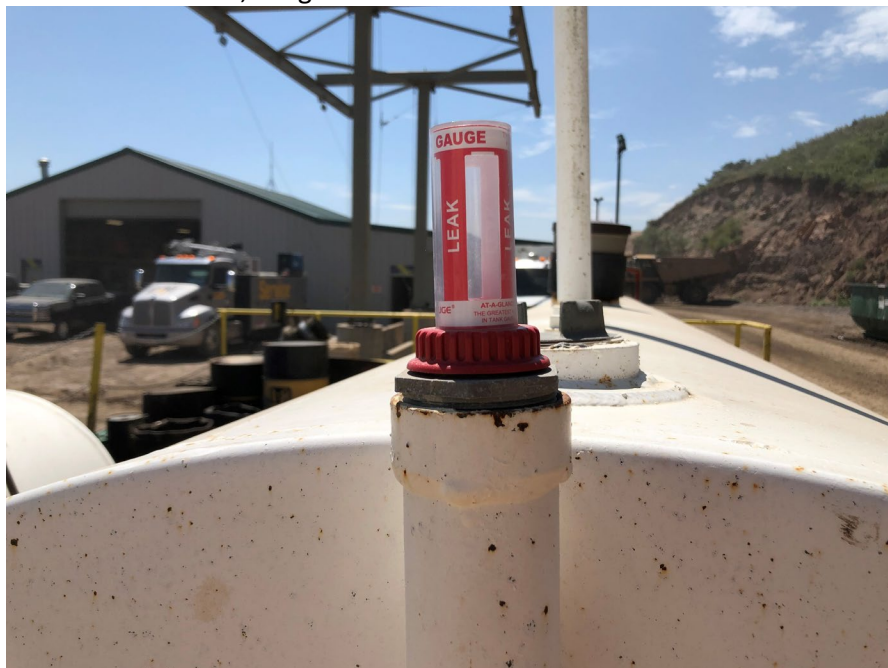
Leak detection on 3,000 gallon double-walled AST

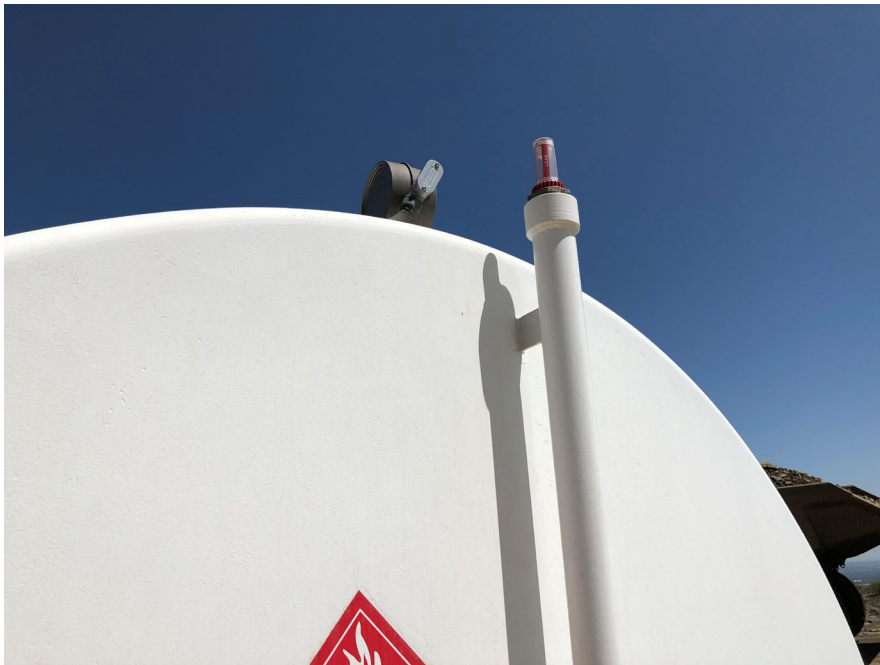
Leak detection on 12,000 gallon double-walled AST

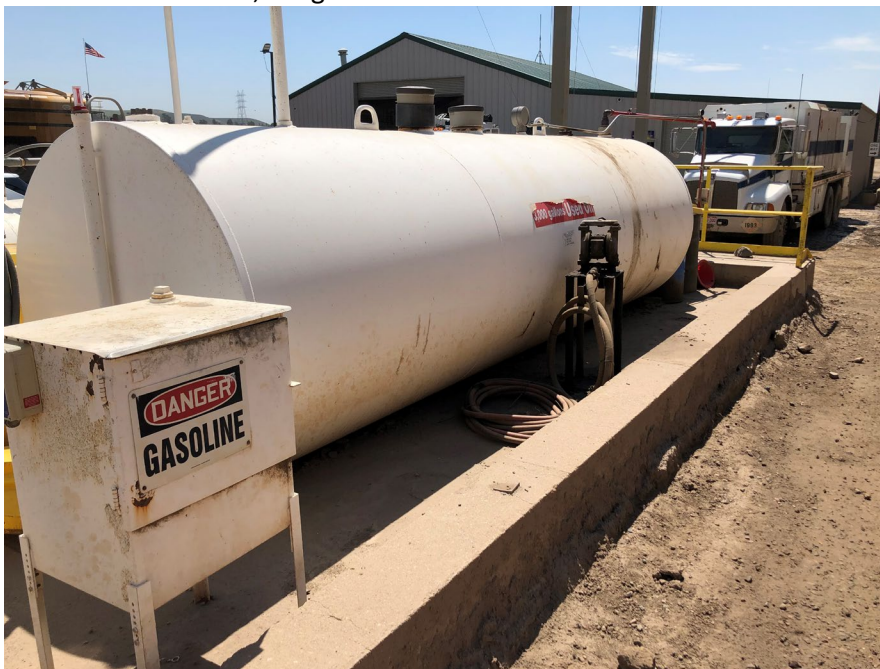
Containment structure

This quarry has a Spill Prevention, Control and Countermeasures ("SPCC") Plan prepared in accordance with 40 CFR 112 that includes the storage tanks and containment structure noted in the corrective action. The SPCC Plan concludes the containment structure measures 65 feet x 20 feet x 3.83 feet, yielding a containment volume of approximately 37,246 gallons. There are 3 Aboveground Storage Tanks ("AST") within this containment structure. All three are double-walled and the largest is 12,000 gallons. Attached are photos that show the leak detection on the 3 double-walled ASTs. The containment structure has adequate capacity to contain even a catastrophic failure of the full capacity of the largest tank, with substantial capacity for smaller containers that must be stored from time to time.

Still, Martin Marietta has removed a number of the small containers from the containment as shown in the final attached photo.
