MINERALS PROGRAM INSPECTION REPORT
PHONE: (303) 866-3567

MINE NAME: Mid-Continent LST	MINE/PROSPECTING ID#: M-1982-121	MINERAL: Limestone (general)	COUNTY: Garfield
INSPECTION TYPE: Monitoring	INSPECTOR(S): Amy Yeldell	INSP. DATE: July 26, 2021	INSP. TIME: 12:00
OPERATOR: RMR Aggregates, Inc.	OPERATOR REPRESENTATIVE: Justin Olin	TYPE OF OPERATION: 112c - Construction Regular Operation	
REASON FOR INSPECTION: Citizen Complaint	BOND CALCULATION TYPE: None	BOND AMOUNT: \$366,179.00	
DATE OF COMPLAINT: NA	POST INSP. CONTACTS: DRMS	JOINT INSP. AGENCY: None	
WEATHER: Clear	INSPECTOR'S SIGNATURE:

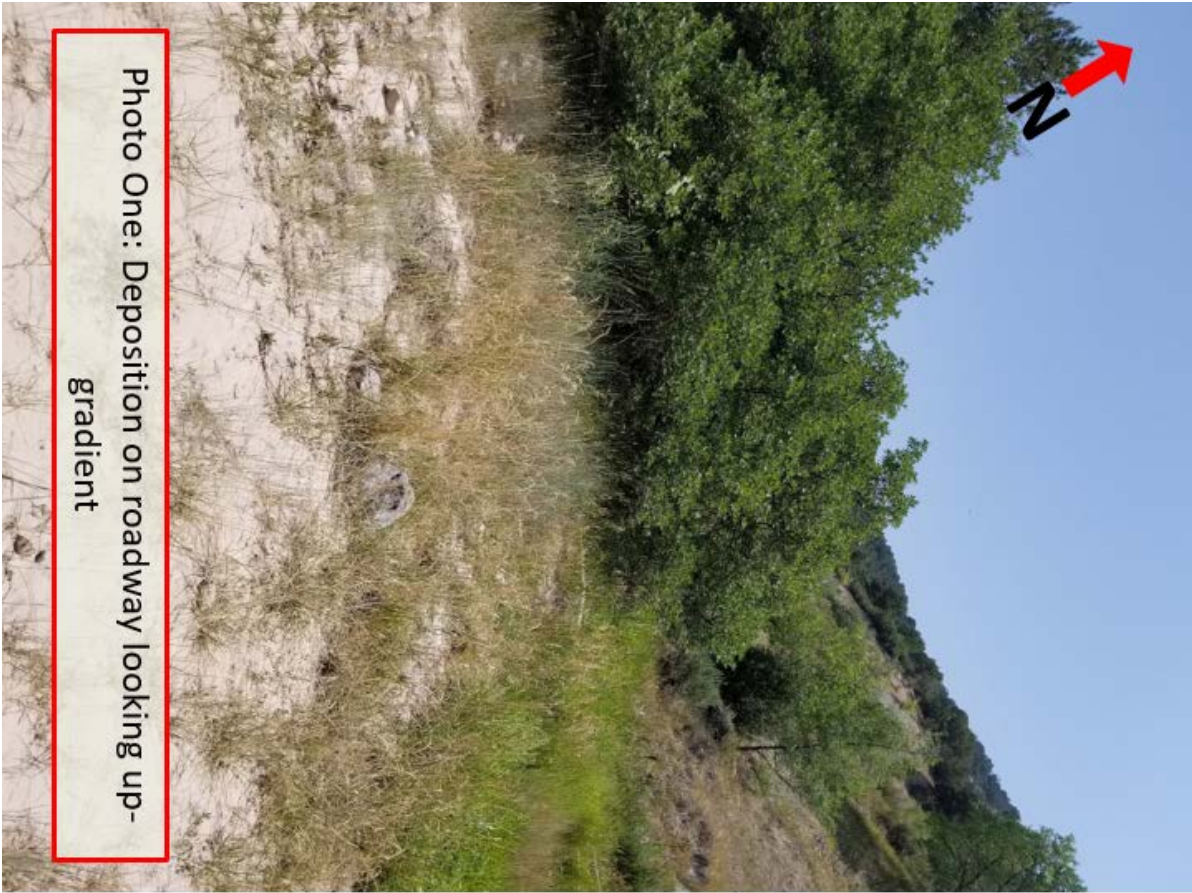
The Division first inspected the two Grasmere Lots (Parcel No. 218504310002 and 218504310001) located in Glenwood Springs, CO on the south side of Traver Trail Road. Mr. Grasmere was not present for the inspection as he lives out of State but he was informed that the Division would be conducting an inspection as part of the investigation process. The lots are accessed from the east via a two track road. A natural drainage way divides the two lots and this is the area of sediment deposition (photo one). At the time of the inspection water was observed trickling downgradient. Staff estimates the flow to be approximately 2-5 gallons per minute. There appears to be no culvert or other armored path for water to flow across the road. This has resulted in both road cutting and sediment deposition (photo two). At the time of the inspection water was limited to just the ditch but dried sediment deposition outside of the ditch was observed. The cut in the road was varied from 2 inches to over a foot deep.

Photo One: Deposition on roadway looking up-gradient

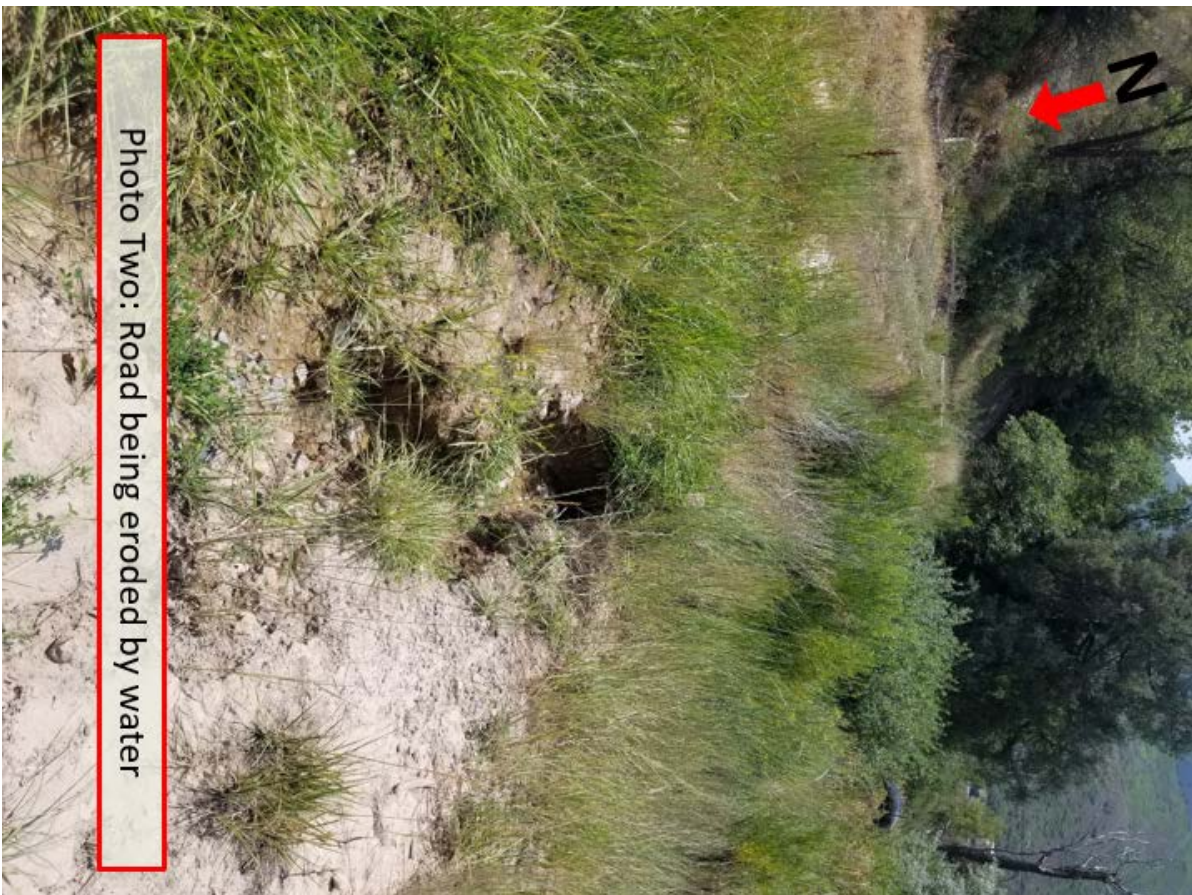
Photo Two: Road being eroded by water

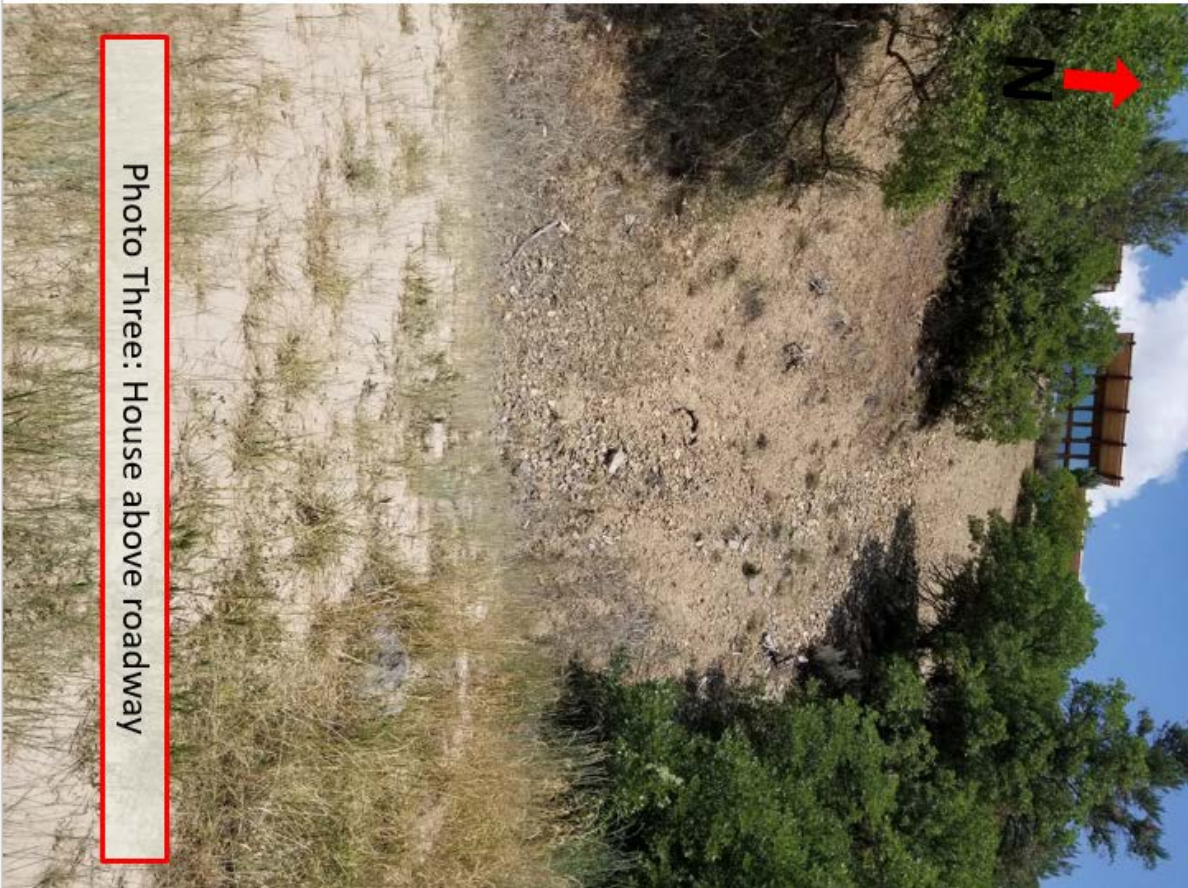
There is a house (Mr. and Mrs. Sims) with a bare rock hillside located approximately 70 feet above the road and directly to the northwest of the road (photo three). Though the sediment deposition extends to the hillside, given the presence of water the sediment is likely being carried from the draw rather than from the house site.

Photo Three: House above roadway

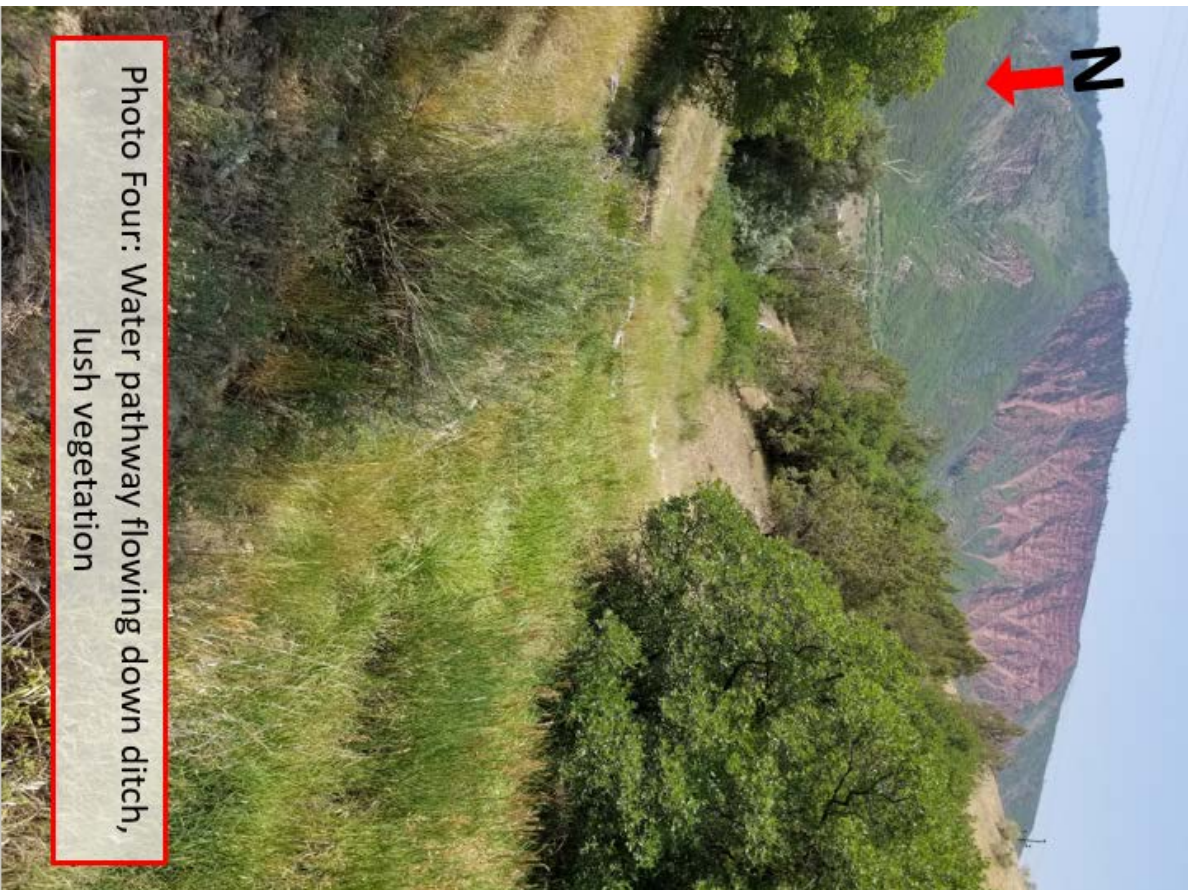
Photo Four: Water pathway flowing down ditch,
lush vegetation

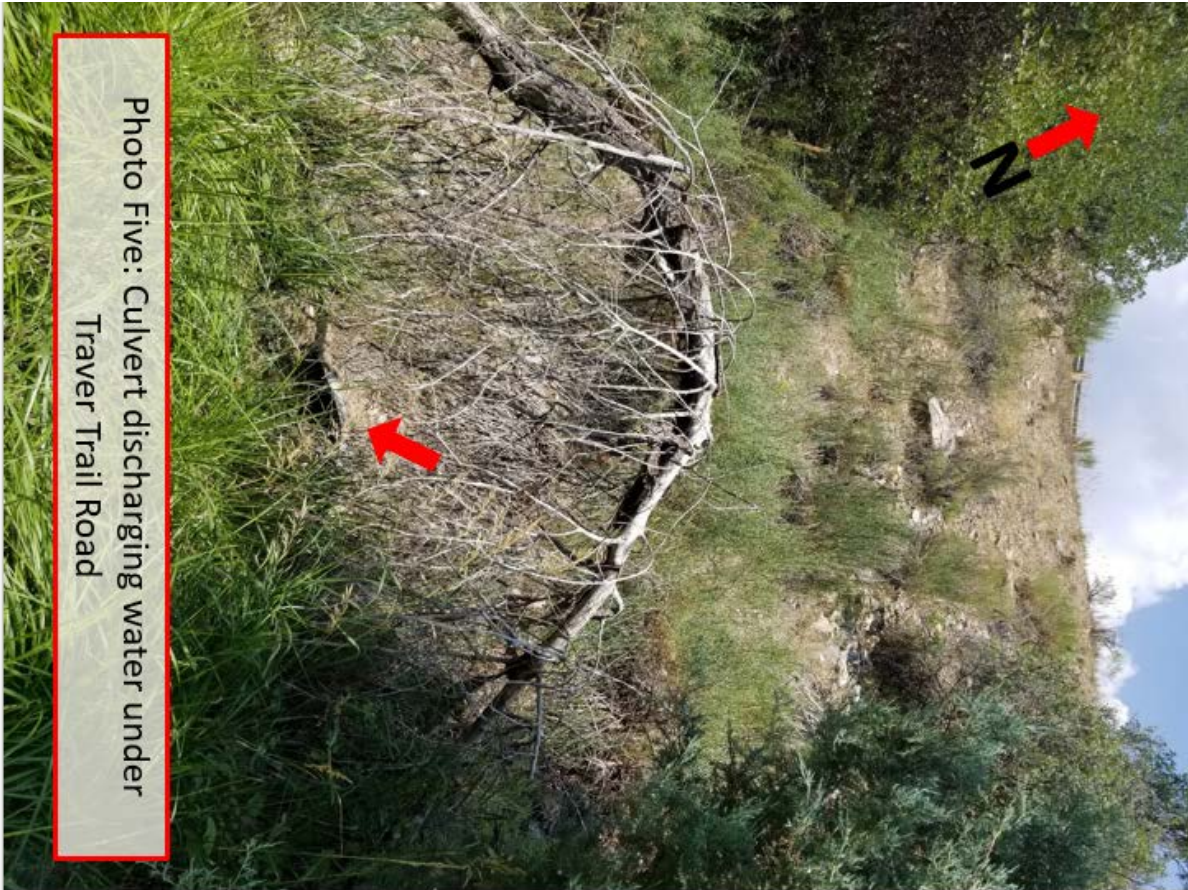
Division staff hiked up gradient towards the northeast to follow the water and attempt to find the source location. Beyond the Grasmere roadway up gradient the property is owned by City of Glenwood Springs on the east and Mr. and Mrs. Sims on the west until the Right of Way where Transfer Trail comes off of Traver Trail Road. Vegetation in the draw was indicative of seasonal water and is significantly lush than adjacent vegetation located on the hillside (photo four). The draw had sediment deposition from where water flowed through the lush grasses and around trees and rocks. At the top of the draw near the Right of Way were two culverts which carry water under Traver Trail Road from the north side to the south side. The eastern side culvert which starts on property owned by Iron Mountain Properties LLC was dry. The western side culvert which starts on property owned by Glenwood Caverns Holdings LLC was observed flowing. The Division would like to note that the culvert was mostly plugged with sediment and only the top few inches of what appears to be a 24 inch culvert was open (photo five).

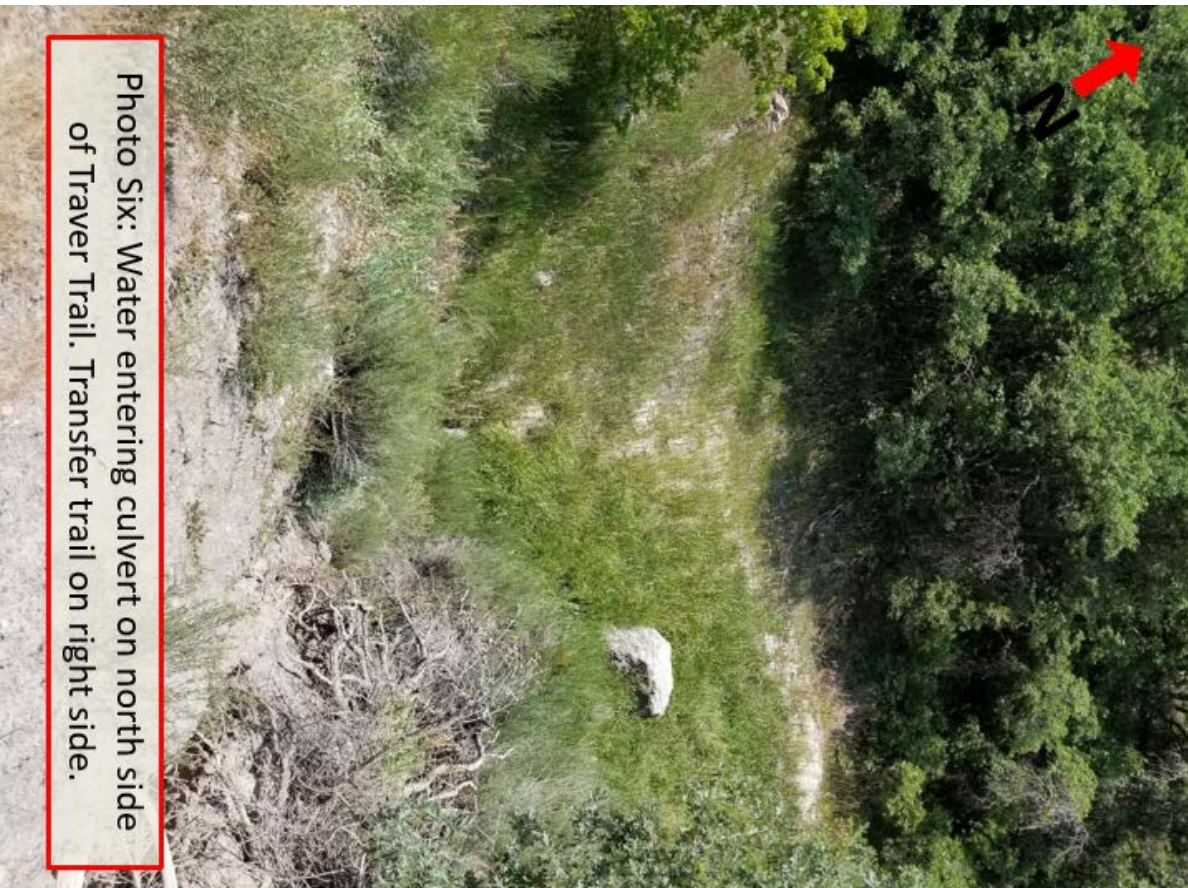
Next the Division followed the source of the water up the Transfer Trail Road towards the mine. As previously stated the culvert carries water from property owned by Glenwood Caverns Holdings LLC along Transfer Trail Road to the south (photo six). There appears to be a separate ditch, not associated with the road ditch that is carrying water. This ditch is on the west side of Transfer Trail Road and varies in size from over 10 feet wide in some spots to as little as 2 feet wide. Vegetation along this ditch is also indicative of frequent water. Approximately 860 feet up gradient from the culvert, the water enters the ditch from a drainage on the west side that comes out of the Oasis Creek Subdivision. Irrigation pipes are adjacent to the waters path as well as an abandoned gate valve where it goes uphill to the subdivision (photo seven). No water was observed flowing through the piping. Upon high flows it appears that the water extends beyond the ditch and will flow into the

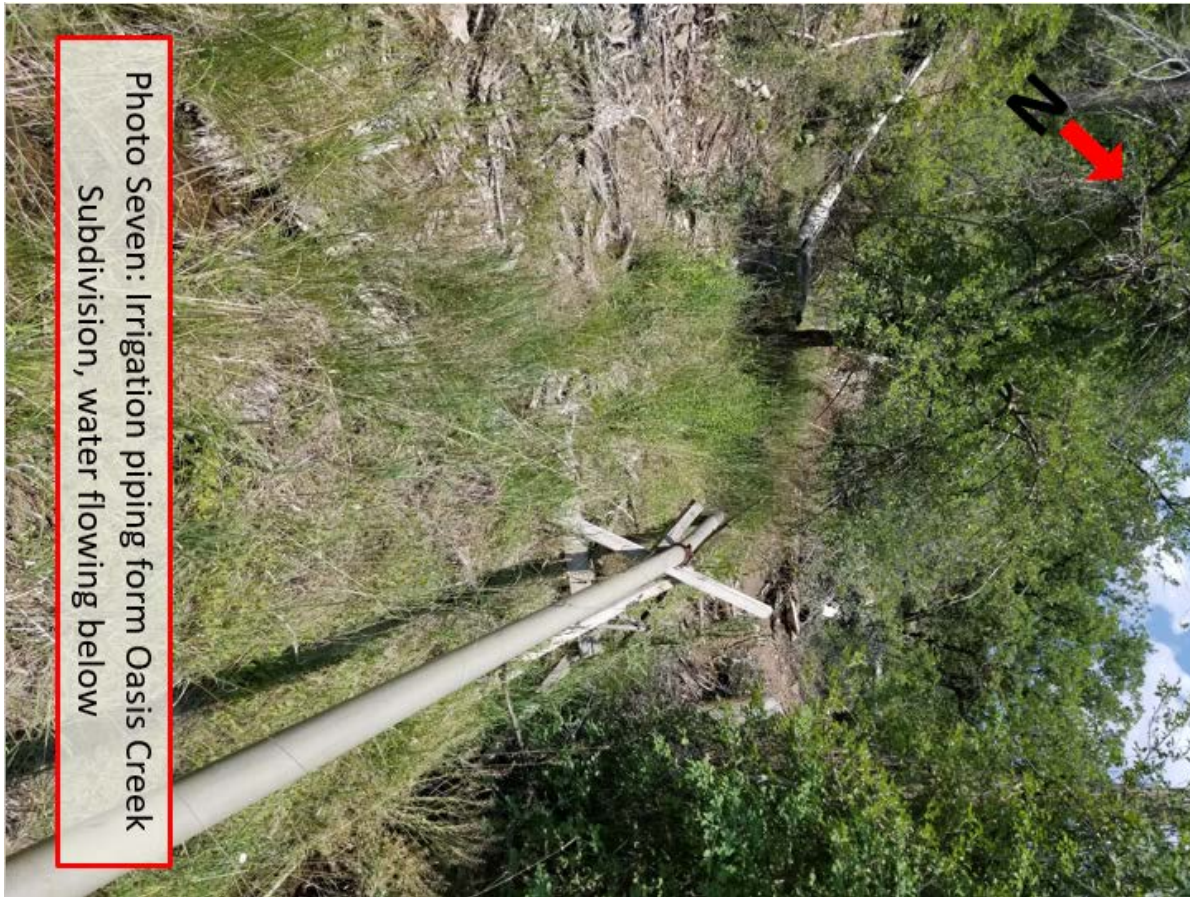
Photo Seven: Irrigation piping form Oasis Creek
Subdivision, water flowing below

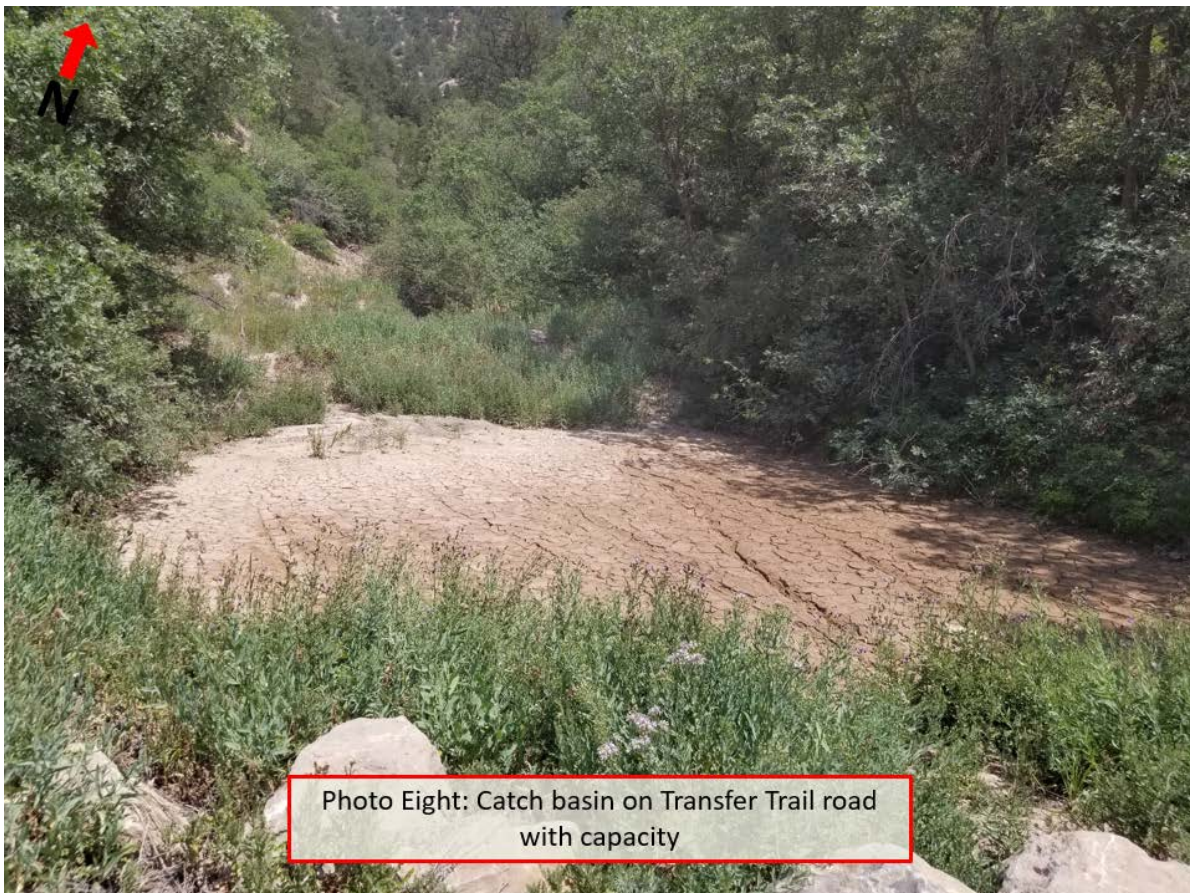
There is a catchment pond located on the north side of the first/lowest switch back (photo eight). Large boulders armor the hillside in the event that the catchment is overtopped and stormwater discharges into the ditch of the road along Transfer Trail Road. The rocks appear to be free of sediment indicating that the catchment has not recently overflowed. The catchment pond itself does have sediment as to be expected and as designed but has sufficient capacity for future stormwater events.

Photo Eight: Catch basin on Transfer Trail road
with capacity

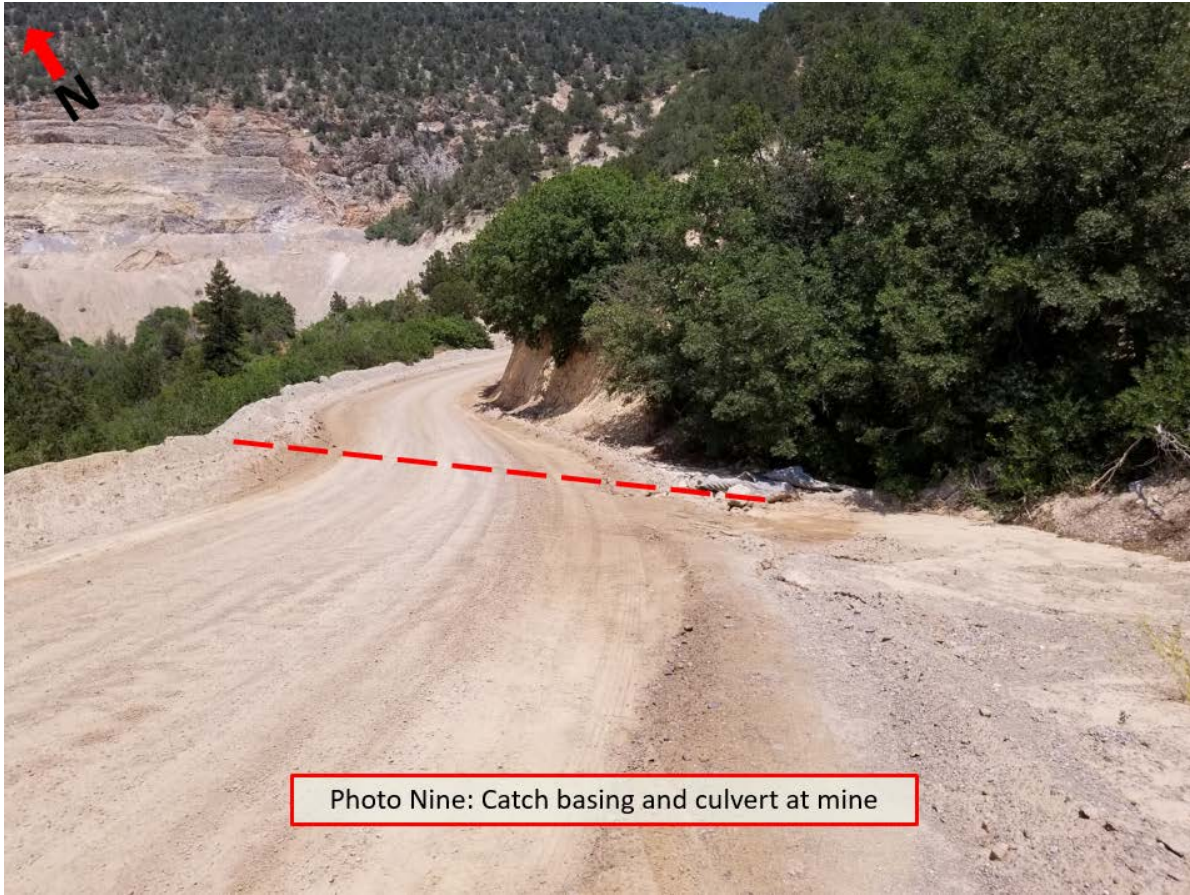
Finally the Division inspected stormwater features located within the permit boundary. Several sediment basins are located on the east or uphill side of the mine road. Culverts then carries water under the road where it discharges down the hill onto armored channels (photo nine). On the west or downgradient side of the road are catchment ponds to collect water flowing down the mine roads (photo ten). This water is collected, sediment drops out and water either infiltrates or flows through riprap and down the hillside. All of the stormwater BMP's along the mine road appear to be functioning effectively. No blow-outs or failures were observed. All catchments had sediment which indicates that they are functioning. The Division does recommend installation of rock check-damns in the ditches of the roads to slow water down and prevent cutting prior to water hitting the catchments. This would be an improvement to the existing BMP system but not a requirement.

Photo Nine: Catch basing and culvert at mine

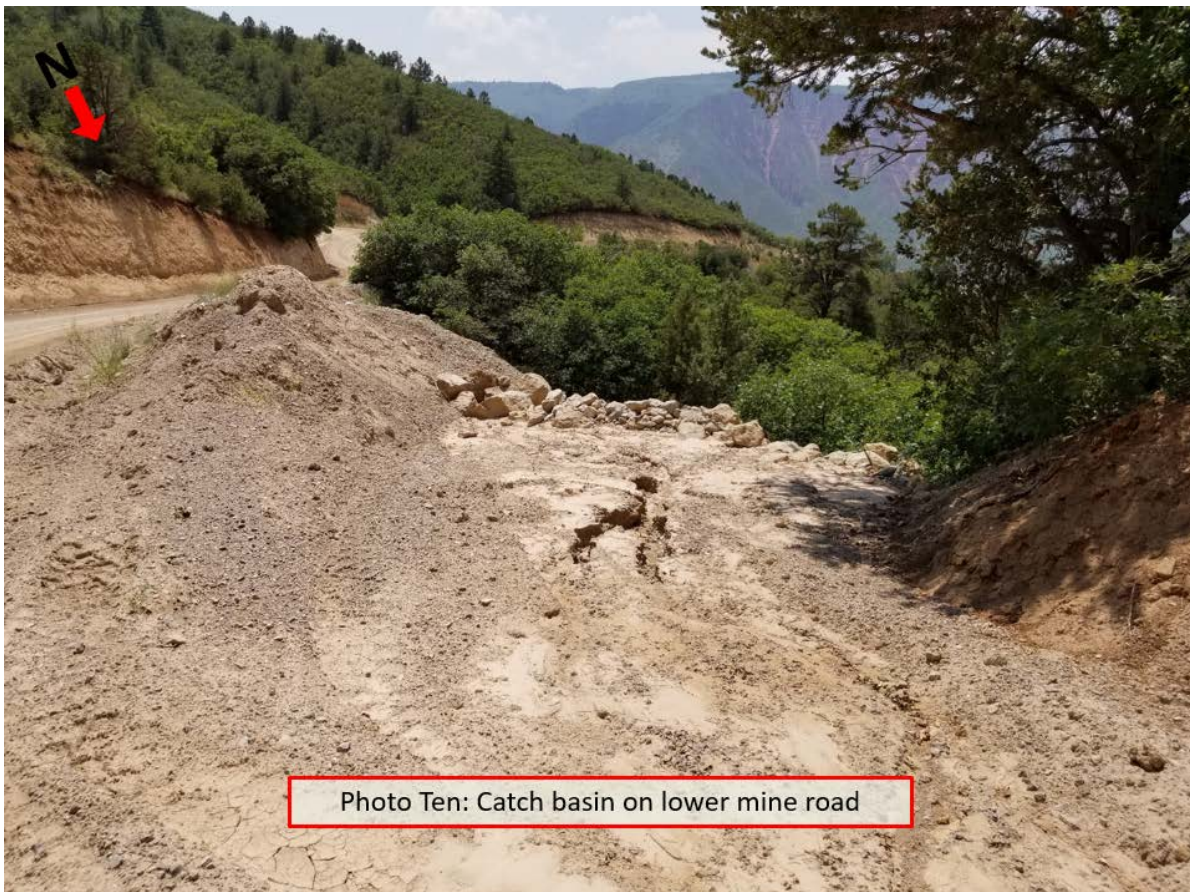
Photo Ten: Catch basin on lower mine road

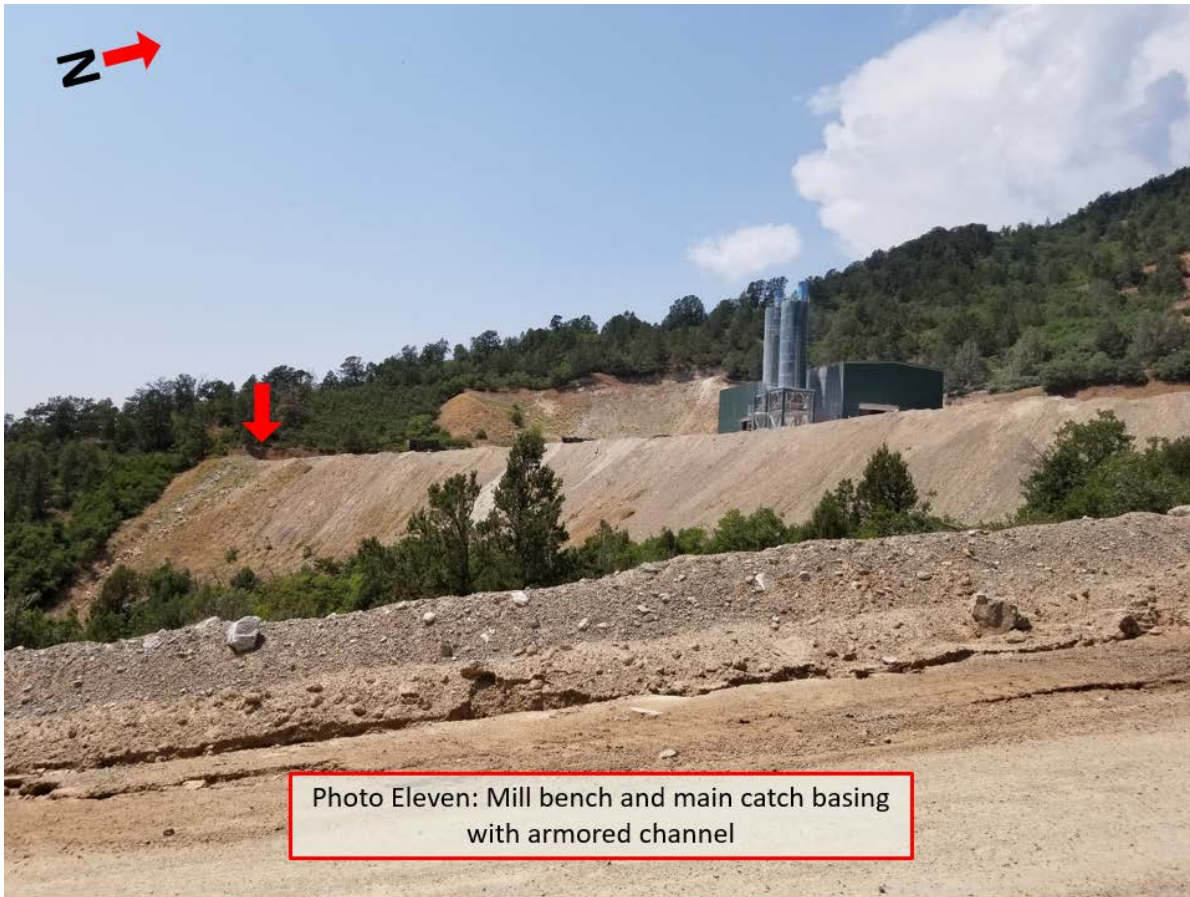
All sediment and stormwater from the production bench (highwall and processing area) flows downgradient along the roadside ditches and/or onto the mill bench. On the southwest corner is the sites main sediment pond (photo eleven). It is approximately 20 feet by 30 feet. Water either infiltrates or flows down an armored channel into the gulch that Transfer Trail follows. The sediment pond has sufficient capacity and does not require any clean out maintenance at this time (photo twelve). Staff inspected the berming for and signs of failures. No areas where stormwater could leak through the berm or had cut is were observed nor did appear that water had overtopped it in recent storms. The channel armoring down the hillside appeared to be in good working order. The armored channel was not full of sediment, nor was any undercutting observed.
