MINERALS PROGRAM INSPECTION REPORT
PHONE: (303) 866-3567

MINE NAME: Revenue Mine	MINE/PROSPECTING ID#: M-2012-032	MINERAL: Lead, silver and gold	COUNTY: Ouray
INSPECTION TYPE: Monitoring	INSPECTOR(S): Lucas West	INSP. DATE: July 12, 2021	INSP. TIME: 11:00
OPERATOR: Ouray Silver Mines Inc.	OPERATOR REPRESENTATIVE: Todd Jesse	TYPE OF OPERATION: 112d-1 - Designated Mining Operation	
REASON FOR INSPECTION: Normal I&E Program	BOND CALCULATION TYPE: None	BOND AMOUNT: \$476,269.41	
DATE OF COMPLAINT: NA	POST INSP. CONTACTS: None	JOINT INSP. AGENCY: None	
WEATHER: Clear	INSPECTOR'S SIGNATURE:

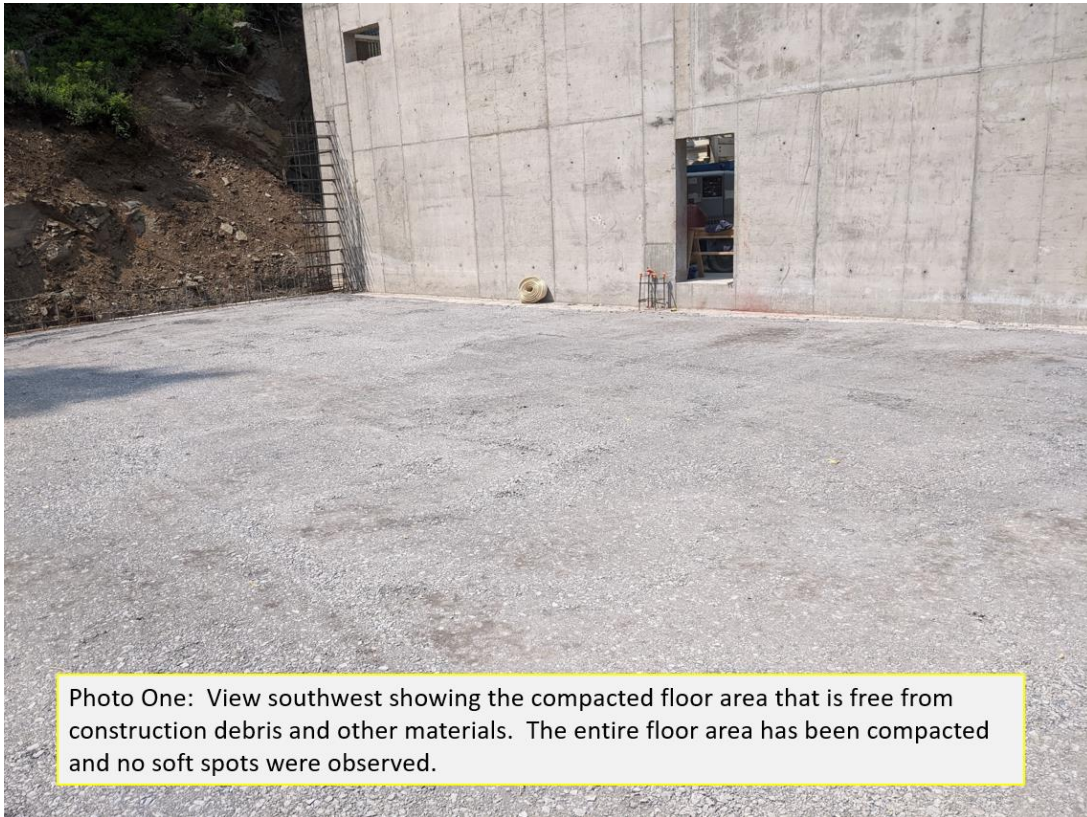
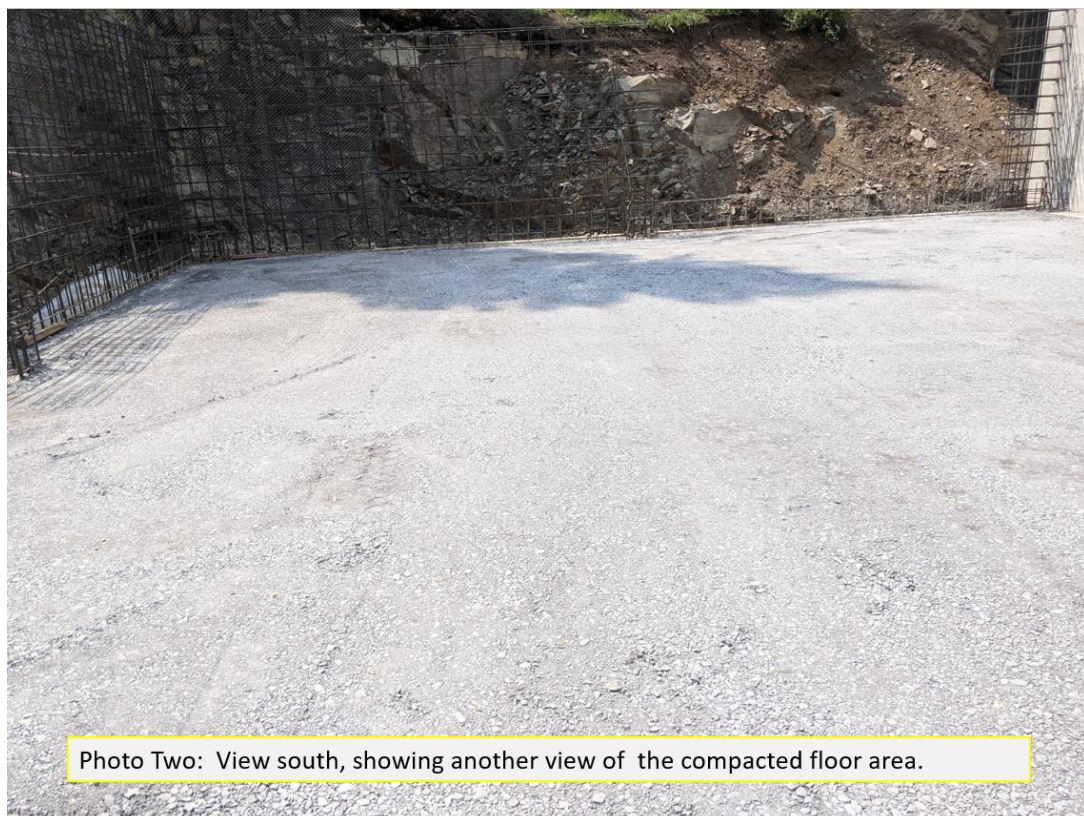
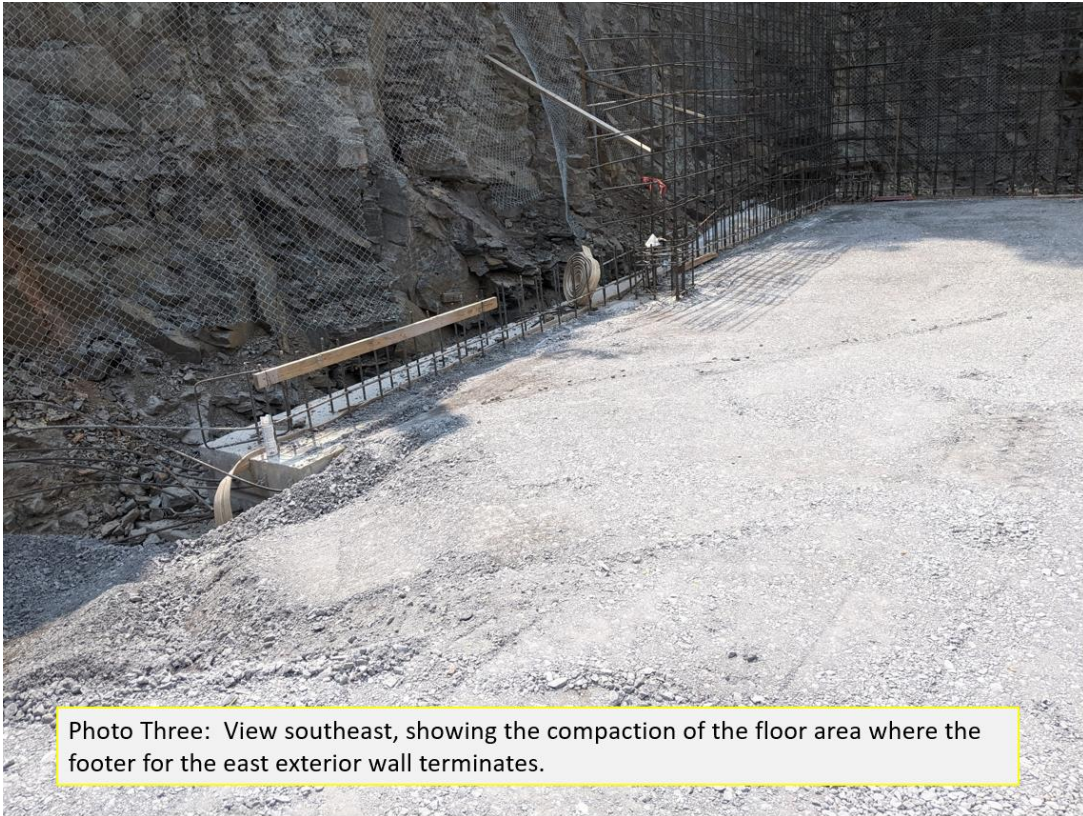
The focus of this inspection was to observe the conditions of the excavation and compaction of the floor area, on which the slab will be poured for the Reagent Room. The plans call for the area to be excavated to bedrock, backfilled and compacted prior to the pour. As seen in Photos One through Three, the floor area has been cleared of all construction debris, excavated and compacted with native material. Visually, the compaction appears to be consistent across the area and no soft spots or areas of settling were noted. Material has been backfilled and compacted on grade with the footers for the exterior walls as seen in Photos Four and Five.

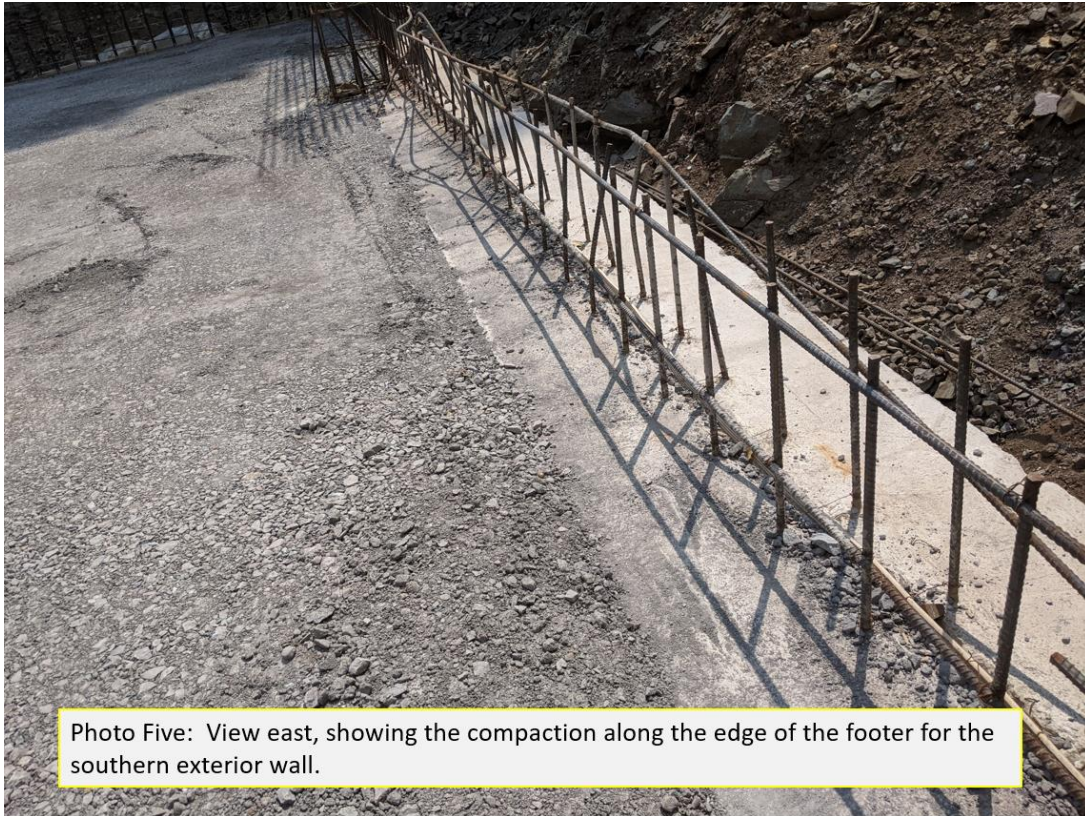
Photo Five: View east, showing the compaction along the edge of the footer for the southern exterior wall.
