PERMIT INFORMATION

Permit Number: C-1981-038 Mine Name: Bowie No. 1 Mine Operator: Bowie Resources, LLC Operator Address: Mr. Basil R Bear P.O. Box 1488 Paonia, CO 81428	County: Delta Operation Type: Underground Permit Status: Active Ownership: Private
	Operator Representative Present: None
Operator Representative Signature: (Field Issuance Only)

INSPECTION INFORMATION

Inspection Start Date: July 30, 2021 Inspection Start Time: 11:11 Inspection End Date: July 30, 2021 Inspection End Time: 11:13		Inspection Type: Aerial Inspection Inspection Reason: Normal I&E Program Weather: Clear	
Joint Inspection Agency: None		Joint Inspection Contacts:	
Post Inspection Agency: None		Post Inspection Contacts:	
Inspector(s): Robert Zuber, P.E. Brock Bowles	Inspector's Signature:

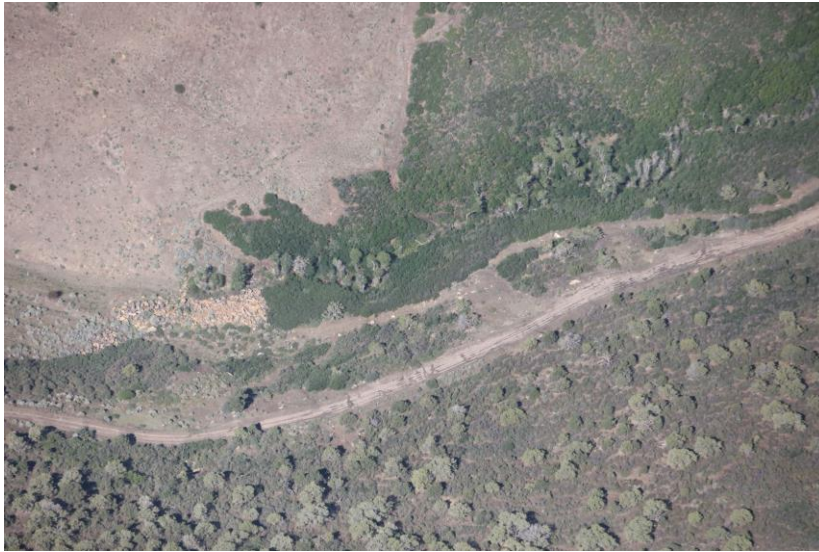
The West Mine was inspected, including the buttress at the northeast corner.

No erosion problems were identified.

Lower part of West Mine, including buttness

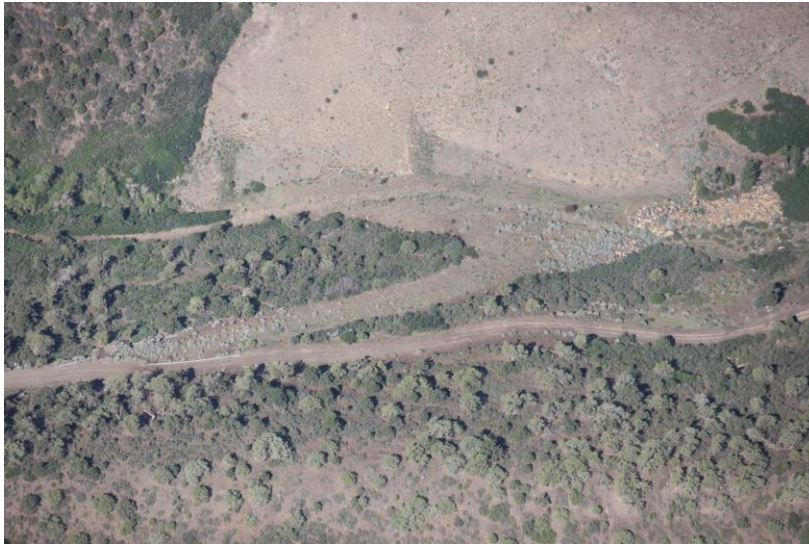
The ponds at the West Mine and the pond at the former coal storage area by Black Bridge Road appeared to be completely dry. No problems were seen with the embankments or other portions of these ponds. The pond at the loadout was not inspected.

West Mine ponds

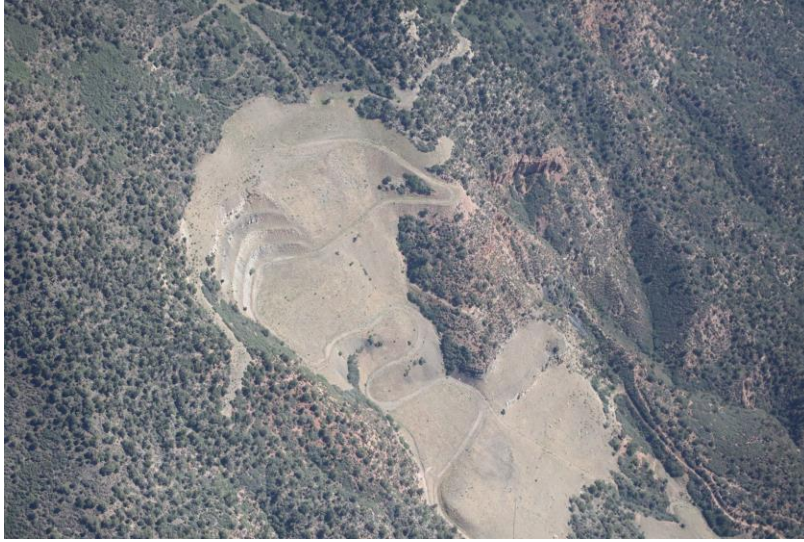
Upper part of East Mine

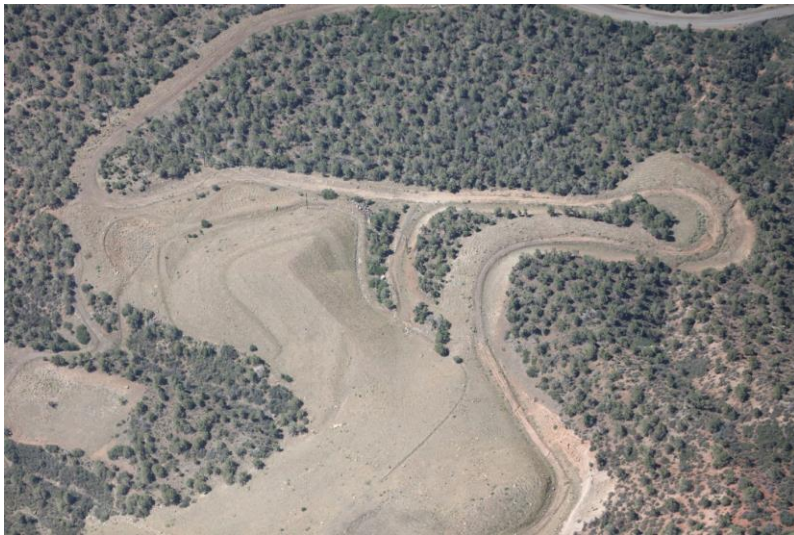
Lower part of East Mine

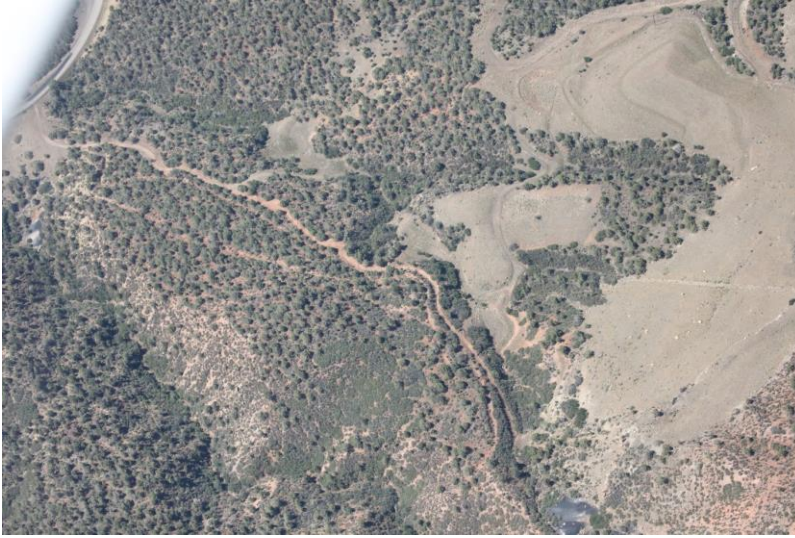
East Mine – Old Waste Disposal Area and reclaimed ponds

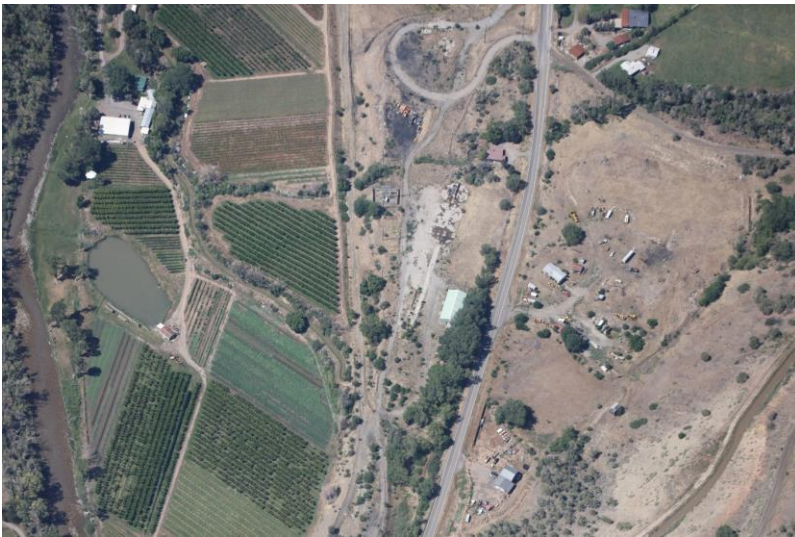
No erosion or other problems were identified at the loadout. This includes the eastern portion, along the UPRR tracks and adjacent to Grange Road and Black Bridge Road.

Loadout
