Inspection Reports

PERMIT INFORMATION

Permit Number: C-1996-083 Mine Name: Bowie No. 2 Mine Operator: Bowie Resources, LLC Operator Address: Mr. Basil Bear P.O. Box 1488 Paonia, CO 81428	County: Delta Operation Type: Underground Permit Status: Active Ownership: Private
	Operator Representative Present: None
Operator Representative Signature: (Field Issuance Only)

Inspection Start Date: July 30, 2021 Inspection Start Time: 11:14 Inspection End Date: July 30, 2021 Inspection End Time: 11:19		Inspection Type: Aerial Inspection Inspection Reason: Normal I&E Program Weather: Clear	
Joint Inspection Agency: None		Joint Inspection Contacts:	
Post Inspection Agency: None		Post Inspection Contacts:	
Inspector(s): Robert Zuber, P.E. Brock Bowles	Inspector's Signature: <i>Robert D. Zuber</i>		Signature Date: 8/1/2021

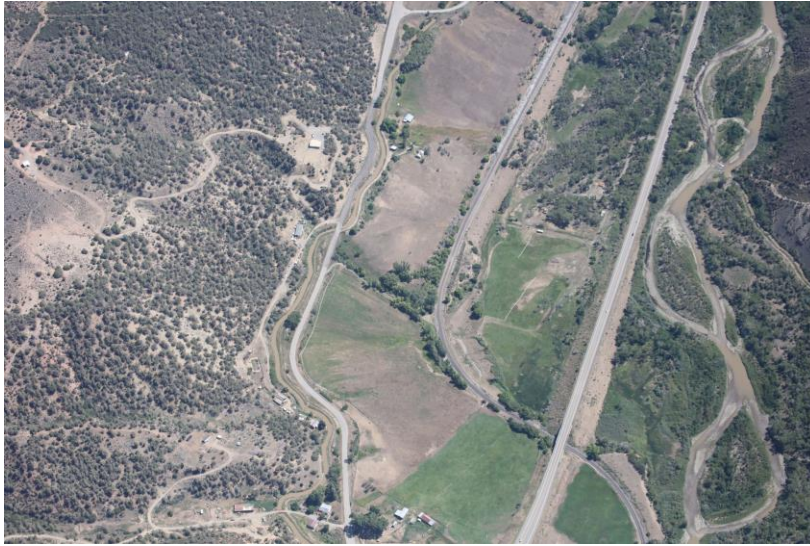
Unit Train Loadout tracks (west side) in center of photo

No problems were identified with any facility areas, including the following: the Utility Bench, the D Portal Bench, the B Portal Bench, the Material Storage Area by Curve #4, the Conveyor Corridor, the Coal Stockpile Pad, the office, the Preparation Plant area, the storage area and buildings near Pond D, the Pump House and Filter Building, the train loadout area.

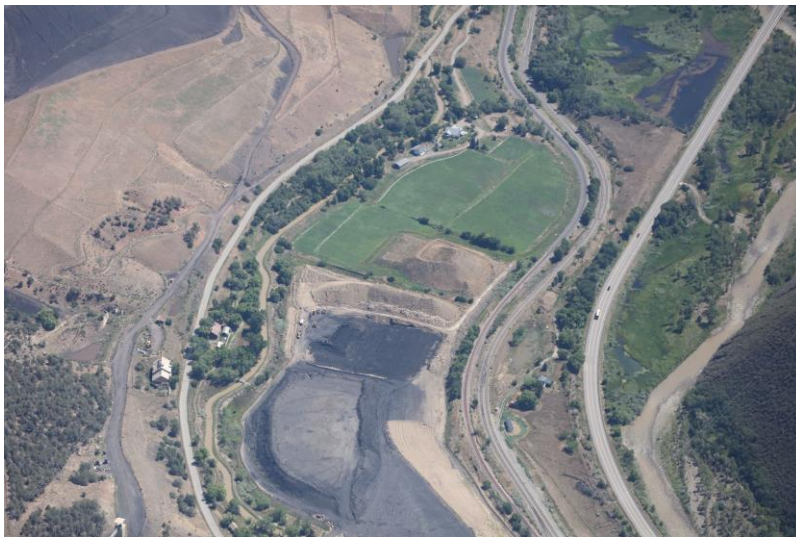
Southeast portion of site (Gob Pile #3 in foreground)

Minor erosion on Gob Pile #2 and Gob Pile #3 does not appear to be a problem, and there is no sign of significant coal waste in the ditch below Gob Pile #3 (Ditch J3).

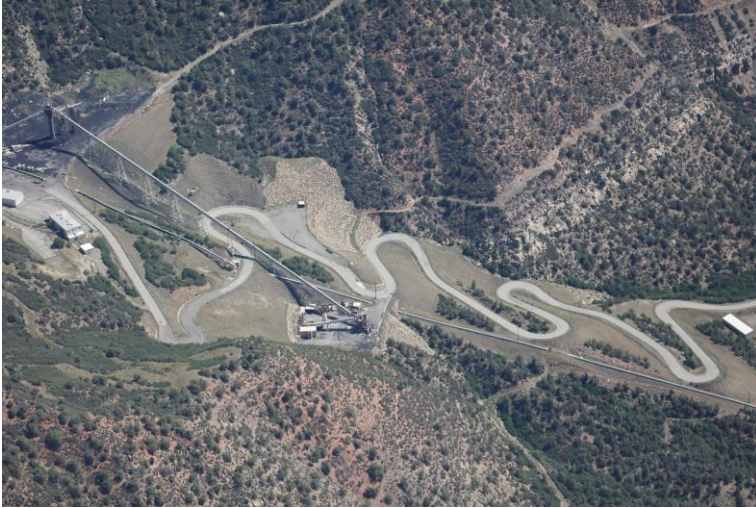
Access road and area near portals

No problems were seen with any roads.

Gob Pile #1, Gob Pile #4, and the reclaimed portion of Gob Pile #2 all appear to be in adequate condition with minimal areas that are bare. The hillsides along the access road to the mine appear to be in excellent condition. No signs of erosion can be seen in the photographs.

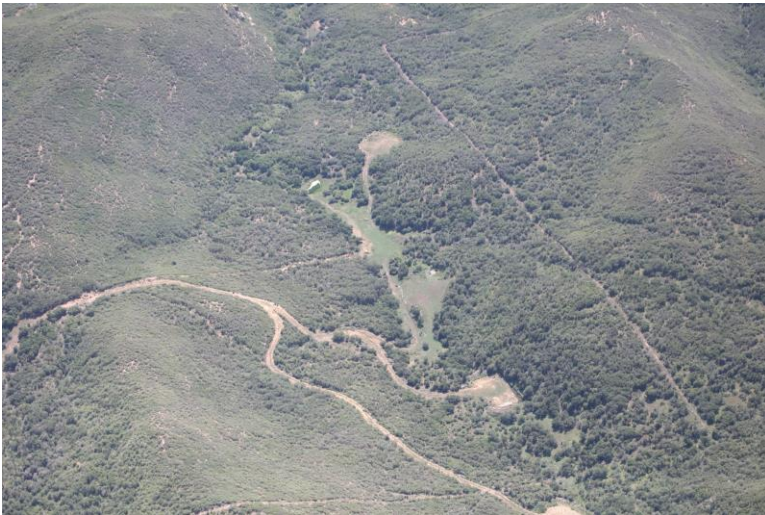
Pads for Gob Vent Boreholes (B17 series)

The pad for the Terror Creek Vent Shaft was inspected. No problems were identified. Also, no problems were seen at the pads for GVB-B17A, GVB-B17B, GVB-B17C, or GVB-B17D.

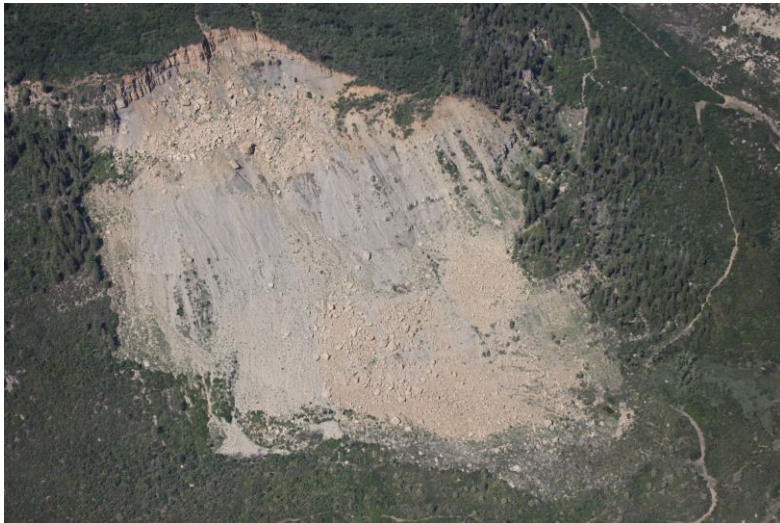
Slide area in Hubbard Creek watershed

The large slide on the hill west of Hubbard Creek was inspected and does not appear to be growing in size.

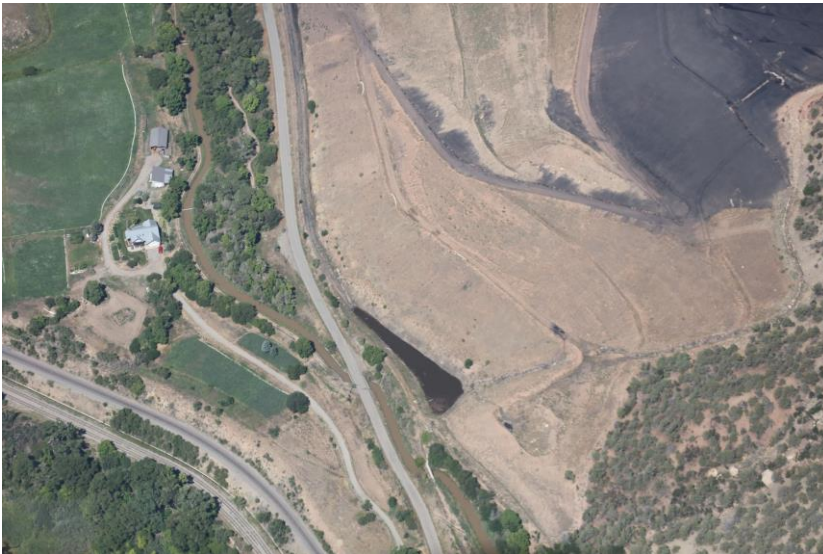
Pond F and nearby area

The following ponds were inspected: B, C, D, F, J, and K. Four of these ponds appeared to contain water (Pond K being the exception). No problems were identified with embankments or other features of the ponds.

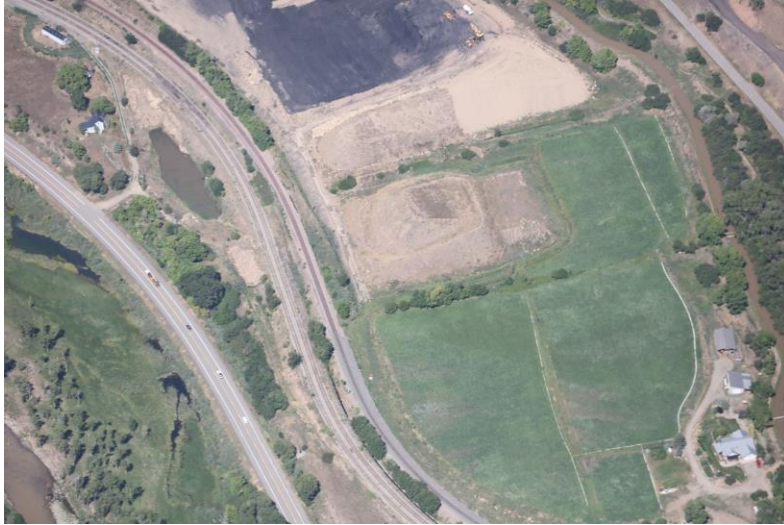
Pond J and soil piles

No erosion or other issues were identified at soil piles.
