To: Jerald Schnabel From: Paul Kos
Continental Materials Corp. Denver, CO 80222
File: June 2021 Monitoring Summary Date: July 31, 2021

Reference: June 2021 Geotechnical Monitoring Summary Pikeview Quarry

Stantec Consulting Services Inc. (Stantec) has prepared this June 2021 Geotechnical Monitoring Summary for the Pikeview Quarry. The Pikeview Quarry is situated along the foothills of the Rocky Mountains, northwest of Colorado Springs, Colorado. Continental Materials Corp. operates the quarry, which is currently closed, pending reclamation. A geotechnical monitoring program was established to monitor reclamation activities which will affect the geotechnical performance of the existing and reclaimed slopes during and following reclamation grading. This report presents the geotechnical monitoring results for the slope reclamation activities at the site through the month of June 2021.

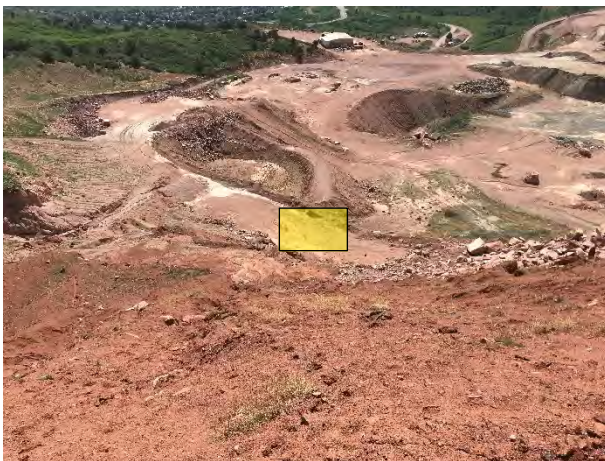
Figure 1

- New Cracks: New tension cracks were observed following the period of heavy rain. These cracks are not believed to be a problem, they are likely due to the recent heavy rain saturating the area (Photos 1, 2 and 4). **Figure 1** below is the area viewed from above with the area of interest highlighted. **Figure 2** is a close-up of the cracks in the highlighted area:

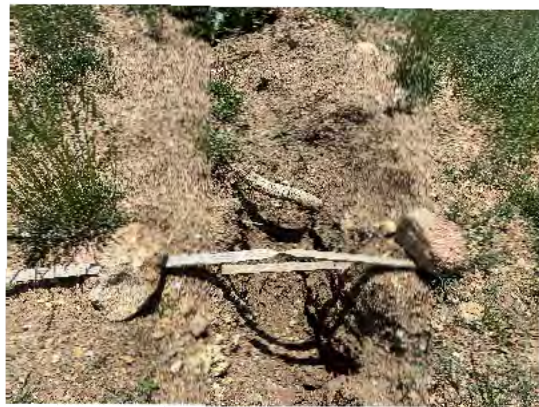
- Survey stakes were placed across a historic crack on the slope above and south of the landslide area to track any changes over the coming months. During this visit the stakes were observed to have moved apart by approximately $\frac{1}{4}$ ". A review of the data for the nearest prism, P70, showed similar-scale movements for the area (Photo 6).

6. PICKETS AROUND ONE OF THE CRACKS

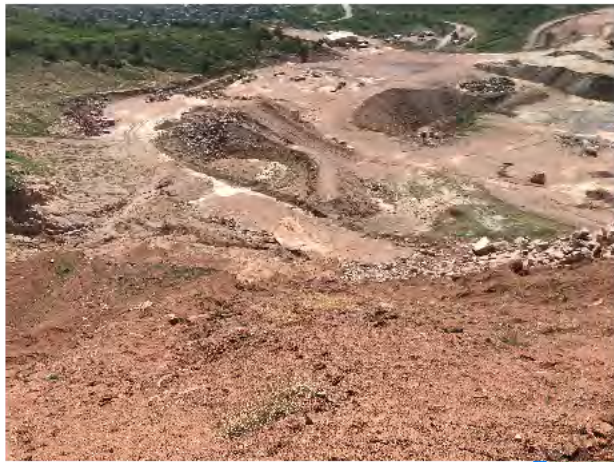
- Fill: Material is being imported and temporarily placed on the “production floor”. During the visit, different types of material including mulch and general fill were being deposited here for future placement (Photo 5).

5. VIEW TO THE EAST FROM RIDGE

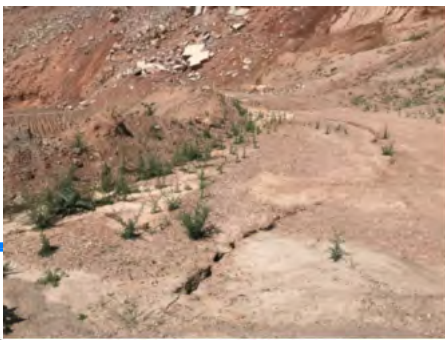
4. RECENT CRACKS NEAR PRODUCTION FLOOR

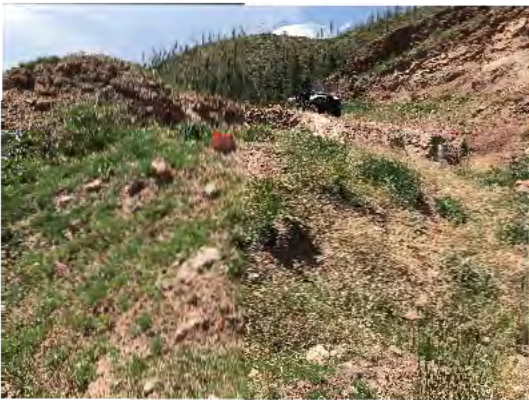
- Prisms: Several prisms were passed along the walking route and appeared to be in their original position and operating normally. Control points are permanently cemented into the ground while some of the monitoring points are cemented into 5-gal buckets to be portable as needed (Photo 3).

3. RIDGE NEAR PRISM NP66

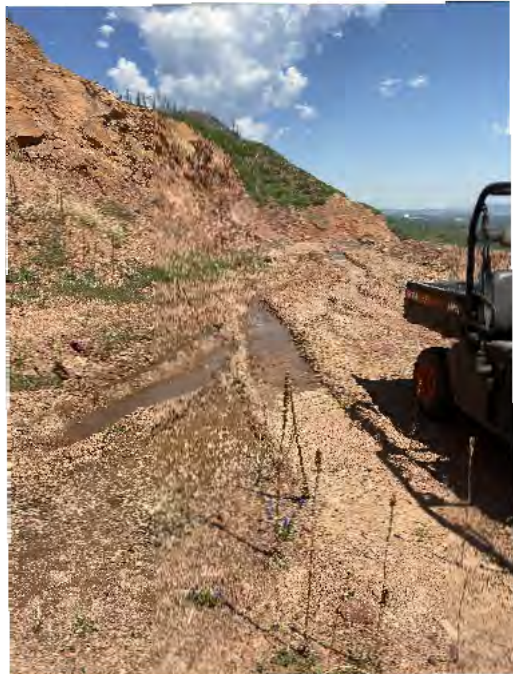
- Seepage continues on the steep slopes of the middle peak, and in some of the haul roads along the uppermost slopes. The flow is from granitic rocks and occurs near the fault line (Photo 7),

7. SEEPAGE ALONG HAUL ROADS

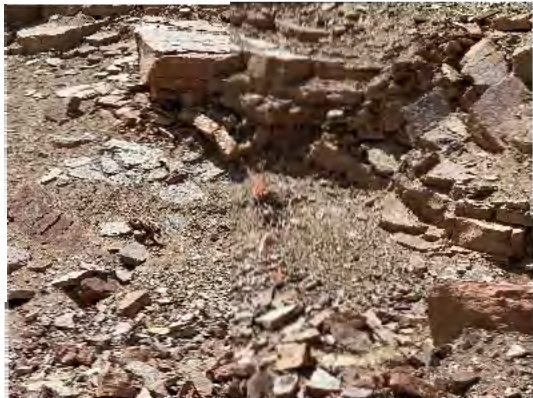
- Prism TOE3 was visually checked during this visit. It is in a rock fall area. As of this visit it was in good condition and operating properly (Photo 8),

8. TOE3 IS IN THE ROCK FALL AREA

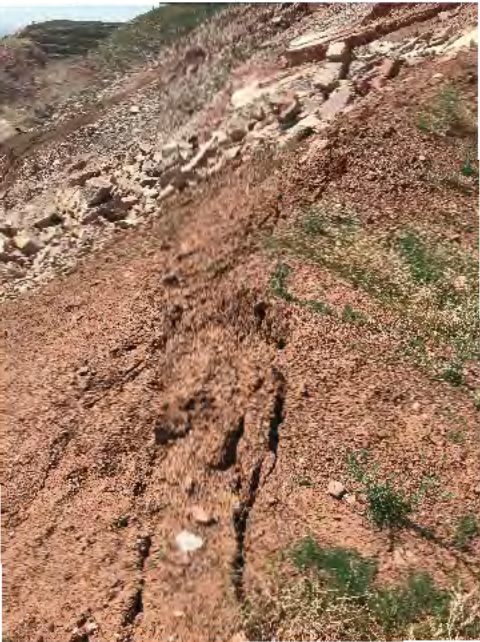
2. CRACKING ON FILL SLOPE

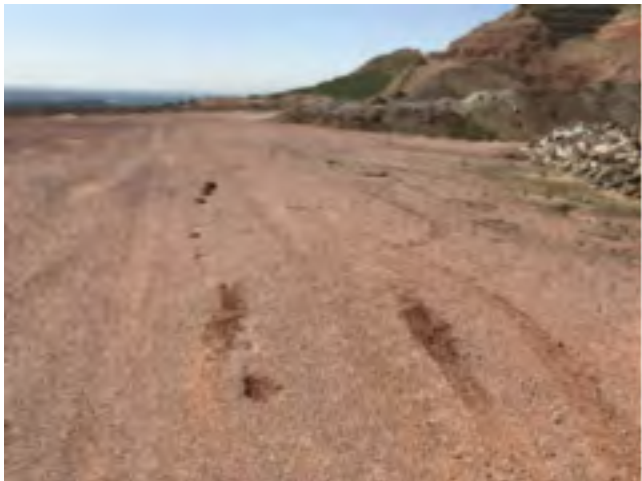
1. RECENT CRACKS ON PRODUCTION FLOOR AFTER RAIN

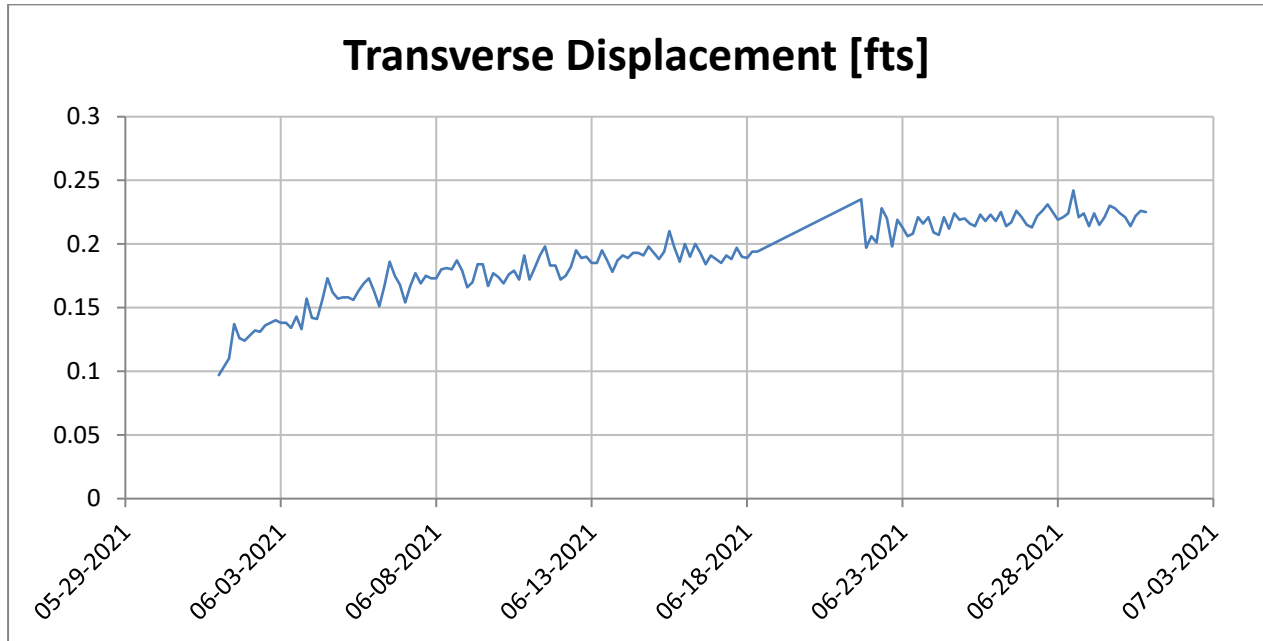
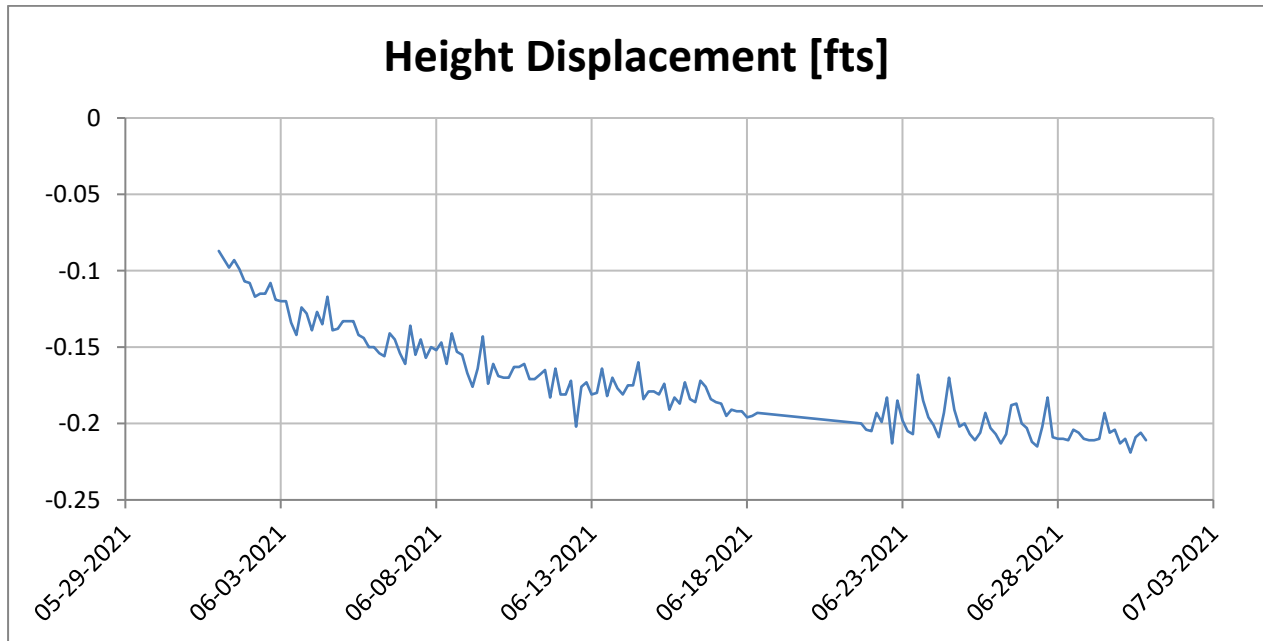
1. Survey accuracy is ± 0.016 feet.
2. Alarm threshold is ± 0.35 feet.
3. Transverse displacement is in the horizontal direction. Positive direction means closer to the robotic station.
4. Height displacement is in the vertical direction. Positive direction means higher in elevation.
5. Prism NP1 is located above loose fill. This prism recorded slope creep movements at slow velocity.

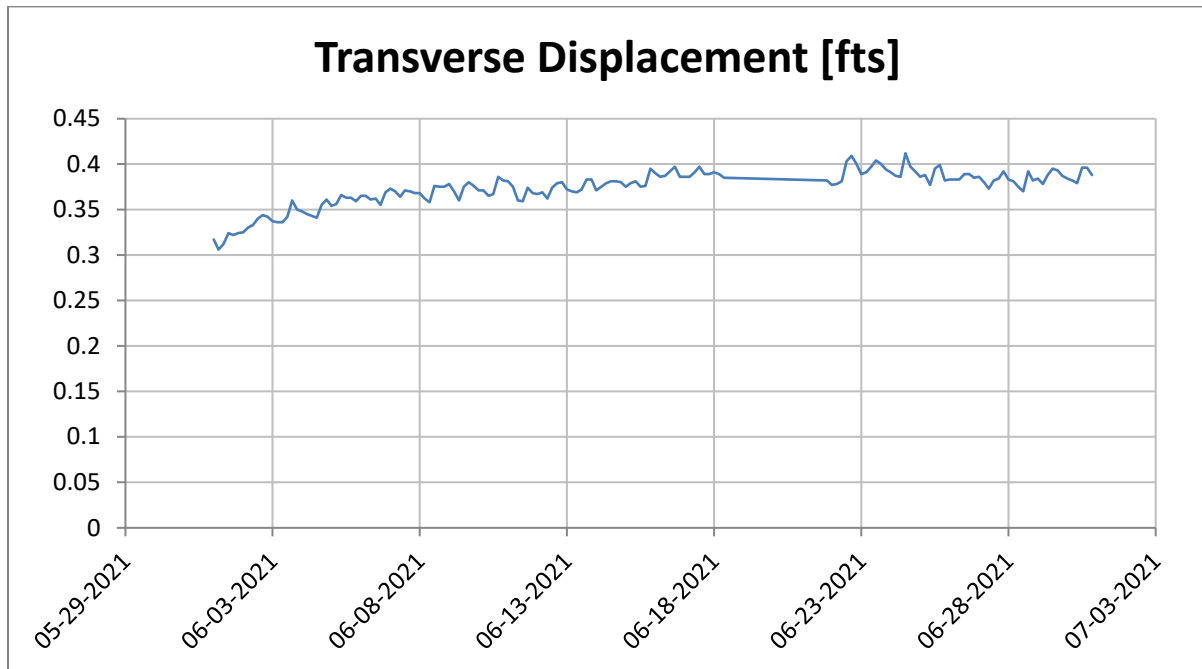
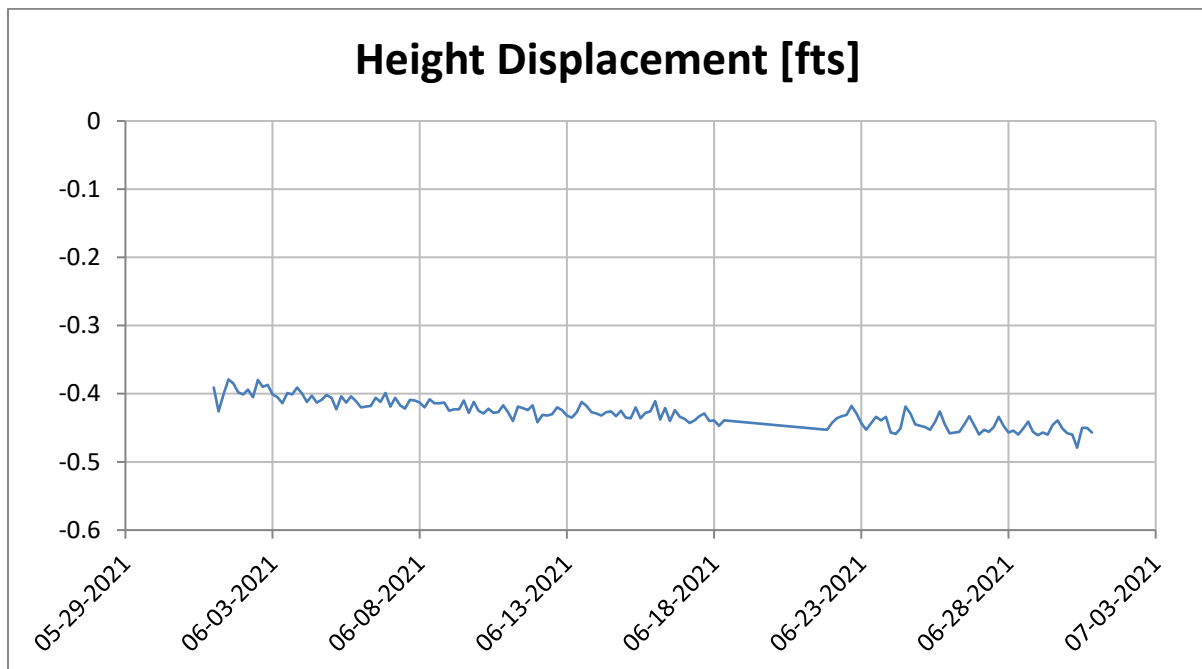
1. Survey accuracy is ± 0.016 feet.
2. Alarm threshold is ± 0.35 feet.
3. Transverse displacement is in the horizontal direction. Positive direction means closer to the robotic station.
4. Height displacement is in the vertical direction. Positive direction means higher in elevation.
5. Prism NP66 is located above the landslide. This prism recorded slope creep movements at slow velocity.

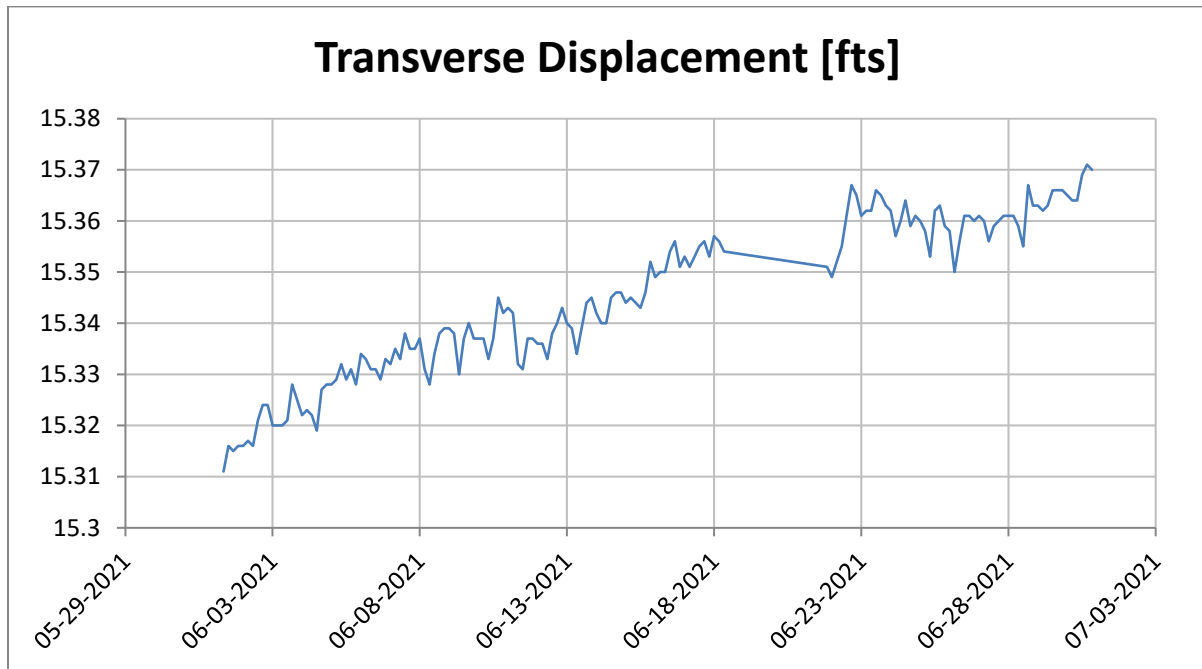
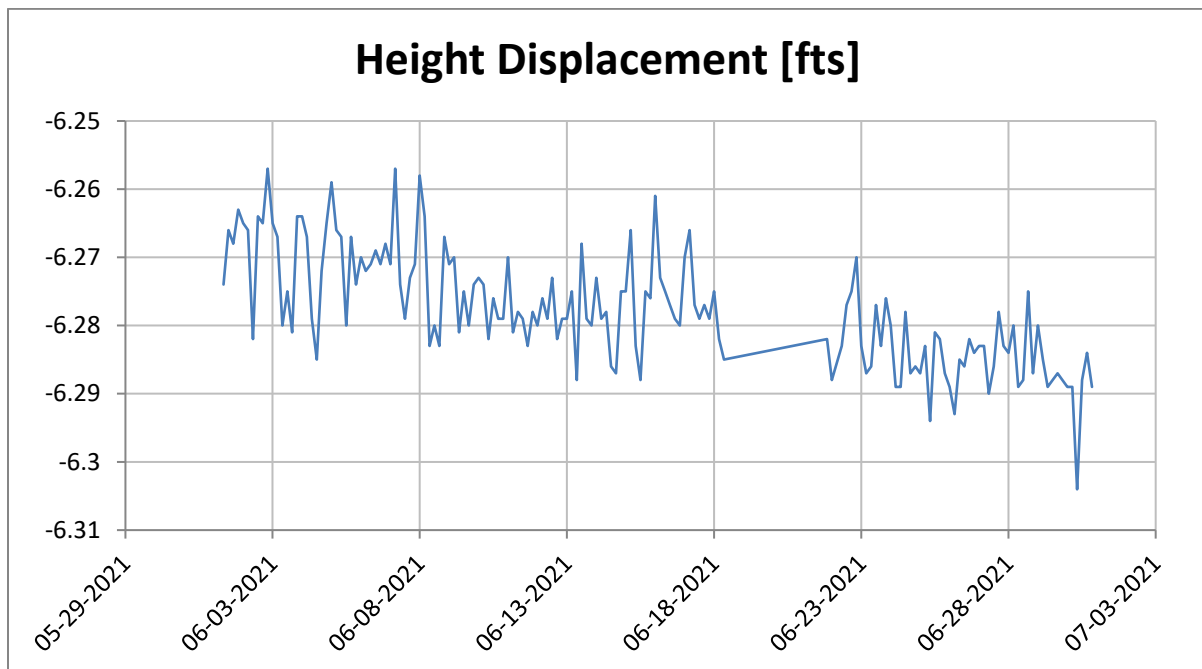
1. Survey accuracy is ± 0.016 feet.
2. Alarm threshold is ± 0.35 feet.
3. Transverse displacement is in the horizontal direction. Positive direction means closer to the robotic station.
4. Height displacement is in the vertical direction. Positive direction means higher in elevation.
5. Prism P63 is located at the toe of the landslide. This location showed slope creep movements at slow velocities.

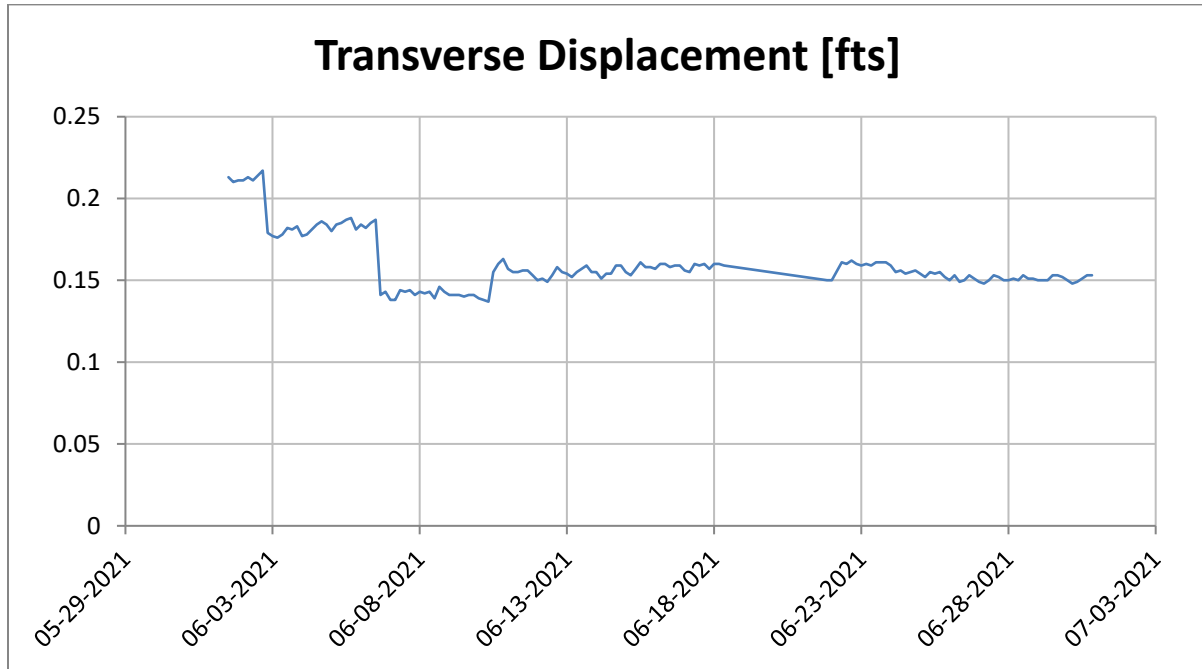
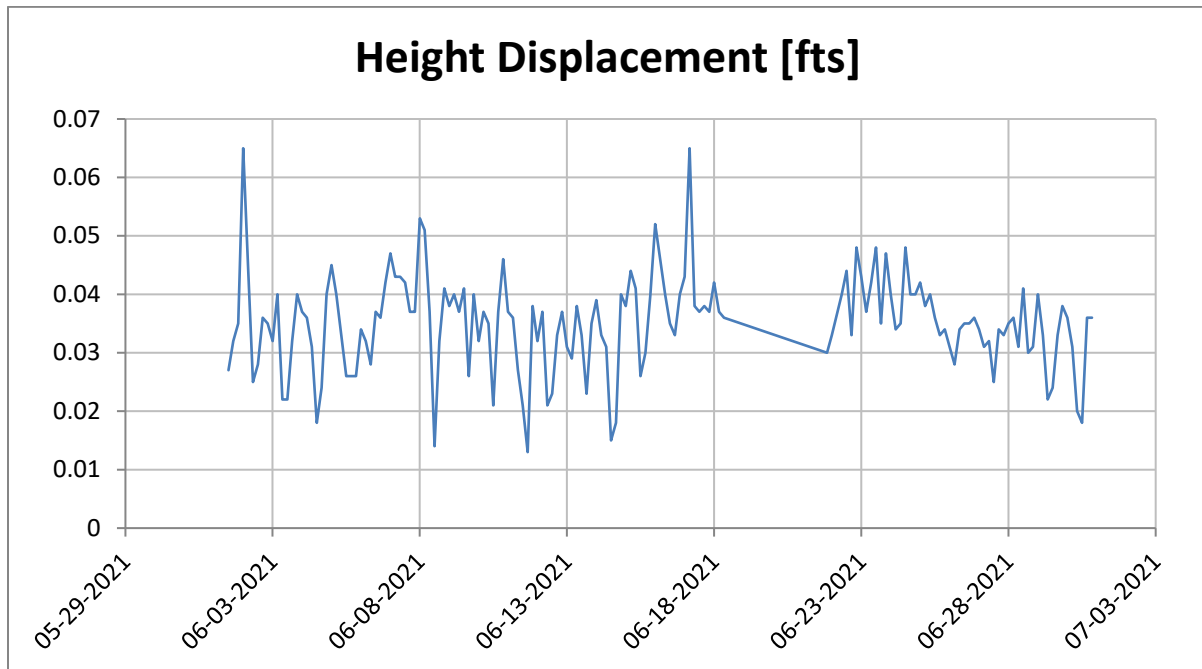
Prism TOE1

Prism ID	Cumulative Transverse Displacement (ft)	Cumulative Height Displacement (ft)	Monthly Delta (ft)	Cumulative Delta (ft)	Notes / Recommendations
CP1	-0.008	-0.010	-0.0172	0.0182	
CP2	-0.060	-0.007	0.0065	0.4124	
CP3	0.282	-0.224	0.0073	0.3649	
NP1	0.225	-0.211	0.1649	0.3087	Slope creep at slow and decreasing velocity.
NP2	0.046	-0.082	0.0112	0.1241	
NP66	0.388	-0.457	0.1188	0.6872	Slope creep at slow and decreasing velocity.
P1	0.345	-0.051	-0.0026	0.3513	
P2	0.153	-0.033	0.0176	0.2274	
P25	-0.008	0.023	0.0179	0.1520	
P32	-0.068	-0.091	-0.0041	0.2646	
P33	-0.090	-0.042	0.0079	0.2135	
P35	0.042	-0.186	0.0245	0.4531	
P4	0.375	-0.130	0.0101	0.4933	
P5	0.400	-0.157	0.0173	0.6288	
P63	15.370	-6.289	0.0602	16.6071	Slope creep at slow velocity.
P69	-0.022	-0.047	-0.0040	1.9787	
P70	0.366	-0.304	0.0123	0.6095	Slope creep at slow velocity. Recorded movements match those measured in field.
TOE1	0.153	0.036	-0.1571	0.1777	Movement recorded June 6.

1. Survey accuracy is ± 0.016 feet.
2. Alarm threshold is ± 0.35 feet.
3. Transverse displacement is in the horizontal direction. Positive direction means closer to the robotic station.
4. Height displacement is in the vertical direction. Positive direction means higher in elevation.
5. Movement recorded on June 6. Movement has not repeated.

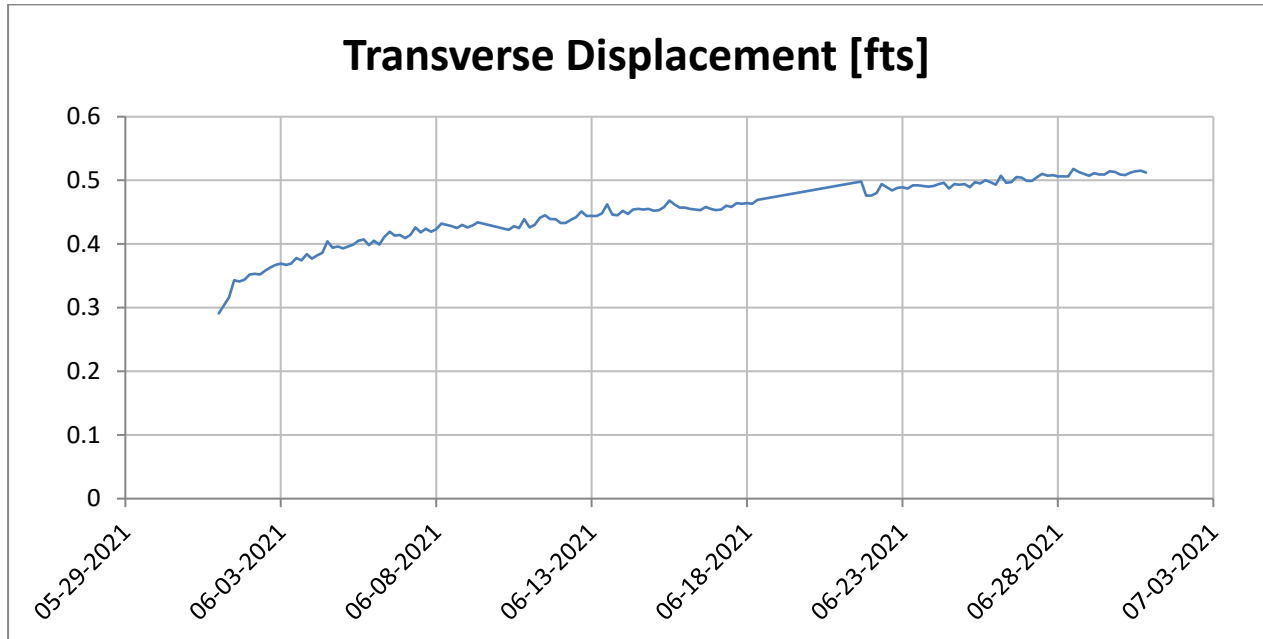
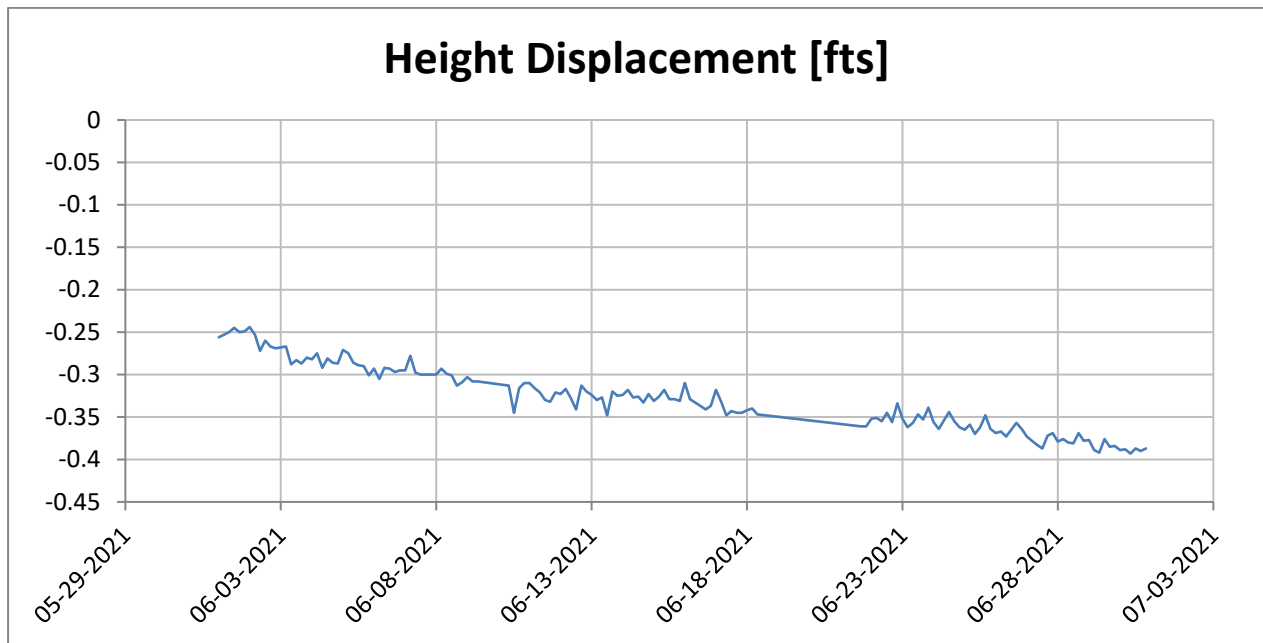
TOE2	0.512	-0.387	0.0000	0.4321	Slope creep at slow velocity.
TOE3	1.683	-0.818	0.2310	2.0043	Movement recorded June 6 and slope creep at slow velocity.

1. Survey accuracy is +/-0.016 feet.
2. Alarm threshold is +/-0.35 feet.
3. Transverse displacement is in the horizontal direction. Positive direction means closer to the robotic station.
4. Height displacement is in the vertical direction. Positive direction means higher in elevation.
5. Prism TOE2 is located at the toe of the landslide. This location showed slope creep movements at slow velocities.

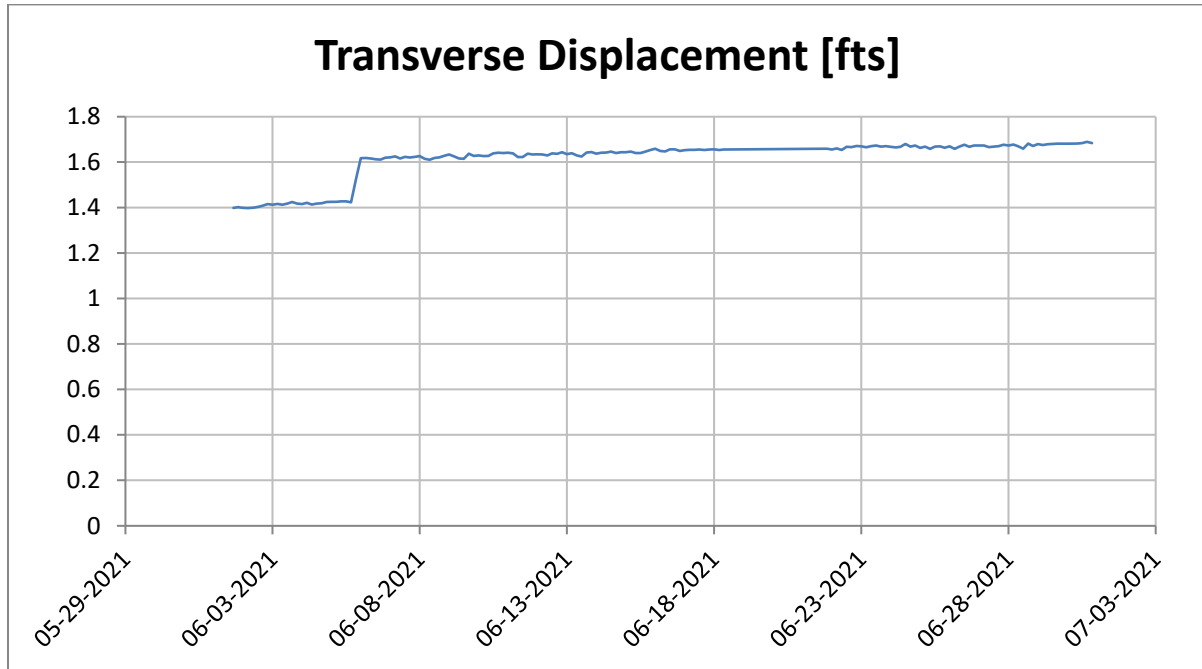
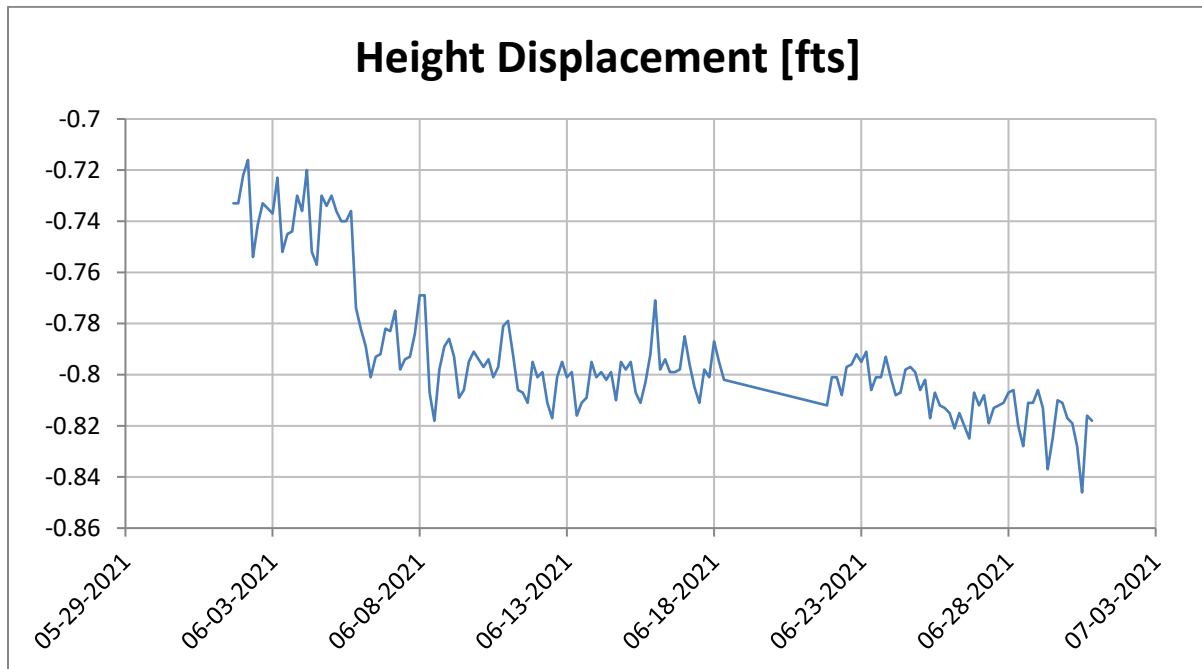
1. Survey accuracy is +/-0.016 feet.
2. Alarm threshold is +/-0.35 feet.
3. Transverse displacement is in the horizontal direction. Positive direction means closer to the robotic station.
4. Height displacement is in the vertical direction. Positive direction means higher in elevation.
5. Prism TOE3 is located at the toe of the landslide. This location recorded a slope movement on June 6 and slope creep movements at slow velocities.

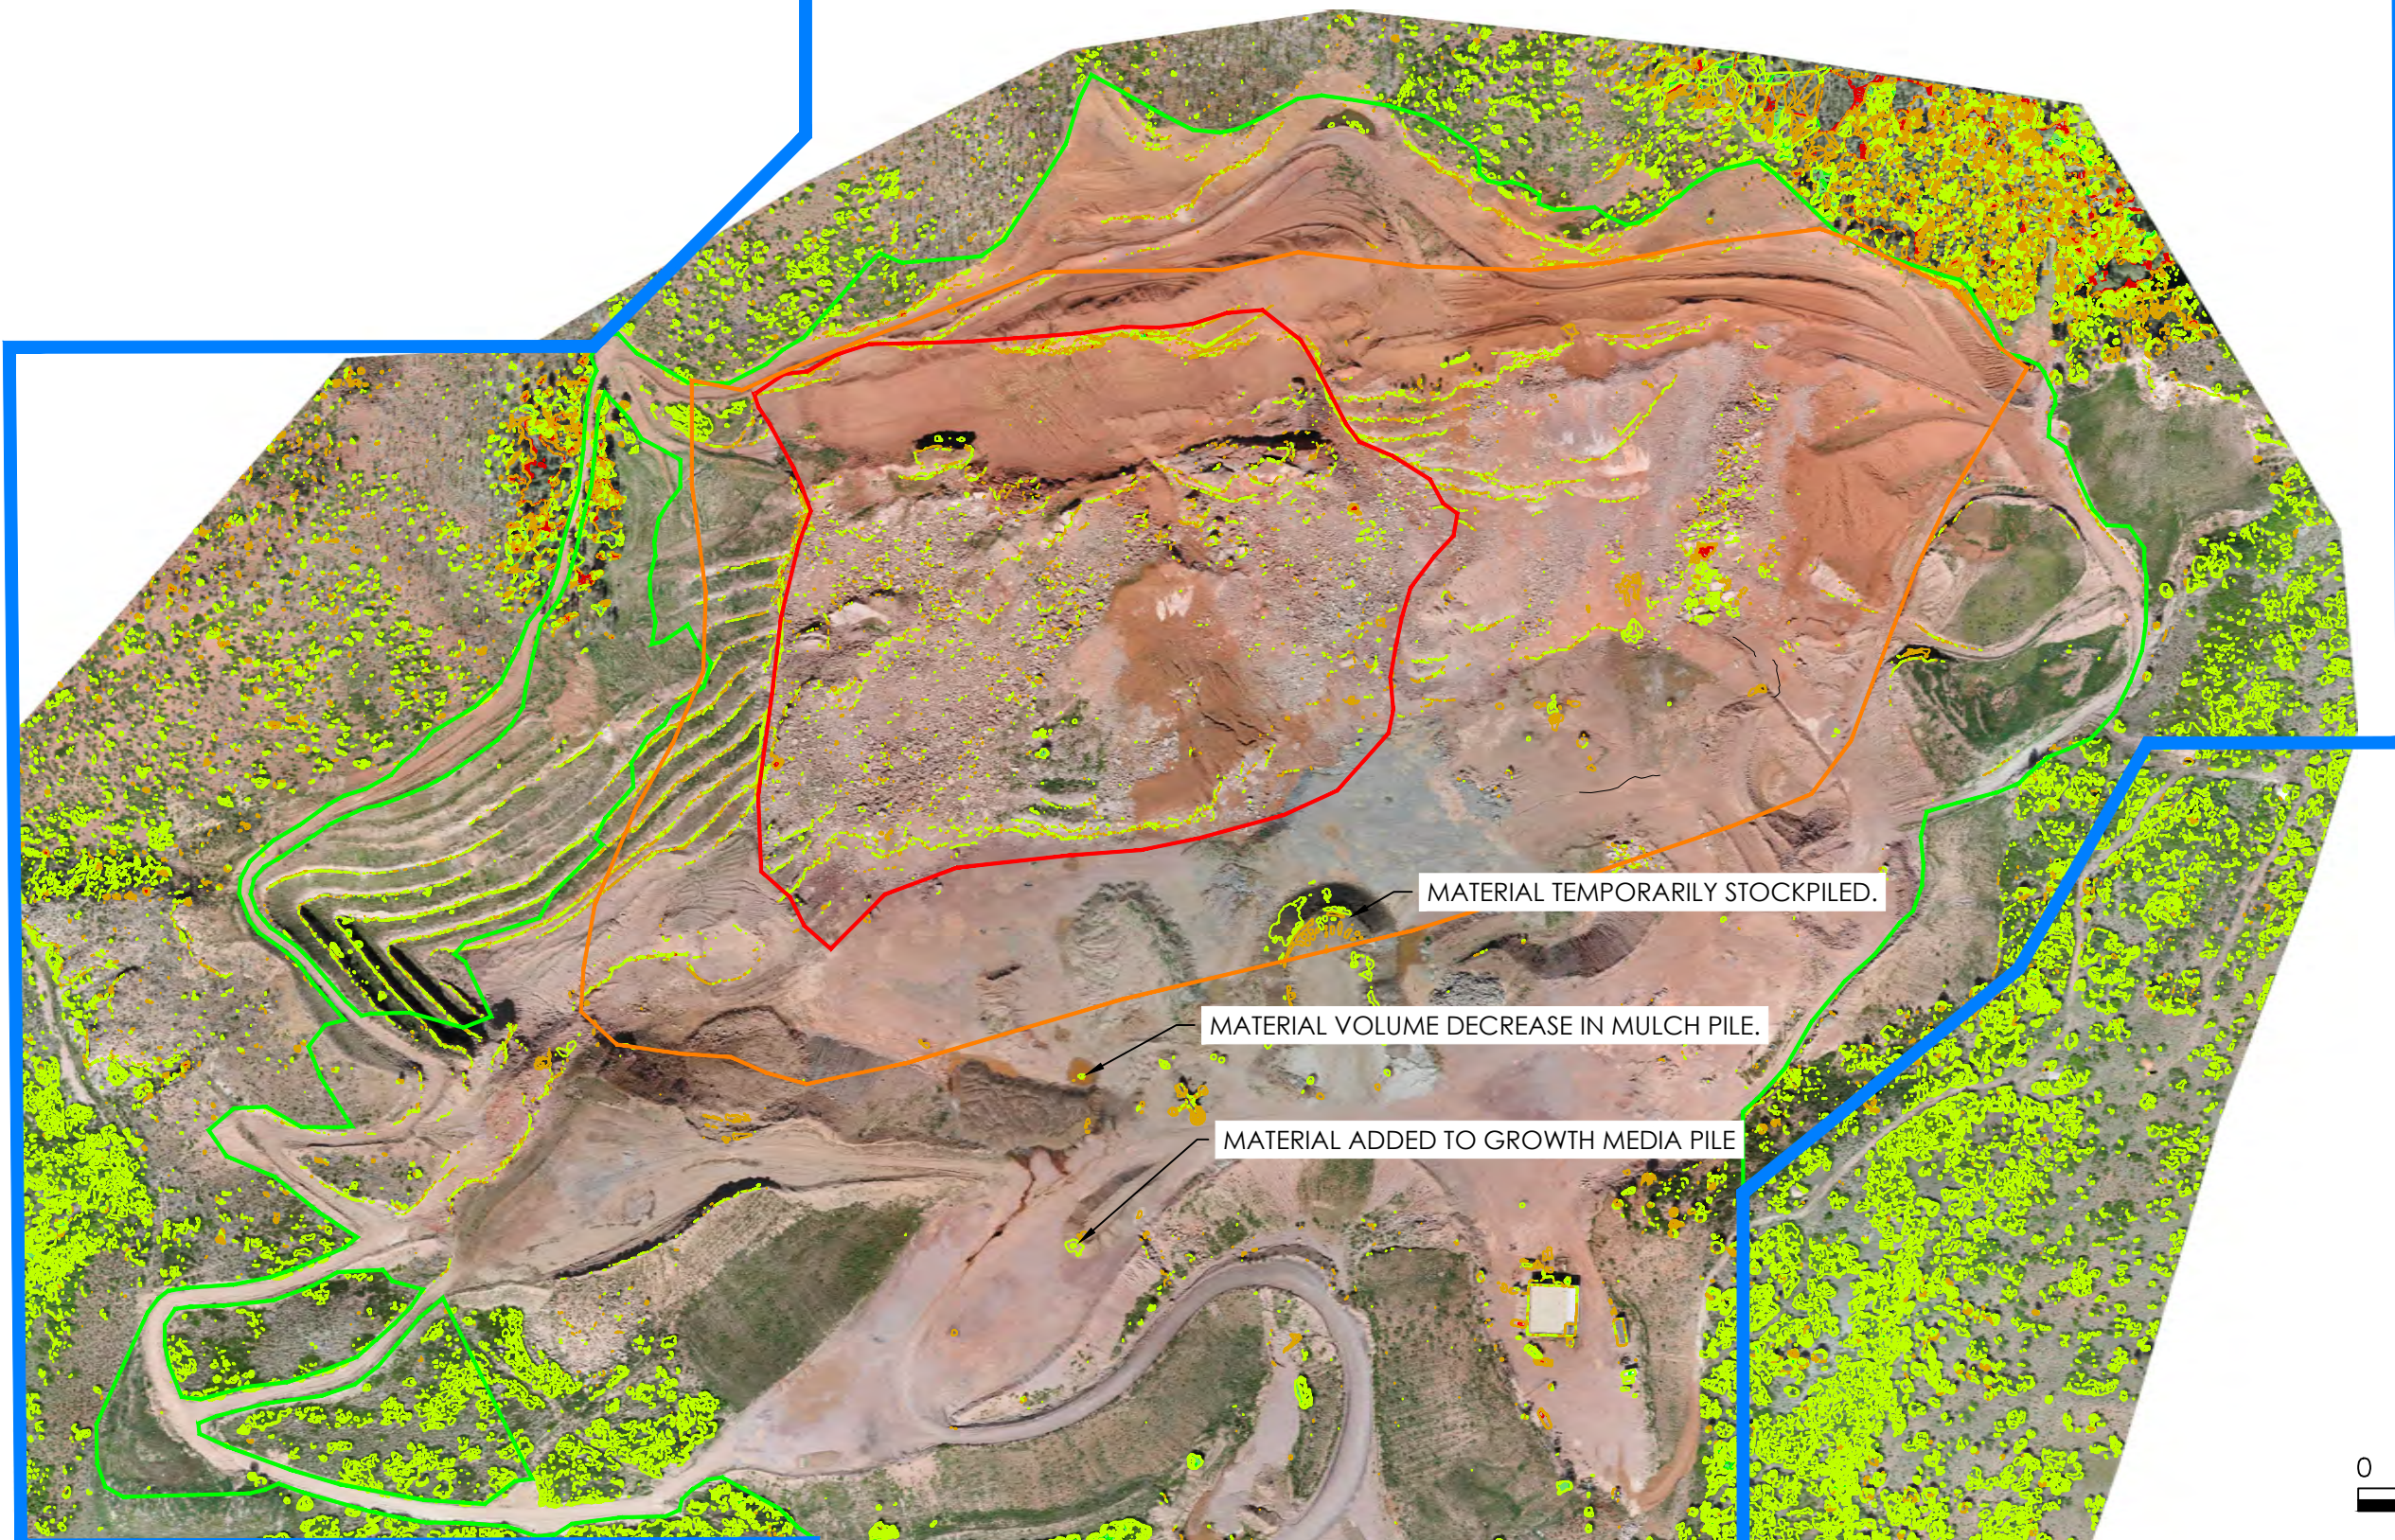
The May topography was also compared to the June topography to identify changes in the site topography. Comparison of the two surveys showed that approximately 1530 yd³ of fill had been imported and temporarily placed. No slope movements or other changes in topography were identified. The current imagery and topography are included in Figures 1 and 3, and the comparison surface is included as Figure 5 in Appendix C.

1. COMPARISON OF DRONE FLIGHTS FROM 05/14/21 and 06/14/2021.
