C1982022, Elk Creek Mine, Aerial Inspection Report

Permit Number: C-1981-022 Mine Name: Elk Creek Mine Operator: Oxbow Mining, LLC Operator Address: Mr Doug Smith 3737 Hwy 133 P. O. Box 535 Somerset, CO 81434	County: Delta, Gunnison Operation Type: Underground Permit Status: Active Ownership: Private
	Operator Representative Present: NA
Operator Representative Signature: (Field Issuance Only)

Inspection Start Date: July 30, 2021 Inspection Start Time: 11:20 Inspection End Date: July 30, 2021 Inspection End Time: 11:24		Inspection Type: Aerial Inspection Inspection Reason: Normal I&E Program Weather: Clear	
Joint Inspection Agency: None		Joint Inspection Contacts: 	
Post Inspection Agency: None		Post Inspection Contacts: 	
Inspector(s): Leigh Simmons Brock Bowles	Inspector's Signature:

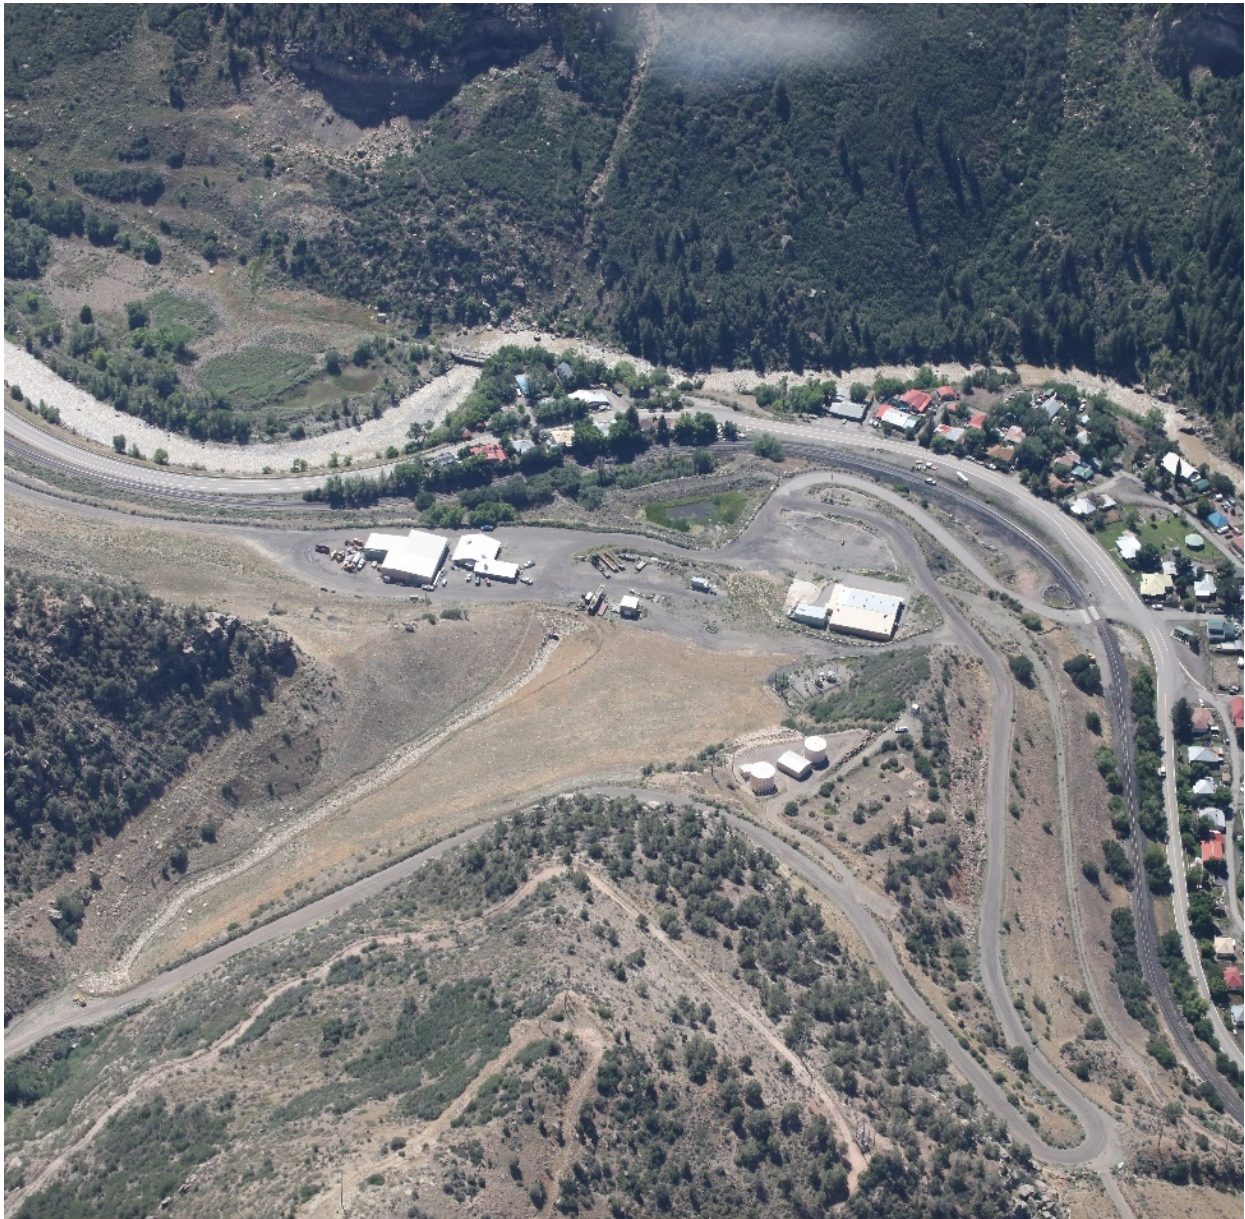
Reclaimed areas around the mine facilities area, including the Elk Creek channel, appeared to be stable. The reclaimed CBM well pads and roads also appear stable, with vegetative cover visible. The reclaimed disturbance in A-gulch also appeared to be stable, with more established vegetation. There is no sign of any erosion on any of the reclaimed areas.

Figure 1: Lower facilities area

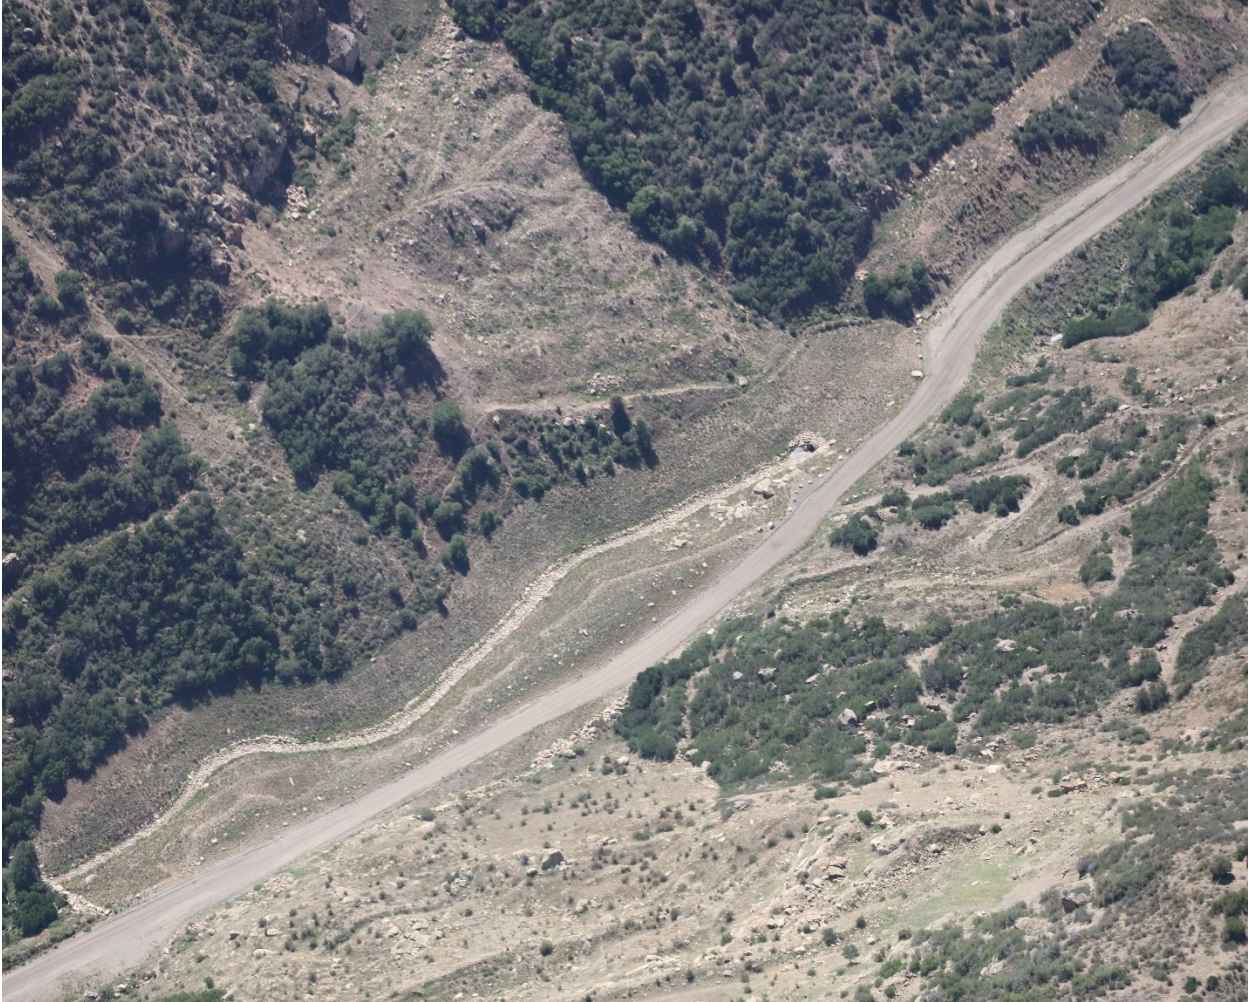
Figure 2: Upper section of reclaimed Elk Creek channel

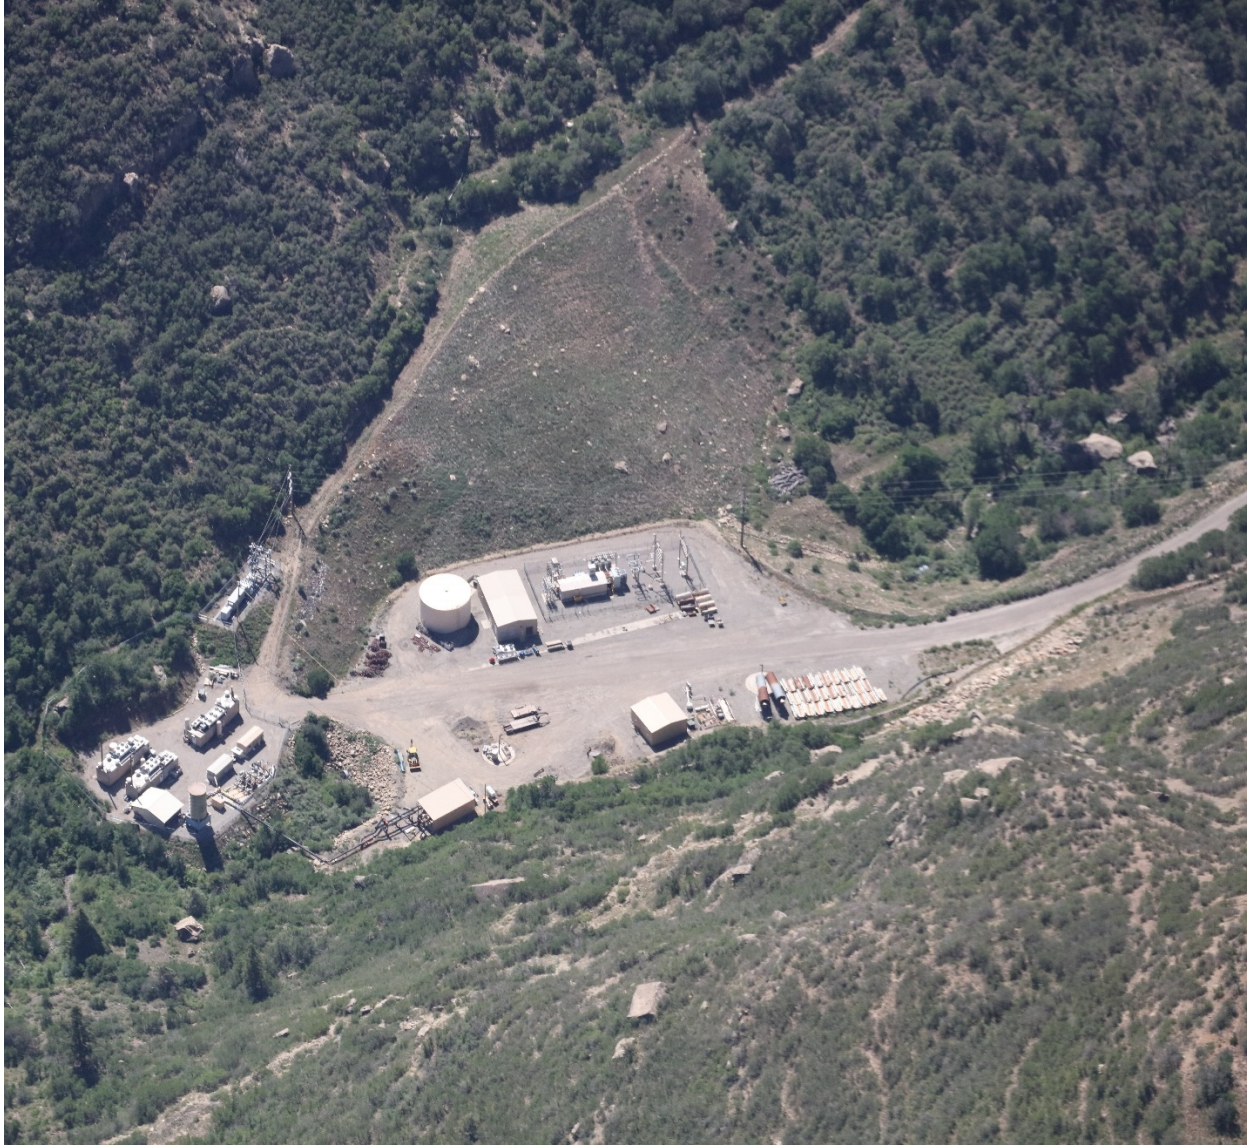
Figure 3: Upper facilities area

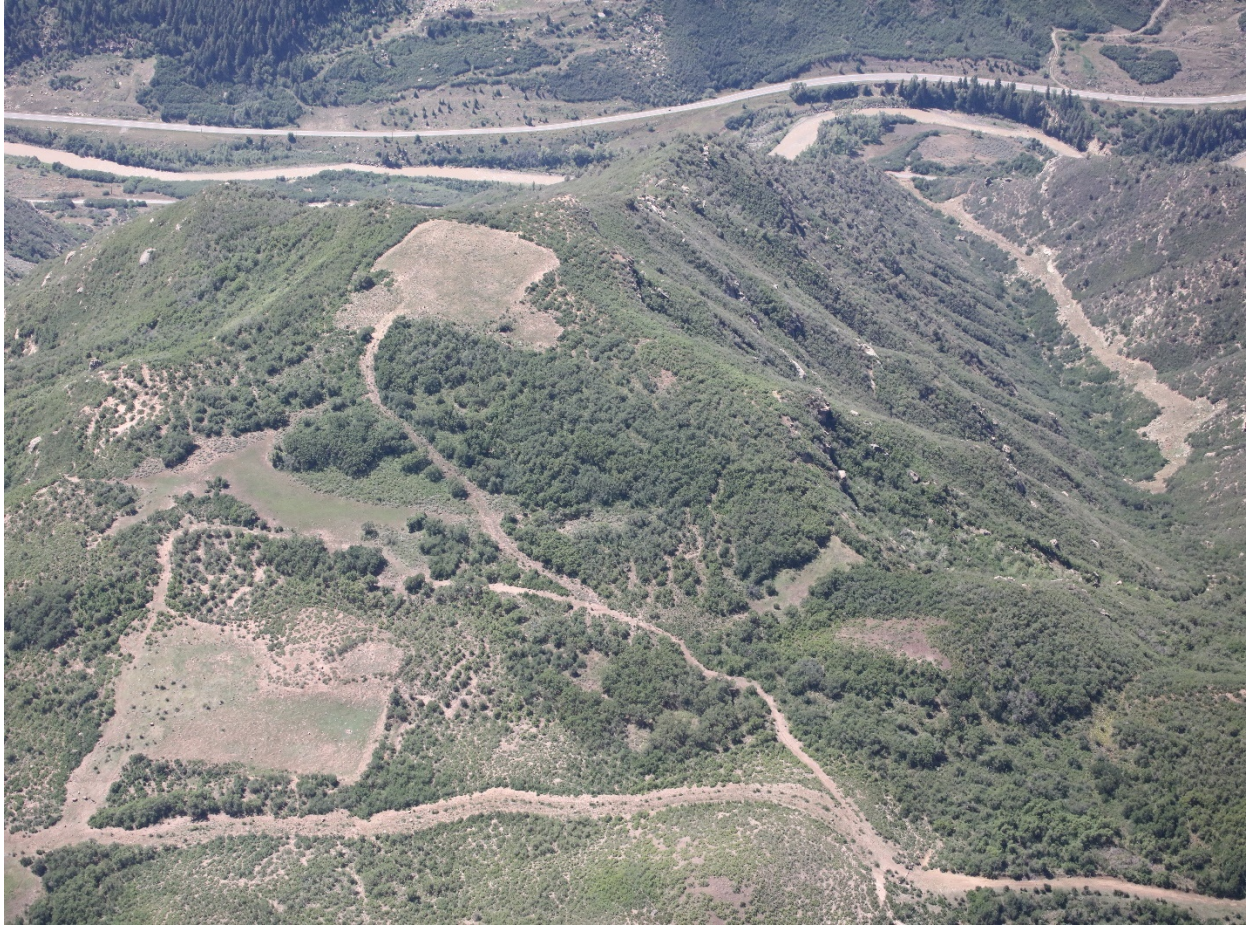
Figure 4: Reclaimed CBM-9/10/12/14 and CBM-8/11/13 (foreground) pads, with reclaimed A-gulch disturbance to the right of the frame

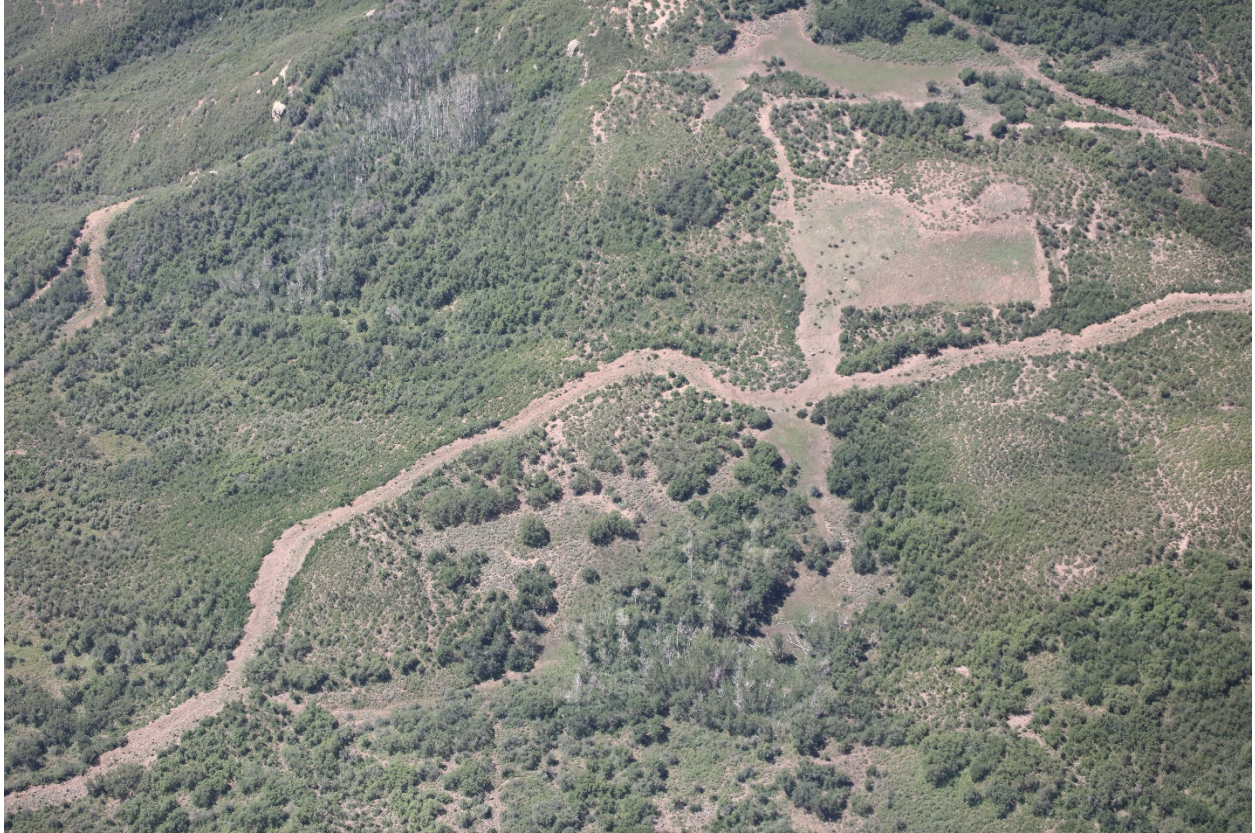
Figure 5: Reclaimed CBM-8/11/13 pad and road

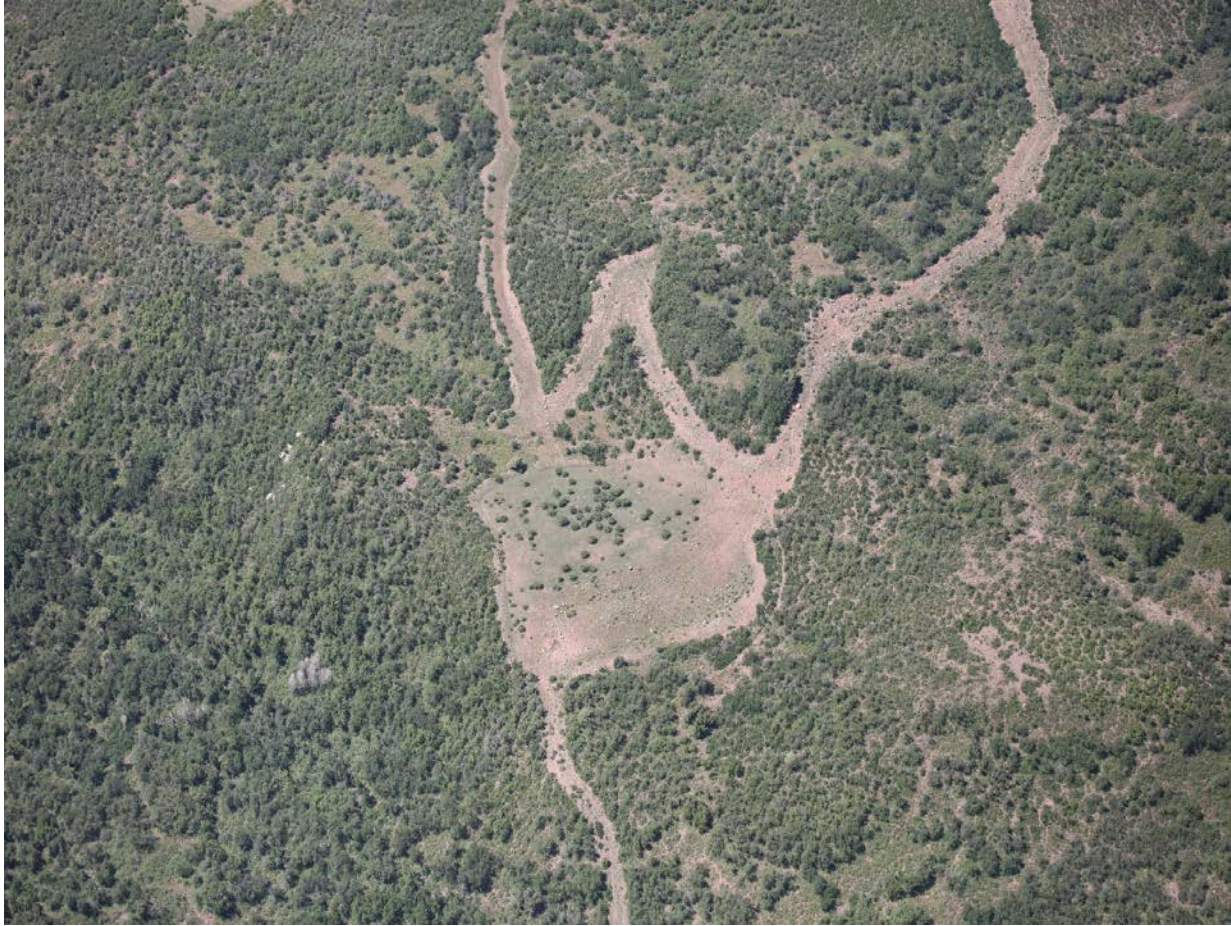
Figure 6: CBM-1/2/3/6/7 pad and road

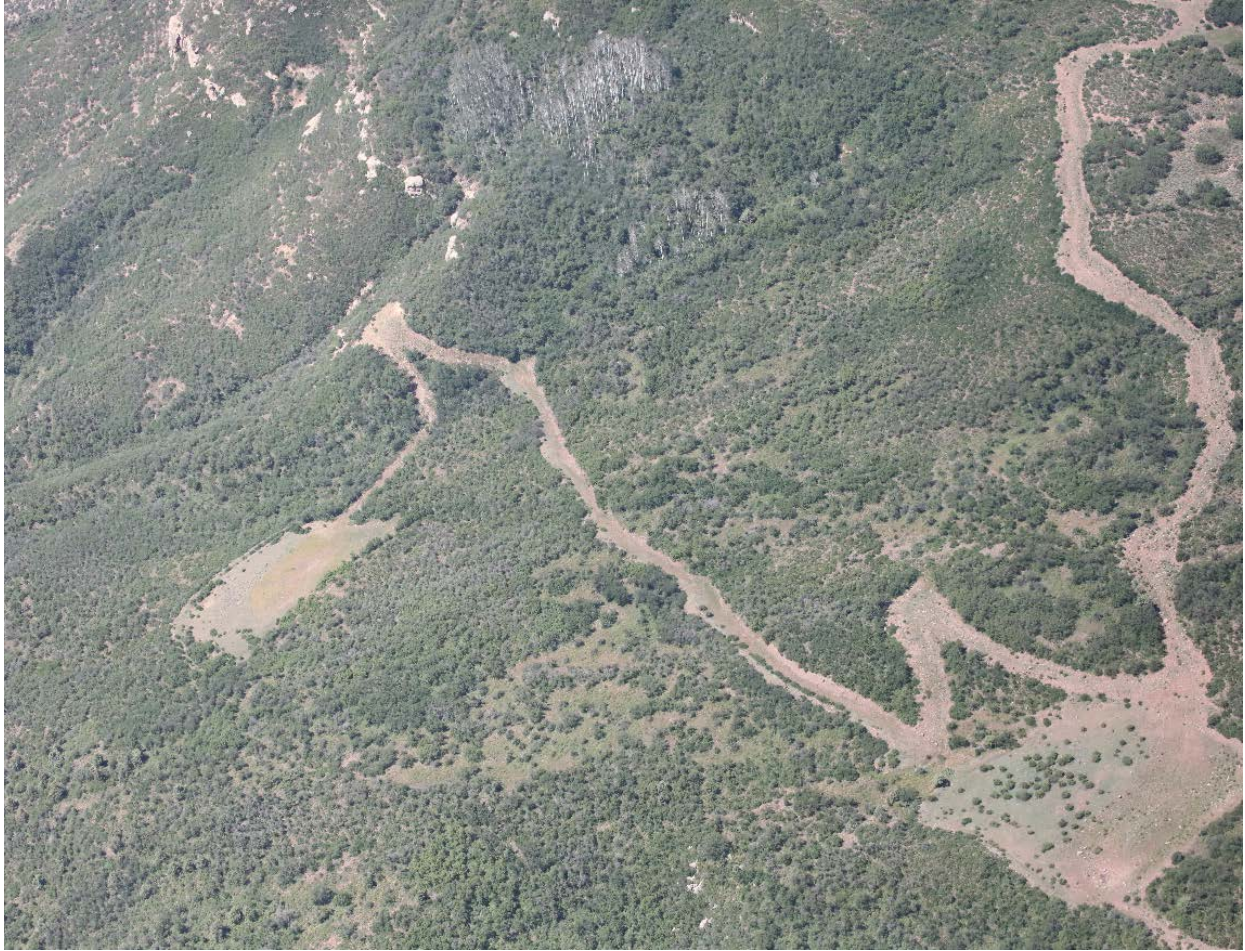
Figure 7: CBM-4/5 pad (left of frame)

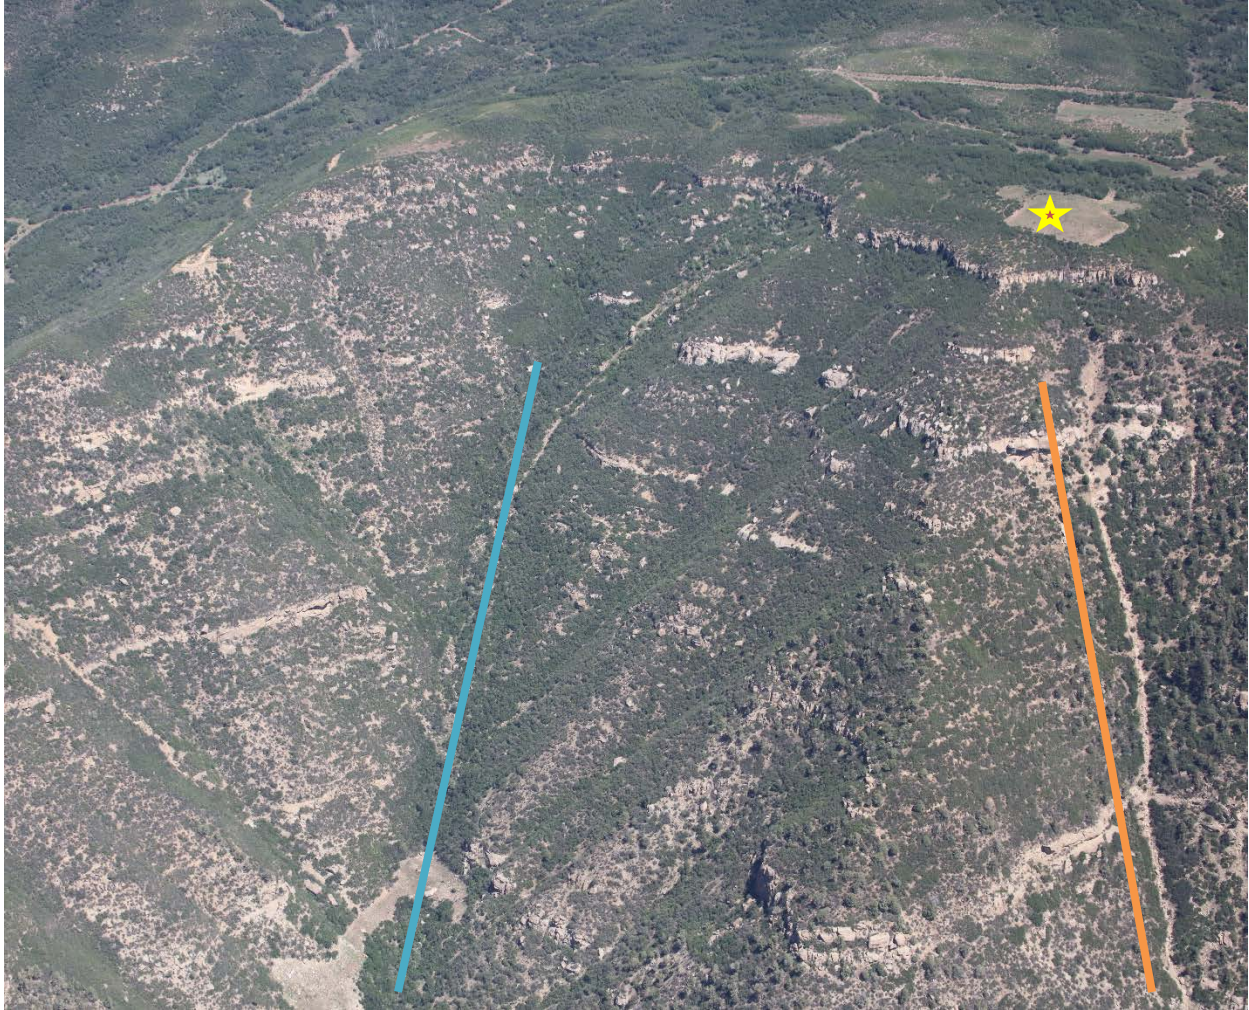
Figure 8: A-gulch (blue), B-gulch (orange) and CBM-9/10/12/14 pad (yellow)

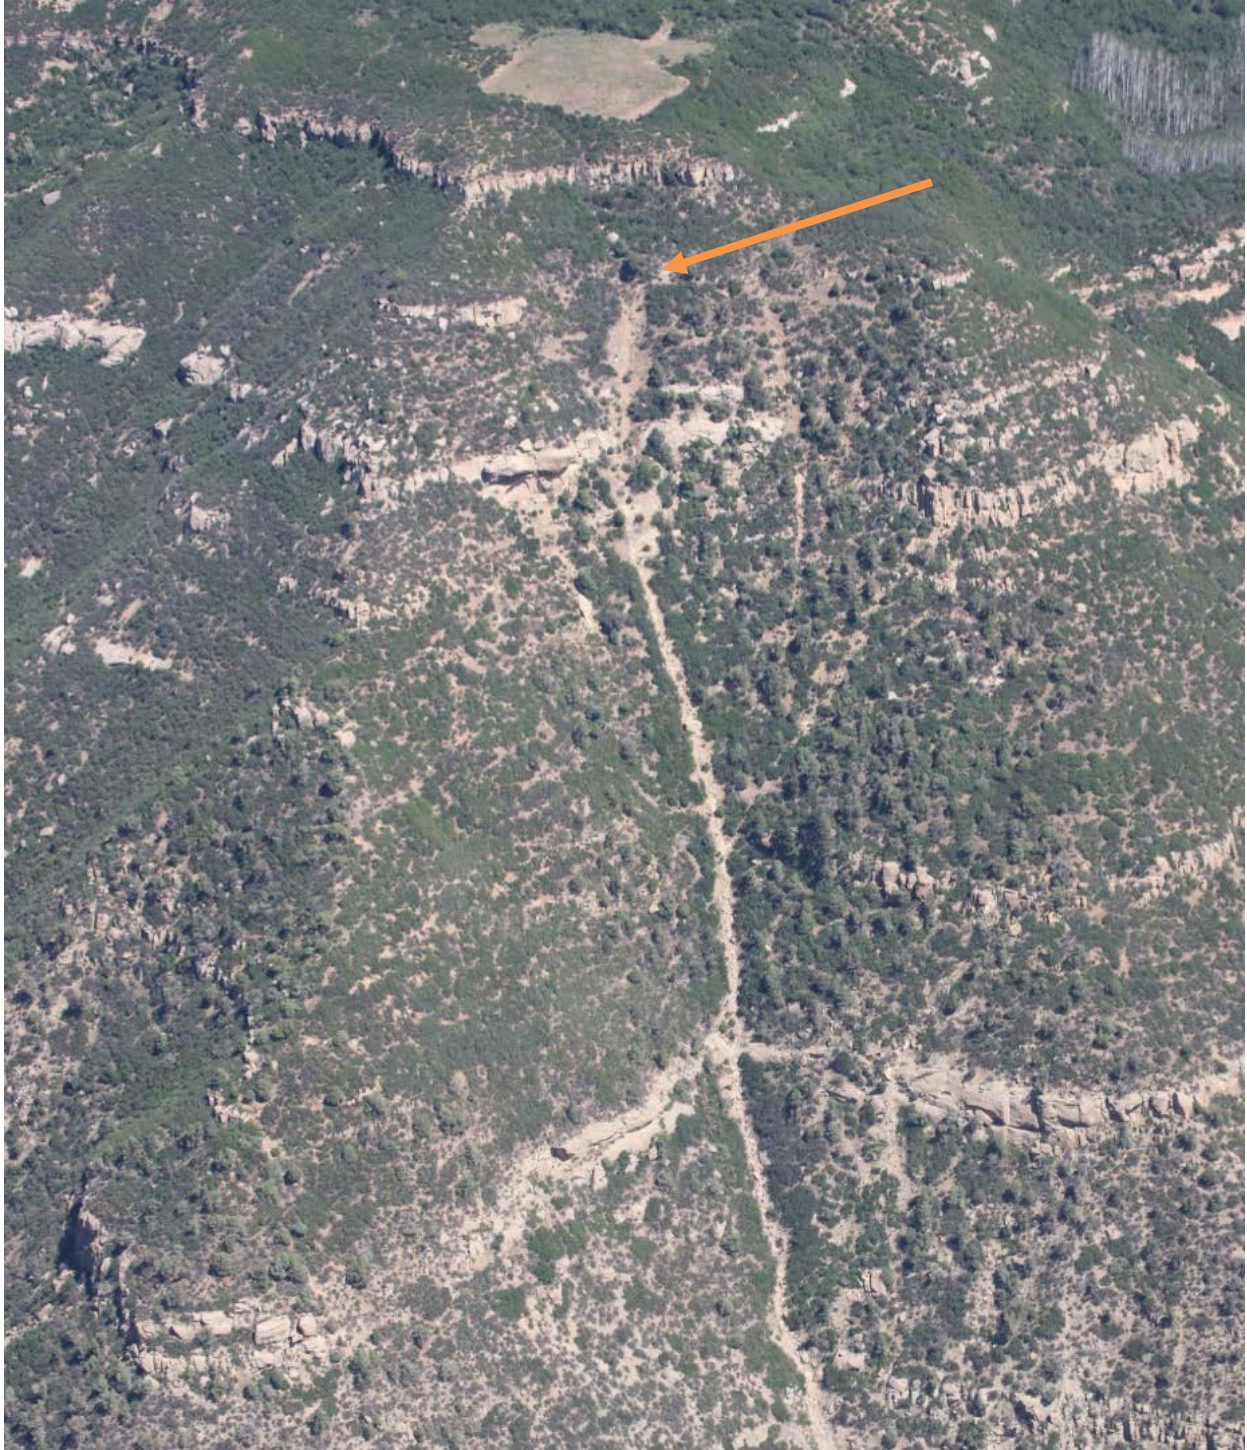
The pictures of B-gulch appear to show a small landslide at a rock outcrop near the head of the gulch. The rockfall/landslide is immediately south of the CBM-9/10/12/14 pad, and perhaps 50-100' lower in elevation. The aerial images do not suggest that the pad contributed to increased runoff down the gulch or could be linked to the landslide.

Figure 9: Rockfall/landslide in B-gulch

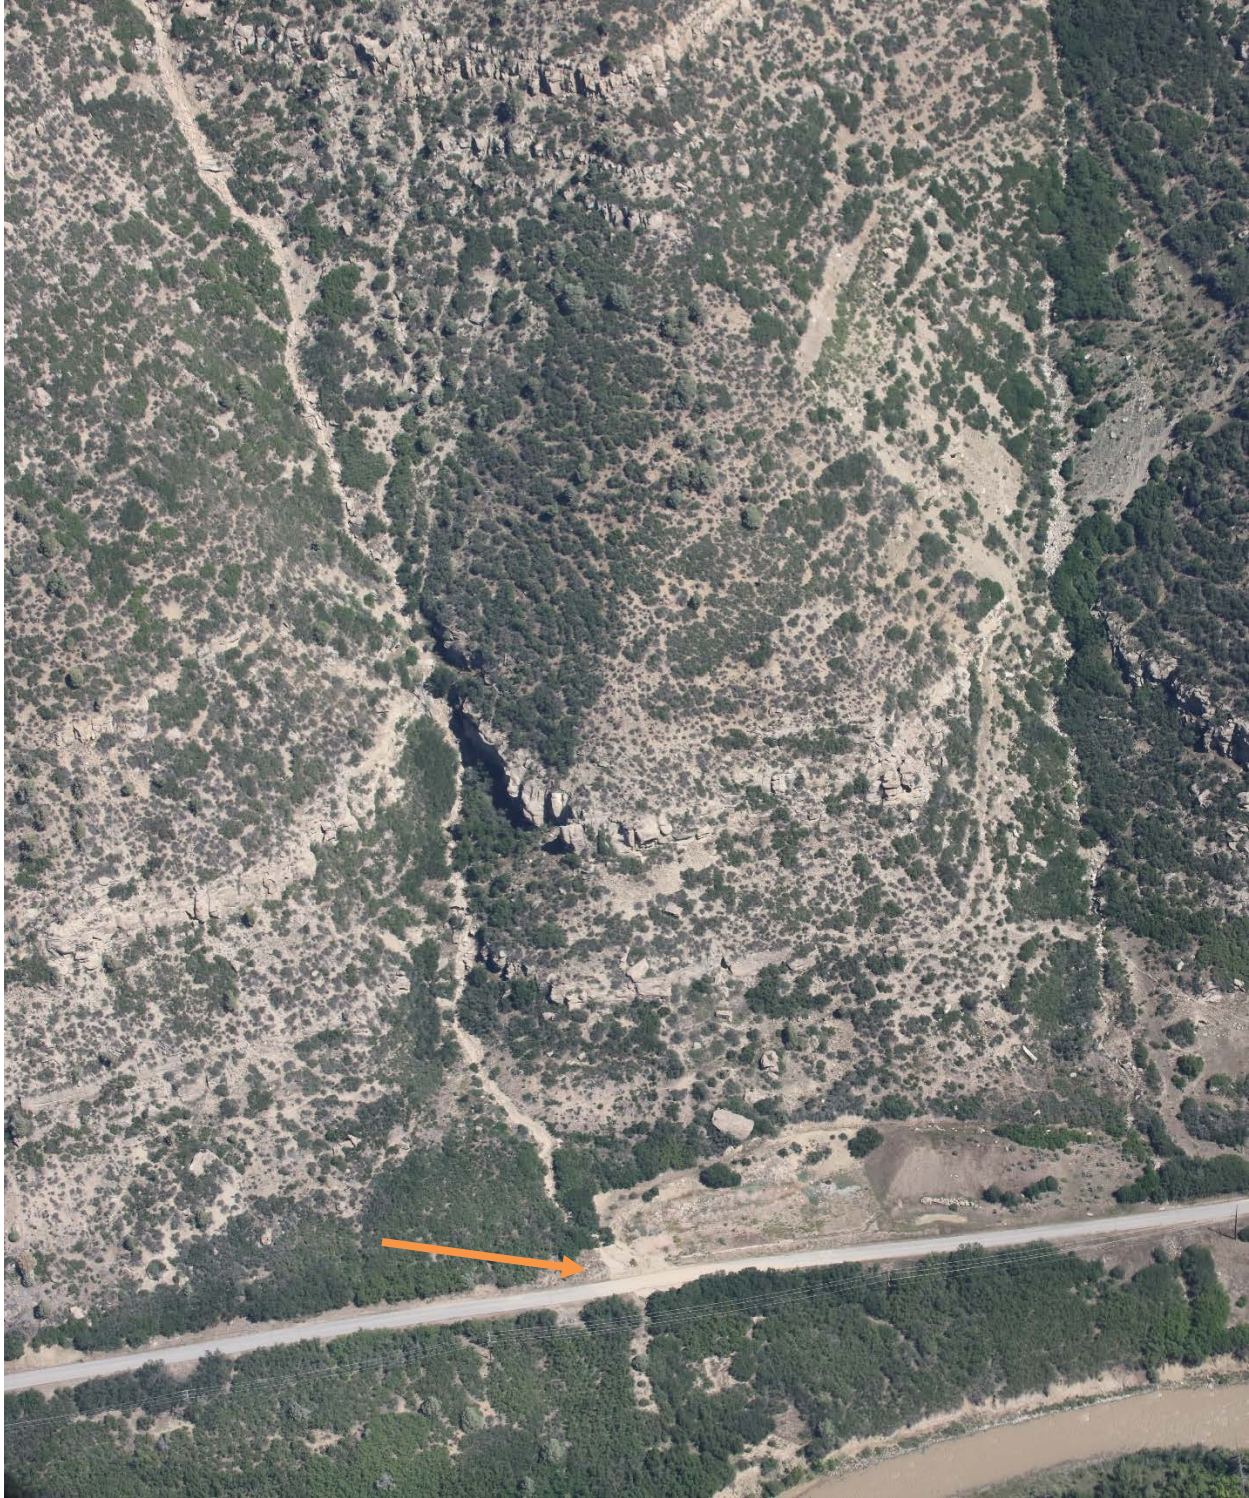
Figure 10: Lower section of B-gulch, with landslide debris near old Highway 133
