PERMIT INFORMATION

Permit Number: C-1981-041	County:
Mine Name: Roadside Portals	County: Operati Permit
Operator: Snowcap Coal Company, Inc.	Permit S

INSPECTION INFORMATION

Inspection Start Date: July 30, 2021 Inspection Start Time: 11:00 Inspection End Date: July 30, 2021 Inspection End Time: 11:05		Inspection Type: Aerial Inspection Inspection Reason: Normal I&E Program Weather: Clear			
Joint Inspection Agency: Join		Joint	oint Inspection Contacts:		
None		None			
Post Inspection Agency: Post		Post Inspection Contacts:			
None N		None			
Inspector(s):	Inspector's Signature:			Signature Date:	
Clayton Wein	Clayton Wein 8/3/2021		8/3/2021		
Brock Bowles	95

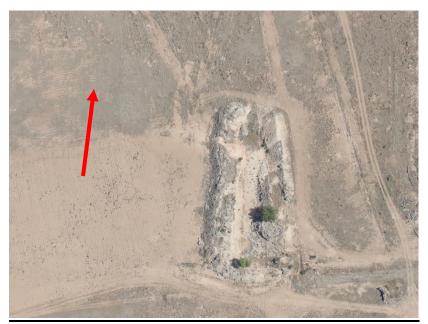
At the time of the inspection the Carey Pit (Photo 1), located to the southwest of the TR-69 repair area, was dry. There were no indications of recent water application to the pit. The landowner's field located to the southeast of the tr-69 repair area was also dry (Photo 2). There was no evidence of recent irrigation practices in that area. The Trenches on top of the Tract 70 Mesa were observed to be dry (Photos 3 and 4). There were no indications off recent water applications within the trenches. The mesa appeared to be stable with no indications of recent sloughage.

Photo 1: The dry Carey Pit.

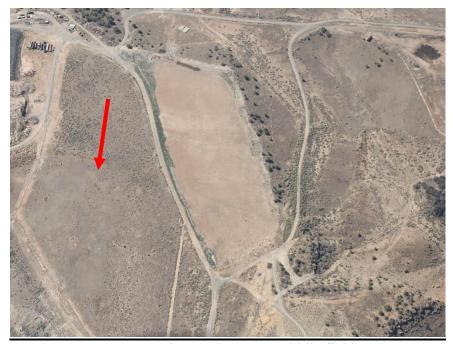
Photo 2: The Landowner's middle field.

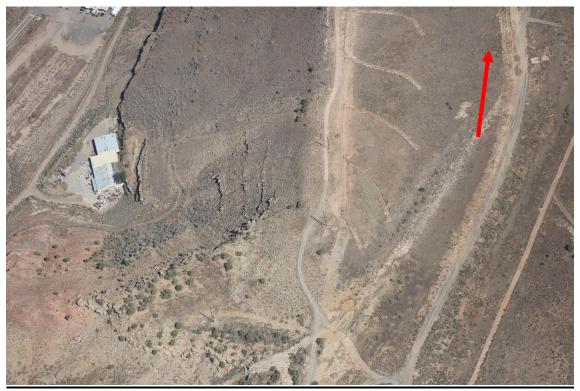
Photo 3: The south section of the Tract 70 Mesa.

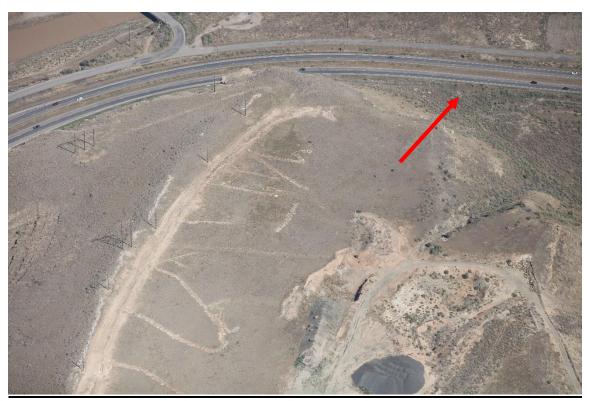
Photo 4: The North section of the Tract 70 Mesa.

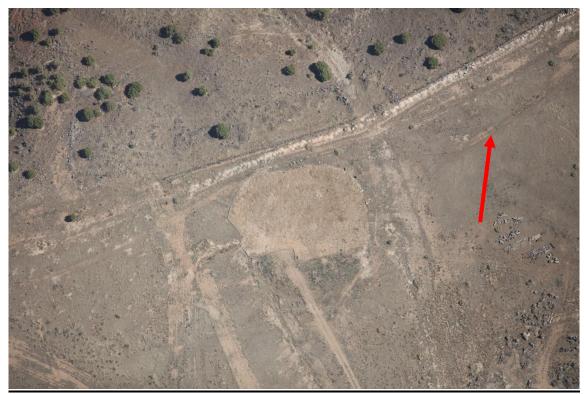
Vegetation on the TR-69 repair area was covering the site (Photo 5). Much of the vegetation has dried out, similar to the surrounding areas. Vegetation in the arid climate typically is this way during the summer months. The site was stable and there was no evidence of erosional features. There was no indication of surface settling at the site. The site is approximately 0.4 acres in size and is the only remaining permitted disturbed area at the mine site.

Photo 5: The TR-69 Repair Area is located in the center of the photo.
