MINERALS PROGRAM INSPECTION REPORT
PHONE: (303) 866-3567

MINE NAME: Perrino Pit	MINE/PROSPECTING ID#: M-2017-007	MINERAL: Sand and gravel	COUNTY: Huerfano
INSPECTION TYPE: Monitoring	INSPECTOR(S): Patrick Lennberg	INSP. DATE: July 28, 2021	INSP. TIME: 08:00
OPERATOR: Colorado Crushing, Inc.	OPERATOR REPRESENTATIVE: Rocky Ryan, Matt Ryan	TYPE OF OPERATION: 112c - Construction Regular Operation

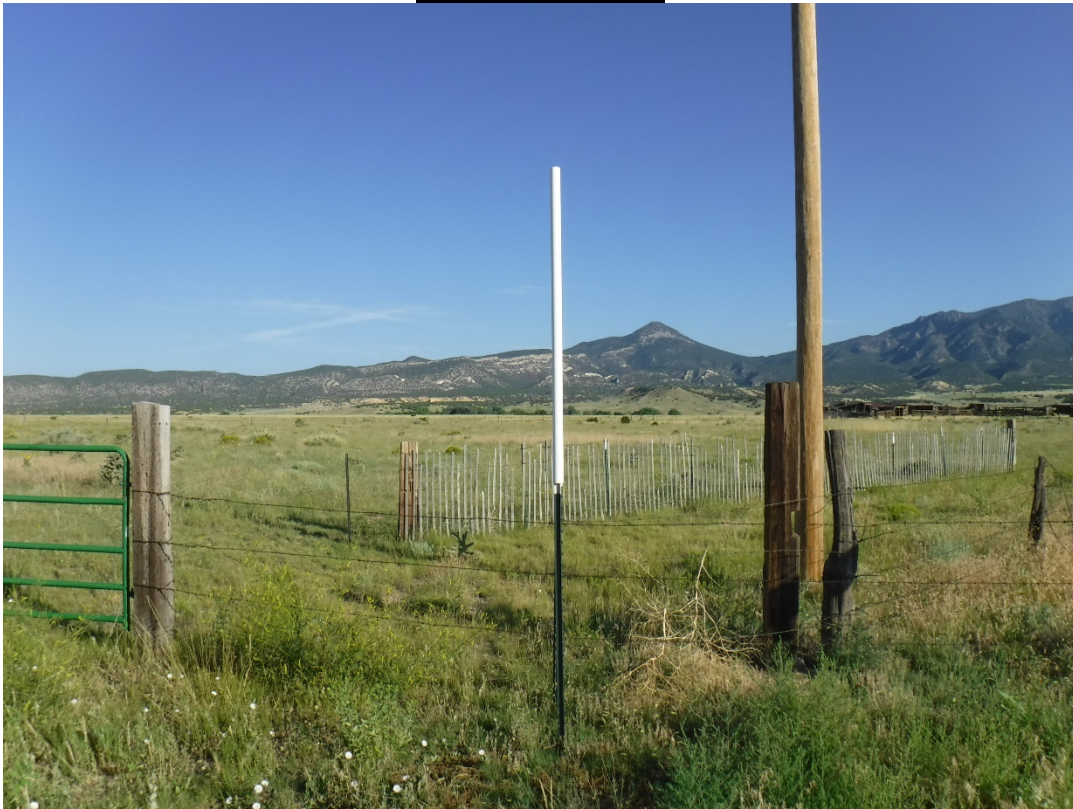
Photo 1: Typical permit boundary marker, southwestern corner

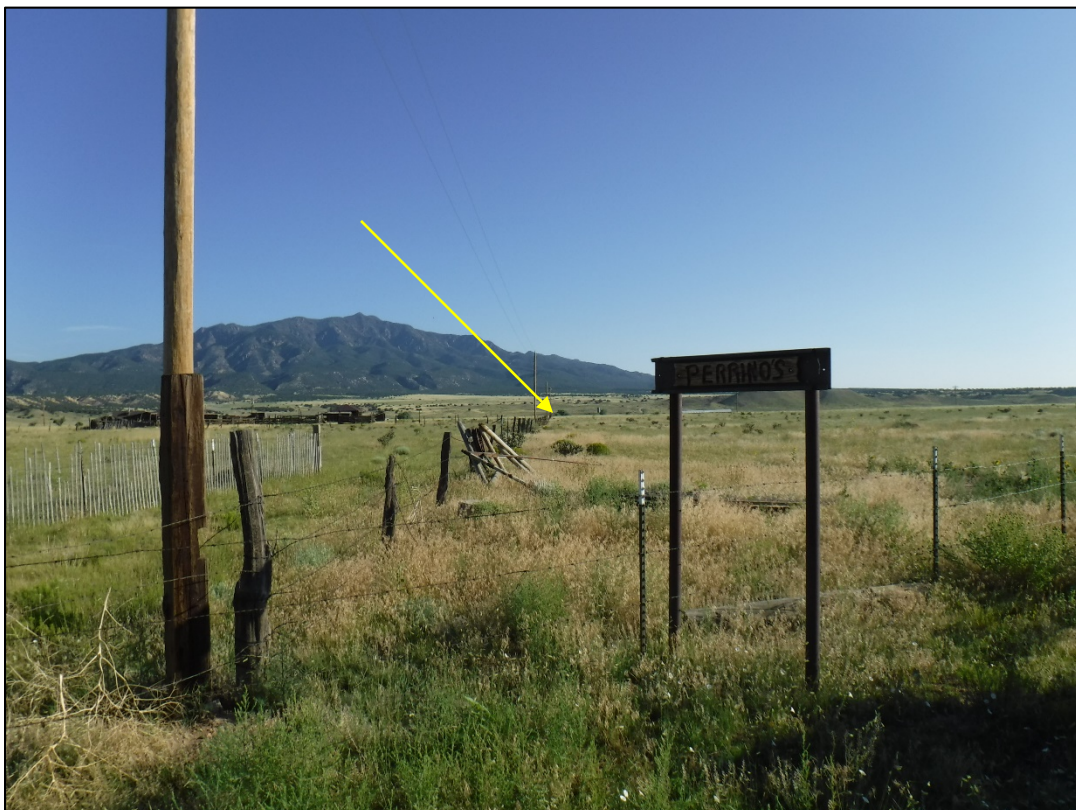
Photo 2: Primary mine entrance southwestern corner, yellow arrow indicates northwestern boundary marker

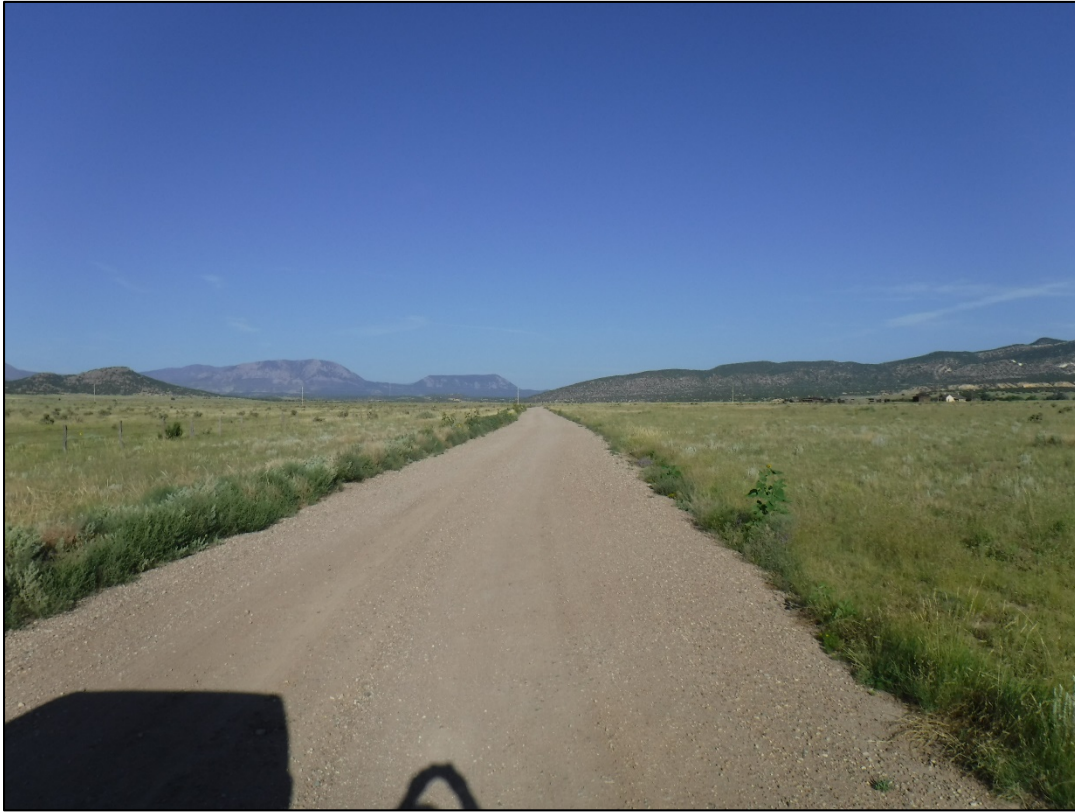
Photo 3: Looking west along haul road leading to southwestern mine entrance

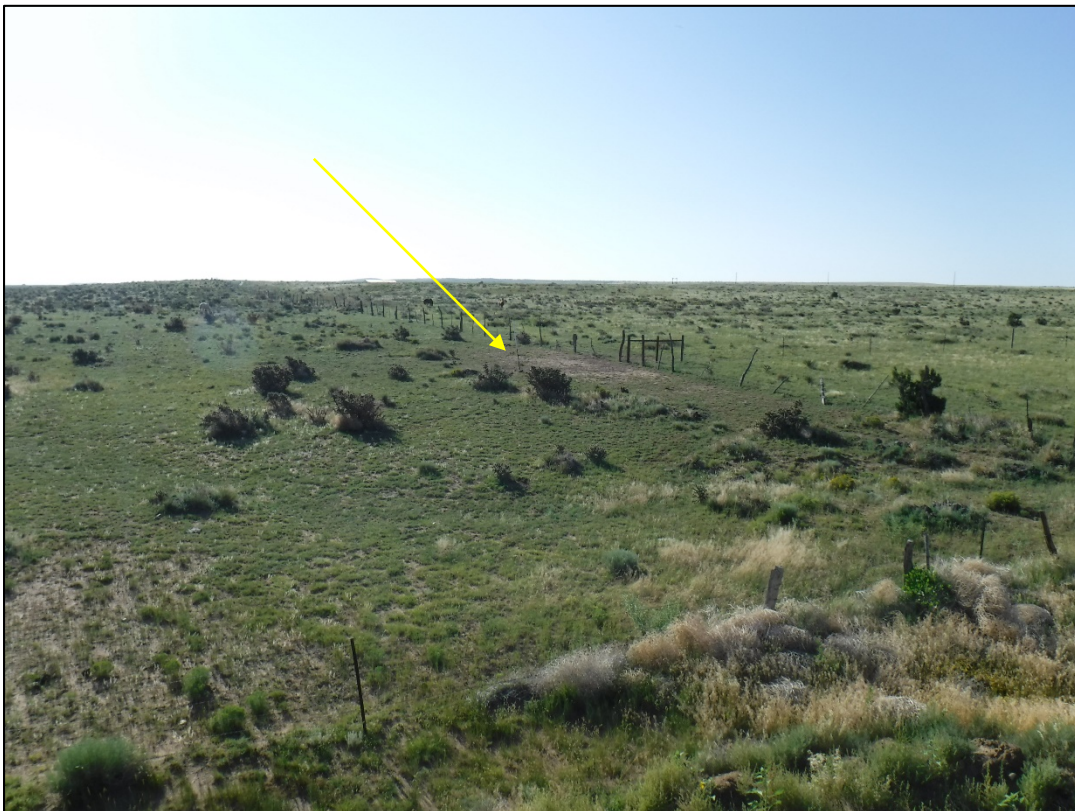
Photo 4: Southeastern permit corner marker, yellow arrow

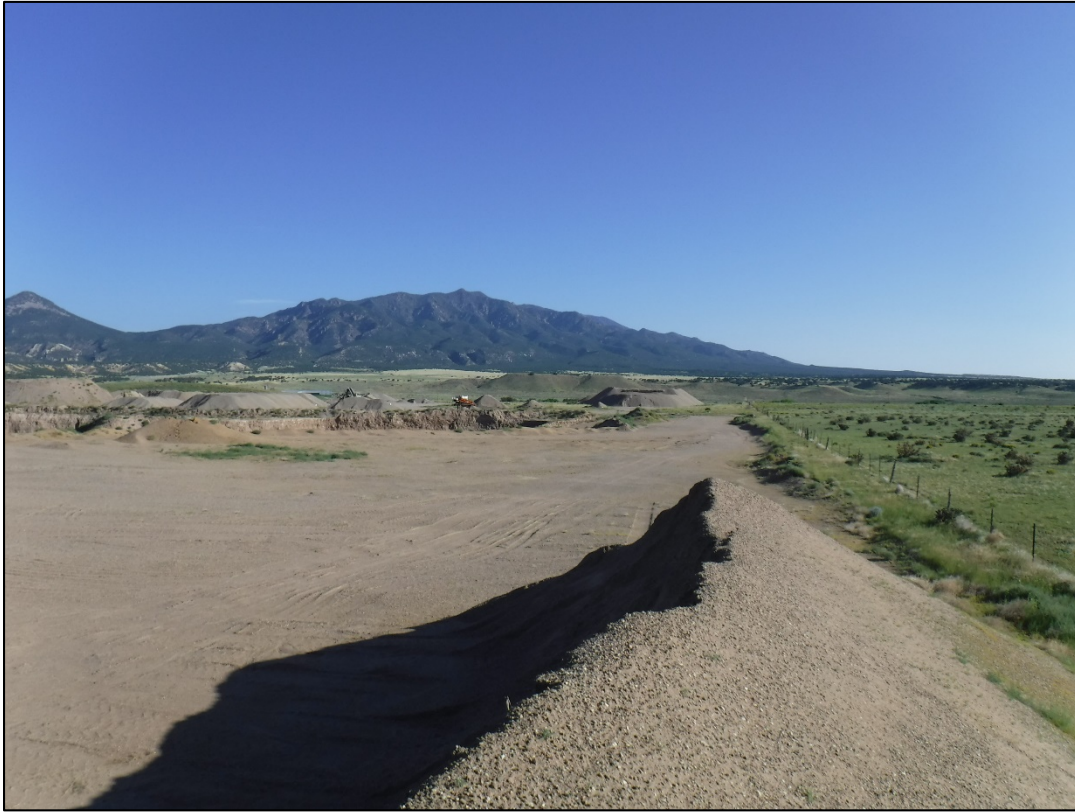
Mining activities began in the southeastern corner of the permit area and is slowly progressing to the north. Rocky stated they have encountered more reject material than was originally anticipated. They have used this excess material to backfill the pit as it moves north. The backfilled pit has been graded but no topsoil has been placed. The excavation is approximately 20-30 feet in depth but varies depending on minable material. The highwall of the pit area is approximately 1,700 feet long with slopes near vertical to 2H:1V. The operator is encouraged to review the approved Mining Plan in regards to highwall dimensions and update if warranted.

Photo 5: Looking north from near the southeastern permit corner, area left of center in foreground has been backfilled

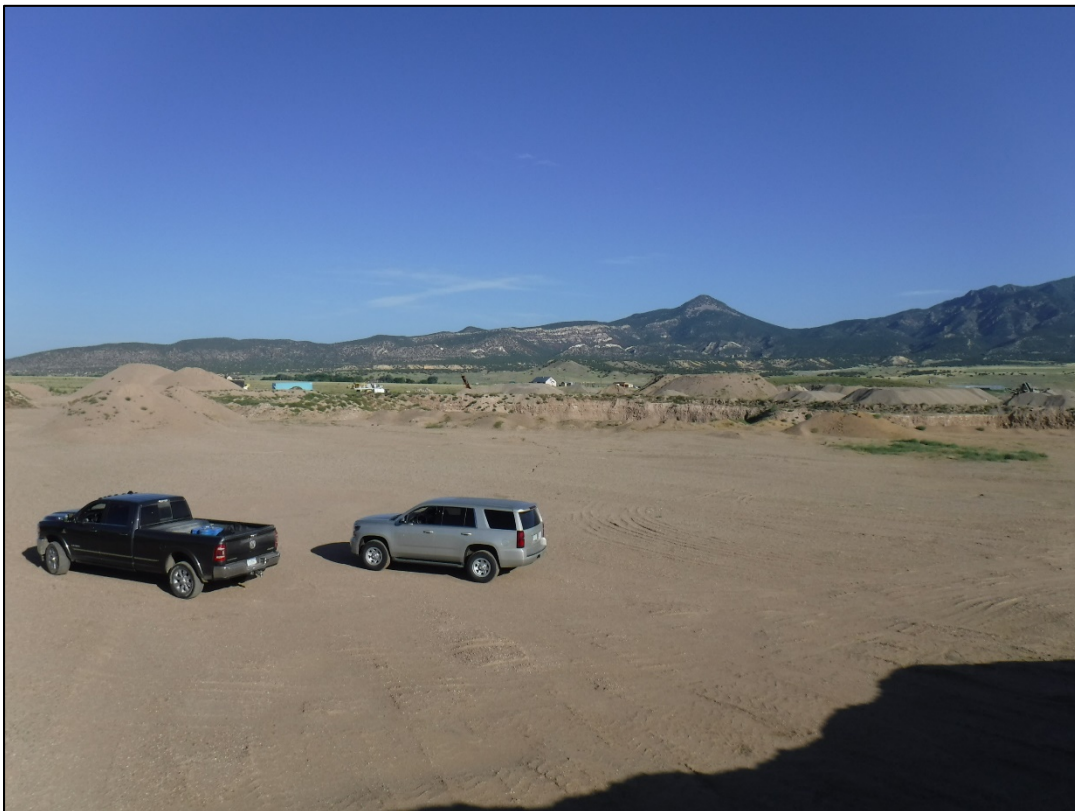
Photo 6: Looking northwest across disturbed area, area beneath the trucks has been mined and backfilled

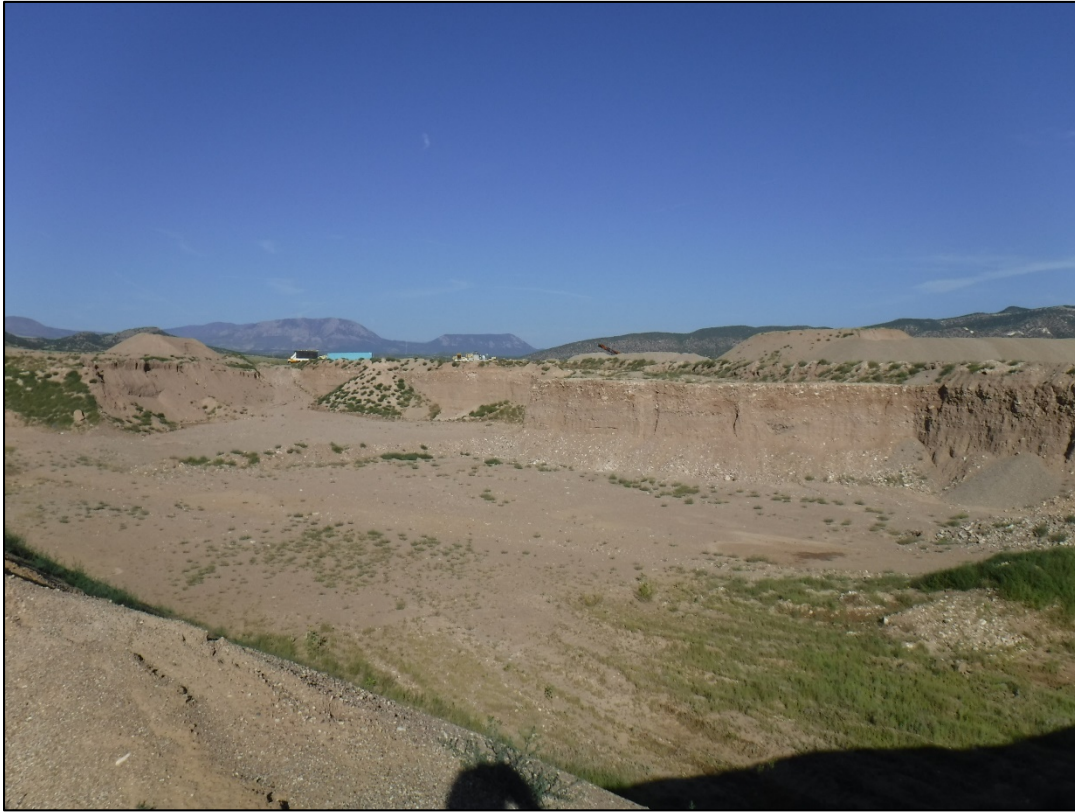
Photo 7: Typical conditions found within the pit area

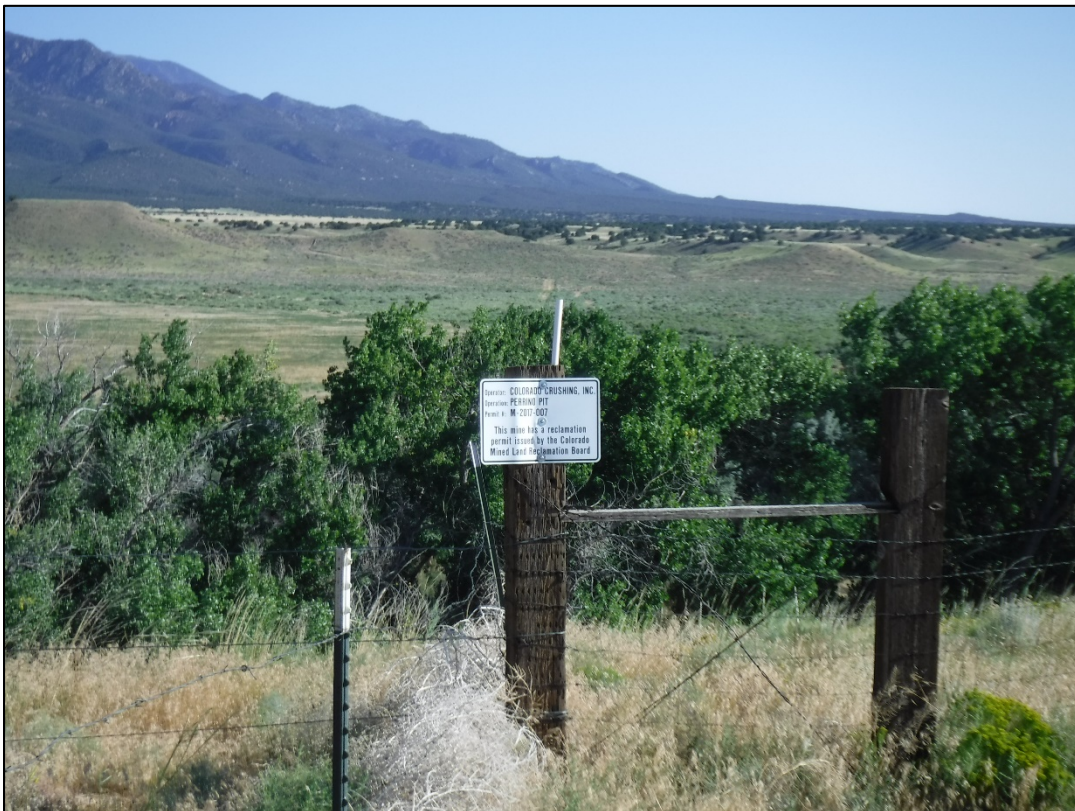
PROBLEM: The mine identification sign was not posted at the main entrance of the mine site. This is a problem for failure to post a mine identification sign as required by Section 3.1.12(1) of the rule. The Operator shall, at the main entrance of the mine site post a sign, which shall be clearly visible from the access road, with a minimum size equaling one hundred and eighty-seven (187) square inches, such as eleven (11) inches in height and seventeen (17) inches in width, with appropriate font size, with the following: the name of the Operator, a statement that a reclamation permit for the operation has been issued by the Colorado Mined Land Reclamation Board; and the permit number.

Photo 8: Mine sign at northeastern mine entrance

CORRECTIVE ACTIONS: The operator shall, at the entrance of the mine site, post a sign which shall be clearly visible from the access road with the following: the name of the operator, a statement that a reclamation permit for the operation has been issued by the Colorado Mined Land Reclamation Board; and the permit number. The operator shall submit photo documentation that a proper sign has been posted by the corrective action date.

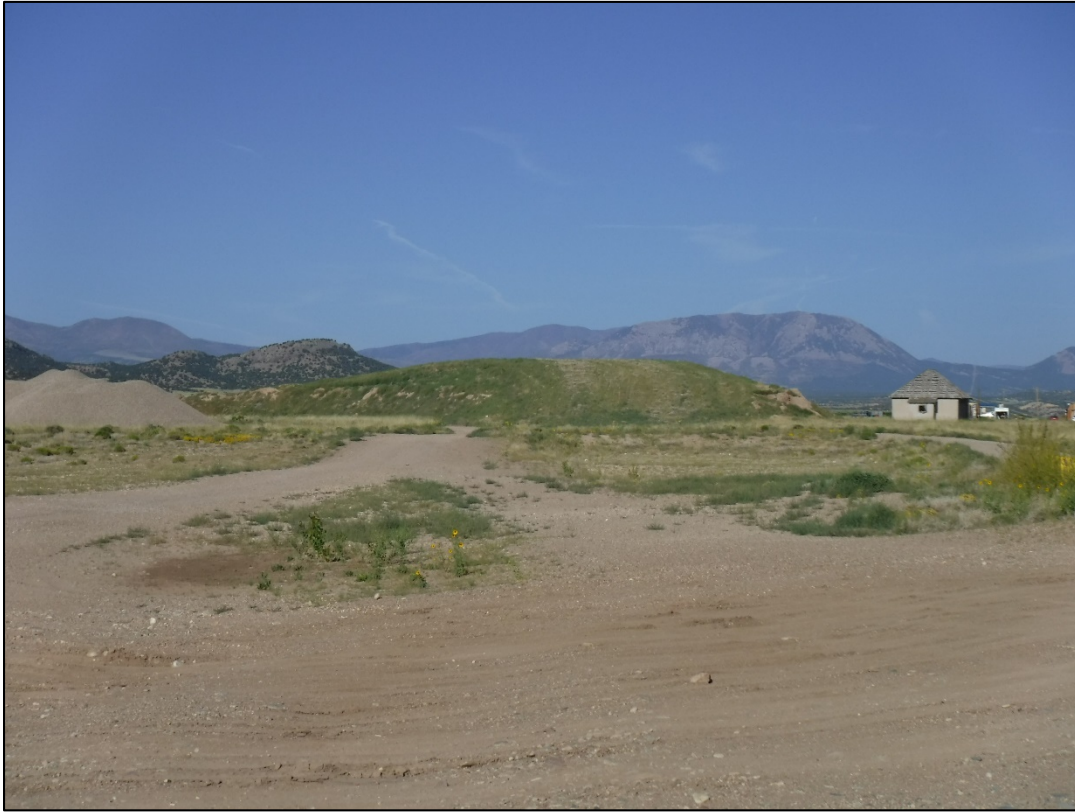
Photo 9: Topsoil stockpile with vegetation growth

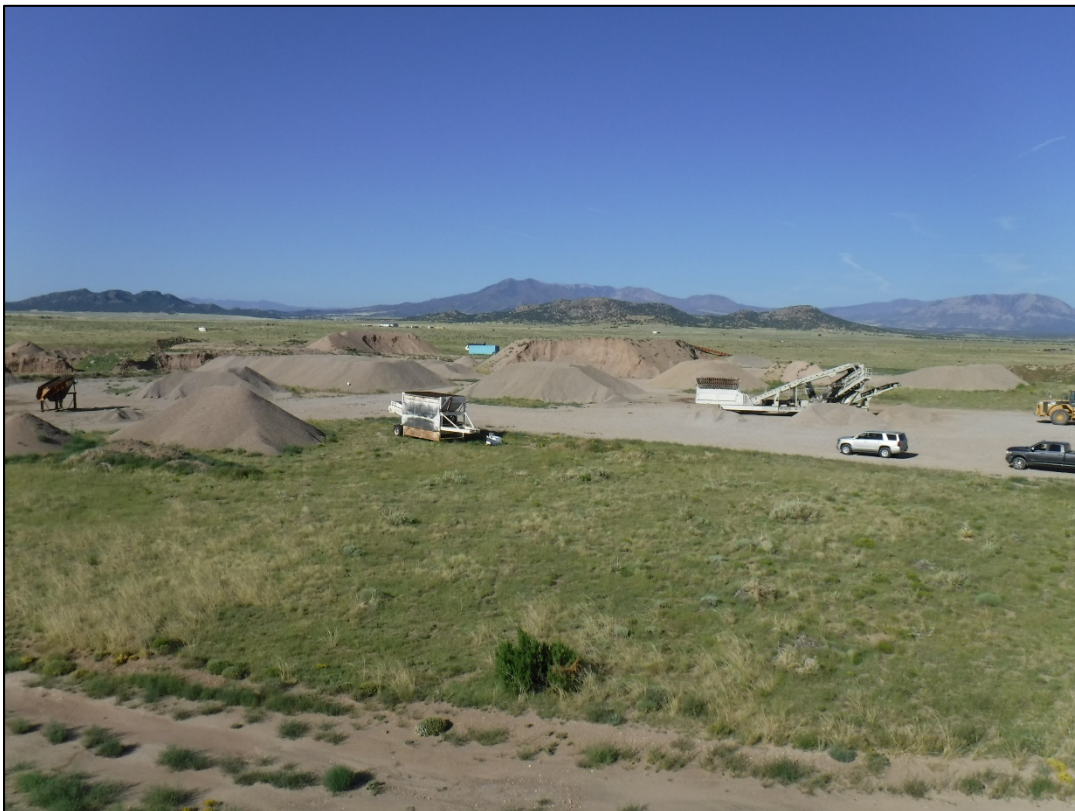
The mine was not active at the time of inspection however there were several stockpiles of processed material throughout the disturbed area. The Mine Plan states only 20 acres will be disturbed at one time. The Division, using the online Huerfano County Public Map Viewer attachment 1, estimated the disturbed area to be 28.6 acres. Disturbing more area than is approved is being cited as a problem pursuant to C.R.S. 34-32.5-112 (1)(c)(VII).

Photo 10: Looking southwest, overview of disturbed area.

CORRECTIVE ACTIONS: The operator shall submit a Technical Revision, with the required \$216 revision fee, to update and clarify the current approved mine plan to reflect existing and proposed activities by the corrective action date.

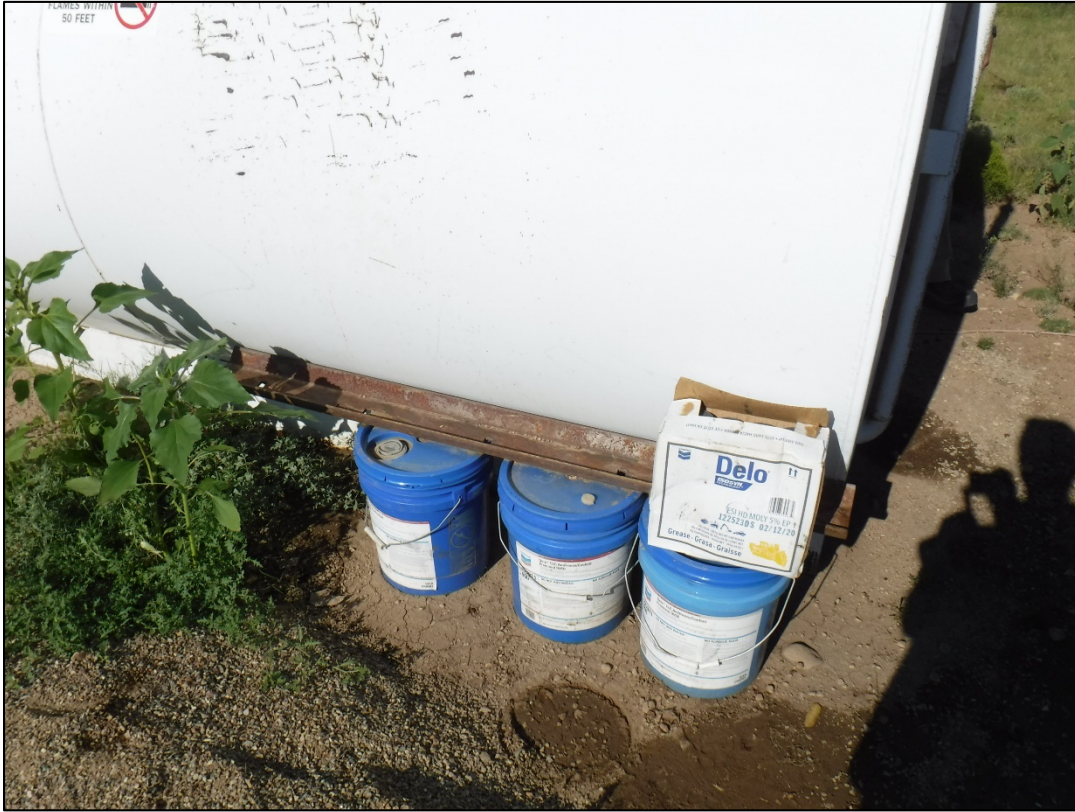
Near the portable screen and 2,000 gallon double walled fuel tank there were several 5-gallon buckets of used anti-freeze and boxes of lubricant grease tubes. The operator was informed the buckets and grease need to be placed in some kind of secondary containment vessel to protect the environment from accidental spills. The operator stated he would get a Job Box or similar to put them in to also protect them from sun degradation.

Photo 11: Anti-freeze buckets and grease box

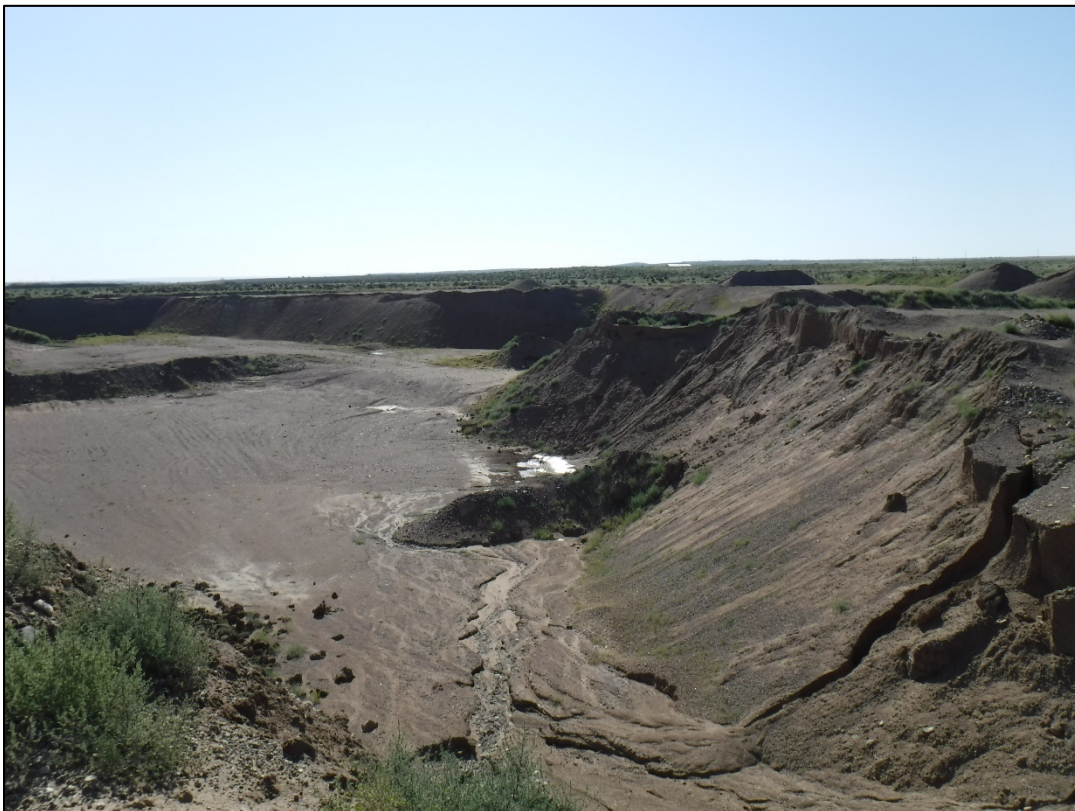
Photo 12: Looking at the pit entrance from the west
