LORENCITO CANYON MINE
Permit No. C-1996-084

INSPECTION OF EXCESS SPOIL-FILLS 7, 8, & 9
June 30, 2021

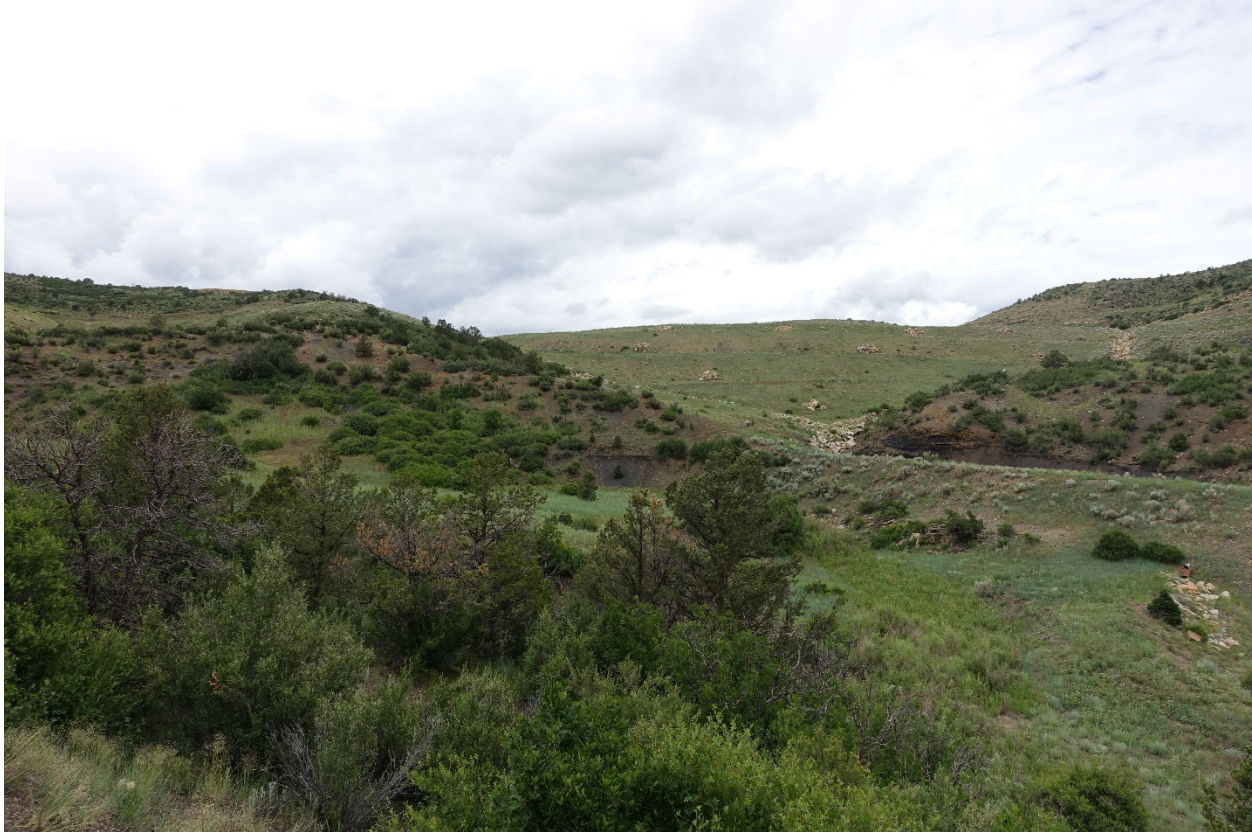
Fill #7

The entire excess spoil fill facility was examined for signs of failure and instability such as tension cracks, ground movement, springs and seeps, and standing water. There was no indication of potential instability at time of inspection.

Overall the site is in good condition. The vegetation on the fill is encouraging.

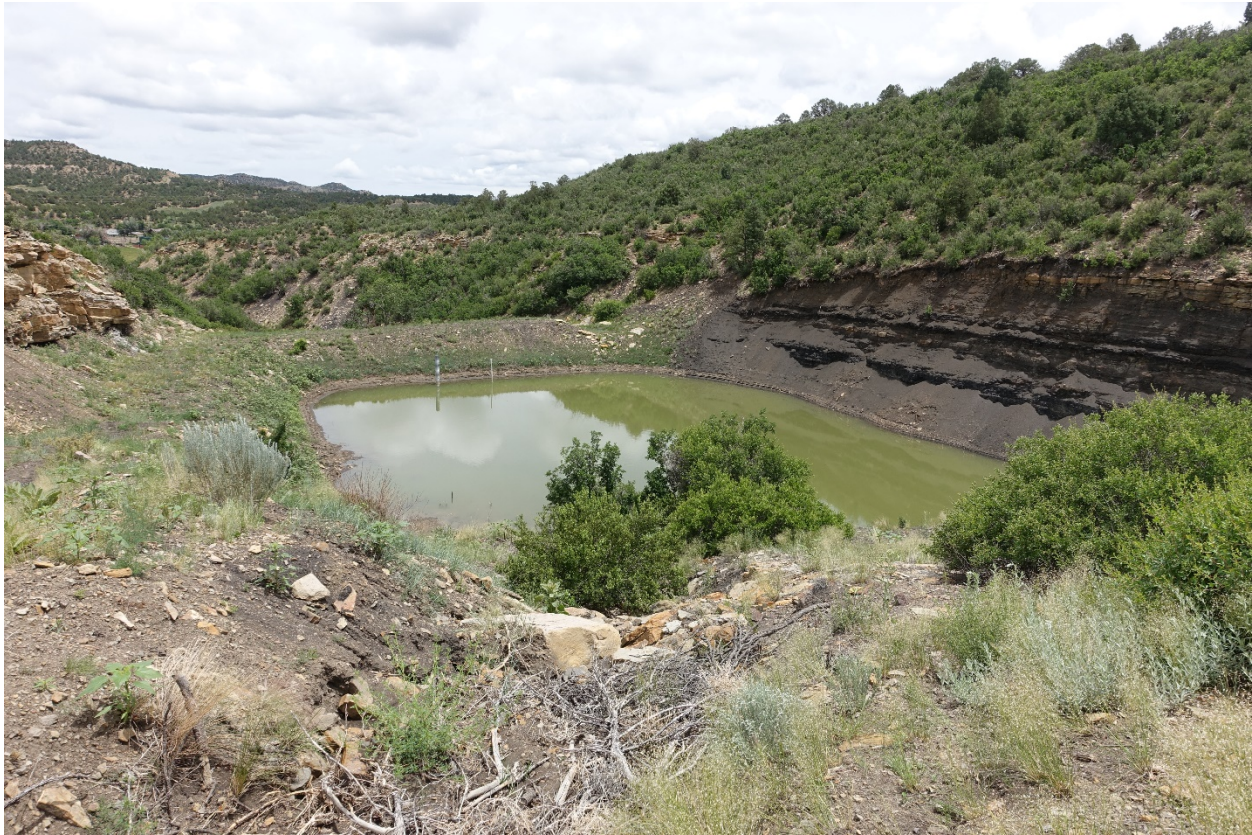
The entire excess spoil fill facility was examined for signs of failure and instability such as tension cracks, ground movement, springs and seeps, and standing water. There was no indication of potential instability at time of inspection.

Overall the site is in good condition. Vegetation is very good on the fill.

Pond at bottom of Fill #8

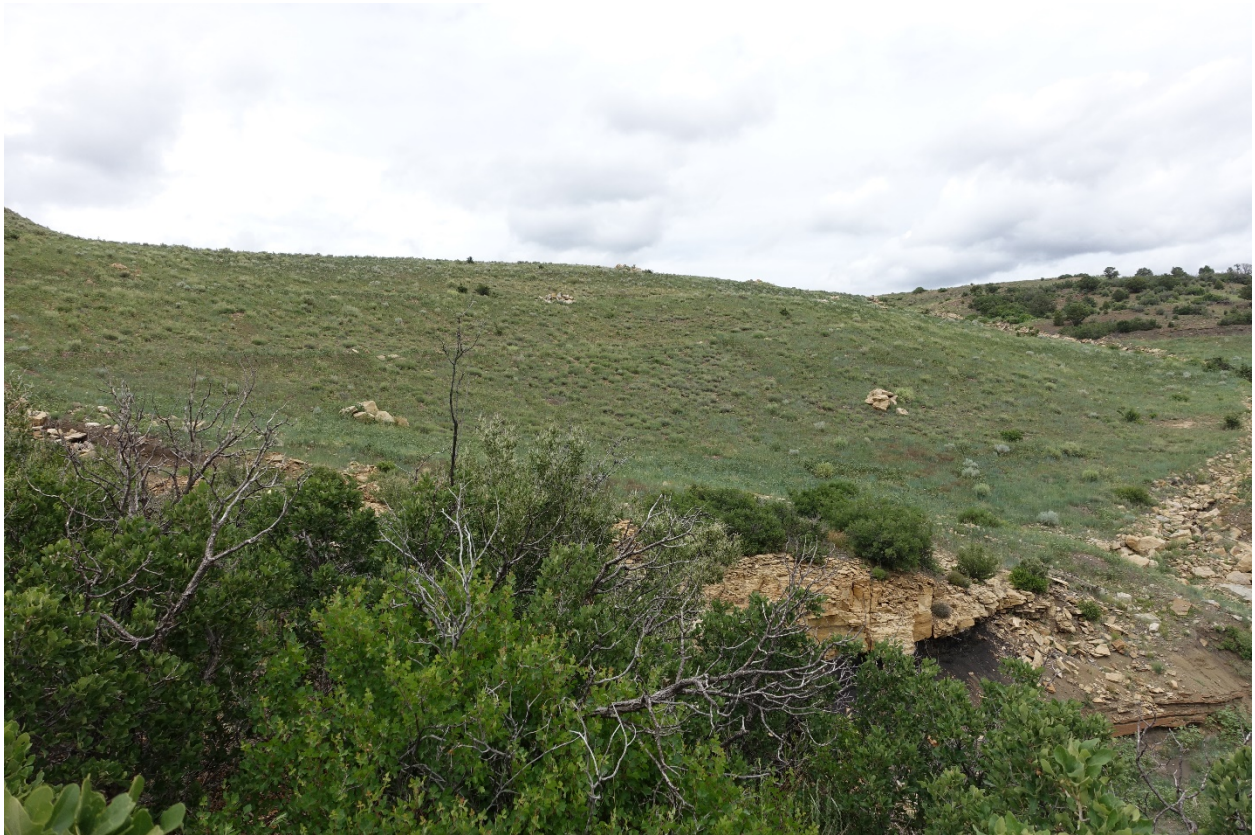
Fill #9

The entire excess spoil fill facility was examined for signs of failure and instability such as tension cracks, ground movement, springs and seeps, and standing water. There was no indication of potential instability at time of inspection.

Overall the site is in good condition.
