MINERALS PROGRAM INSPECTION REPORT
PHONE: (303) 866-3567

MINE NAME: LBC Bentonite Pit	MINE/PROSPECTING ID#: M-1977-231	MINERAL: Clay (general)	COUNTY: Fremont
INSPECTION TYPE: Monitoring	INSPECTOR(S): Timothy Cazier, P.E.	INSP. DATE: July 21, 2021	INSP. TIME: 11:20
OPERATOR: First Bentonite Company Colorado	OPERATOR REPRESENTATIVE: Pam Wedge	TYPE OF OPERATION: 110c - Construction Limited Impact	
REASON FOR INSPECTION: Normal I&E Program	BOND CALCULATION TYPE: None	BOND AMOUNT: \$11,100.00	
DATE OF COMPLAINT: NA	POST INSP. CONTACTS: U.S.BLM	JOINT INSP. AGENCY: U.S.BLM	
WEATHER: Clear	INSPECTOR'S SIGNATURE:

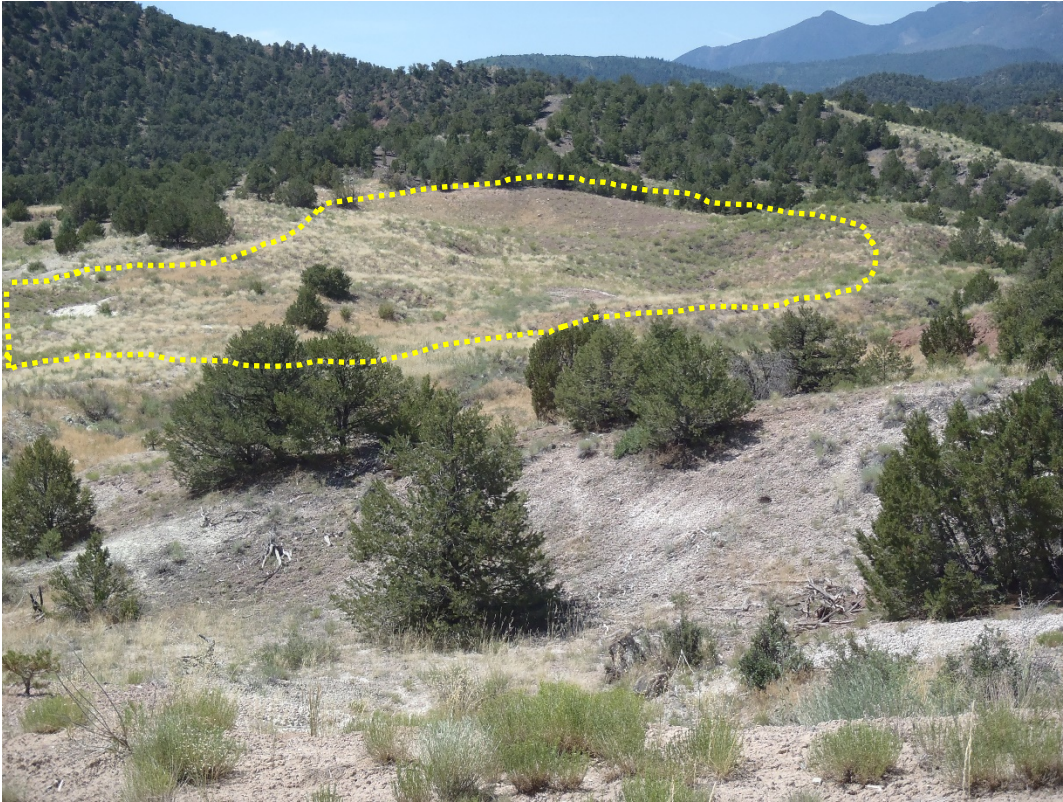
Backfilling and Grading: All backfill and grading have been completed (see **Photos 1 and 2**).

Photo 1. Reclaimed site (circled, looking south).

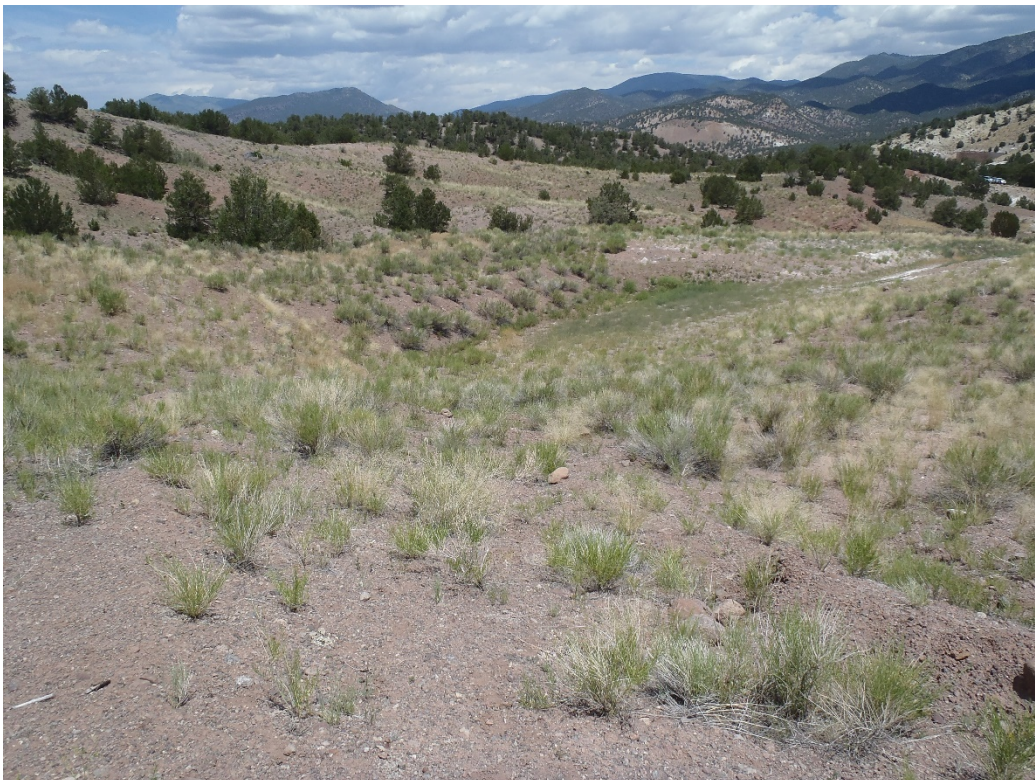
Photo 2. Reclaimed site (looking north from highwall)

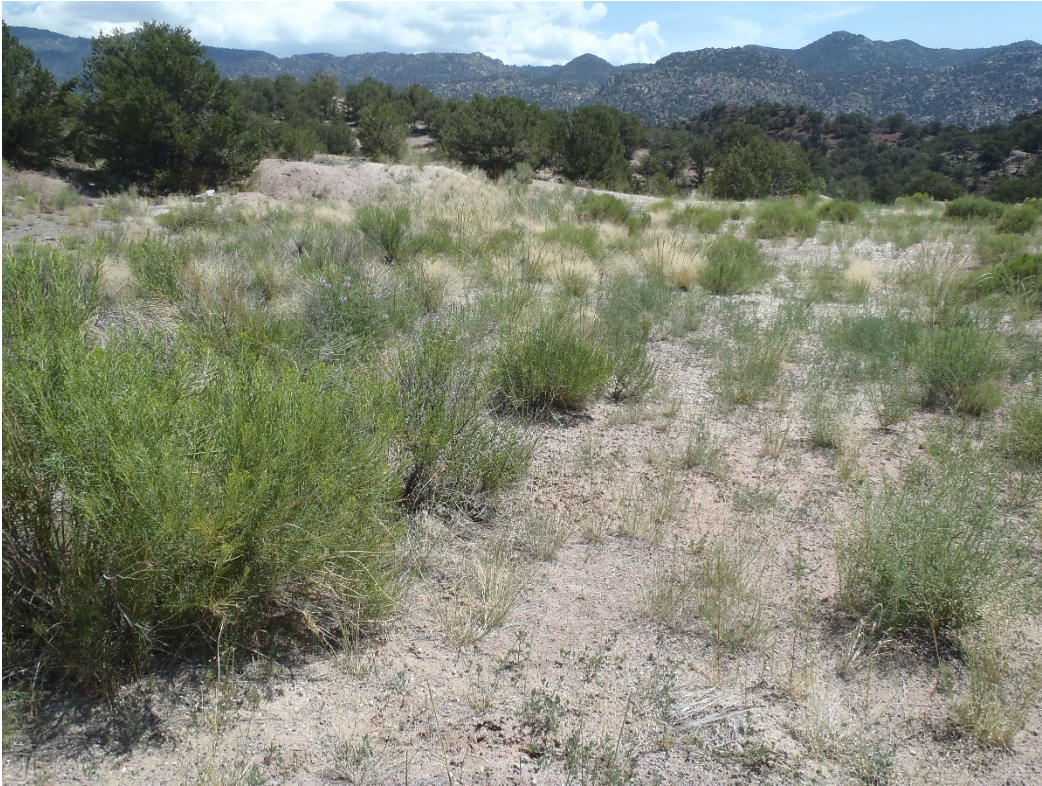
Roads: Haul and access roads have been reclaimed (see **Photos 3 and 4**).

Photo 3. Reclaimed haul road (looking NE from site center).

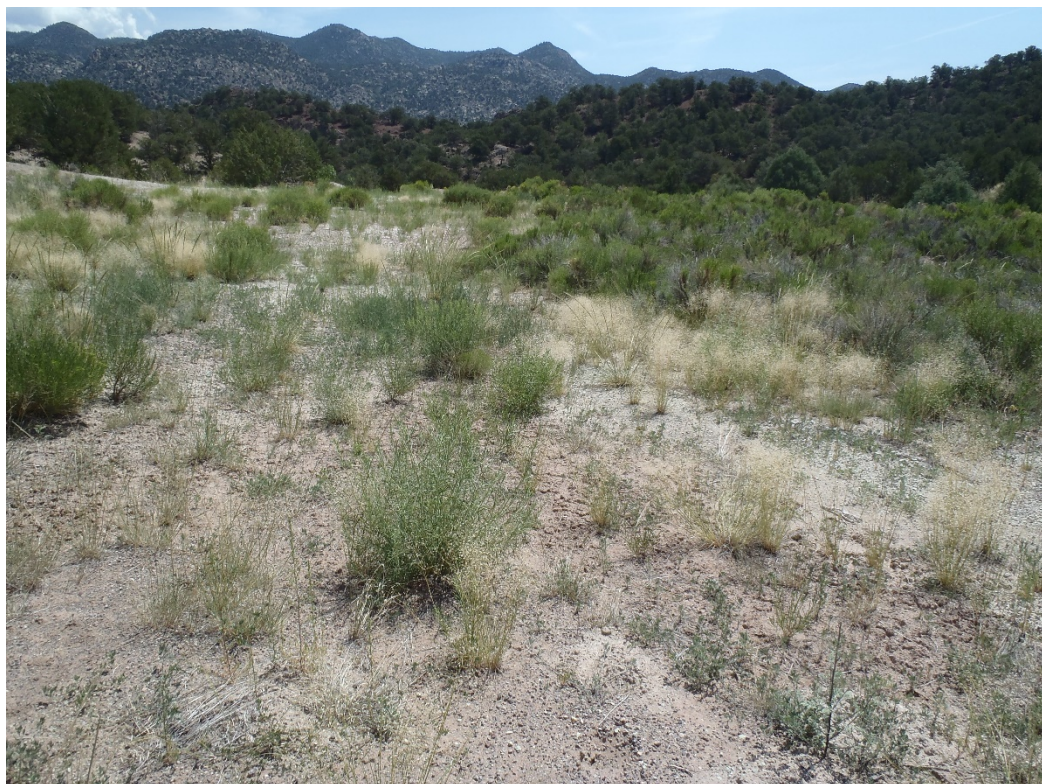
Photo 4. Reclaimed haul road (looking SW from site center).

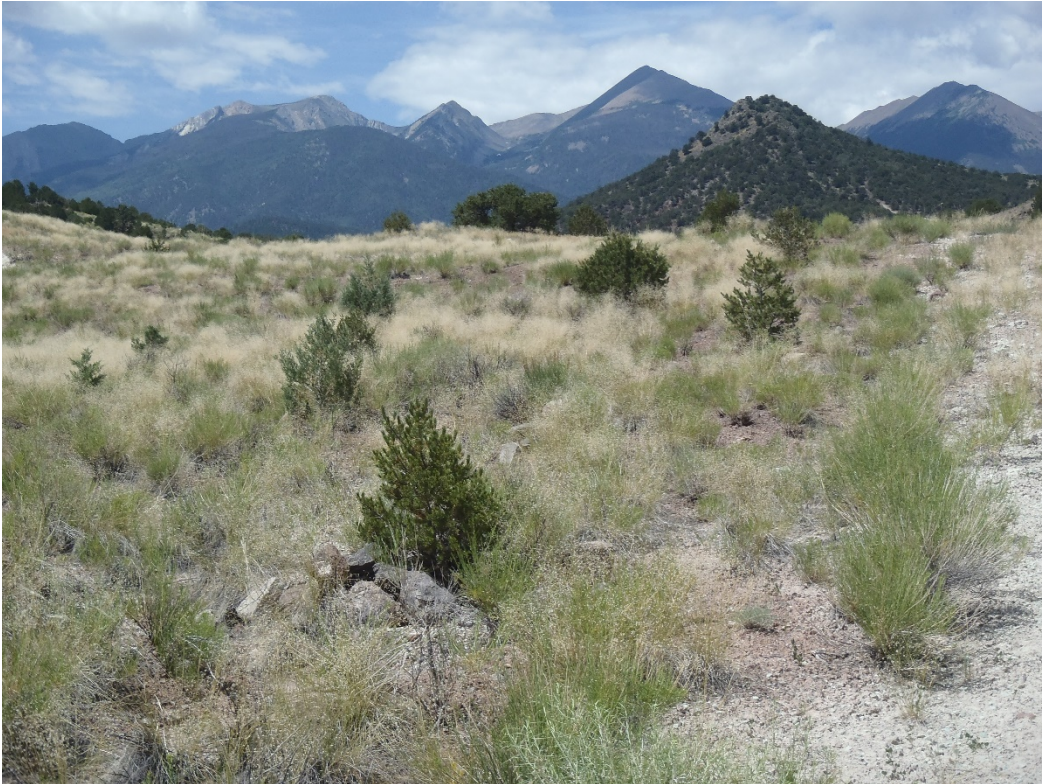
Revegetation: Ms. Wedige stated the site has been seeded three times: 1) October 2018, 2) early spring 2020, and 3) spring 2021. She said the site had been sprayed for thistle in 2019. The condition of the revegetation was very good. Some trees were also planted and are doing well (see **Photo 5**)

Photo 5. Reclaimed area – south-center (looking south from haul road, note trees).

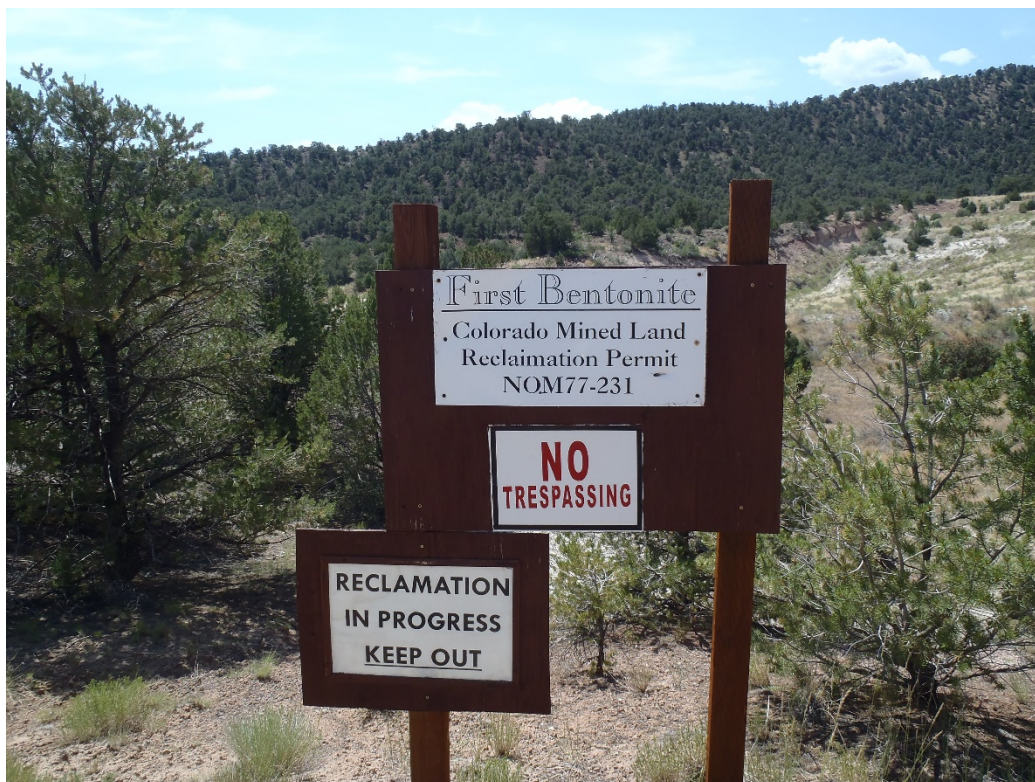
Signs and Markers: The permit sign was properly posted (see **Photo 6**) and boundary markers were observed to still be in place.

Photo 6. Permit sign off Rd 101A.

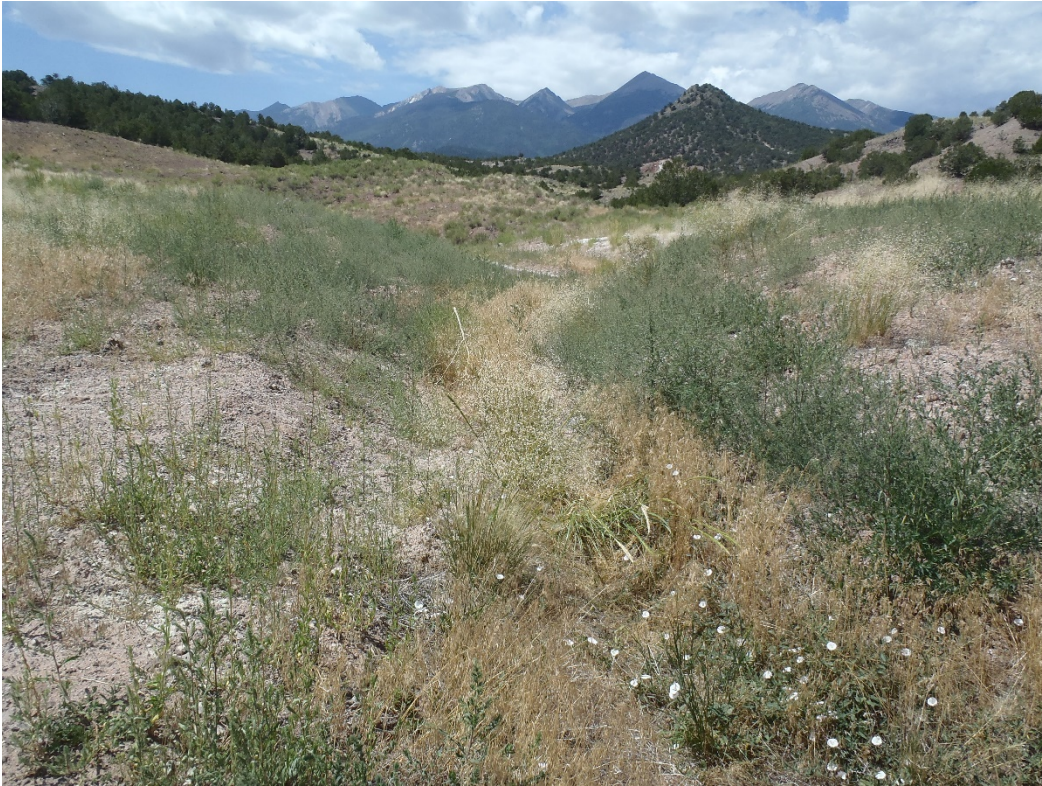
Storm Water MGT Plan: No oil or fuel spills observed. The last element of the reclamation plan to be completed was the swale cut to allow stormwater to flow out of a pond (see **Photo 7**).

Photo 7. Completed swale cut for pond outlet (looking downstream/NE from pond).
