MINERALS PROGRAM INSPECTION REPORT
PHONE: (303) 866-3567

MINE NAME: Schuler Construction Pit # 1	MINE/PROSPECTING ID#: M-2005-002	MINERAL: Gravel	COUNTY: El Paso
INSPECTION TYPE: Surety-Related Inspection	INSPECTOR(S): Timothy Cazier, P.E.	INSP. DATE: August 3, 2021	INSP. TIME: 12:15
OPERATOR: Schuler Construction	OPERATOR REPRESENTATIVE: Travis Casey	TYPE OF OPERATION: 110c - Construction Limited Impact	
REASON FOR INSPECTION: Surety Related	BOND CALCULATION TYPE: Partial Bond	BOND AMOUNT: \$10,000.00	
DATE OF COMPLAINT: NA	POST INSP. CONTACTS: None	JOINT INSP. AGENCY: None	
WEATHER: Cloudy	INSPECTOR'S SIGNATURE:

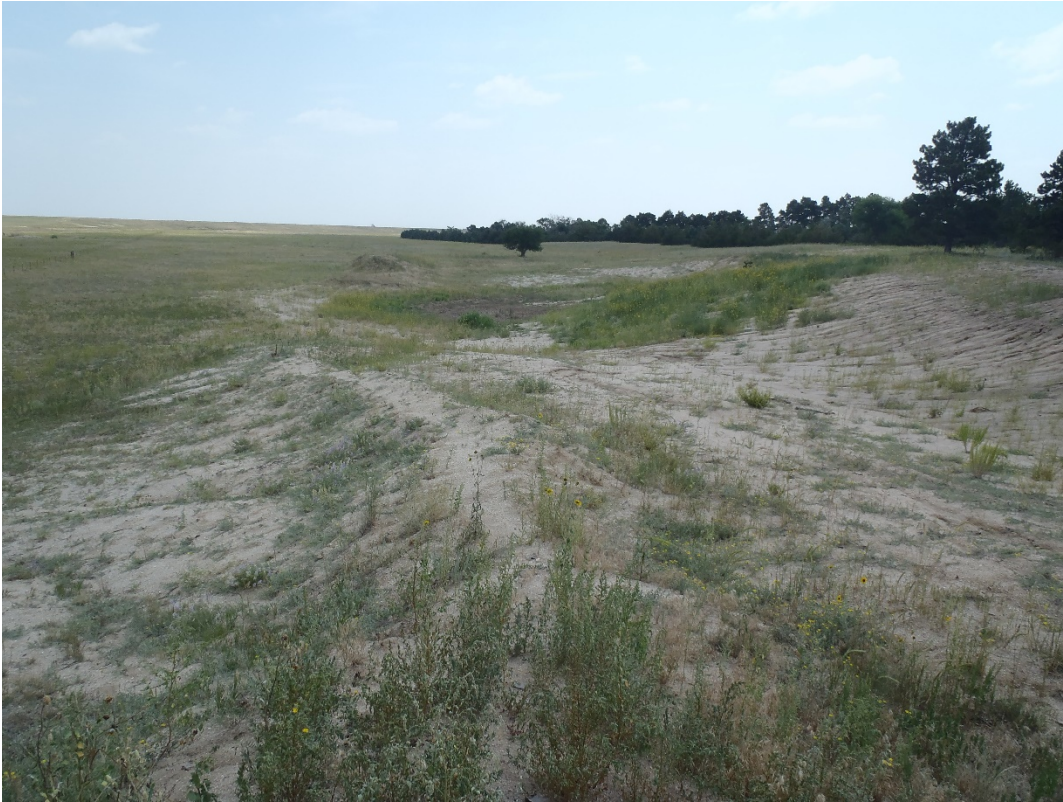
Roads: Haul and access roads have been reclaimed (see **Photo 1**).

Reclamation Success: Highwalls have been sloped to 3H:1V or flatter (see **Photos 1 and 2**) and natural vegetation appears to have established itself (see **Photo 3**). Mr. Casey agreed the vegetation was adequate. The DRMS recommends approving a request for full reclamation liability release.

Photo 1. Reclaimed access road (looking east, area left of road is undisturbed).

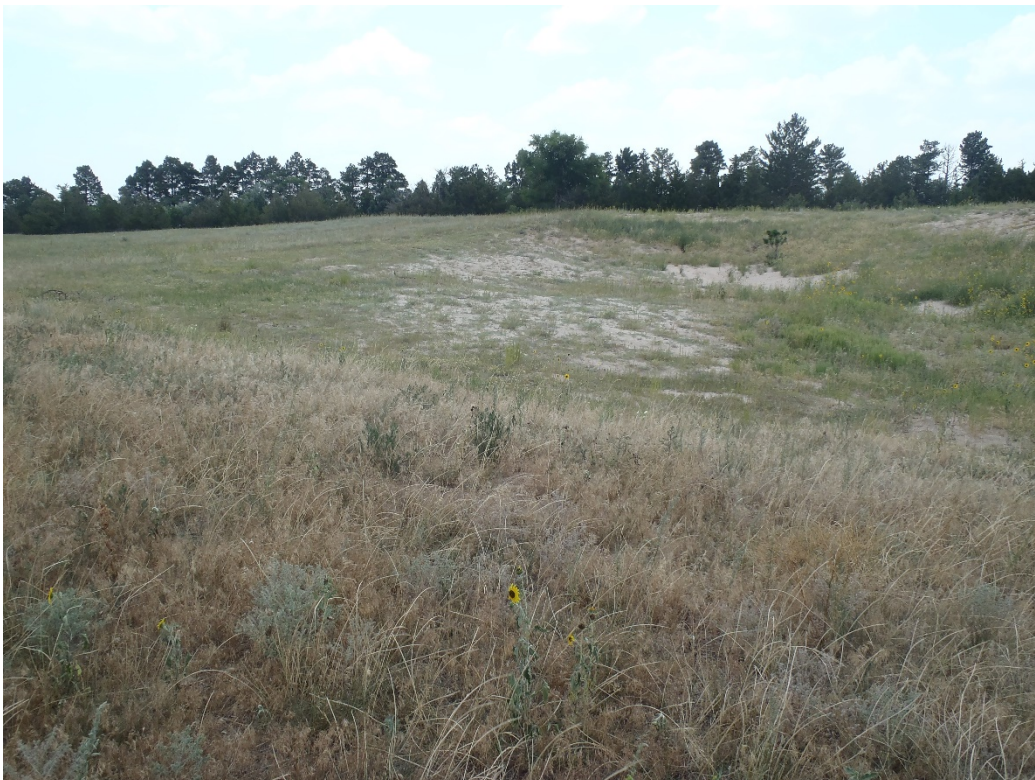
Photo 2. Reclaimed east end of pit (looking south).

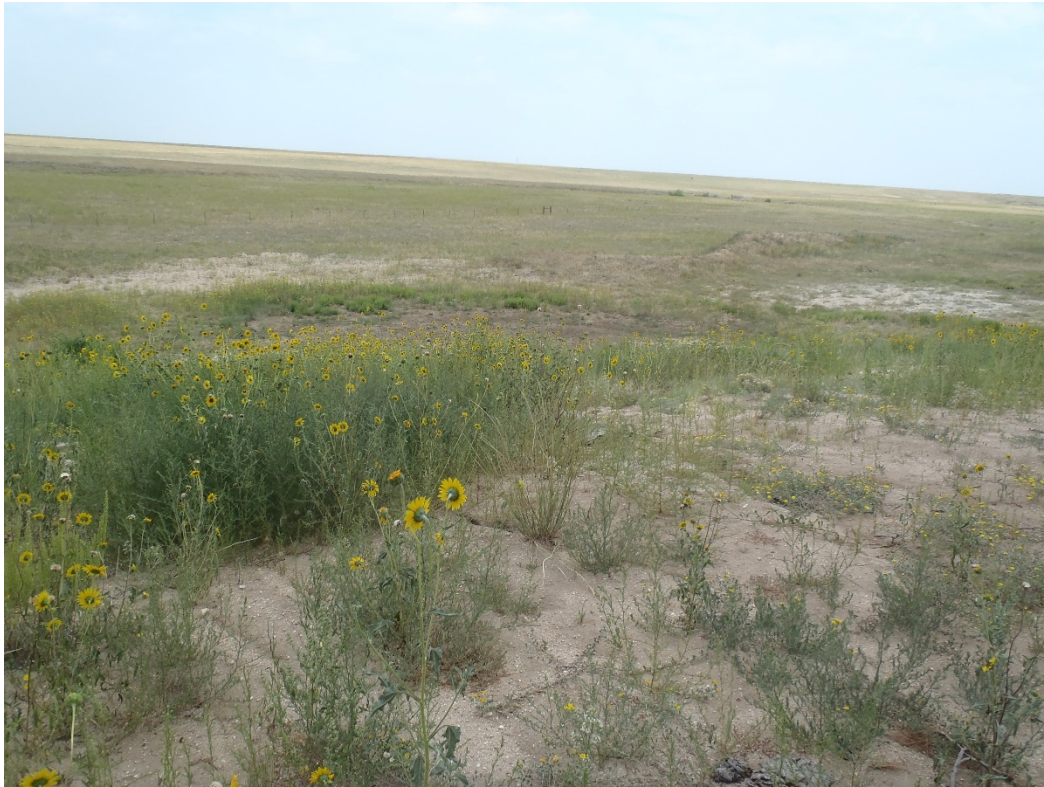
Photo 3. Reclaimed pit (looking NE from crest on south side).

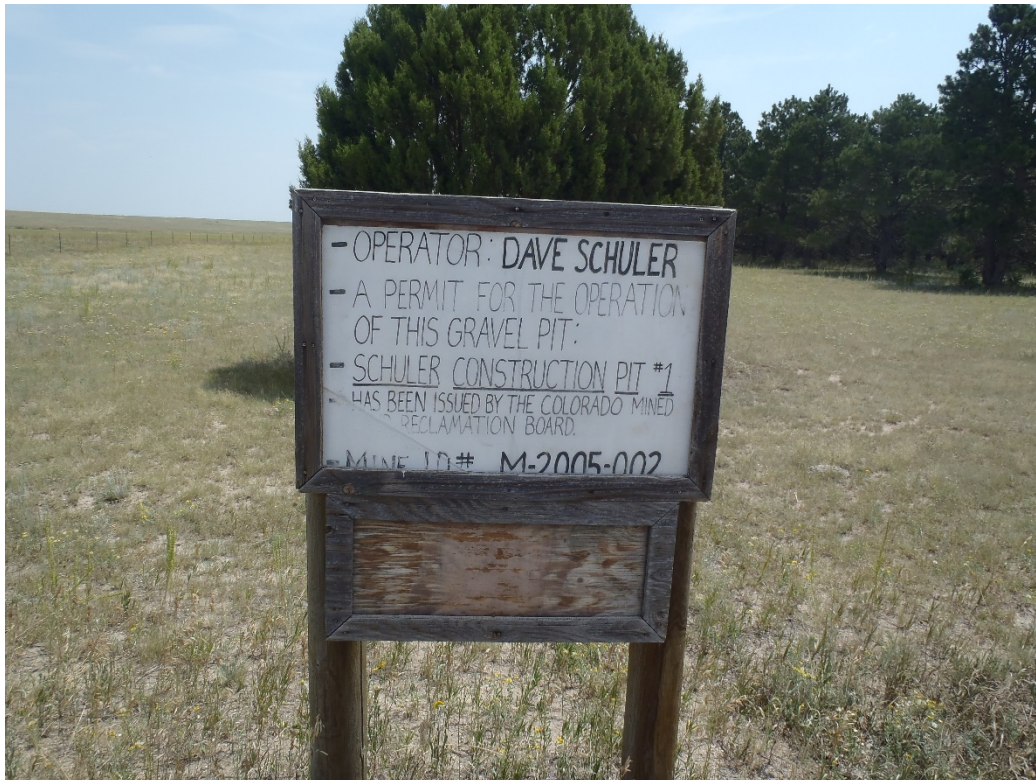
Signs and Markers: The permit sign was properly posted (see **Photo 4**). The north boundary is delineated by a three-wire fence.

Photo 4. Permit sign at entrance off Ramah Hwy.
