MINERALS PROGRAM INSPECTION REPORT
PHONE: (303) 866-3567

MINE NAME: Ghost River Gravel Pit	MINE/PROSPECTING ID#: M-2003-002	MINERAL: Sand and gravel	COUNTY: Huerfano
INSPECTION TYPE: Monitoring	INSPECTOR(S): Patrick Lennberg	INSP. DATE: July 28, 2021	INSP. TIME: 09:30
OPERATOR: HCR High Country Repair	OPERATOR REPRESENTATIVE:	TYPE OF OPERATION: 110c - Construction Limited Impact

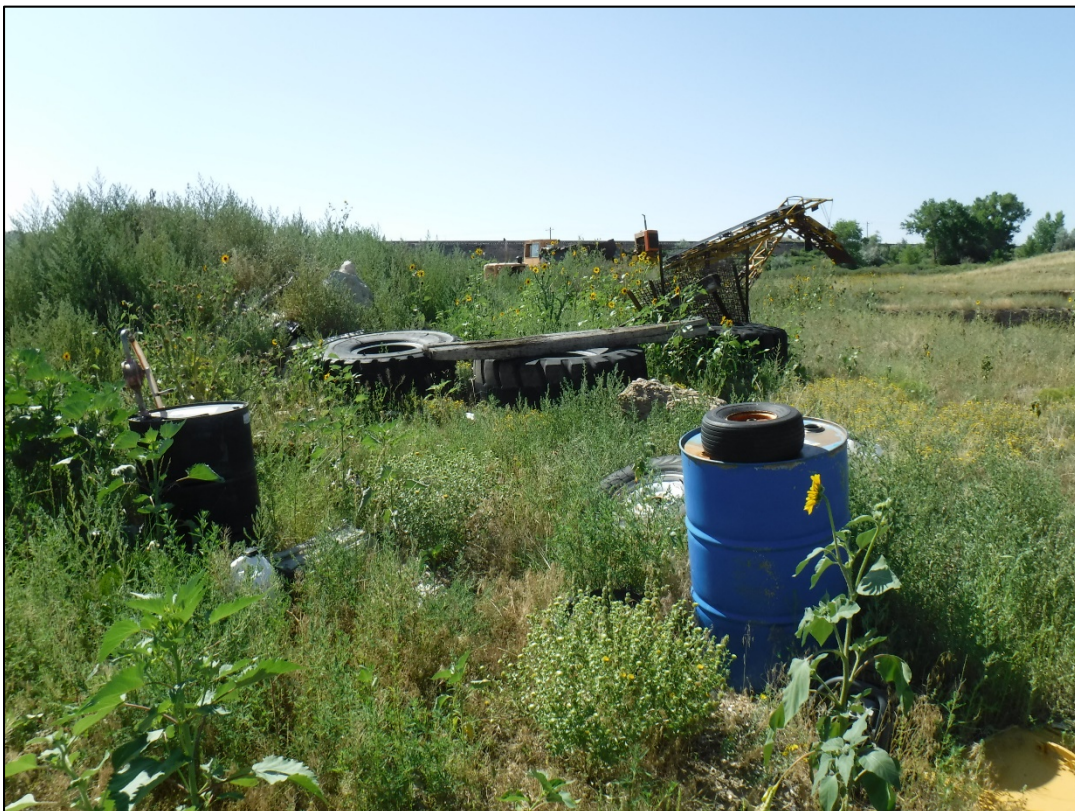
PROBLEM: Trash and refuse was noticed on the site. This is a problem at this time for failure to dispose of refuse in a manner that controls unsightliness or deleterious effects of such refuse pursuant to C.R.S. 34-32.5-116(4)(e).

Along the southern permit boundary, approximately 360 feet from the mine entrance, there were several items of trash that need to be removed. There were empty 55-gallon drums, a small air compressor, and a couple large heavy equipment tires that have heavy vegetation growing around them. Also, the Division noted that a black 55-gallon drum and two concrete pipes have been dumped into the ephemeral drainage along the southern permit boundary and these must be removed. The abundance and types of trash are being cited as a Problem within this report. Pursuant to C.R.S. 34-32.5-116 (4)(e), a duty of the operator, all refuse shall be disposed of in manner that controls unsightliness or deleterious effects of such refuse. It should be noted that a similar problem was cited in the 2017 inspection report.

Photo 2: Trash and refuse, including a 55-gallon drum

CORRECTIVE ACTIONS: The operator shall submit a written notice to the Division with photo documentation, that the trash has been removed from the site by the corrective action date.

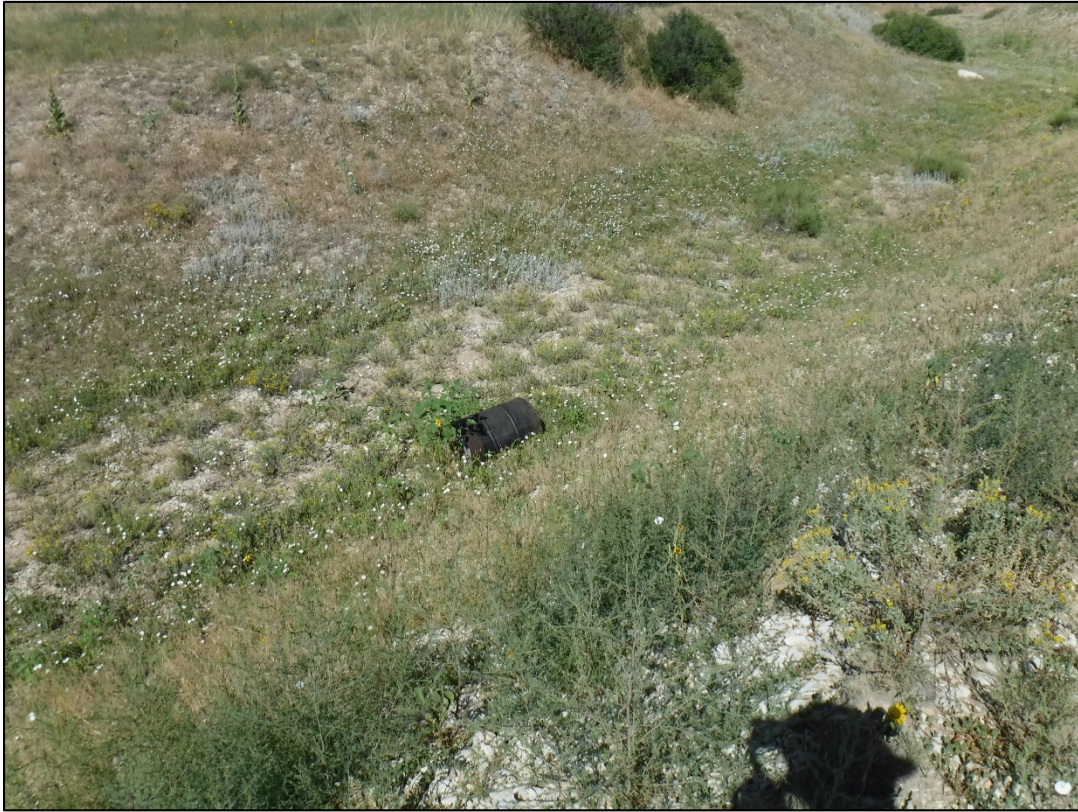
Photo 3: Drum in the ephemeral drainage adjacent to other refuse stored at the site

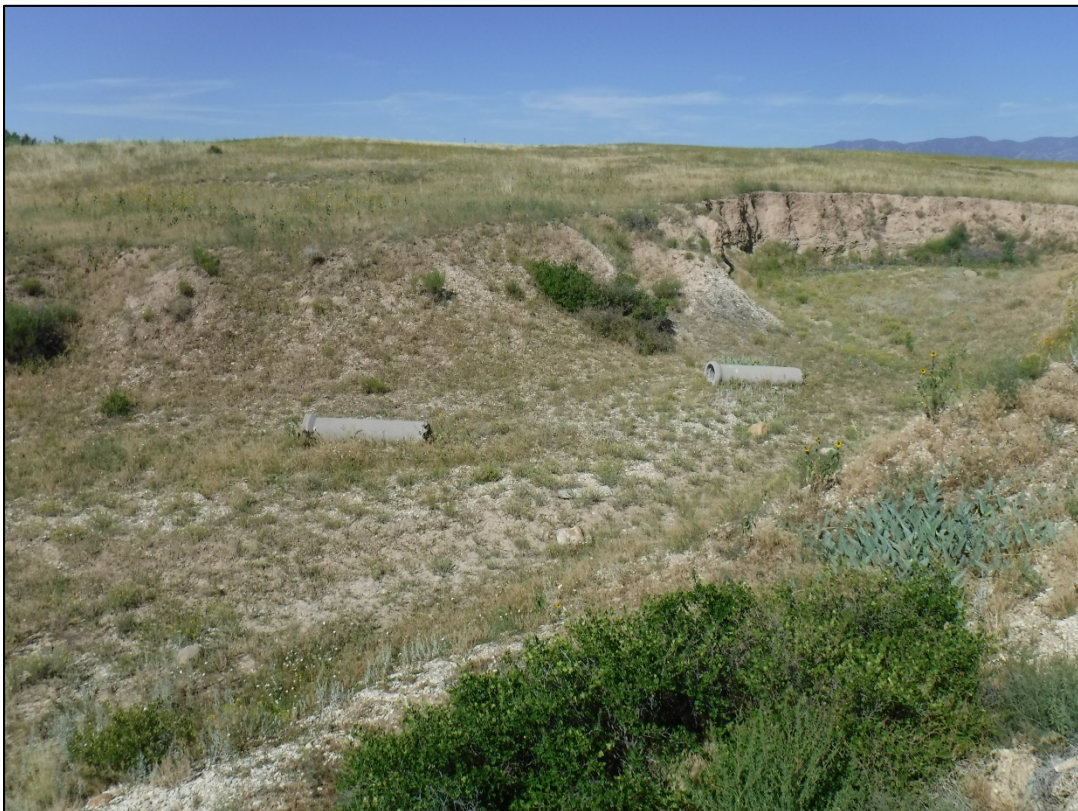
Photo 4: Concrete pipes discarded into ephemeral drainage, downgradient of drum

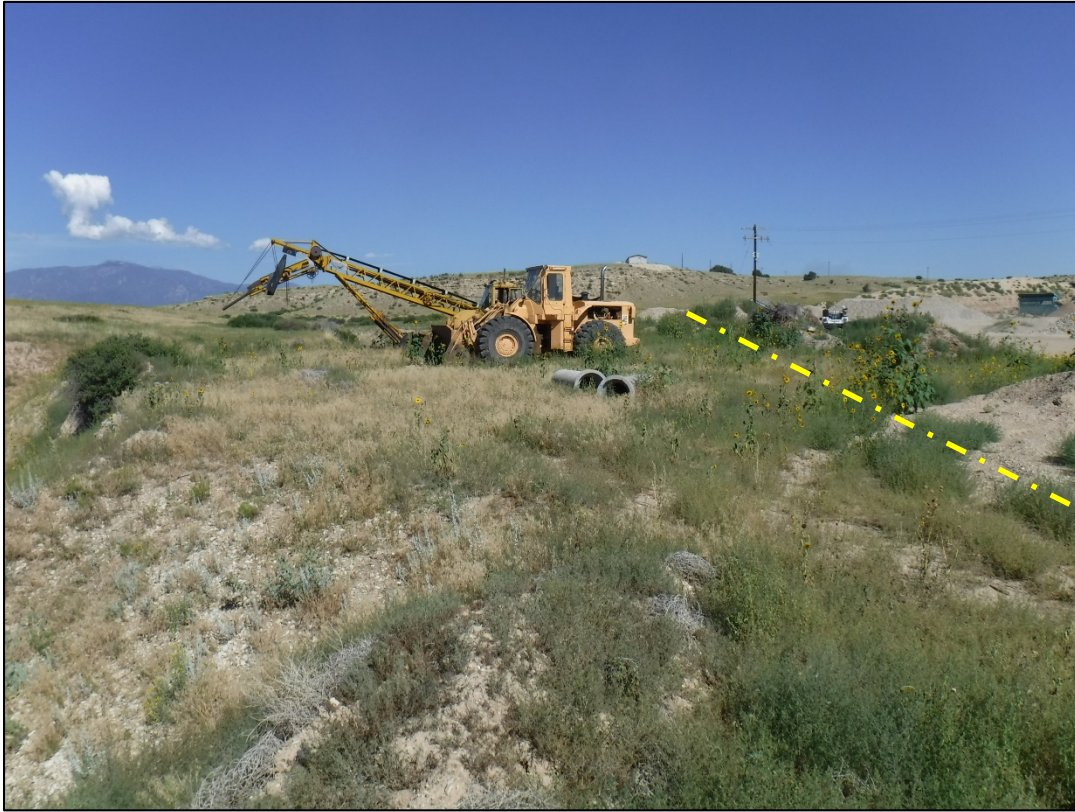
POSSIBLE VIOLATION: Land has been affected outside of the approved permit boundary. This is a possible violation at this time pursuant to C.R.S. 34-32.5-116(4)(i) for failure to protect areas outside of the affected land from slides or damages occurring during the mining operation.

Photo 5: Concrete pipes and mining equipment stored adjacent to ephemeral drainage, center left of photo, yellow dashed line is the approximate approved permit boundary

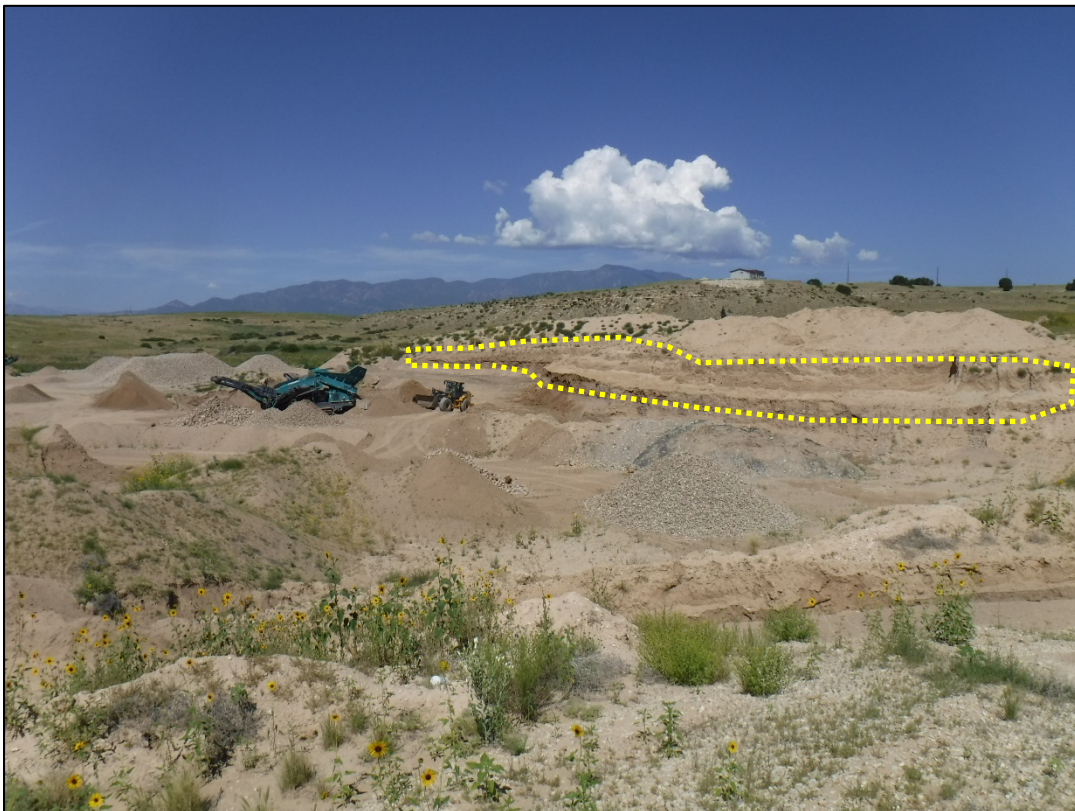
Photo 14: Current central area mining area, area circled in yellow has been benched for safety

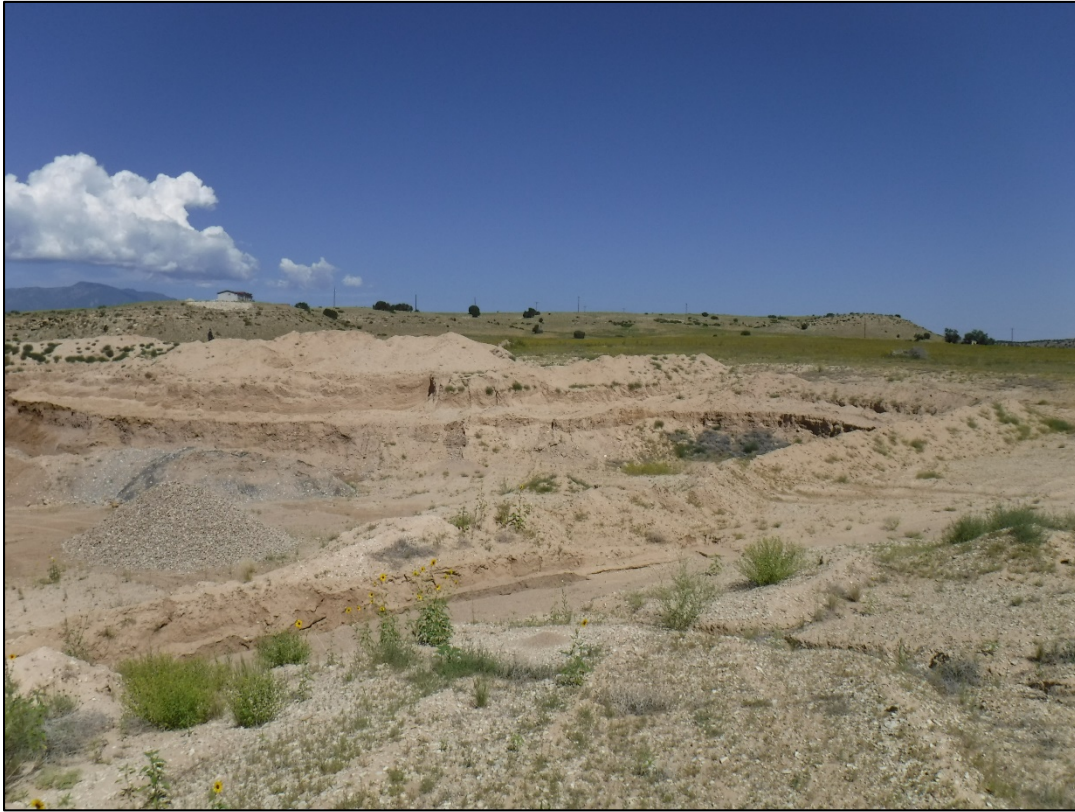
The mine was active at the time of inspection. Kevin Schramek was mining on behalf of the permittee High Country Repair. He was using a portable screening operation to process material at the site. He was working a highwall, near vertical except for safety bench, which extended across the northern portion of the permit area. The highwall was estimated, from aerial imagery, to be 650 feet long and varied in height from 15 to 30 feet. The highwall was benched and bermed by Mr. Schramek for safety purposes. The mining plan states the depth of overburden to be 8-inches to 8 feet depth with the estimated depth of mining to be near 30 feet in depth. The mining plan does not provide details of the highwall configuration.

Photo 15: Northern pit area showing benched highwall

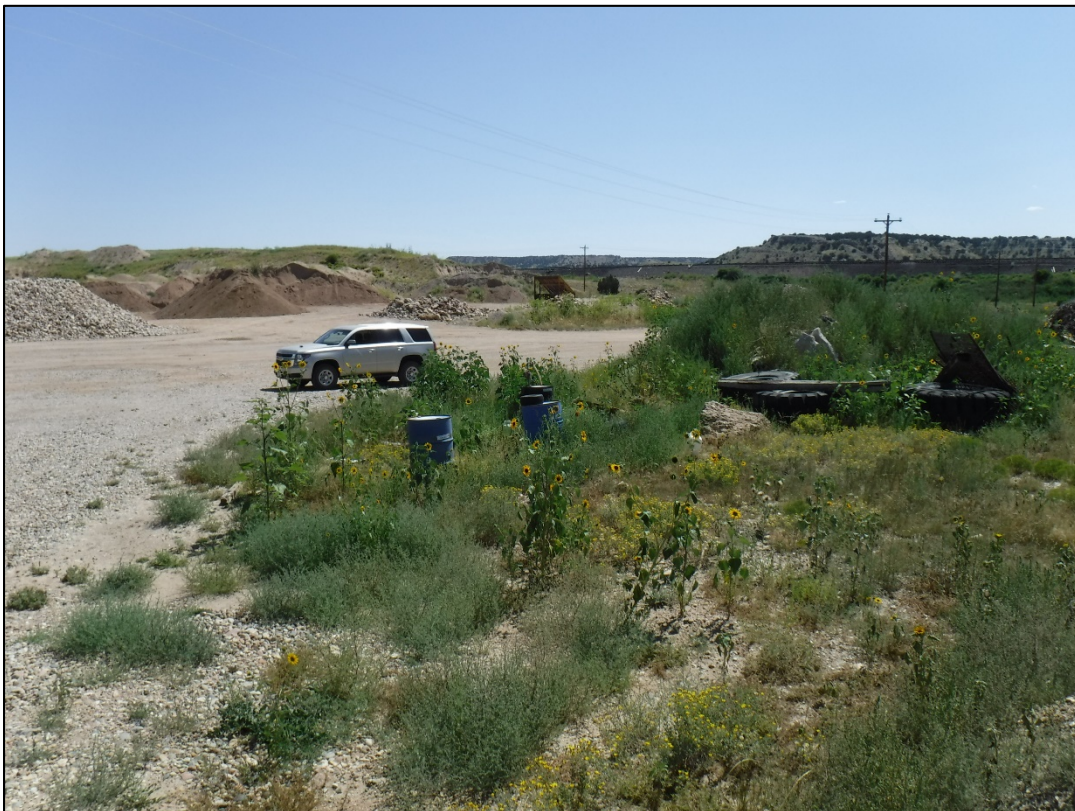
Photo 16: Overview of trash and refuse

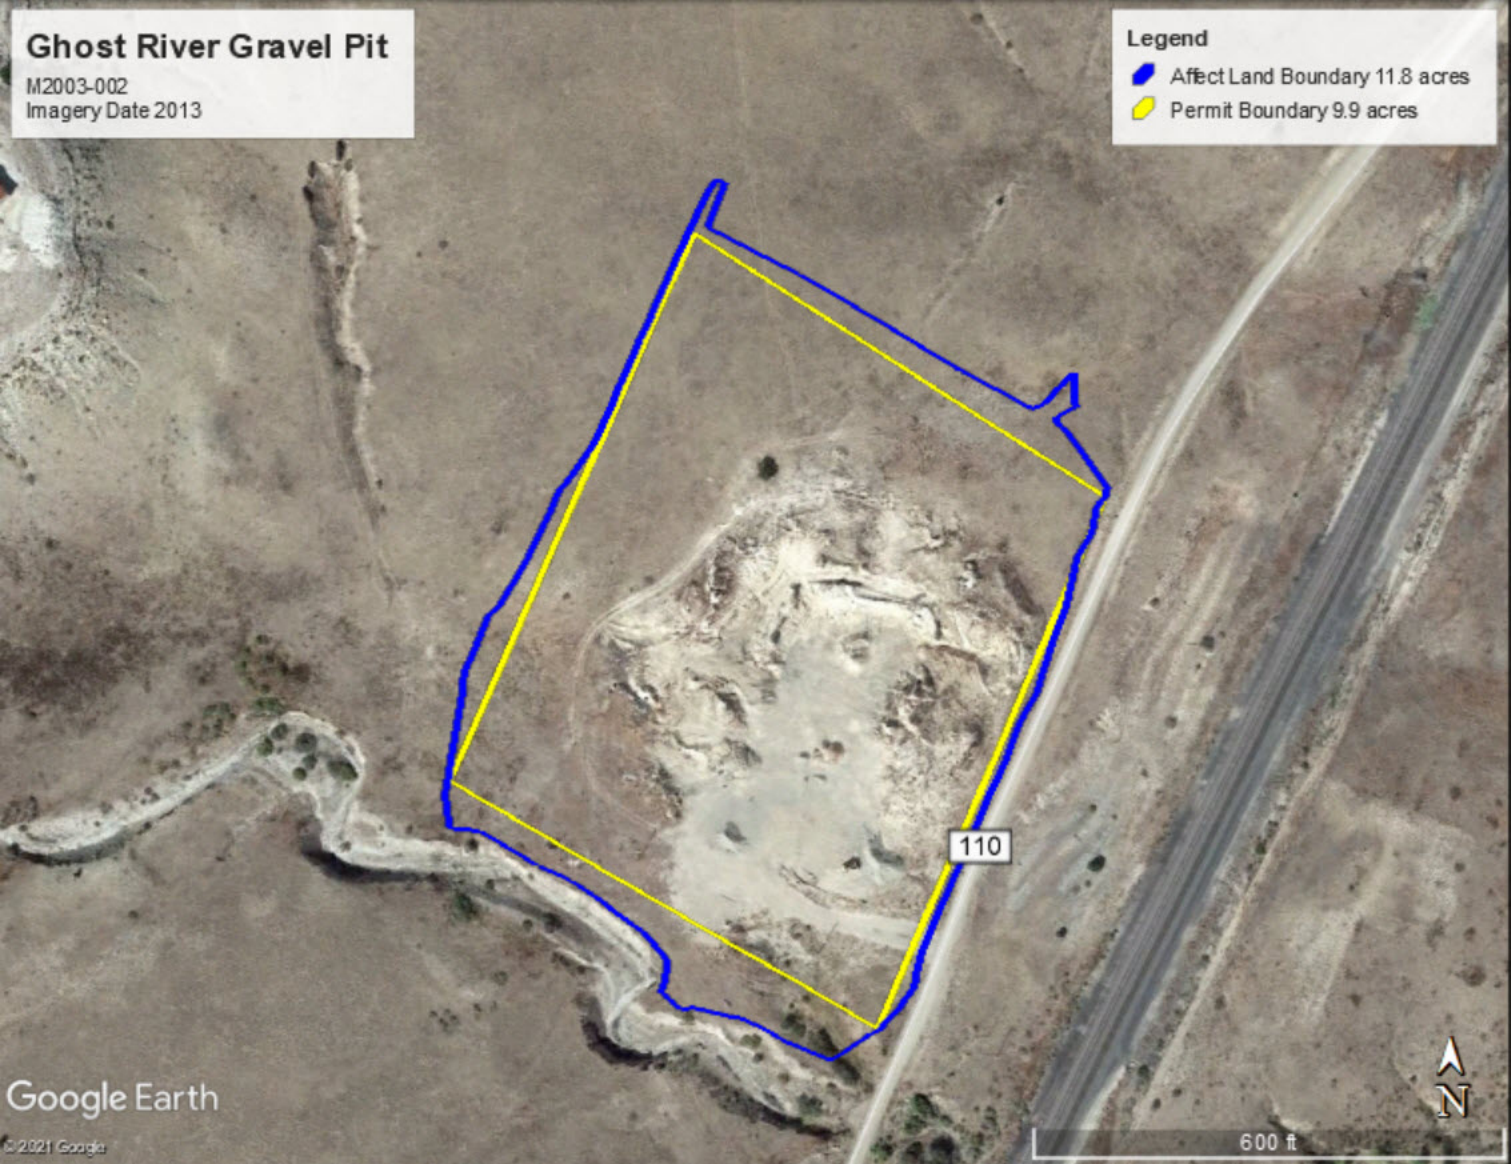
Attachment 1

During the inspection the Division was able to locate all four permit boundary markers. At that time the Division noted that there were mining related disturbances outside the approved permit boundary. The Division used a handheld GPS unit, Garmin 64ST, to measure the perimeter of the disturbed area and determined the disturbed area was 11.8 acres, see attachment 1. The permit is only approved to affect 9.9 acres. The land affected outside the permit boundary, approximately 1.8 acres, is being cited as a Possible Violation pursuant to C.R.S. 34-32.5-116(4)(i) for failure to protect areas outside of the affected land boundary from damages occurring during the mining operation. The Division reviewed the permit area using the Huerfano County Public Map Viewer online and it appears there are some mining related disturbance has occurred on land not owned by Ms. Goldberg, see attachment 2. Additionally, the area measurement using the Map Viewer estimated the disturbance to be 11.3 acres.

Affect Land Boundary 11.8 acres
-
